## PHASE 2 BAT ACTIVITY SURVEY

### LAPWORTH GRANGE

**Project name:** Lapworth Grange, Lapworth, Warwickshire, B94  
5NT

**Date:** 21/09/2022

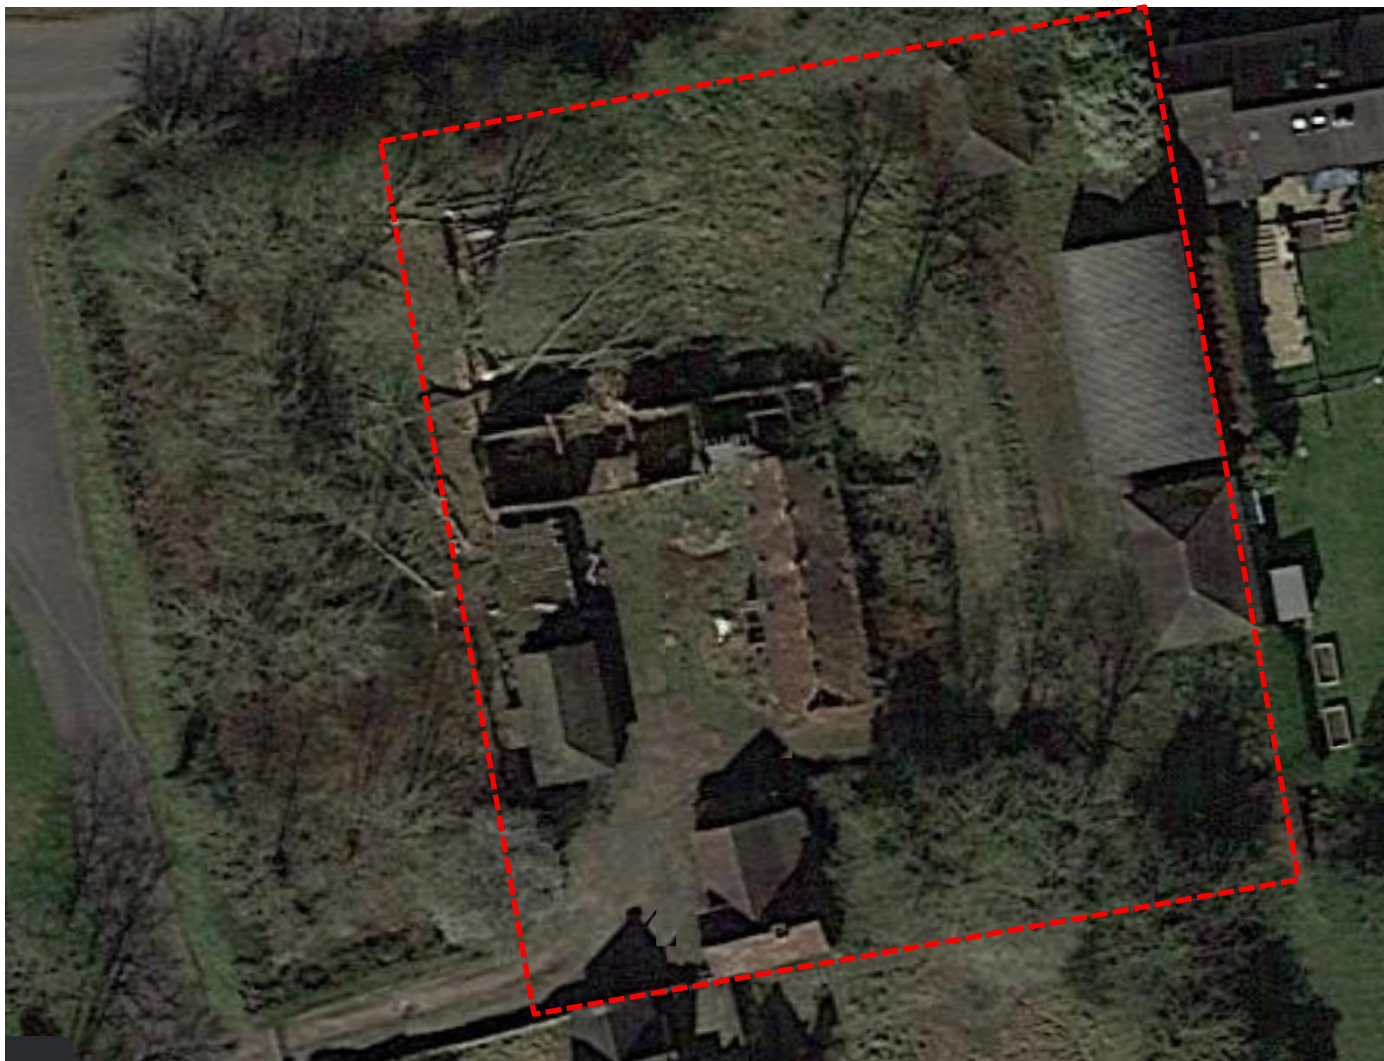
FIGURE 2 AERIAL PHOTOGRAPH AND SURVEYOR LOCATION

Lapworth Grange lies just north of the M40's junction 16 in Warwickshire (Figure 1). The land surrounding the house is a mixture of open parkland with mature trees, large detached residential properties and working farms with agricultural pasture fields (Figure 2). Pools Wood is located 700m from the site which features ancient and semi-natural woodland.

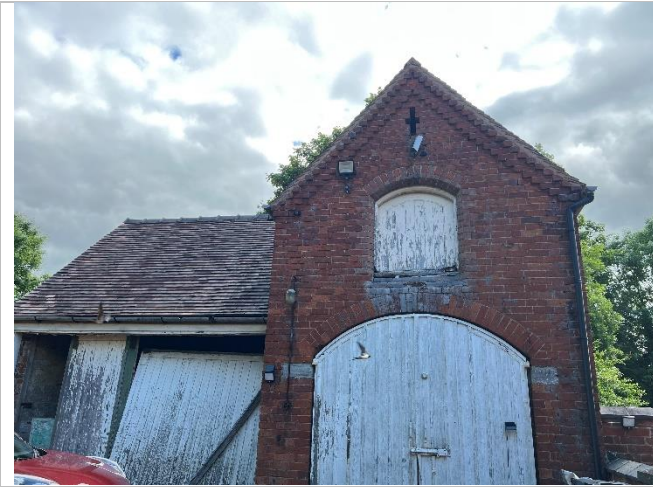
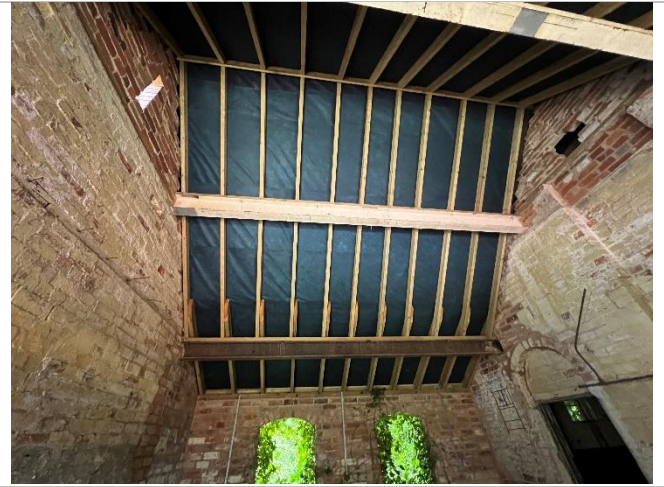
The Original Coach House for Lapworth Grange (referred to as B1) dates back to the 19<sup>th</sup> century. It features one and two storey sections, open access into both areas through uncovered apertures, brick construction with a clay tiled roof and is newly lined throughout. Some of the roof timbers have been replaced with new material and the whole roof has been upgraded. There is a lean-to brick extension at the north gable and ventilation slits in the external brickwork.

Reference	Description
<b>B1</b>	Small number of brown long-eared bats found roosting in 2016. Conditions similar, building provides suitable shelter for bats.
<b>B2</b>	A small number of potential roosting features identified e.g. slipped tile and areas beneath timber soffits. No bat evidence, low potential.
<b>B3</b>	Most of the roof is missing and the structure is entirely open to the elements. Very limited suitable roosting opportunities and negligible potential as a roost.
<b>B4</b>	Roof in good condition but some potential roosting features in slipped tiles. Low potential.
<b>B5</b>	Seemingly very little potential for bats but a single common pipistrelle was found to be using the barn as a day time roost in 2016.
<b>B6</b>	Roof almost entirely obstructed by vegetation growth. No evidence of bats and low potential as a roost.
<b>B7</b>	Roof in good condition but partly obstructed by vegetation growth. Low potential.

- The work will be timed so as to avoid the main activity window for bat species i.e. building to be sealed and roof repairs carried out between October and April in a given time period.
- A purpose built bat loft will be created in-situ above B1 and will be ready by 1<sup>st</sup> May in any year following the conversion work. The bat loft will comprise the following features:
  - The void height (floor to ridge) should be at least 2m and preferably exceed 2.5m (Razgour et al. 2013), with a length and width of at least 4m (preferably 5m) as detailed in English Nature's Bat Mitigation Guidelines (Mitchell-Jones 2004).

- An access hatch measuring 600mmx600mm will be the only entrance to the loft which will provide a point of entry for inspections by NE or the licenced ecologist.
- Bat access points will be created at the north facing gable using the existing ventilation gaps in brickwork.
- Internal roosting features will be installed to include rough sawn boards and sheets fixed to the underside of the rafters to create voids and crevices within.
- Any parts of the roof which are currently exposing breathable roof membrane will be covered over to prevent the trapping and death of individual bats. Use of breathable roofing membrane within a bat roost is not permitted.
- The bat loft will not be used for storage or other purposes.
- A Wildlife Sensitive Lighting Plan will be designed and implemented for the site as a whole.

B1 should be sealed entirely during the winter months between October and March to prevent returning birds from nesting within. The nesting season can sometimes fluctuate and therefore the building should be sealed once it has been confirmed that swallows or other nesting birds have left/are not present.

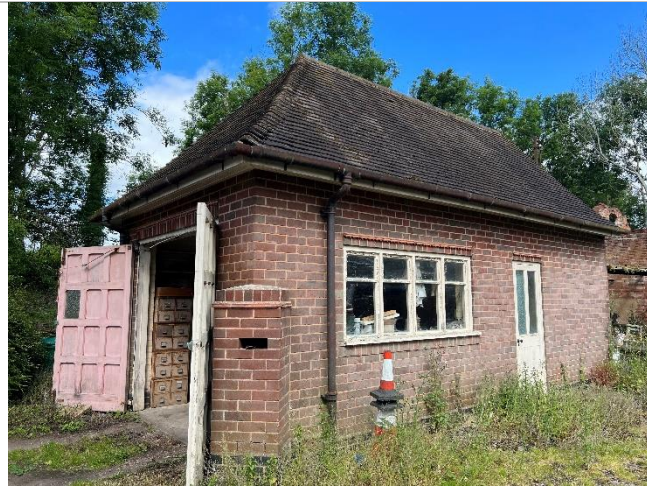
B2 is a one and two storey garage/workshop with a part hipped clay roof and a boarded/plastered room above. Timber soffits are fixed around the edge of the building and some windows are broken/missing.

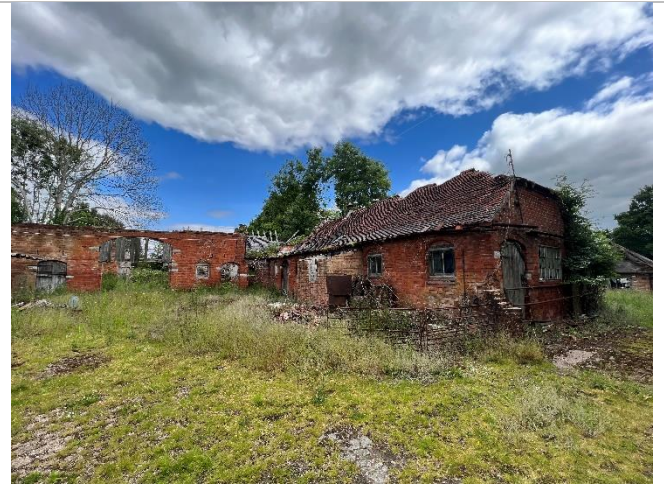
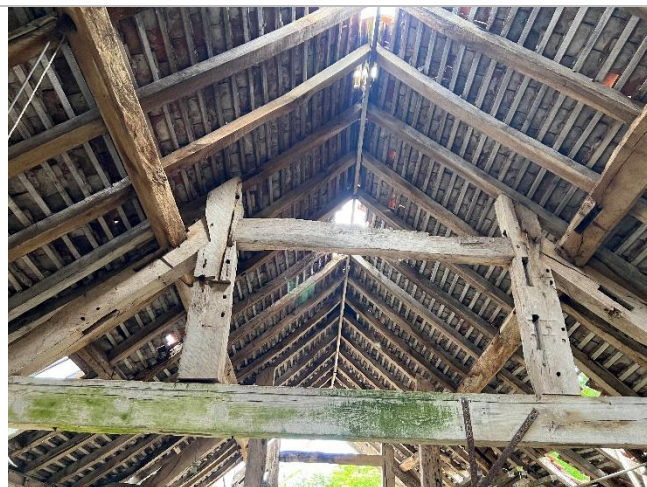
B3 is an L-shaped barn which has partly fallen down. The east wing remains but with the roof in serious decline and entirely open to the elements.

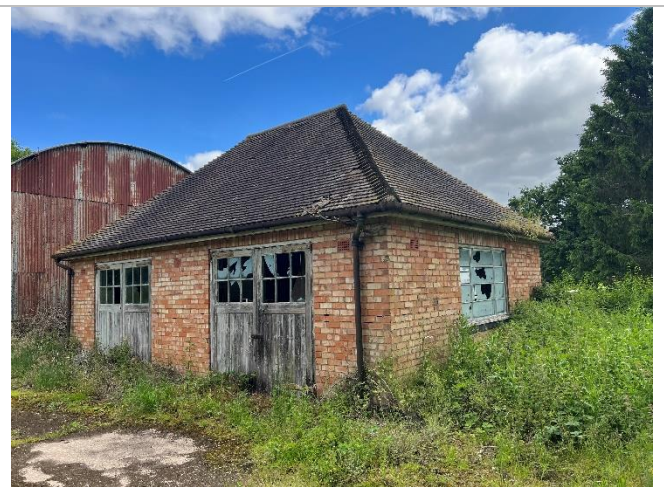
On the east side of the site, B4-6 are aligned with B7 adjacent. B4 features brick under clay garage with a hipped roof and enclosed loft above. The roof is lined and there are several broken windows providing access points into the structure. B5 is a steel frame Dutch barn with a small brick wall base and a tin roof covering. B6 is a single storey stable block of brick under clay construction. The roof is now overgrown with vegetation and shaded by overhanging branches of nearby trees. The verges of the roof are cemented at the gable ends. B7 is similar in construction to B4- hipped clay roof over a brick base with an enclosed loft above which is felt lined.

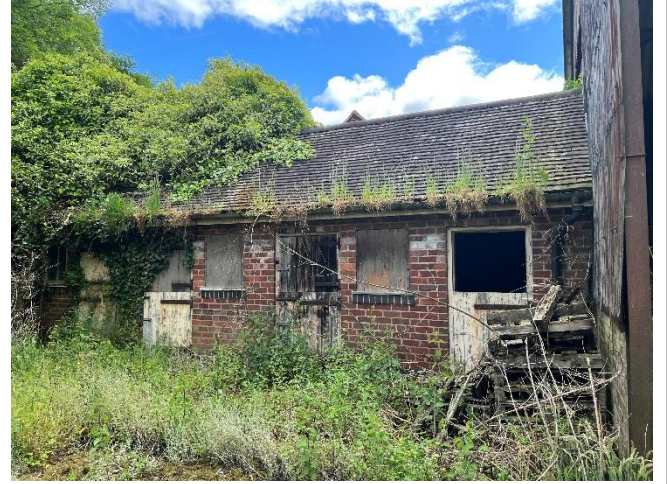
The north elevation of B6 and B7 is entirely obstructed by mature, dense vegetation growth. The areas were not visually accessible but similarly, would not provide suitable access points.
