Preliminary Roost Assessment & Preliminary Ecological Appraisal Smerill Farm, Kemble

October 2023

Client	Mark Harris
Project Name	Smerill Farm, Kemble
File Reference	PRARP-20231101-V001-Smerill Farm

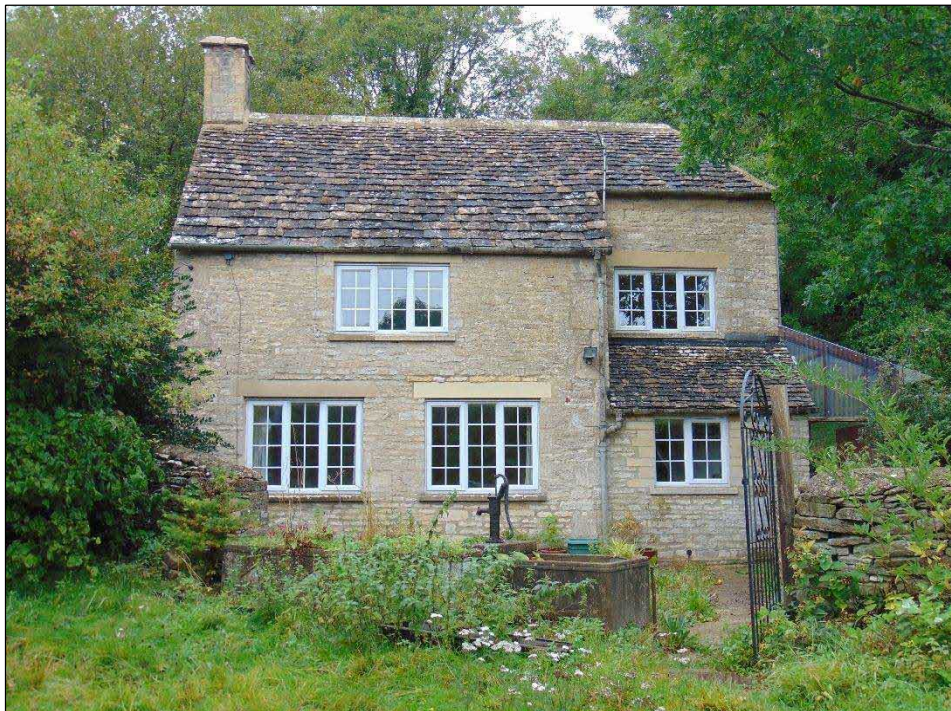
The main structure here is a small traditionally-built two storey dwelling, here referred to as “the cottage,” constructed from mortared Cotswold limestone rubble and with a double-pitched Cotswold tile-stone roof; a small single pitch section of tile-stone roof is present over the western elevation of a kitchen extension. The ridge tiles are in good condition. The southern and eastern elevations have a 1m wide concrete surfaced walkway around their edge with a stone revetment

Above: western elevation of the cottage

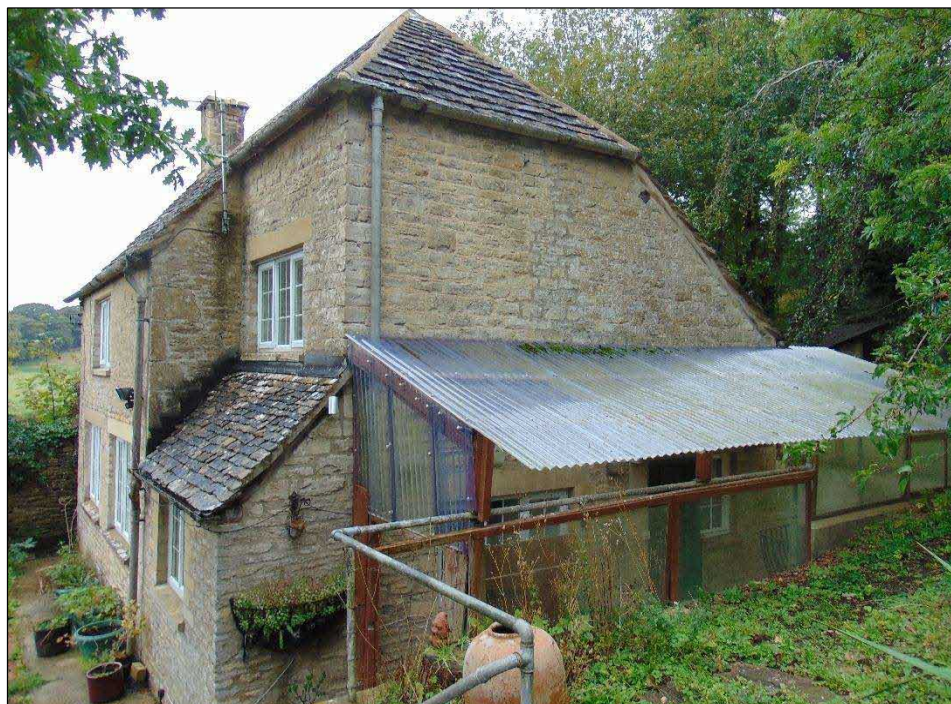
Above: the southern and western elevations of the cottage

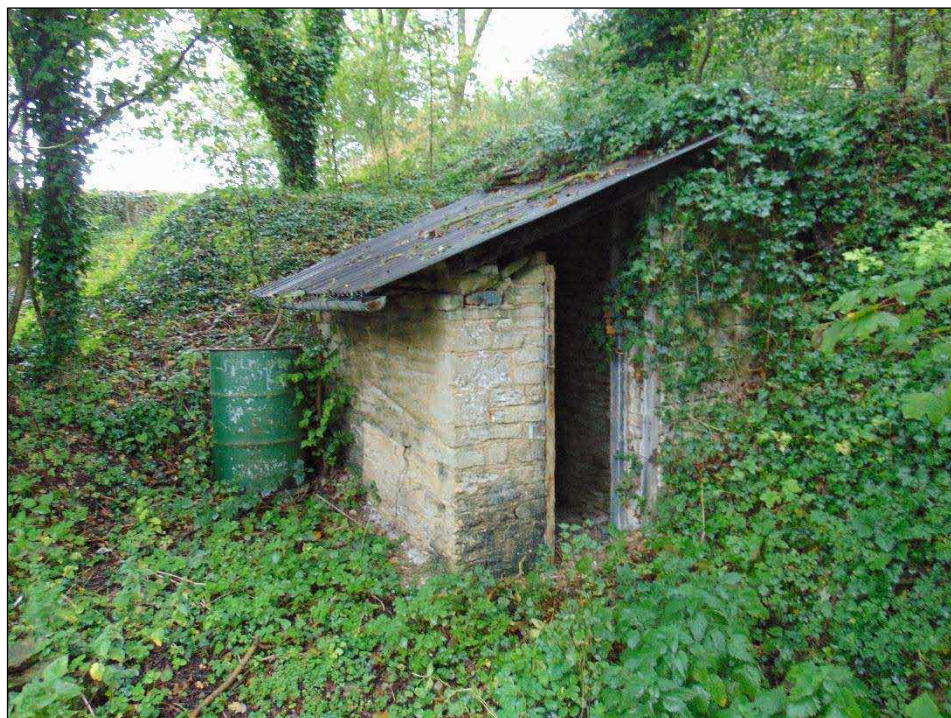
Immediately north-east of the dwelling are two redundant small structures: a greenhouse and a shed, the latter constructed from mortared Cotswold stone rubble and partly-dressed stone with a single pitch corrugated metal roof and a doorway without a door. Between these structures and the cottage is an area of paved courtyard.

Above: The small stone-built shed

In addition the stone-built shed to the north of the cottage has Moderate potential as a night roost for bat species. The byre in the west of the northern paddock also offers Moderate night roost potential for bats but to a significantly lesser extent than the stone-built shed due to its construction materials having poorer thermal properties and the size of the byre's entrance potentially allowing for greater exposure to wind, rain and temperature fluctuations.

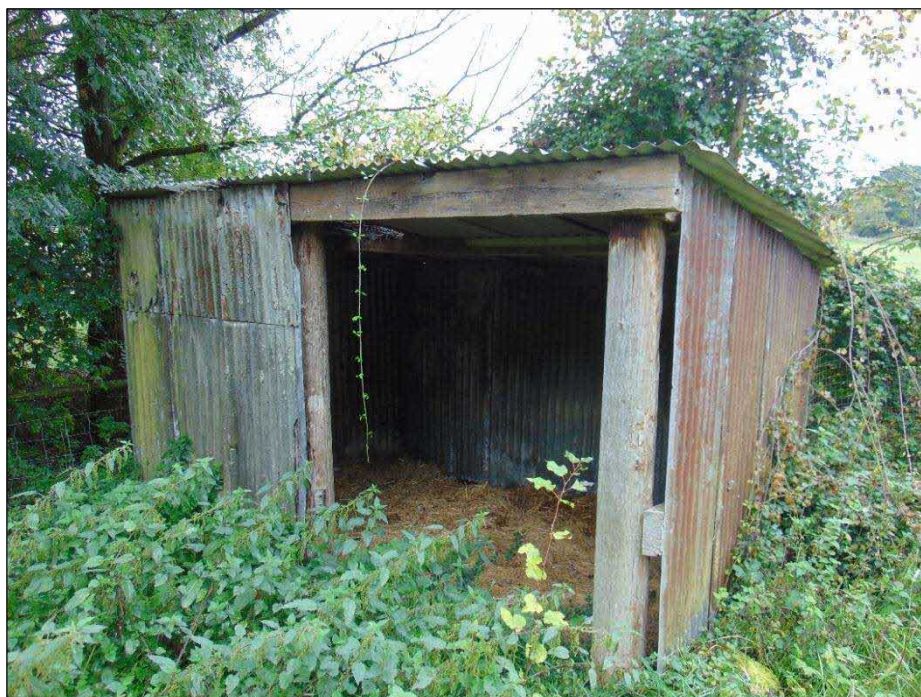
In the paddock immediately west of the dwelling, where the proposed annexe would be built, is a derelict byre built from corrugated metal panels over a timber framework and with a single pitch corrugated metal panel roof. The byre's entrance, in the south-eastern elevation of this structure,

has no doorway and thus is permanently open. A quantity of old hay and straw within the byre suggests that it was formerly used as a stable or other animal shelter.

Above: the byre

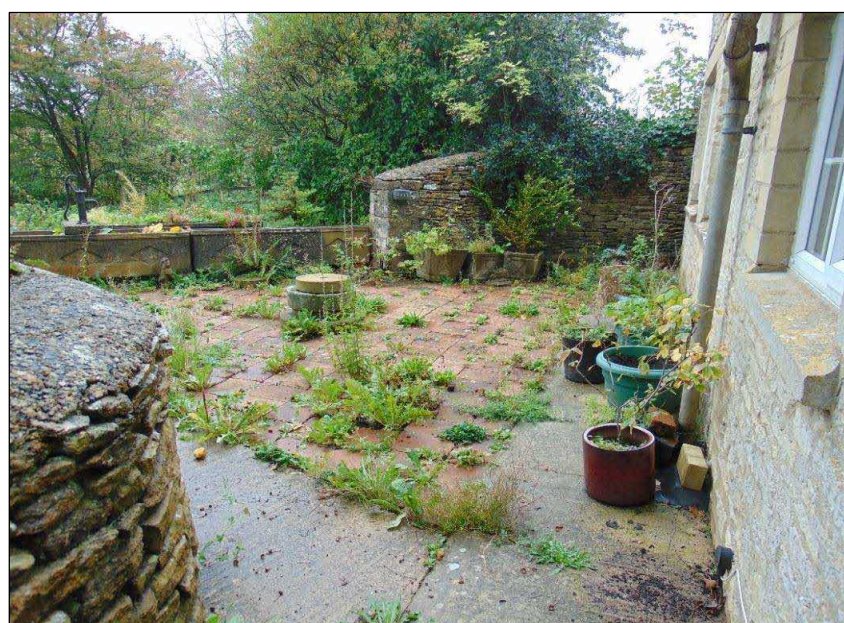
To the south-west of the cottage is a small paved courtyard with several herbaceous and woody species in planters. There are also many weeds here -a mix of native and non-native species. Two large and one small concrete water troughs form much of the western curtilage of this courtyard whilst a drystone retaining wall forms its southern edge.

Above: the western courtyard

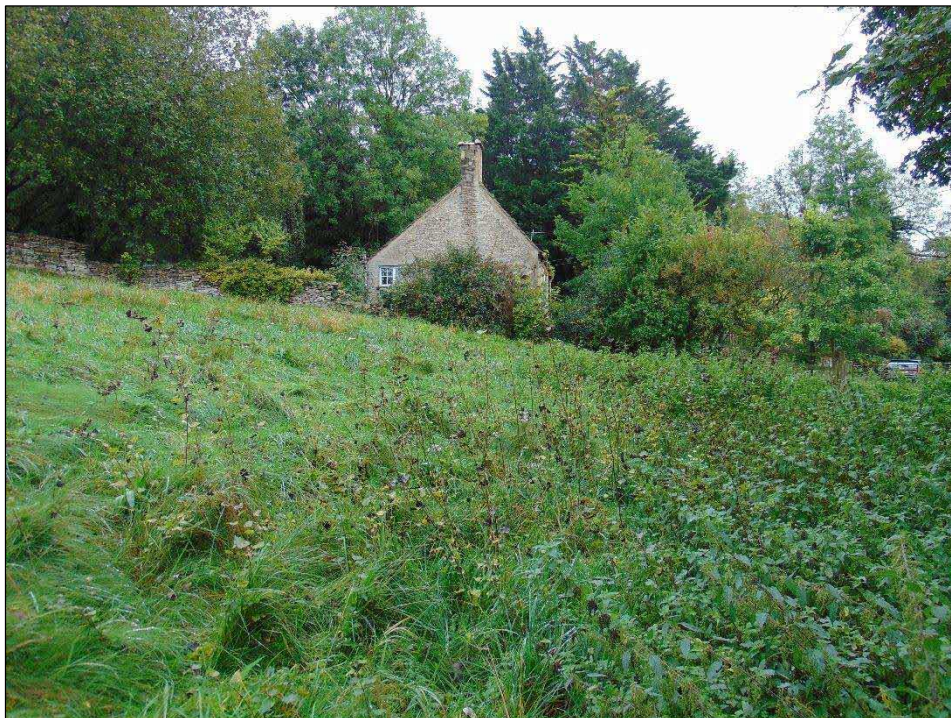
Above: area of the northern paddock where the annexe will be built -looking south-east

However the part of this paddock where the proposed annexe is located has a semi-improved neutral grassland sward where common bird's-foot trefoil *Lotus corniculatus*, rough hawkbit *Leontodon hispidus*, common rest-harrow *Ononis repens* and lady's bedstraw *Galium verum* are all present in small quantity.

To preserve this grassland community on the site it is recommended that it be carefully lifted as thick turves (preferably as long strips of thick turf with much soil attached) and placed outside the area of the northern paddock where works and associated vehicle movements and material storage will be occurring. The receptor site will have to have been prepared beforehand by stripping an equivalent area of species-poor turf elsewhere in the northern paddock. Once the semi-improved neutral grassland turf has been translocated in this manner it will need to be watered regularly, particularly so if the operation is conducted during a period of dry weather.

In addition it is recommended that the area of the northern paddock supporting semi-improved neutral grassland be turf stripped and the turf translocated elsewhere within the paddock.

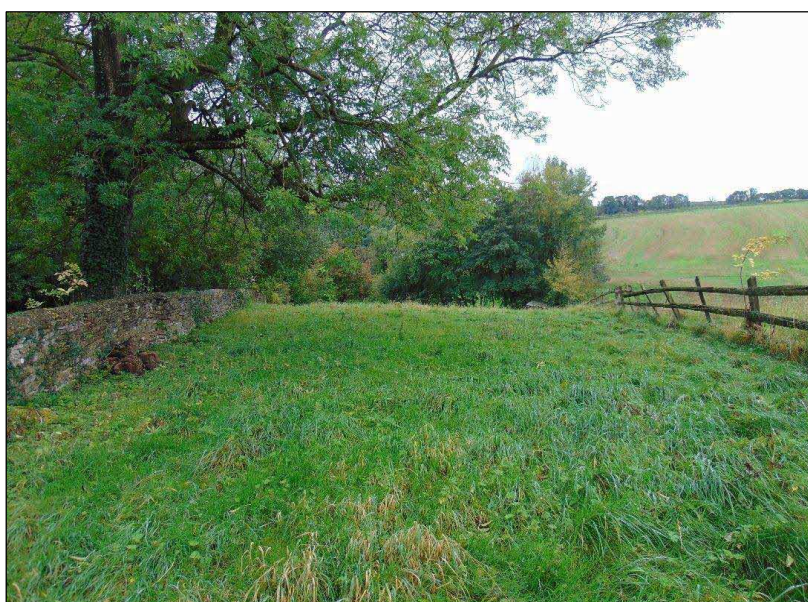
The northern half of the northern paddock is a species-poor semi-improved grassland dominated by false oat-grass and with a very low diversity and abundance of herb species; no species of any note were recorded here.

Above: northern half of the northern paddock -looking south

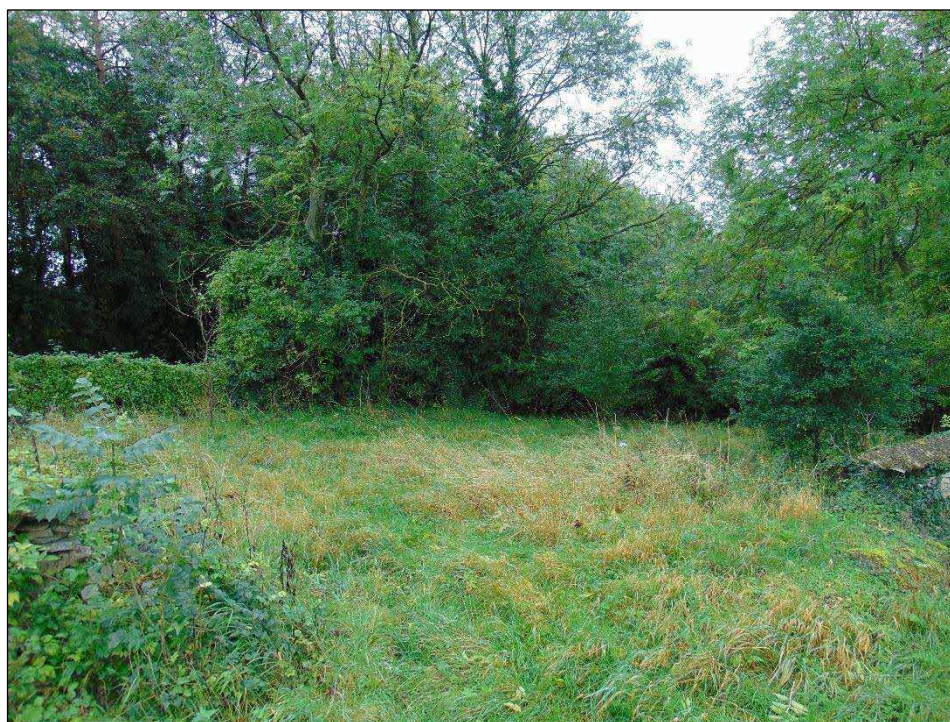
Within the northern part of this woodland there is a large glade of species-poor grassland.

Above: glade within the woodland area

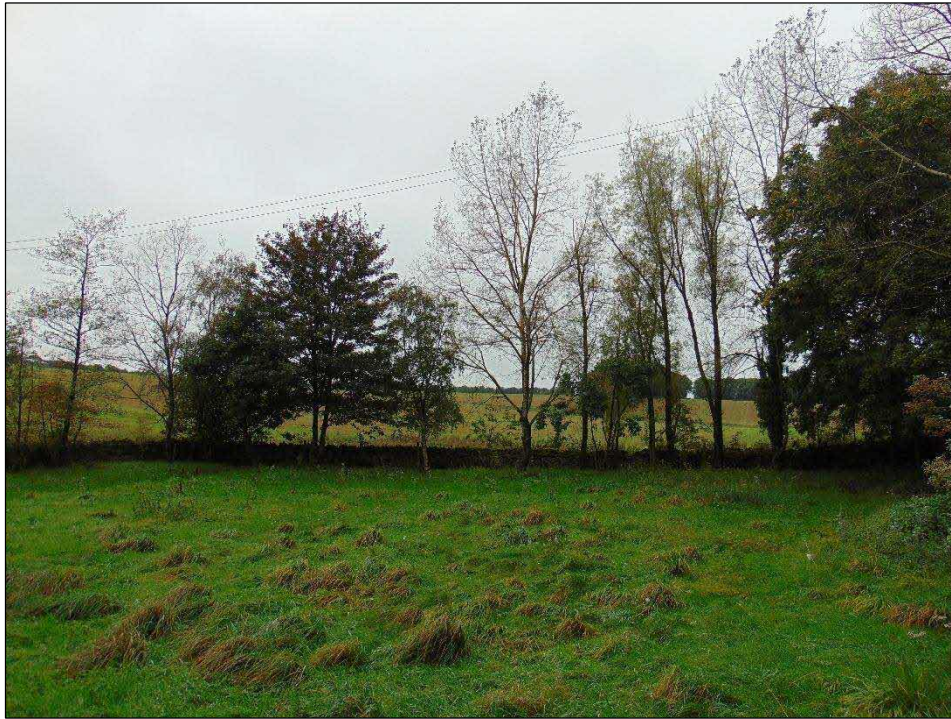
The western paddock has a species-poor semi-improved grassland sward apparently dominated by perennial rye-grass, bents *Agrostis* spp., false oat-grass, fescues *Festuca* spp., cocksfoot, yarrow, ribwort, creeping buttercup *Ranunculus repens*, meadow buttercup, ground ivy, and a small quantity of black knapweed *Centaurea nigra*.

The boundaries of this field are dry stone walls, however numerous native and non-native trees and shrubs have been planted adjacent to these walls and which include alder *Alnus glutinosa*, goat willow, weeping willow *Salix babylonica*, crack willow, grey poplar, alder buckthorn *Frangula alnus*, and a cotoneaster species *Cotoneaster* sp. amongst others.

Above: the western paddock –looking north

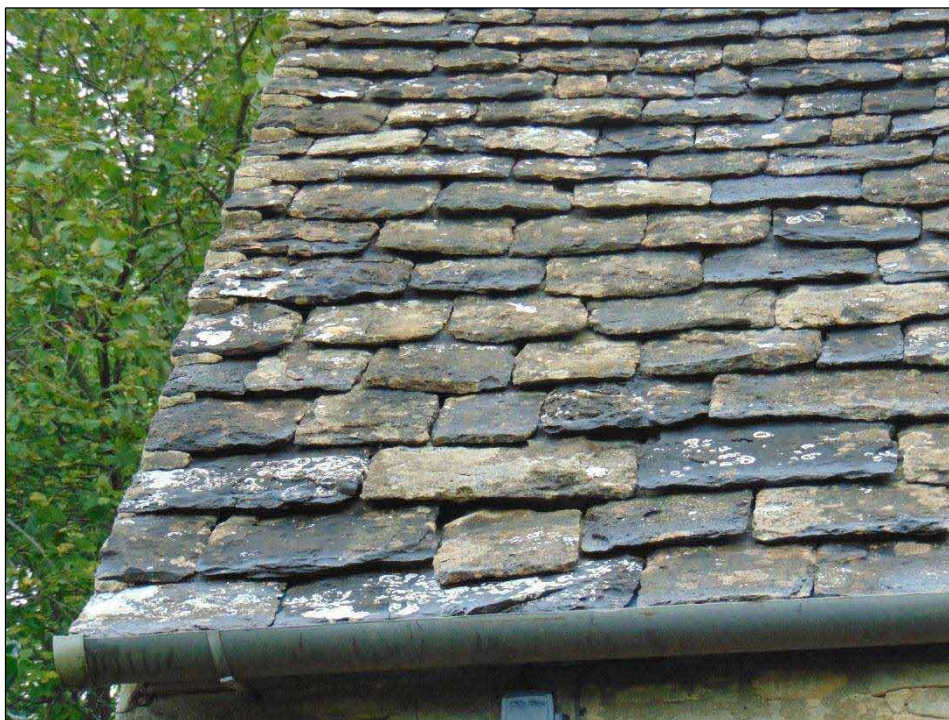
Above: a slipped tile-stone over the western elevation of the cottage

As the cottage is so close to the proposed development site and has been identified as supporting features with both Moderate and Low bat roost potential, it would be advantageous to determine whether bats use this structure as a roost site. Thus it is recommended that additional survey effort to determine the likely presence or absence of bats.

Thus two emergence / roost return surveys should be conducted over the building over dates between May and August inclusive; both surveys could potentially be done in May if atmospheric conditions are favourable or could be staggered across the survey season according to choice and surveyor availability -ideally the surveys need to be a minimum of two weeks apart.

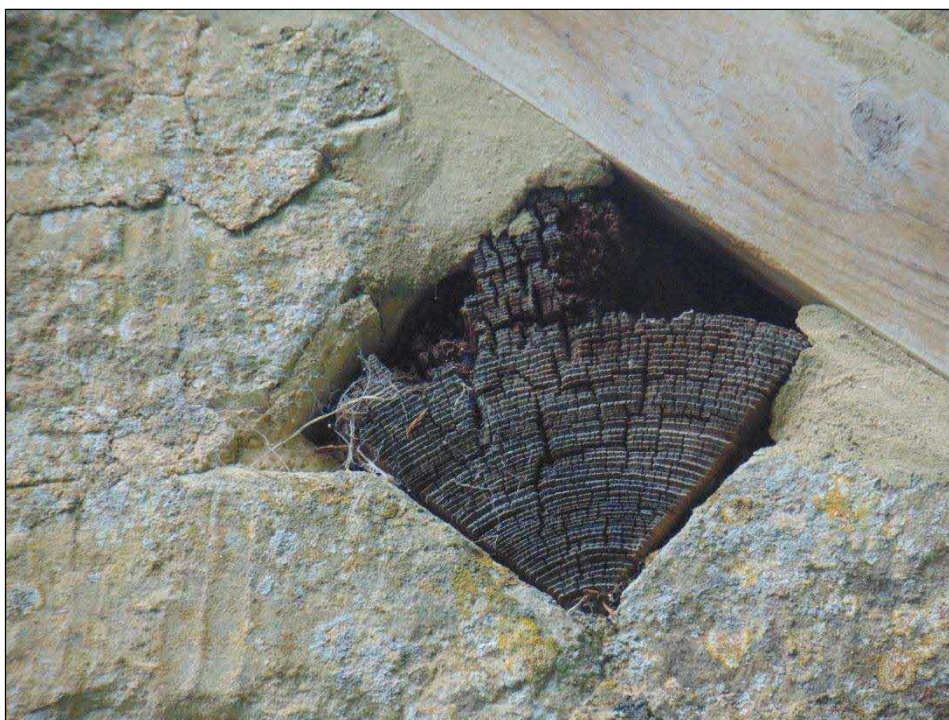
An exposed end of a roof timber is present in the southern elevation of the cottage and a considerable part of this beam has rotted thus creating a cavity which it is considered offers a Low bat roost potential.

Above: the partially rotted end of a roof timber in the cottage's southern elevation

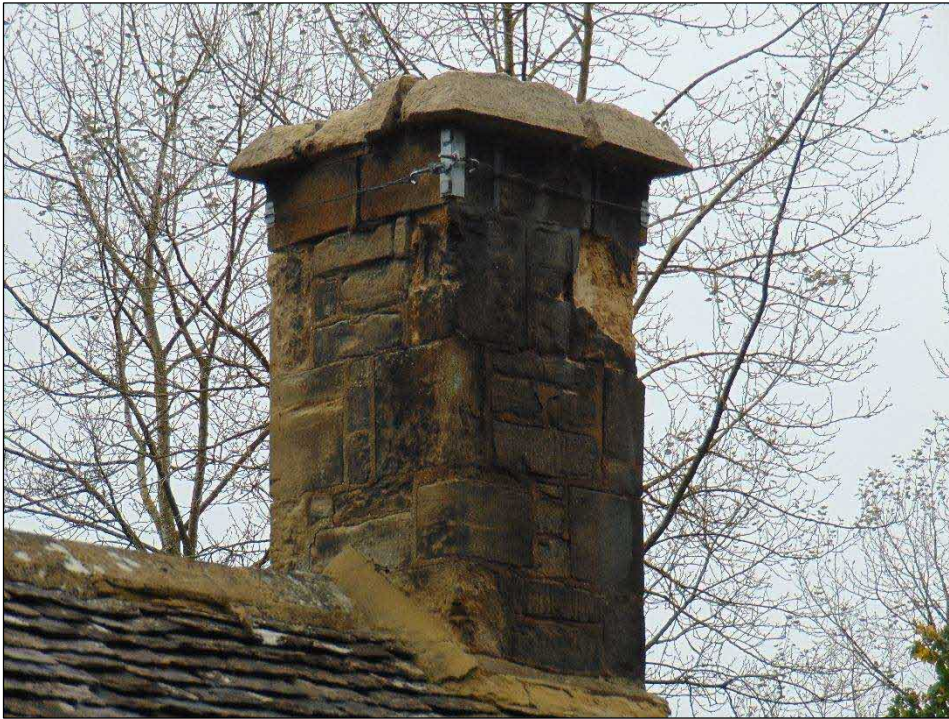
The top of the cottage's chimney is in a poor condition with several gaps between stones having formed and thus this feature offers Low bat roost potential.

Above: the chimney on the northern elevation of the cottage: in poor condition and with Low bat roost potential

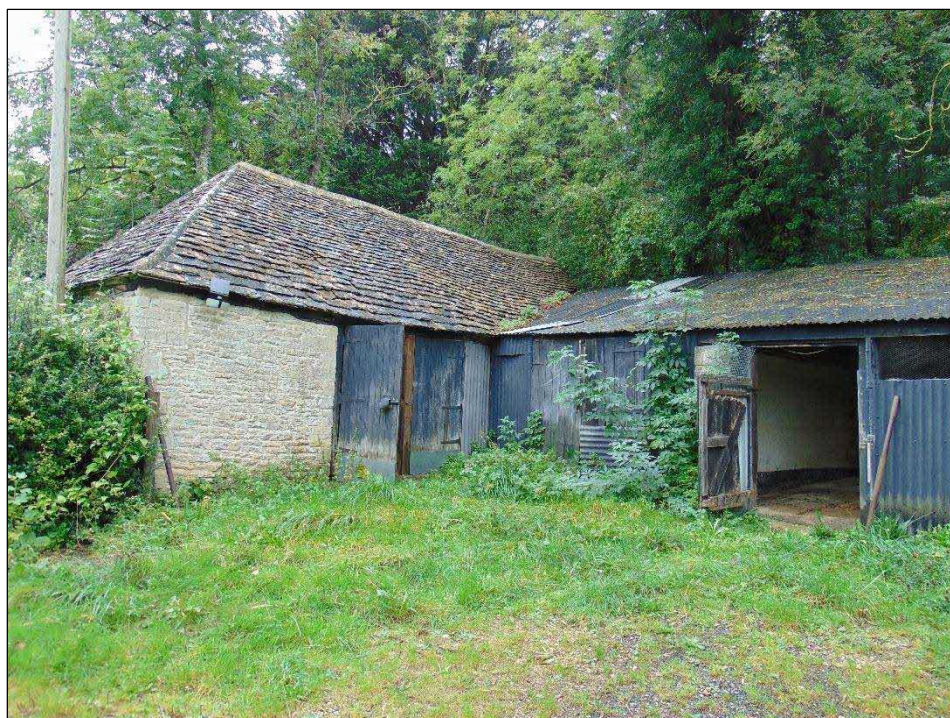
The northern barn, with mortared stone walls, a stone-tile roof and a screed floor has no windows but has a large wooden door in its southern elevation. At the time of survey the barn was largely empty except for some tables and was generally in a clean condition.

The barn provided evidence of breeding swallow *Hirundo rustica* and also a roosting bat, most likely lesser horseshoe bat *Rhinolophus hipposideros*.

Above: the stone barn and the northernmost of the stables
