MILLFIELD HOUSE, BARNSTON

PRELIMINARY BAT ROOST ASSESSMENT

May 2023

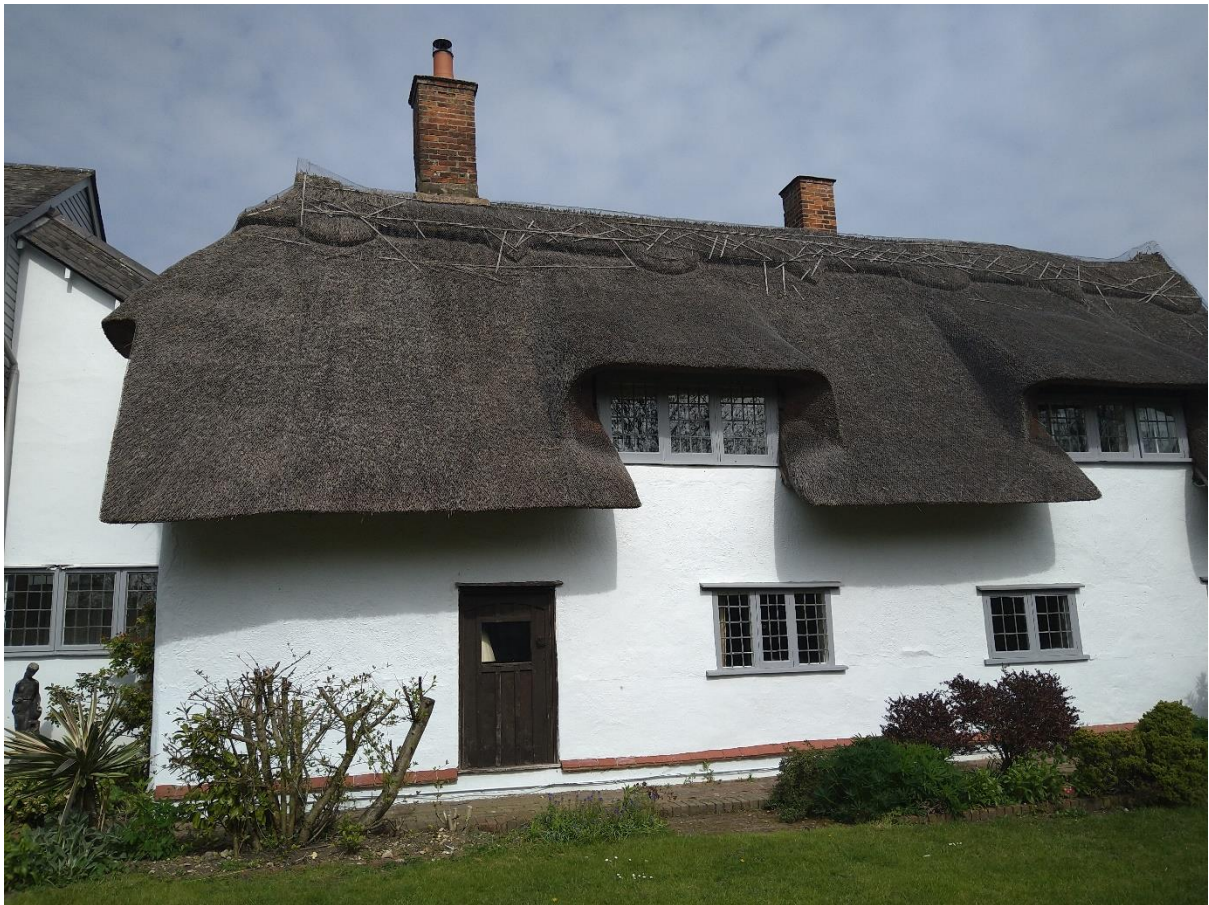
Photo 1: The cottage

The main cottage roof is thatched; this thatching was replaced sometime around 2016, and is well-sealed with narrow mesh, including around the eaves of the roof on all sides. Although gaps in the mesh itself are just over a centimetre in diameter, there were no outfalls or breaks that could be seen around the eaves of the roof where bats could access any part of the building.

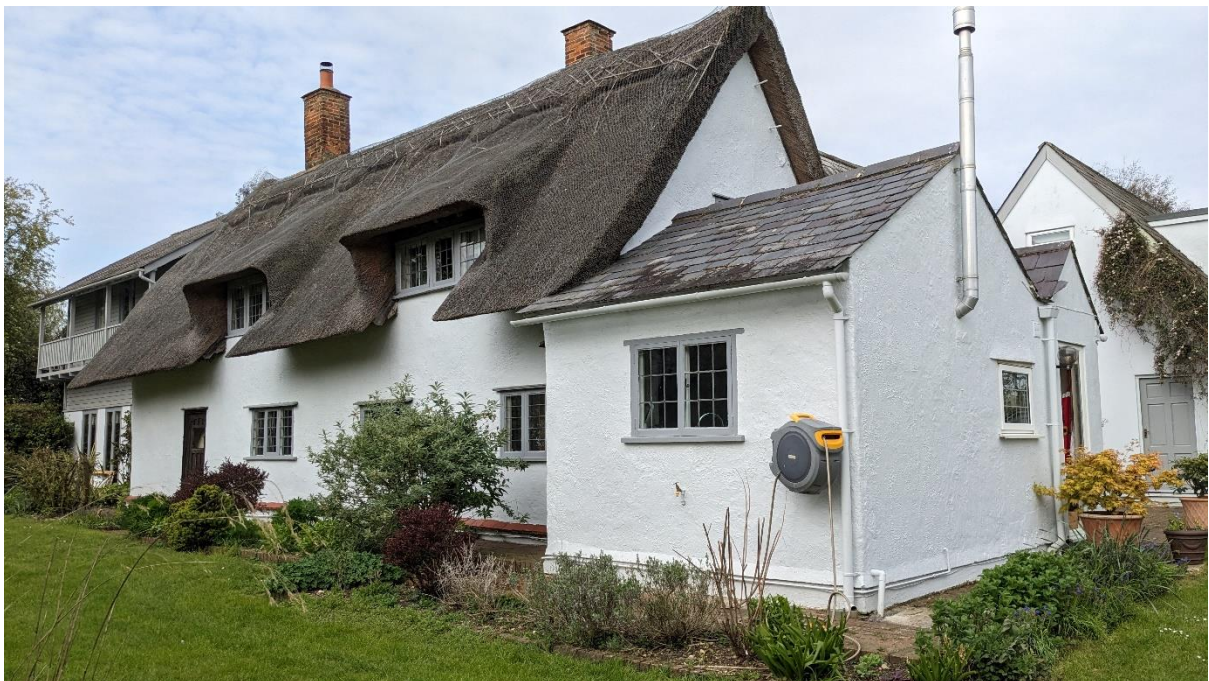
The exterior of the existing extension was comprised of plaster-covered brick in the same style as the main cottage, with a slate-tiled double pitched roof (Photo 7, Appendix 1) and an interior ceiling. While there is almost definitely some sort of internal space between the ceiling and the apex of the roofs, there is no access into this space and as such it was not able to be inspected.

Photo 2: The cottage extension

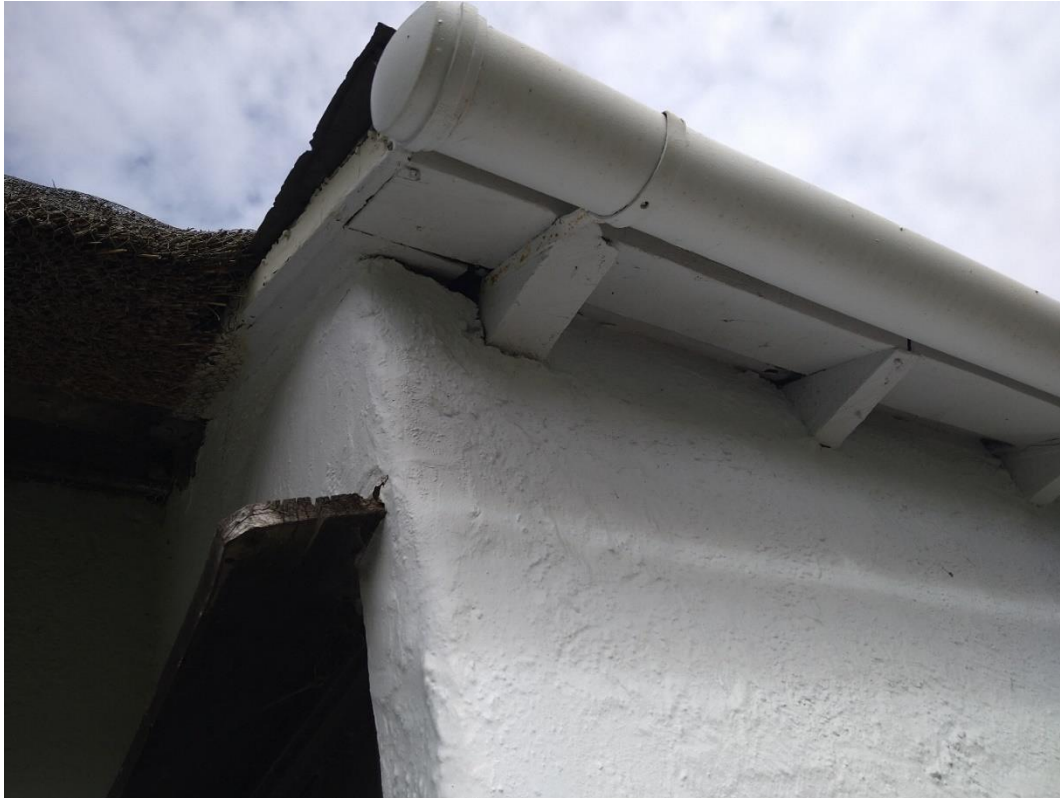
On the exterior, the slate tiles were laid flat over the top of one another and there were no gaps sufficient for bats to use. There were no gaps seen under the guttering (Photo 5, Appendix 1). Under the eaves on the side facing the pond, there were several 4-5 centimetre gaps between projecting wooden timbers; all of these except one were superficial and did not lead anywhere. A single gap on the corner of the building (Photo 6, Appendix 1) went at least 5 centimetres back, probably more, perhaps leading into the internal roof space. The area around and below this gap was searched thoroughly for signs of bat activity without success, and it can be asserted that during the time of survey there were no signs of current or previous activity around both the gap in question, or the extension as a whole.

Photo 3: The largest gap under the extension eaves

The surveyed building is considered unlikely to support bat roosts and was assessed as having a negligible bat roost potential. Therefore, no further bat surveys are recommended. The gap which may have provided access to an internal space on the extension did not show any signs of bat activity (droppings, lack of cobwebs, staining, scratching or insect remains), and there were no other suitable access areas or bat evidence on or around any of the other buildings.

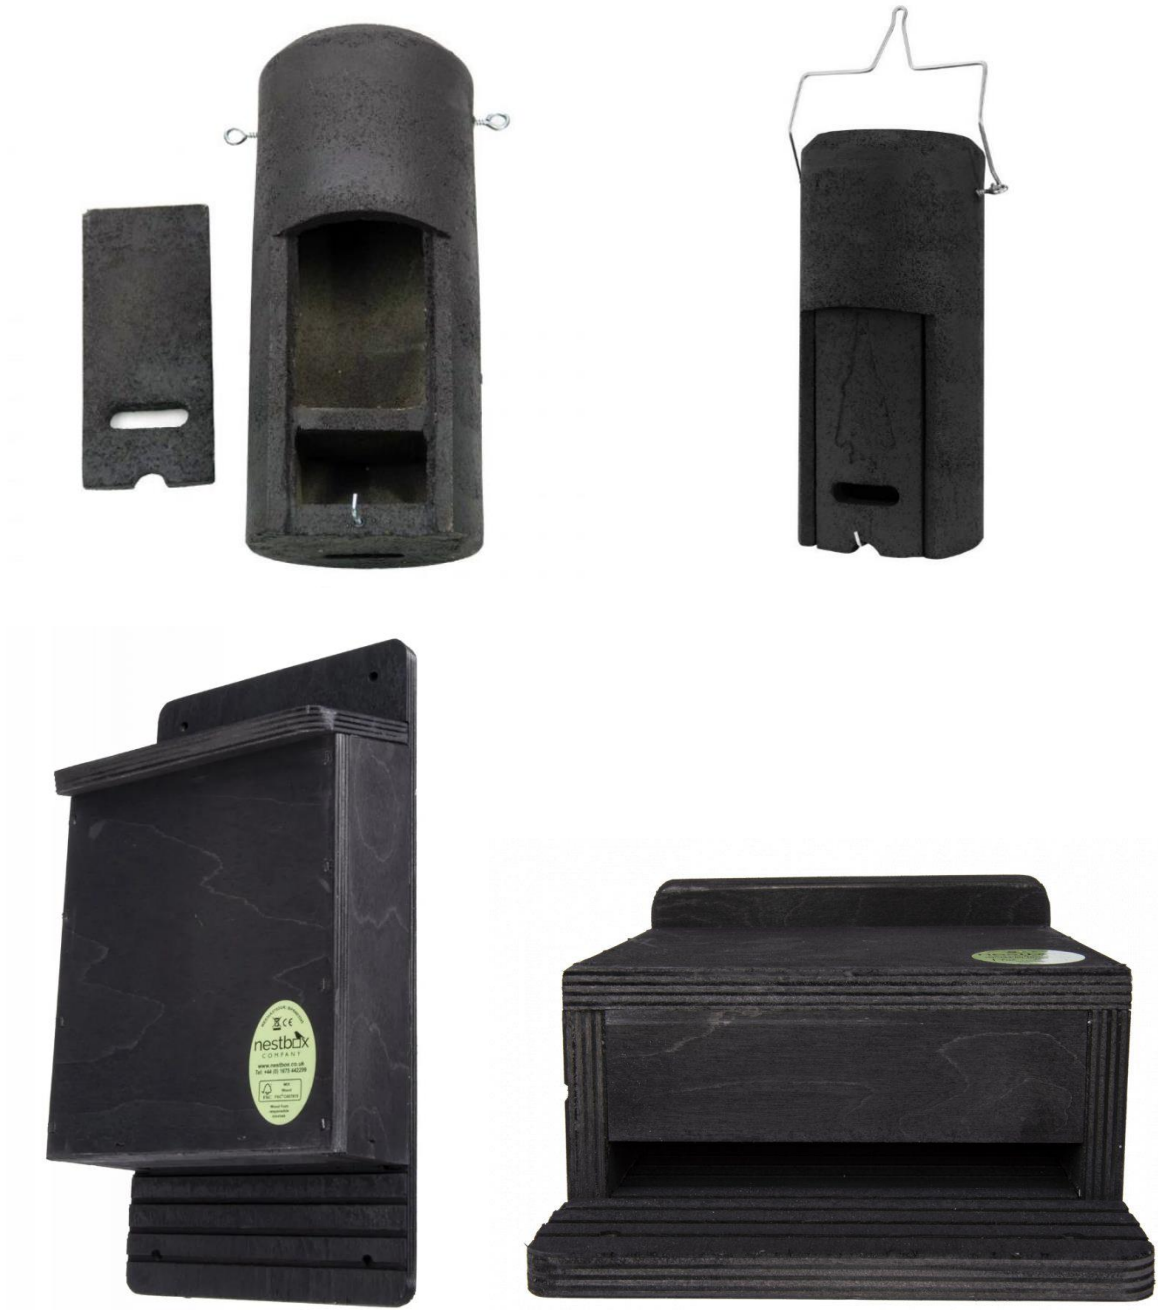
Bat boxes are available in a variety of designs and can be fitted on buildings, trees and other features of appropriate height. Both of the below designs are suitable, with the flat back of the second allowing for easier installation on flat walls or underneath the eaves of buildings. These designs are not exhaustive, and other styles of box are available. Any further questions regarding the style and use of the bat boxes can be directed to Essex Ecology, who are happy to offer advice.

The surrounding area, or the building itself, could be enhanced for bats via the installation of a bat box. See Appendix 2 for two recommended bat box designs. Essex Ecology is happy to be contacted regarding the installation or design of bat boxes, as well as any other queries regarding enhancing the property for bats.
