# Leigh Ecology Ltd

22 Bridge Street,  
Chester,  
Cheshire.

## Bat Scoping Survey Report

**Report number:** Bridge/01/23      **Author:** C. Leigh

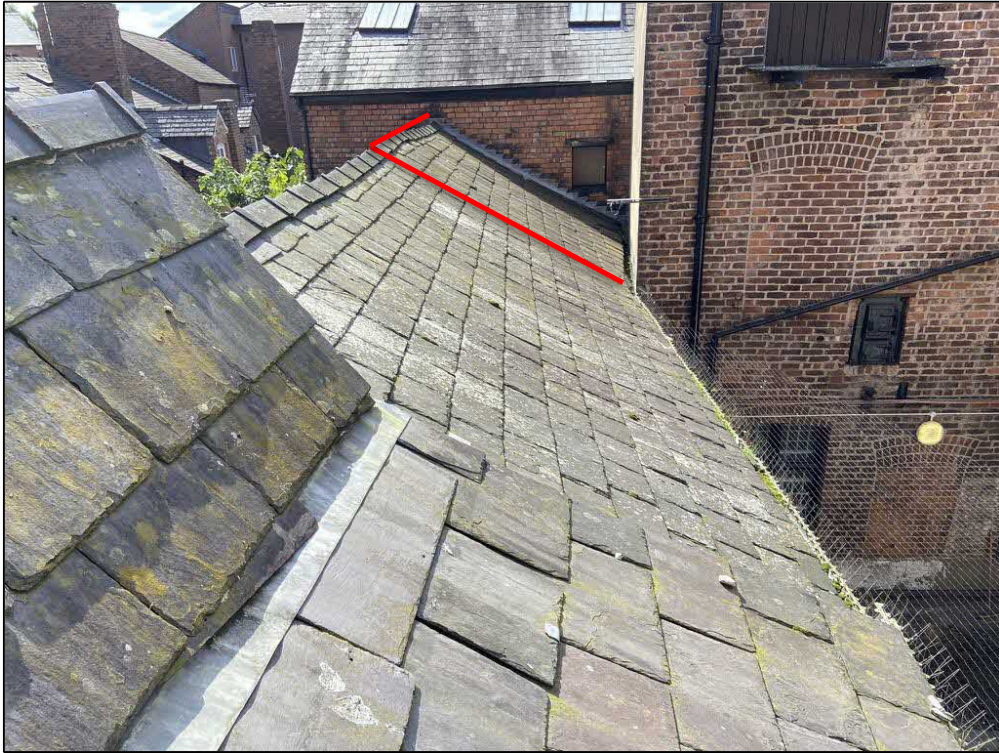
Fig 2: A view of the roof of the section to be removed (labelled building A). The roof tiles and ridge lining was in good condition throughout.

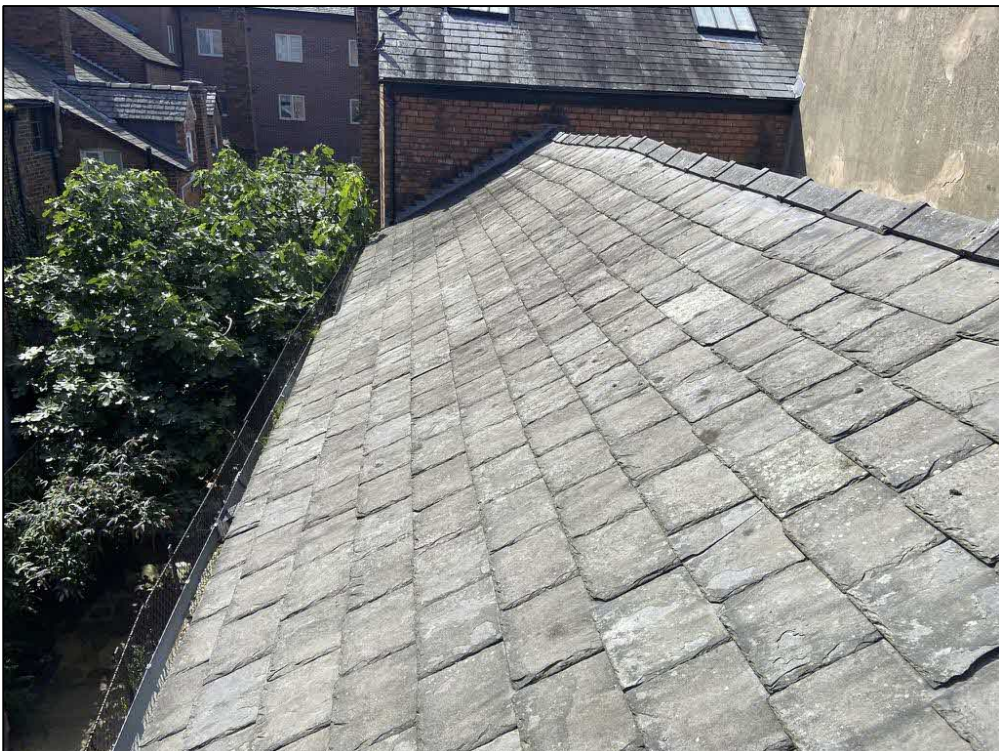
Fig 3: A further view of the roof to be removed as part of the proposals.

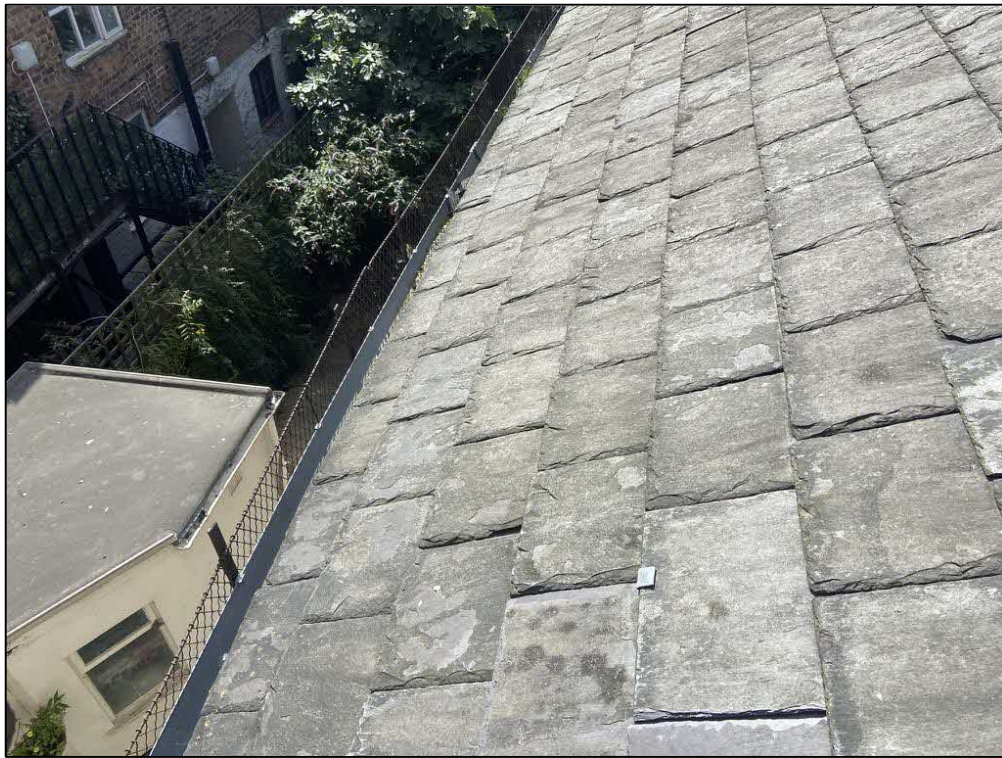
Fig 4: The fascia of this roof section features some netting, presumably anti-bird netting.

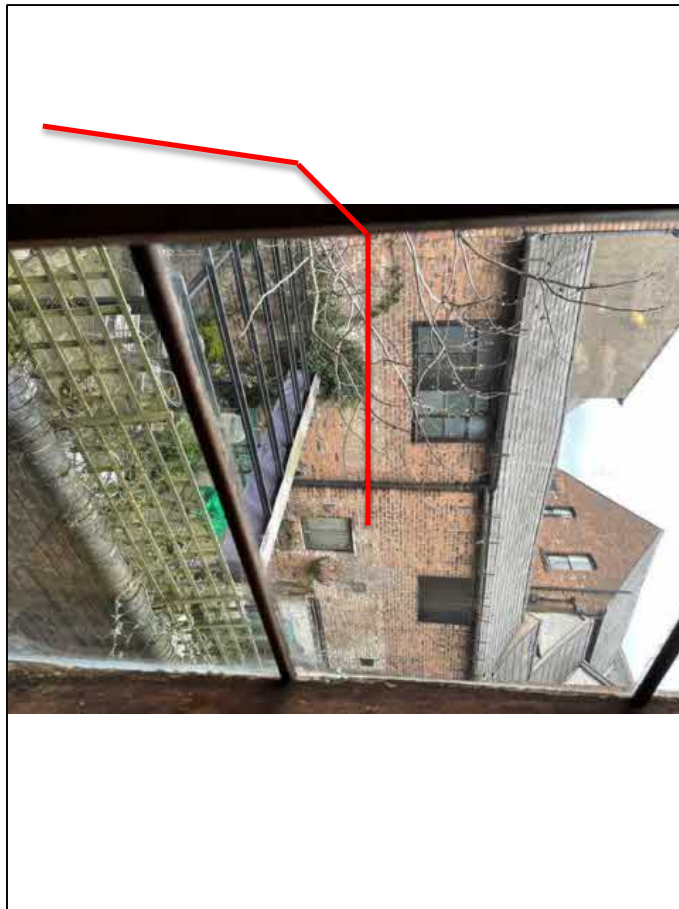
Fig 5: A view from an adjacent retail unit of a subject section for removal. The fascia lining and guttering is in good condition.

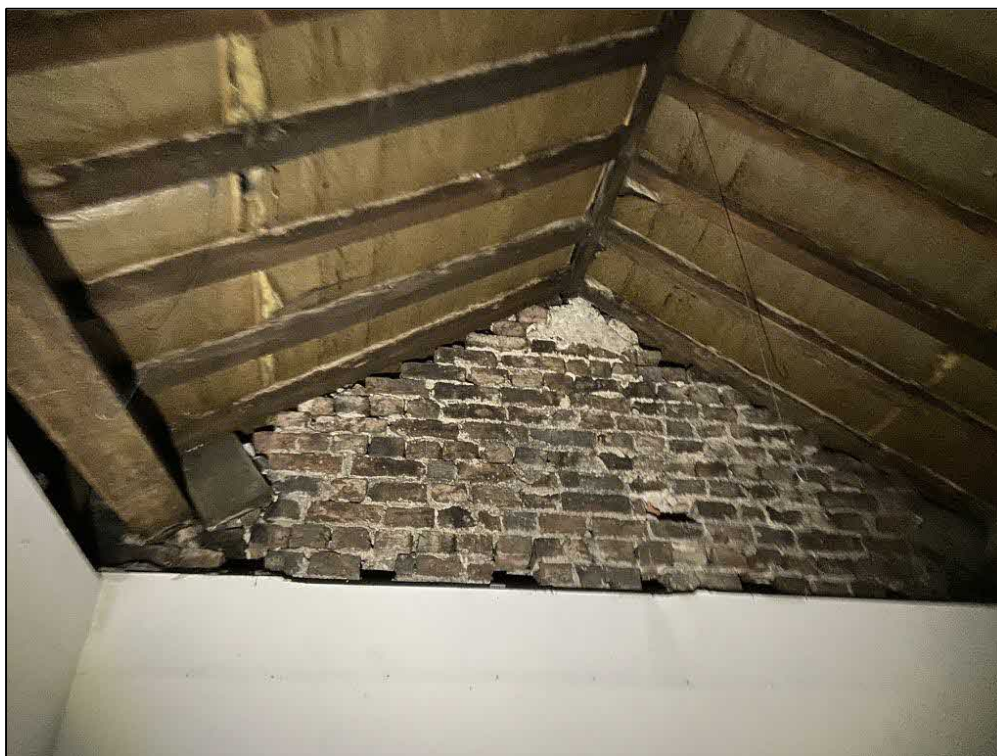
Fig 6: An internal view of the previously pictured section. The internal brick walls are narrow, with no access to any cavities noted.

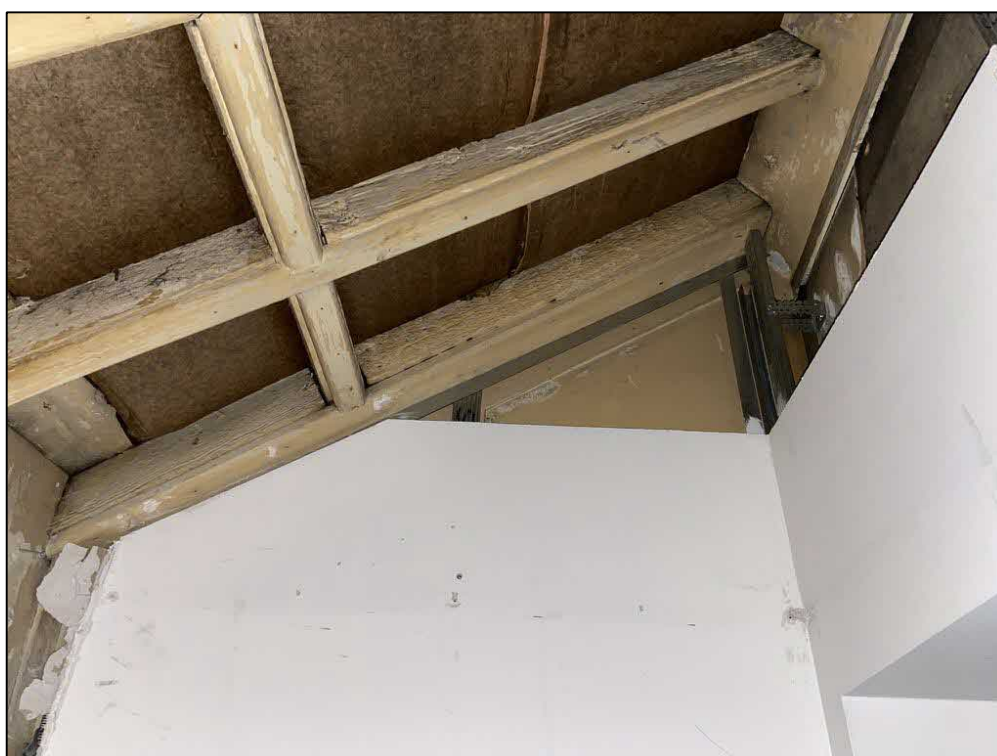
Fig 7: A further internal view of building labelled A. Wooden boarding features beneath the external roof tiles. This boarding is in good condition and features no signs of damage. No signs of previous bat usage were noted within the building section during the survey.

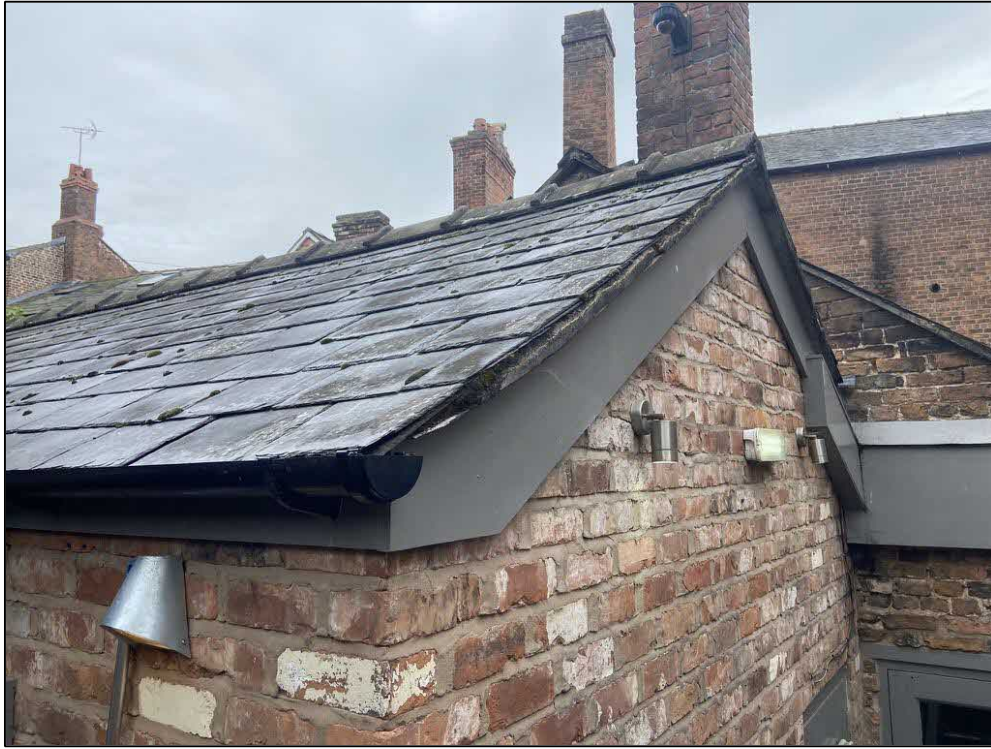
Fig 8: A view of another section to be removed (Building labelled B). This building comprises a single storey, with a standard slate roof. The building is relatively new, and this is reflected by its excellent condition throughout.

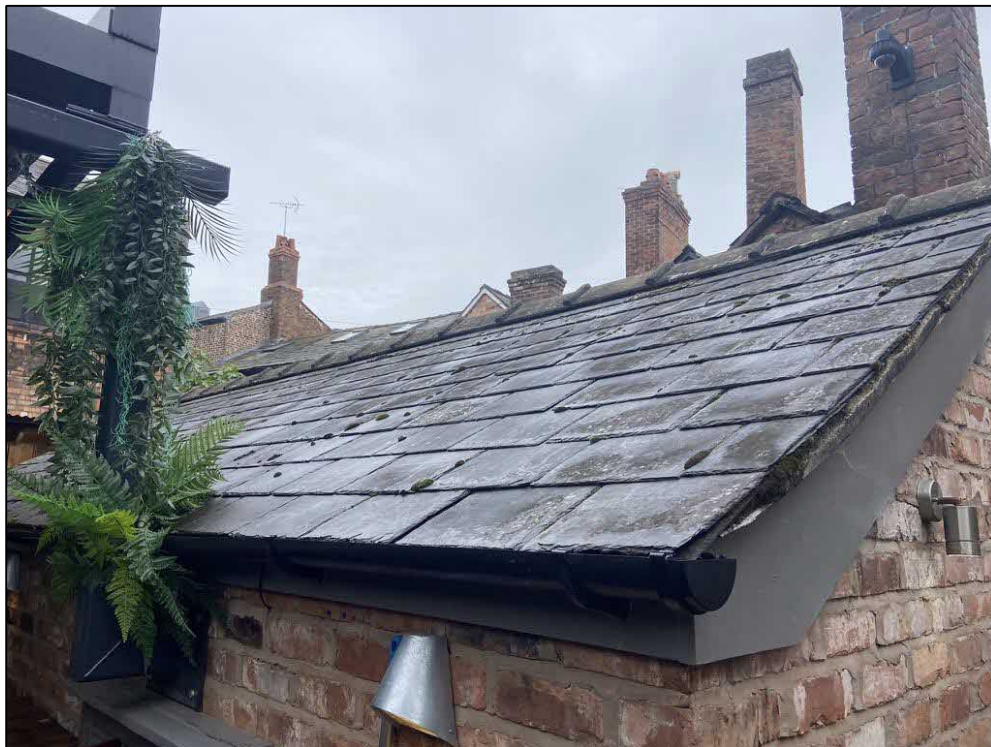
Fig 9: A further view of the building. The building features kitchen infrastructure for an active bar.

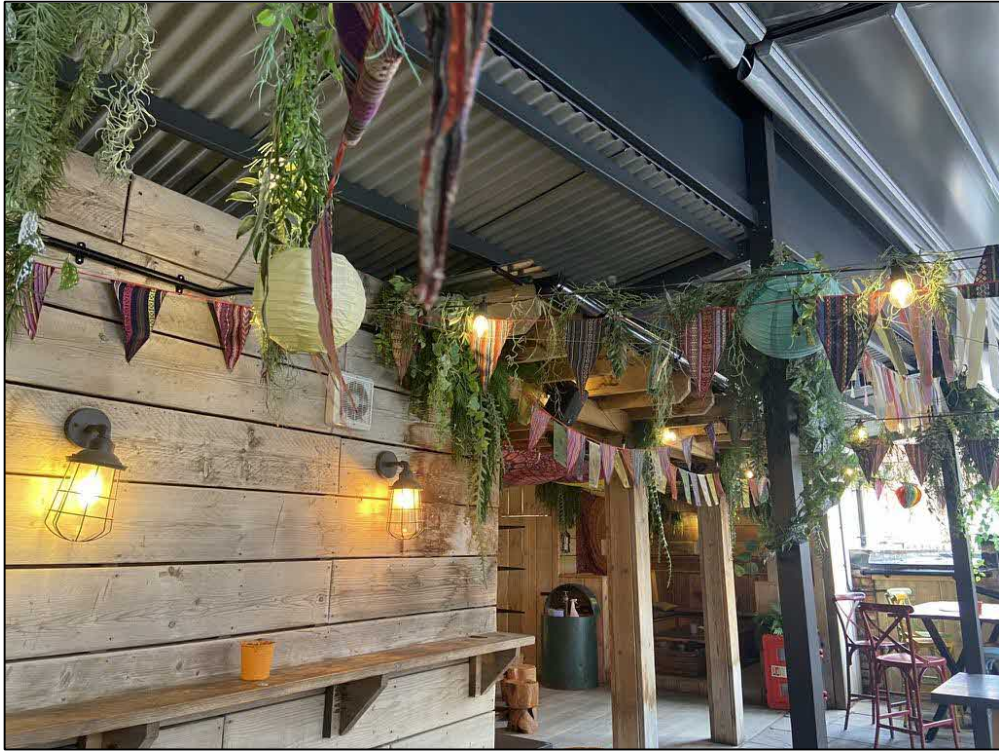
Fig 10: Another section that is to be removed (Building labelled C). The building is a timber construction with a corrugated tin roof. Again, erected not long ago to support the adjacent active bar, this building is utilised as an outdoor terrace shelter.
