# Site Investigation Report

129960.1.TSI

Client	Sedgwick
Client ref	9255790
Visit date	22/11/2021
Report date	22/11/2021

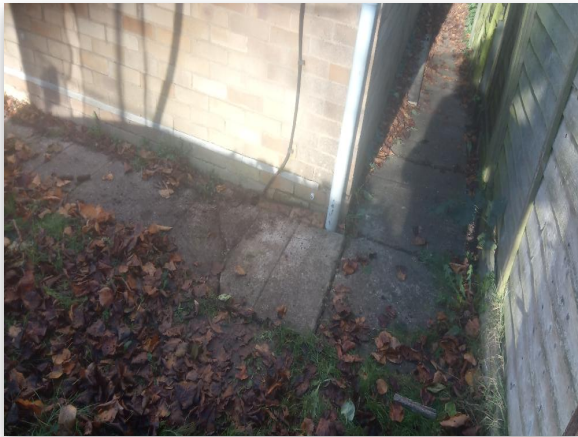
Fig 1.1: Trial Hole 1 Location

Auger were advised to excavate a single trial hole at the rear left corner of the property, from this we were to collect soil and root samples

TH1 was excavated as proposed and the requested soil and root samples were retrieved.

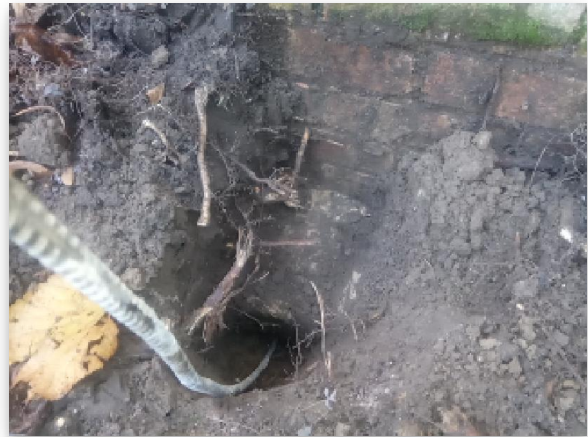
Fig 1.2: Trial Hole 1 Footing

Depth (m)	Symbolic Log	Strata Description	Insitu Tests		Soil Sample	Root Sample
			SV(19)			
0.0	<p>200mm</p> <p>Ground Level</p> <p>Flagstones</p> <p>Brickwork</p> <p>Concrete</p>					
0.5		Brown slightly sandy gravelly silty CLAY	48kpa		Soil @ 0.6m	Root @ 0.6m
1.0			52kpa		Soil @ 1.1m	Root @ 1.1m
1.5		Moist stiff Brown sandy silty CLAY	58kpa		Soil @ 1.6m	
2.0		62kpa		Soil @ 2.1m		
2.5		72kpa		Soil @ 2.6m		
3.0		TRIAL HOLE TERMINATED	72kpa

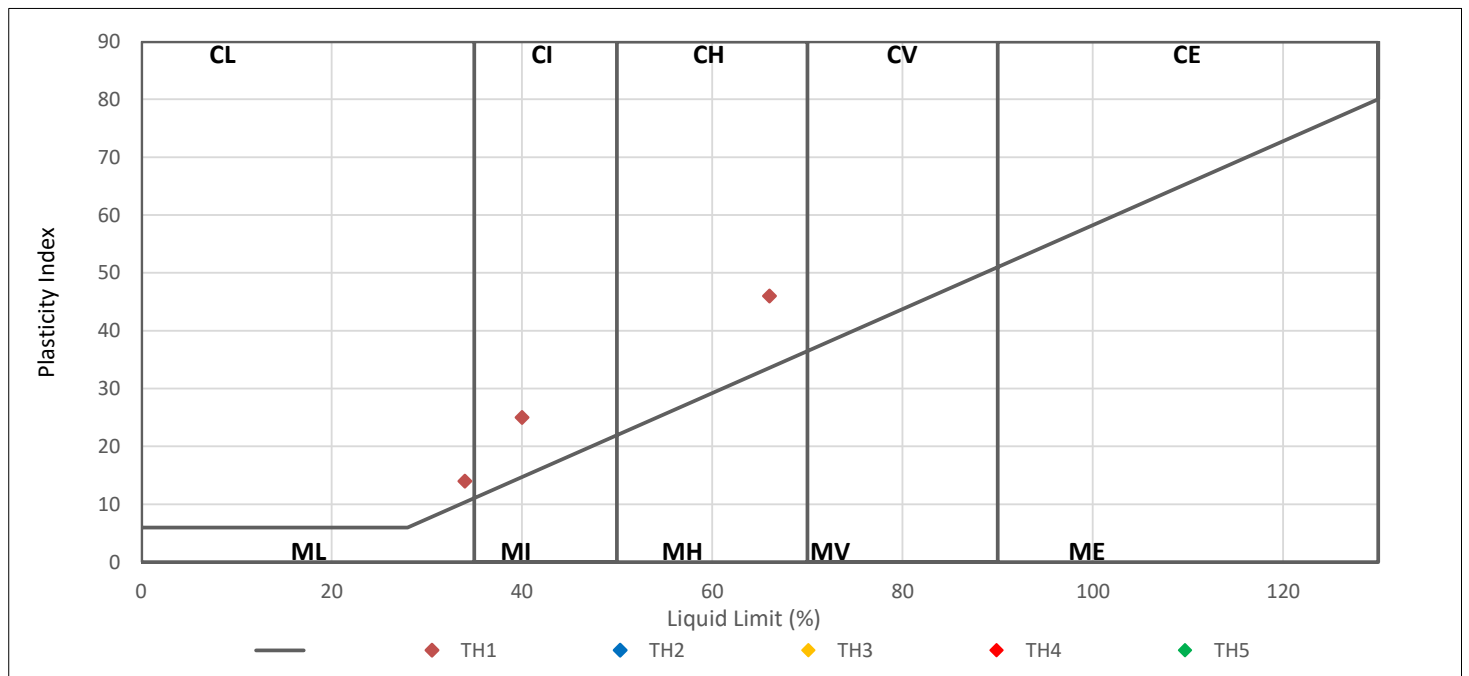
PLASTICITY CHART FOR CASAGRANDE CLASSIFICATION  
BS 5930:1999+A2:2010

Modified Plasticity Index (PI) <10 : Non Classified  
 Modified PI = 10 to <20 : Low volume change potential (LOW VCP)  
 Modified PI = 20 to <40 : Medium volume change potential (Med VCP)  
 Modified PI = 40 or greater : High volume change potential (HIGH VCP)

The Atterberg Limits May also be used to classify the volume change potential of fine soils using the National House building system, as given in the NHBC's Standards Chapter 4.2 (2003) "Building Near Trees"
