PHOTOGRAPHIC SCHEDULE

South facing elevation of the Bodley and Garner gate viewed from the high street.

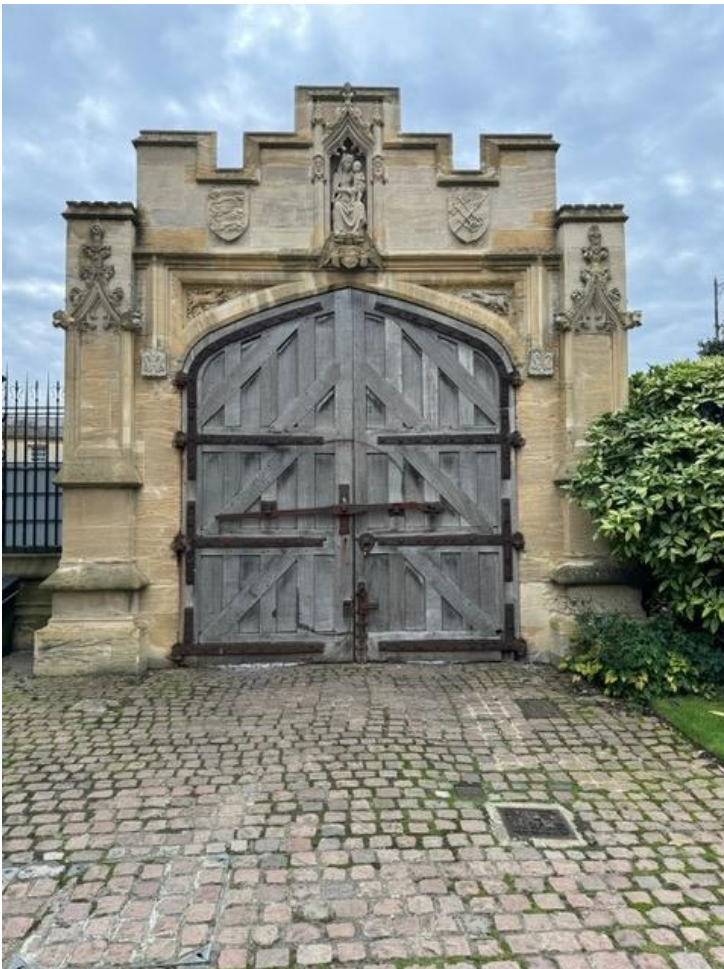
Photograph No 2

North facing elevation of the Bodley and Garner gate viewed from St Johns Quad.

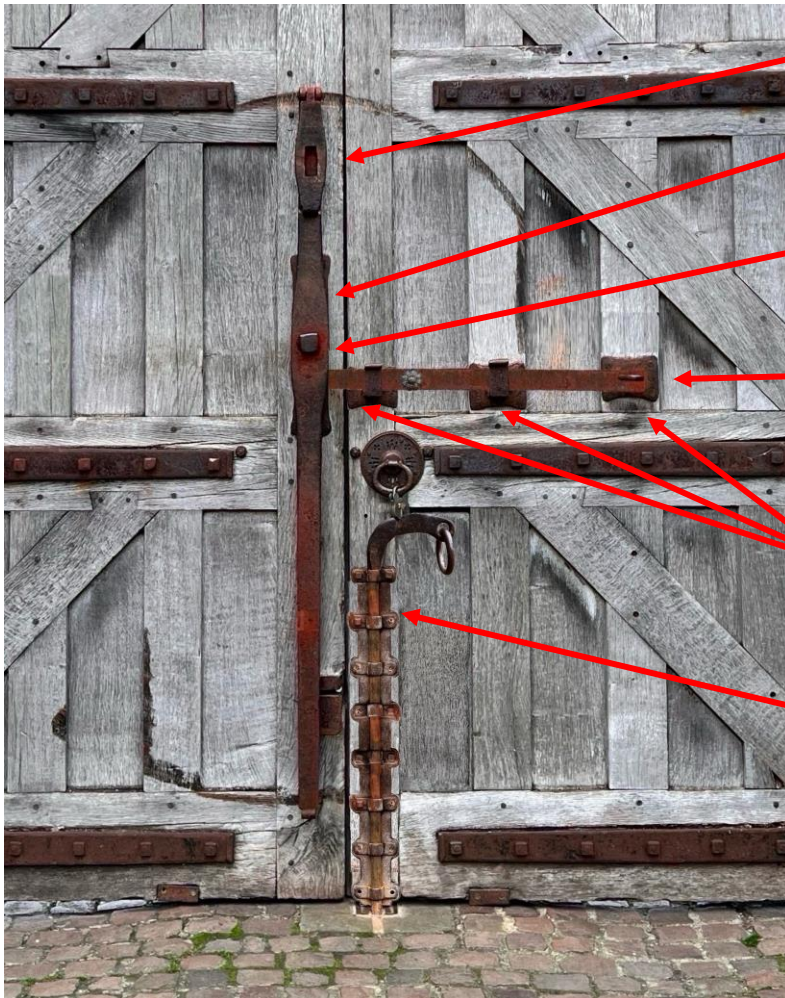
Photograph No 3

Modified photograph showing impression of proposed ironmongery arrangement.

Hasp folded back and fixed in place.

Pivoting Brace rotated 90 degrees and fixed in place retaining the existing ironmongery.

Boss installed to rear of brace back plate with notch to receive proposed slide arm.

New slide arm produced in materials to match existing ironmongery with new padlock ring and cast iron rosette knob.

Existing brackets relocated. 'Chock' to be installed with aperture to suit and secure new slide arm.

Existing 'shoot bolt' to be retained and extended in length using materials to match existing improving use. Later addition Hasp to be removed.

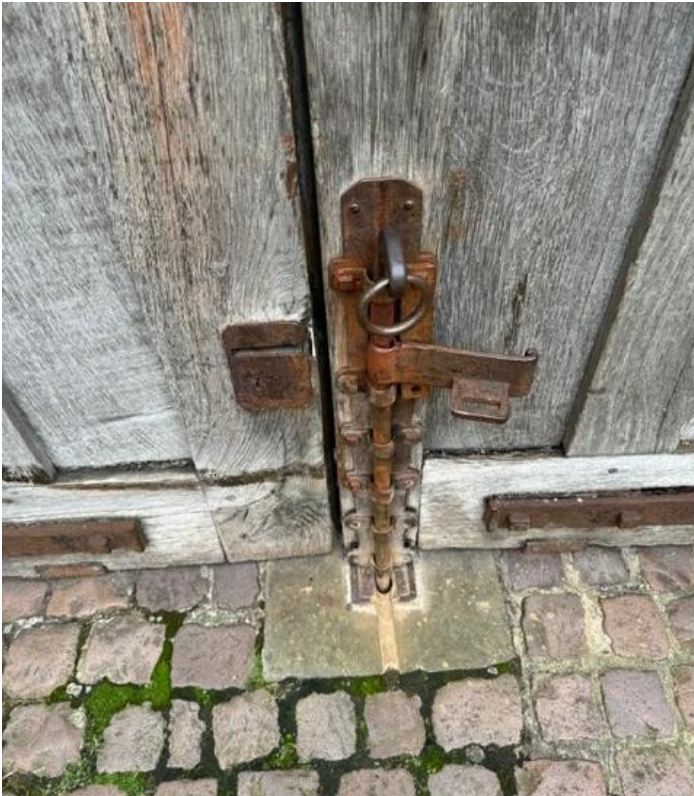
Photograph No 4

Existing 'Shoot bolt' retained and extended. Later addition hasp arrangement to be removed.

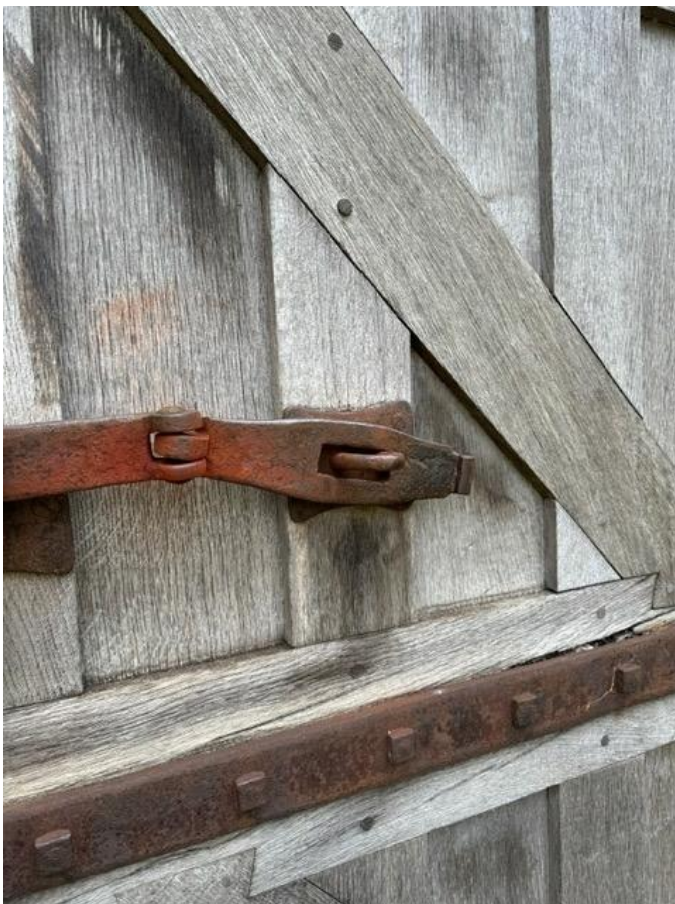
Photograph No 5

Existing Hasp retained. Hasp to be folded back and fixed in place on pivoting brace.

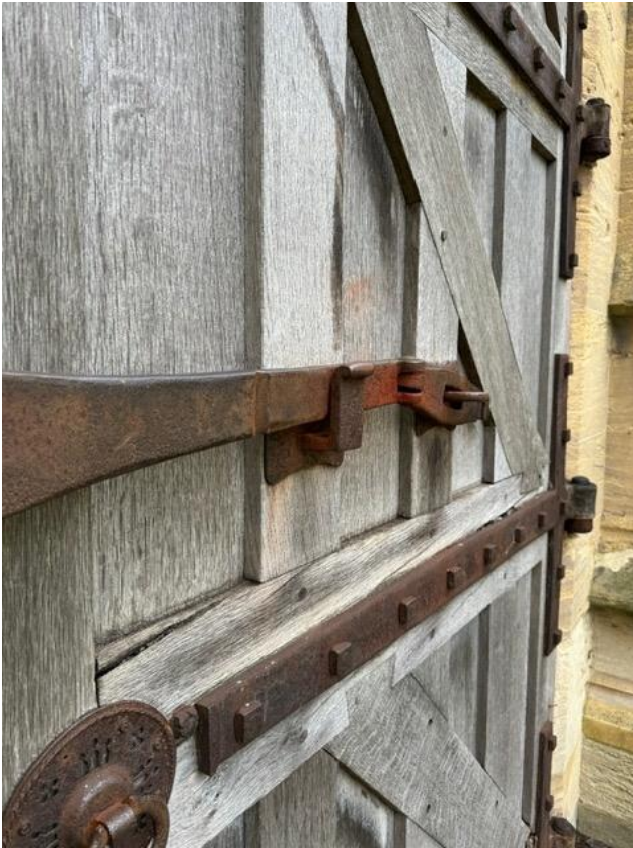
Photograph No 6

Existing bracket retained and relocated.
'Chock' to be installed within bracket with
aperture to receive new slide bolt.

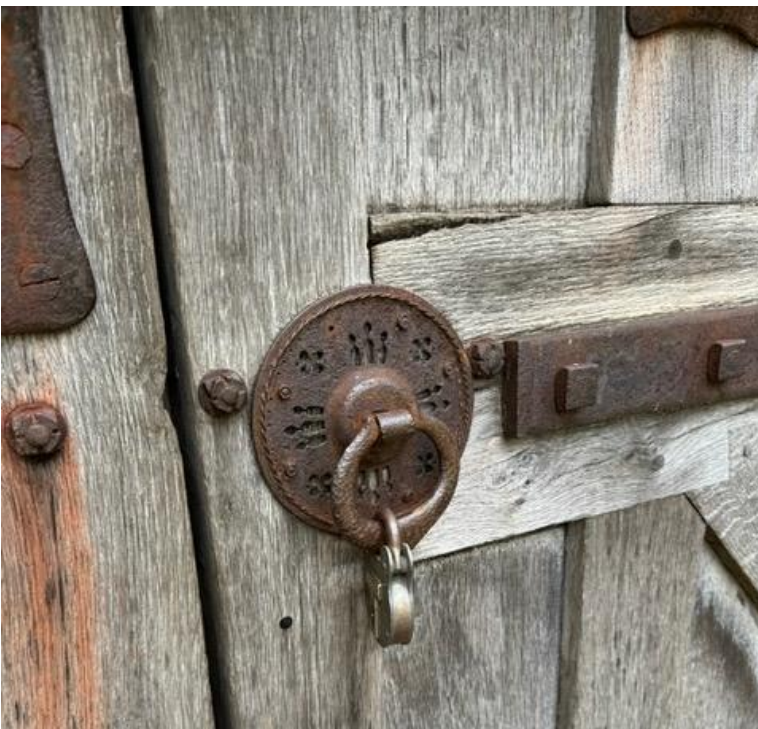
Photograph No 7

Existing handle retained.

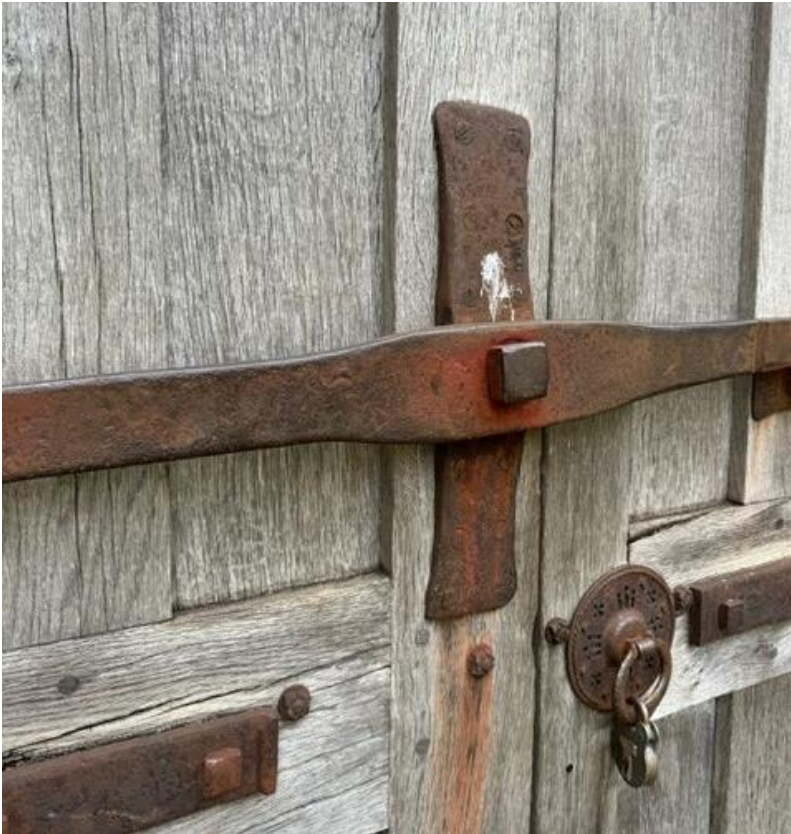
Photograph No 8

Existing Pivoting Brace retained. Brace to be turned 90 degrees and fixed in place. Boss to be installed behind back place with notch to receive proposed slide arm.

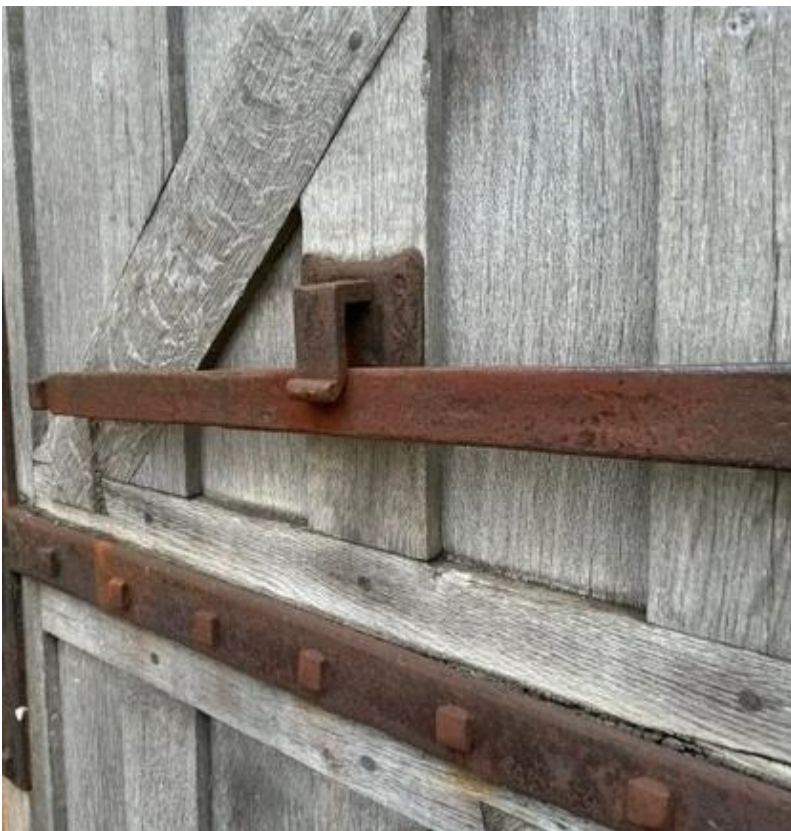
Photograph No 9

Existing bracket retained and relocated. 'Chock' to be installed within bracket with aperture to receive new slide bolt.
