Bat Survey: 1 Tyn-Y-Graig Road, Llanbradach, Caerphilly, CF83 3LH

1. Background and Purpose
2. Site description
3. Report Constraints
4. Legal Constraints
5. General Information
6. External Inspection
7. Internal Inspection
8. Exit and Return Surveys
9. Concluding Remarks
10. Appendices
 - Aerial Site Photo**
 - Surveyor Positions**
 - OS Map**

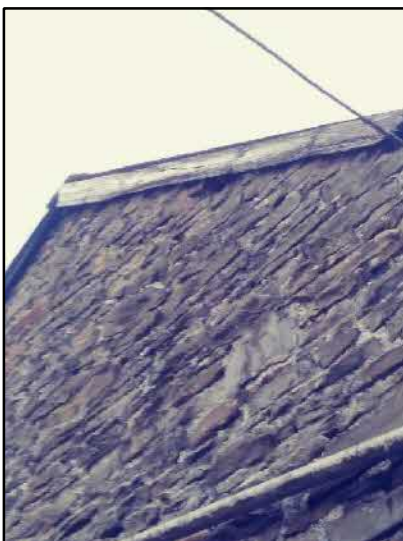
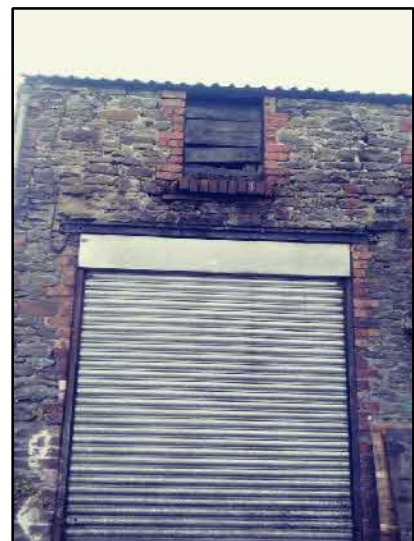
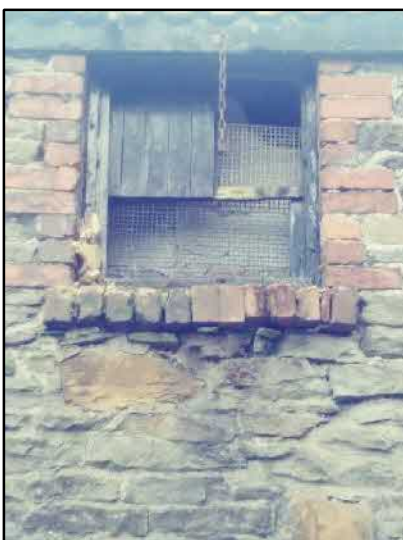
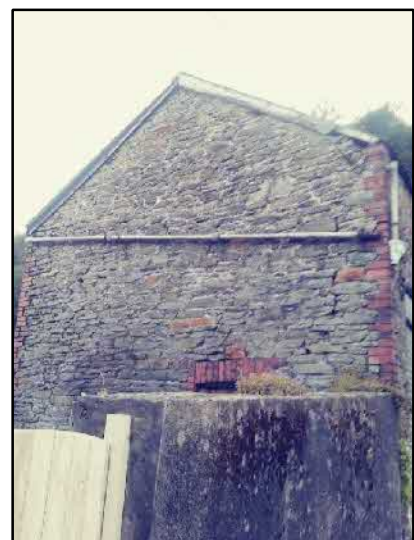
6.3 Due to the condition of the building, there were unlimited opportunities for bats to access and use the building. Those that were available were deemed as moderate-high potential. There were apertures in the stone; under the timber fascia and in the timber boards covering the windows. There was a missing piece of timber fascia on the building. The building was classed as moderate-high potential for roosting bats.

6.5 Examples of apertures allowing access to cavities in the building:

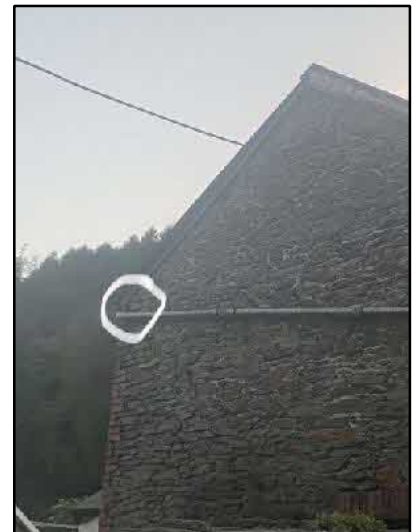
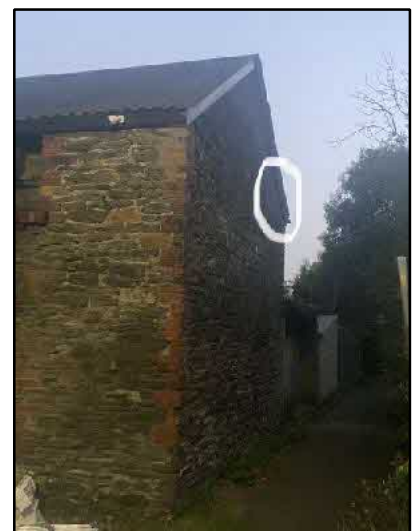
8.7 The best viewing conditions were obtained.
