Babmaes Street Elevation

CLIENT	The Crown Estate		
PROJECT	15 Regent Street London SW1Y 4LR		
DRAWING	Defect Location Proposed Elevation 2		
DRW NO	230546/DL01	REV	-
DATE	Jun 2023	DRAWN BY	GP
SCALE	1:100	SIZE	A1
■ PROPOSED

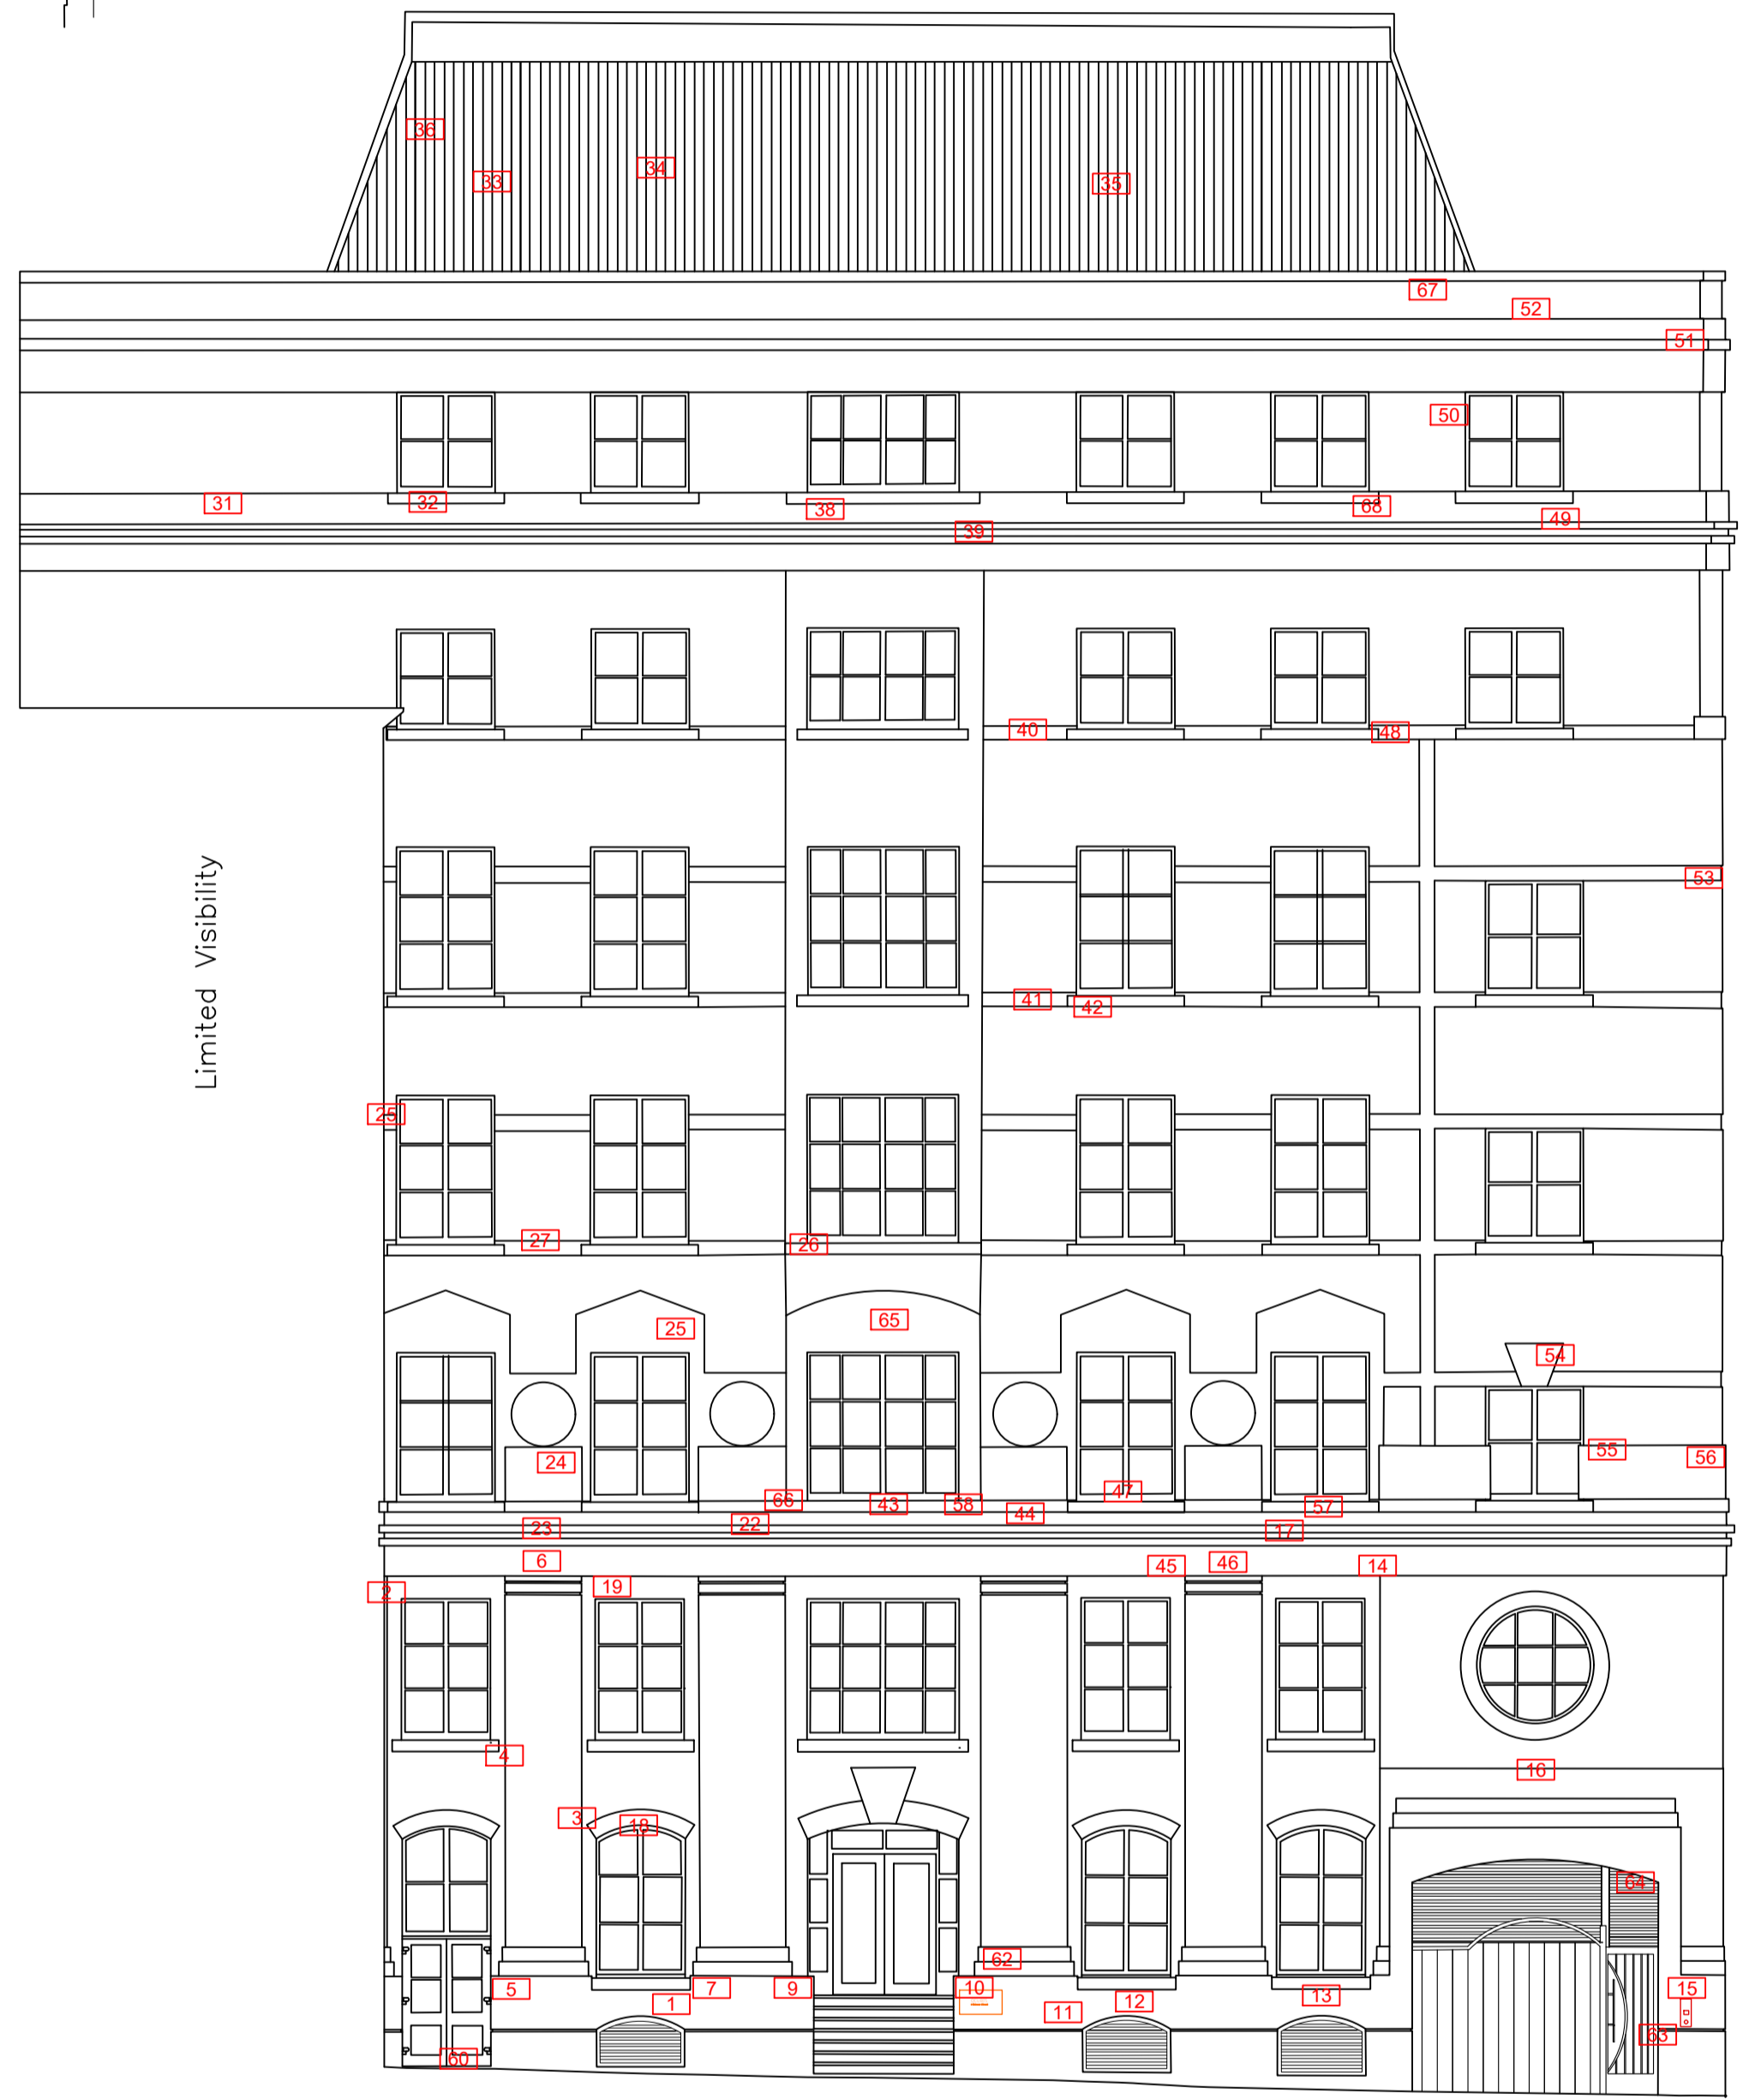
Scope of Repair Works		
Repair Type	Description of works	Photo Reference(s)
A Nothing required	No action at present. (Hairline cracks, previous repairs, or small spalls deemed too small to repair – subject to close access inspection on rear elevations) Locations recorded for future monitoring.	43, 45, 50, 53-58, 61, 62, 64 - 67,
G & H Repointing to open/reopened cracks	Wash and rake out any existing repointing repairs or other debris. Repoint joint to a minimum depth of 50mm using 3:1 sharp sand: NHL 2 hydraulic lime mortar.	1-3, 6, 8-11, 15-22, 24, 35, 37-42, 44, 48, 49, 51, 52, 59, 63, 68-74
P Repairs to lintels/cills potentially damaged by corrosion of embedded metal	Tap test area around cracks to determine extent of loose material. Remove loose material and determine if cracking extends into main lintel structure. If no, carry out Repair Type N. If yes, locally break out existing concrete to fully expose the corroded surface of existing rebars or beams (indicative extents shown on details below). Refer to engineer if corrosion found is excessive and has resulted in significant steel section loss. Clean back exposed steel surfaces by hand or with a needle gun to Grade ST2 as far as reasonably possible. Paint exposed steel and concrete surfaces with 'Ronafix' repair system (or similar approved) cement primer. Re-form concrete encasement to original profile using Ronacrete 'Ronafix' repair system (or similar approved) mortar, applied in strict accordance with the manufacturers' recommendations. Re-render surface if applicable, as per Repair Type N	4-5, 13, 23-29, 47

N Cracked render to wall panels or lintels	Tap test area of render around crack. If no loose material, rake out crack and repair with a colour-match mortar. If there is loose material, remove back to base substrate and check if the cracking extends into the substrate. If yes, allow for stainless steel pinning of substrate cracks (see Repair Type K), or in the case of lintels, consider the need for Repair Type Q if cracks indicate likely internal corrosion. Apply new render to affected area to match existing (1:1:6 cement : lime : sand mix – colour matched). If whole panel to be replaced, consider using NHL lime : sand mix render only	
W Corroded embedded fixings (no visible masonry) or abandoned fixing holes	Tap test area around fixings to determine if there is any loose material. If no loose masonry, remove any ferrous fixings/sockets and then plug all fixing holes with 3:1 sharpsand: NHL2 hydraulic lime mortar.	7, 12, 30-34, 36, 60
