Pump Farmhouse, Brentwood Heritage Statement

Client:
CB Architecture

Date:
April 2023

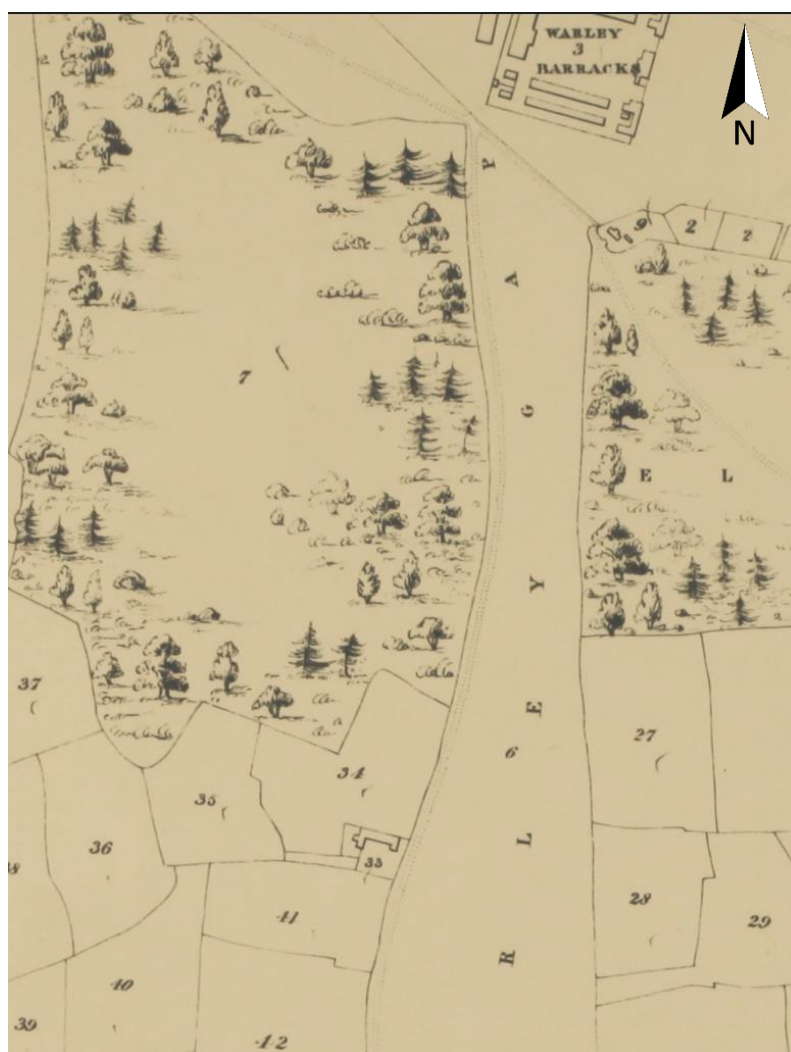
Figure 3: Tithe Map, 1837

- 3.10. The 1837 Tithe Map (**Figure 3**) is the earliest source to show the building footprints within the Site in detail. The maps shows the main house joined to the outbuilding, although this is actually shown detached on the later and more accurate Ordnance Survey map (**Figure 4**). The house is shown on the west side of the Site within a domestic curtilage to the west and the yard to its east. Plot 33 is recorded on the Tithe Apportionment as a homestead which was owned by a Charles Winn and leased to Richard Alexander. The same owner/lease arrangement was also recorded for the surrounding fields. Plot 34 was called Barn Field (in arable use), confirming the outbuildings were likely barns. Plot 35 was a field under pasture called

'Pightle'. Plot 36 was a field under pasture called 'Pump Field'. Plot 40 as called 'Grove Field' and under pasture. Plot 41 was called 'Home Field' and in arable use, this was likely named as it was adjacent to the dwelling house. Charles Winn also leased further fields to Alexander in the wider area. The Winn family are recorded to have held the barony of Great Warley and Little Warley until 1913. There were two family members named Charles Winn in the nineteenth century, the elder died in 1877 (likely mentioned in the Tithe Apportionment) and the second died in 1913 with whom the barony ceased.

- 3.11. The Tithe Map suggests the Site was the core of a farm in the mid nineteenth century which was leased by the owners of an extensive estate across Warley.

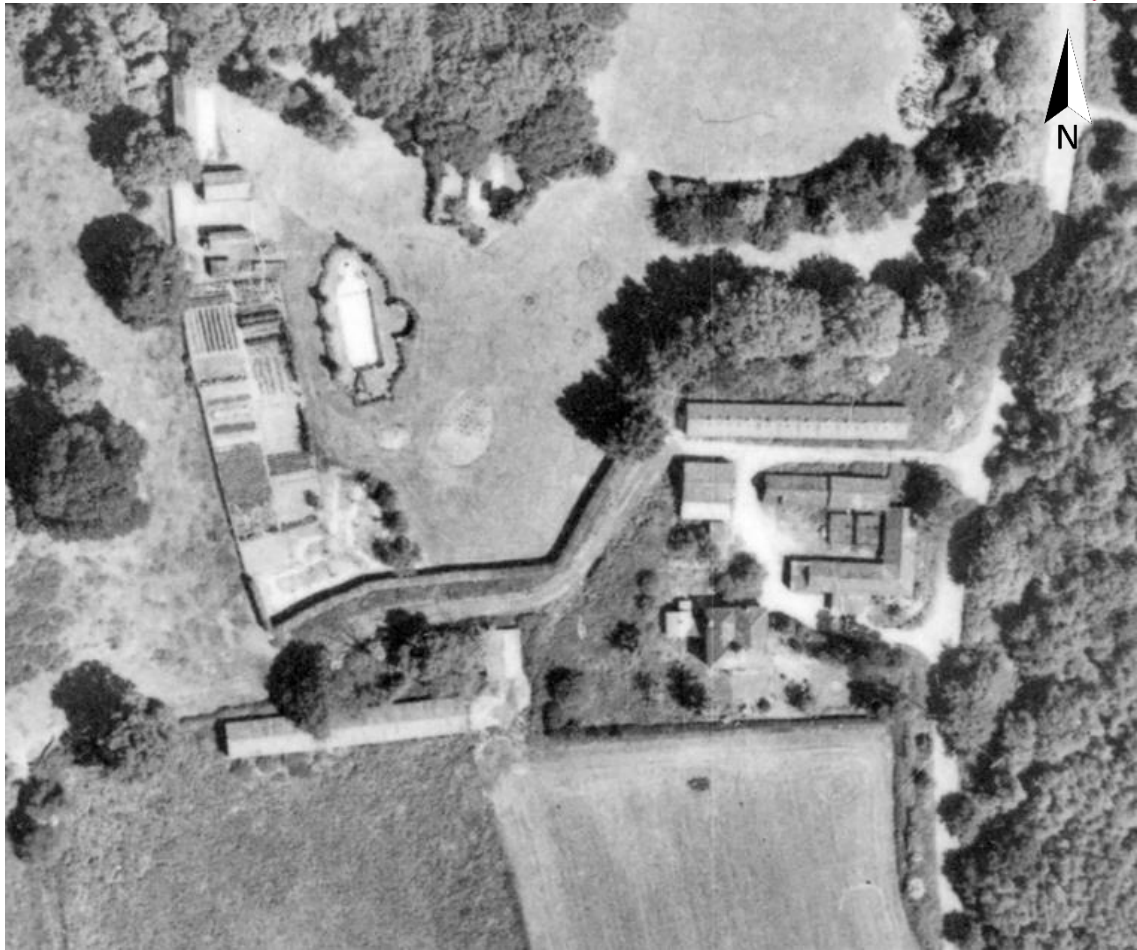
Figure 9: Aerial Photograph, 1960 (Essex County Council)

3.19. An aerial photograph taken in 1960 (**Figure 9**) shows minor changes at the Site. The formal gardens of the neighbouring dwelling to the north had matured. Additional agricultural buildings, in the form of long sheds, possibly for chickens, had been constructed at the farm, to the west of the dwelling and along the northern boundary. A 1970s aerial photograph (**Figure 10**) shows a new access, in the form of a track, had been formed from the road along the southern boundary of the domestic garden. Documents passed with the house suggest it was once divided into two houses for a period. The second track, leading to the west side of the property may be a result of this.

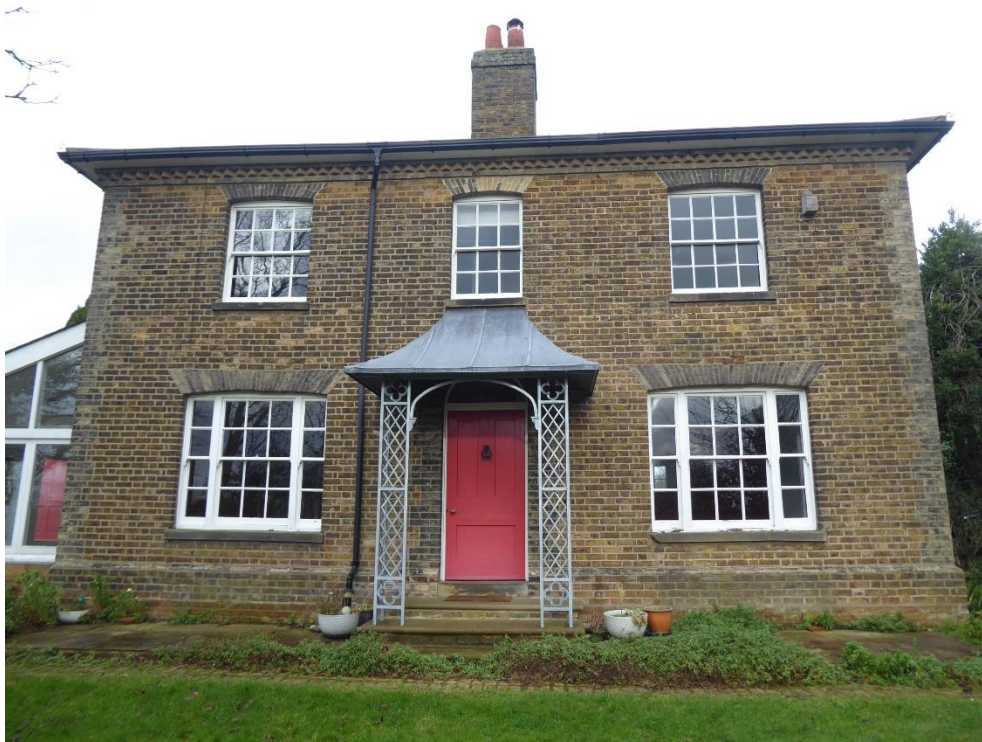
- 4.4. The principal elevation of the building faces south. The façade is constructed of a yellow stock brick laid in Flemish bond with queen closers flanking fenestration. Differing colours of bricks are used at the corners, presenting a quoin arrangement in the masonry. The elevation terminates at a decorative eaves course and overhanging eaves. The windows have stone cills and brick voussoirs in segmental arch heads. The sash windows in this elevation, with horns at the sash meeting rails, are believed to be original.
- 4.5. The recent porch addition is unfortunate as it over embellishes the elevation which was designed to be a more simple façade. The rainwater downpipe is also located in an unfortunate position in the centre of the façade.

Figure 15: View of front south elevation

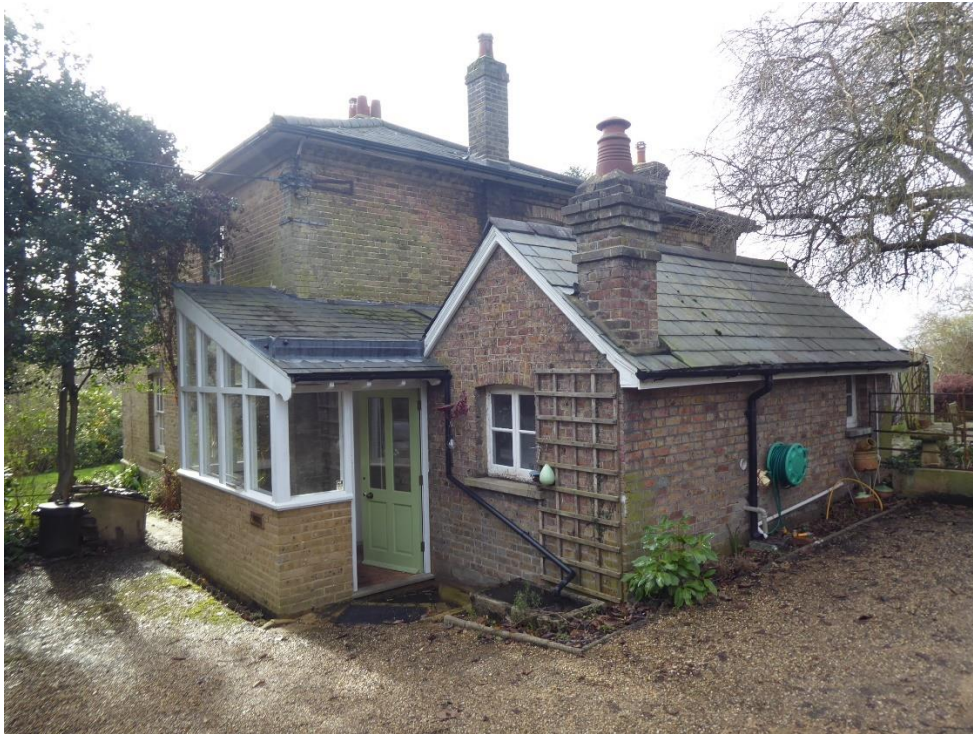
- 4.6. The east elevation contains four original sash windows set within the brick masonry. A monopitch extension has been added to the northeast corner of the building since 2015.

- 4.8. What is believed to have been a detached washroom (also constructed 1919-1946) is attached to the main pile, on the north side, via a later lean-to link. The single storey former washroom has been extensively altered which is observed in the brick masonry.

Figure 16: View of northeast corner

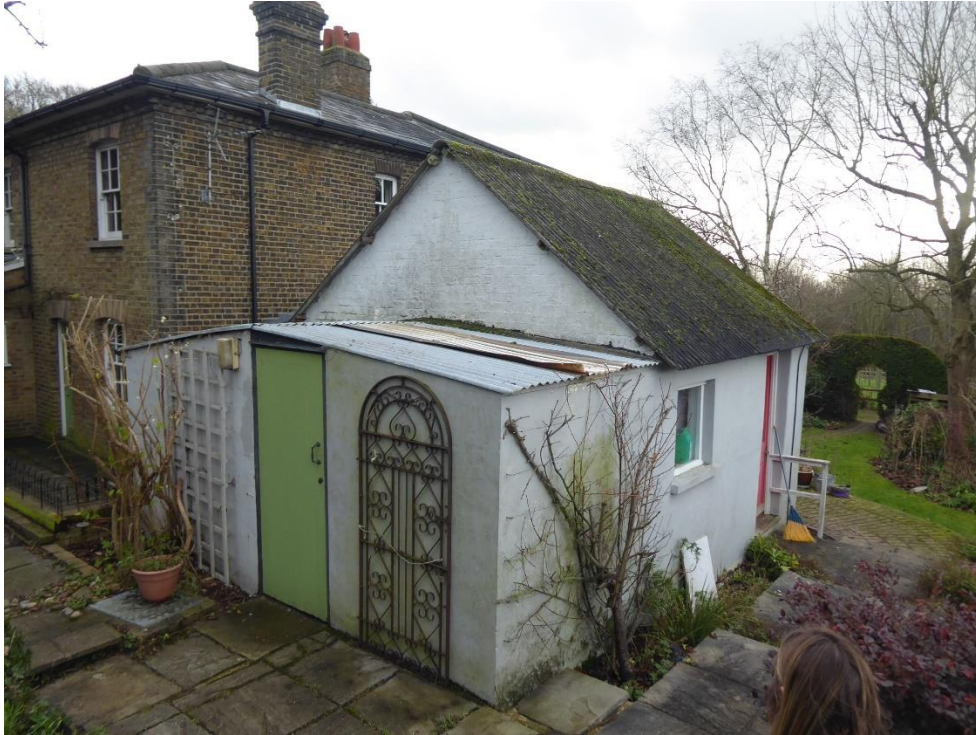
4.10. The outbuilding attached to the west elevation is part of the original building. This has however been subject to some alteration. The link to the building has been widened. The significance of this nineteenth century ancillary part of the building has been compromised by the asbestos roof replacement and the brick masonry

has a mixture of crude phases of patchy and poor-quality masonry. Many of the window and door locations are of modern derivation.

Figure 19: View of north west corner of outbuilding

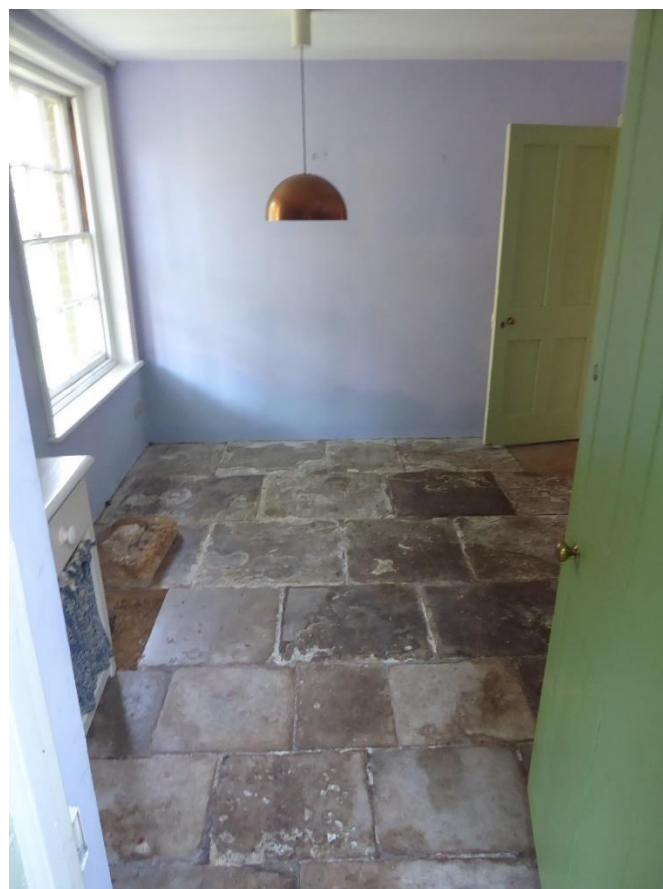
- 4.12. The room at the north east corner, within the original footprint, was the early kitchen which has retained its stone floor and the location of the former range is evident.

Figure 23: View of original kitchen at northeast corner

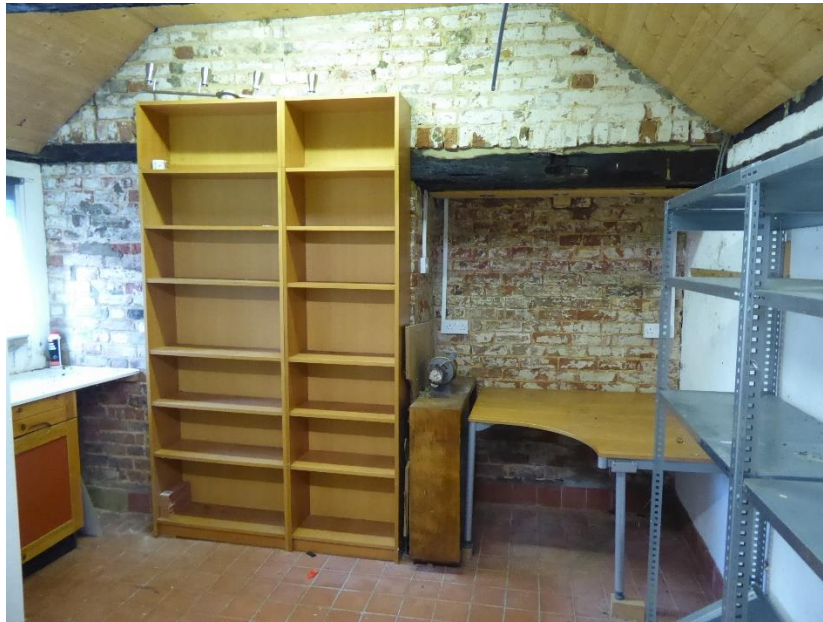
- 4.15. The attached outbuilding to the west of the pile has been subject to much alteration with many phases and patches of brick masonry. A historic timber is located at ceiling height; this is considered to be reused and not primary to this structure, due to the joint locations for joists which are not present. The floor of the link between the outbuilding and main pile suggests it was enlarged; the floor shows the original width in the brick surface and also the remains of the earlier wall and a rear door, this also accounts for the slackening of the pitch to form a subtle catslide roof.

Figure 24: View of attached outbuilding at west of main pile

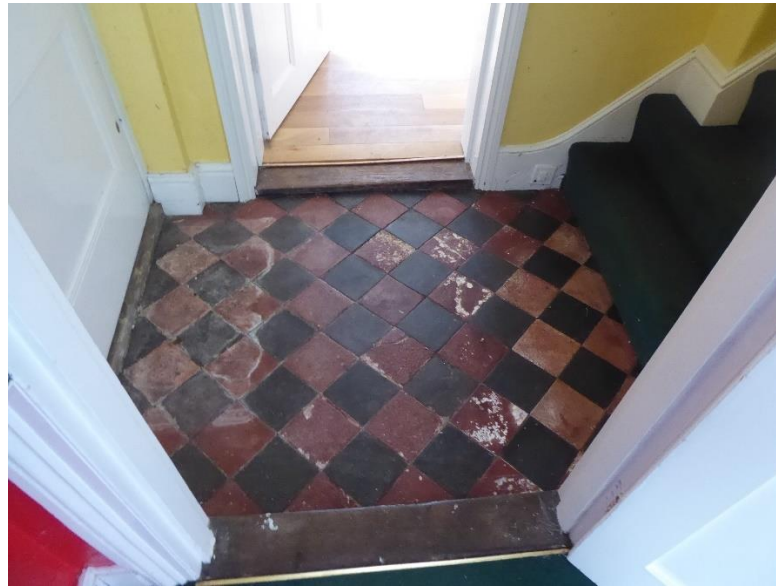
- 4.16. The entrance lobby to the main pile, at the base of the stair, has a tiled surface which is believed to be early/original to the building.

Figure 26: View of lobby to main entrance with early tiles

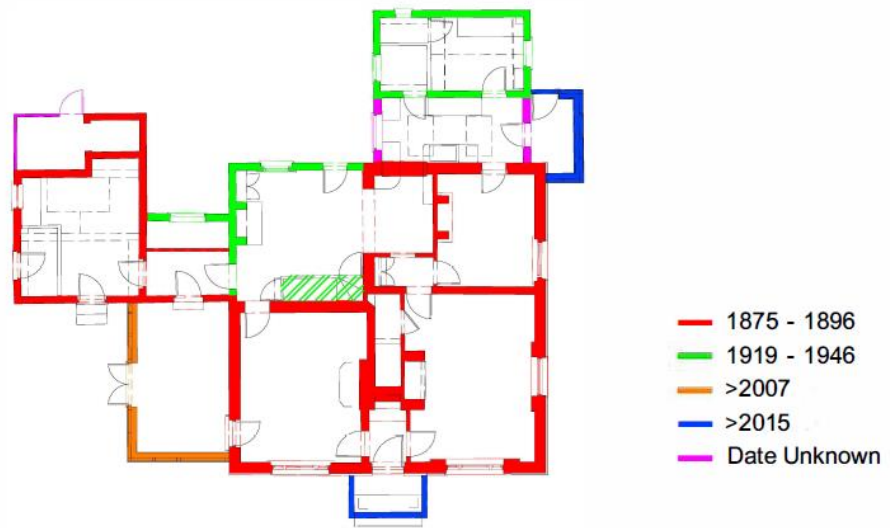
4.20. The phased plans below show an interpretation of the building's chronological development.

4.21. Site investigation and historical analysis has revealed that a farm has been located at this Site since at least the eighteenth century. The earlier farmhouse and outbuildings were demolished in the period 1875-1896 when the existing farmhouse was constructed. The original building was L-shape in plan with a three bay south facing frontage with an ancillary building attached on the west side. In the period 1919-1946, a significant two floor extension was added to the northwest corner of the main pile. The connection to the outbuilding was widened and a single storey outbuilding, likely a wash house, was added to the rear north. This outbuilding was then attached, via a lean-to, either at the same time or soon after, to the main pile. During the past 15 years a garden room has been added to the west elevation, a boot room/porch to the east elevation and an open porch to the front south elevation.

Figure 31: Floor plans (GF top / FF bottom) showing phases of development

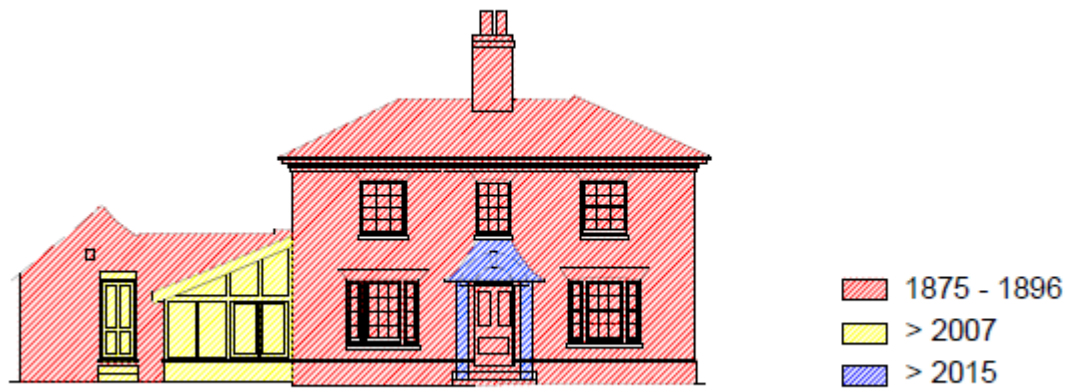
Figure 32: South elevation showing phases of development

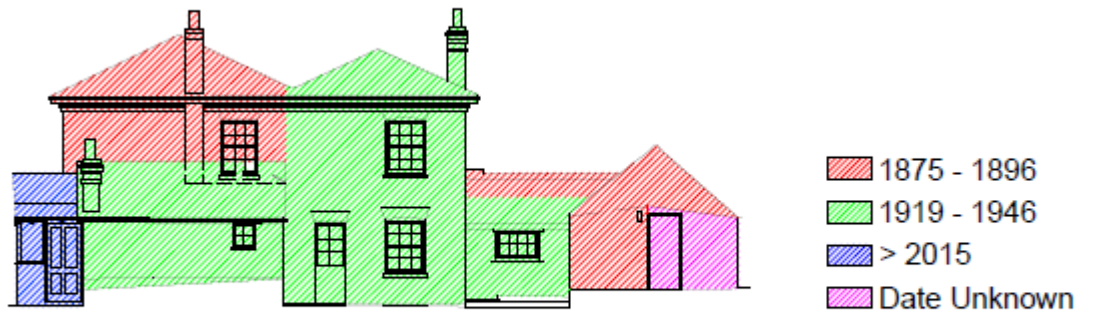
Figure 33: North elevation showing phases of development

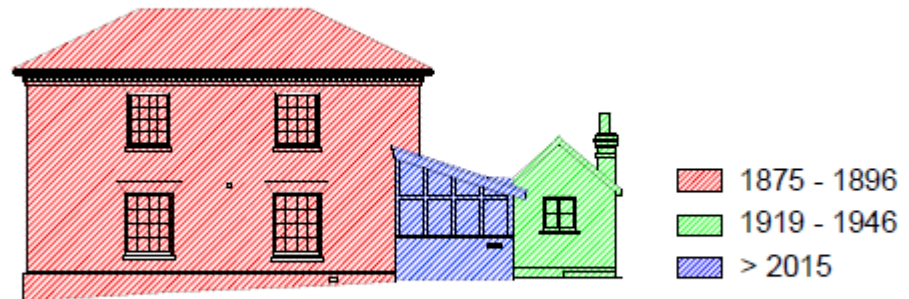
Figure 34: East elevation showing phases of development
