Project  
Reawakening Brighton Royal Estate  
Phase 2

Drawing  
North Gate Details

Job Ref	Draw No	Revision
P1154-RHP-ZZ-00-DR-A-5040	P1	
Scale(s)	Size	Drawn
Varies	A1	TP PN

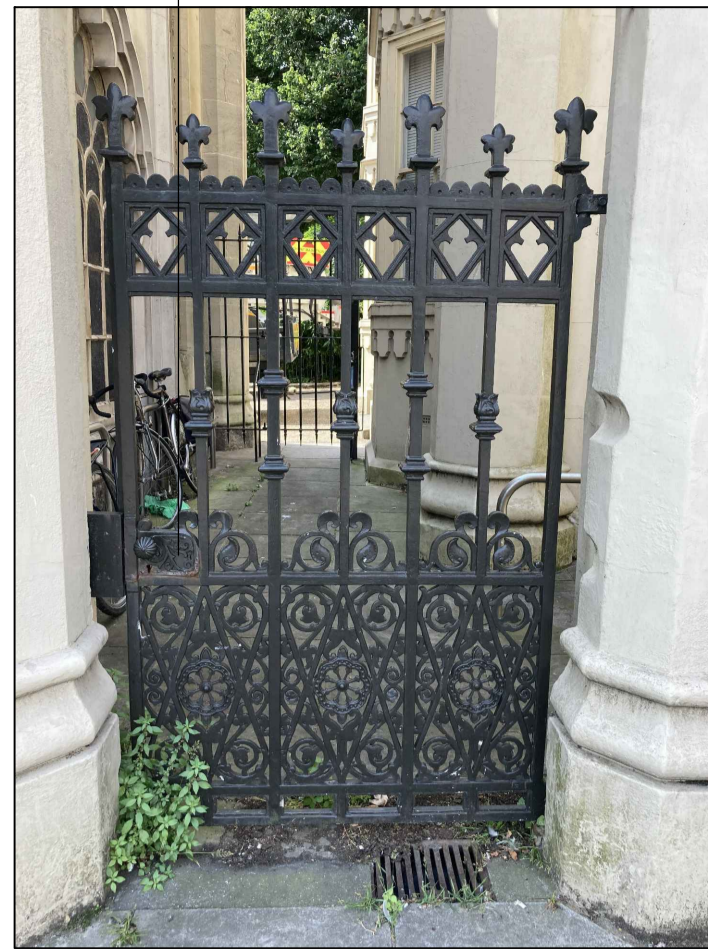
1 Elevation of North Gate Pedstrian Gate NG1  
5040 NTS

Lock box has significant corrosion. Allow for repairing, easing, overhaul and adjust to make fully operational.

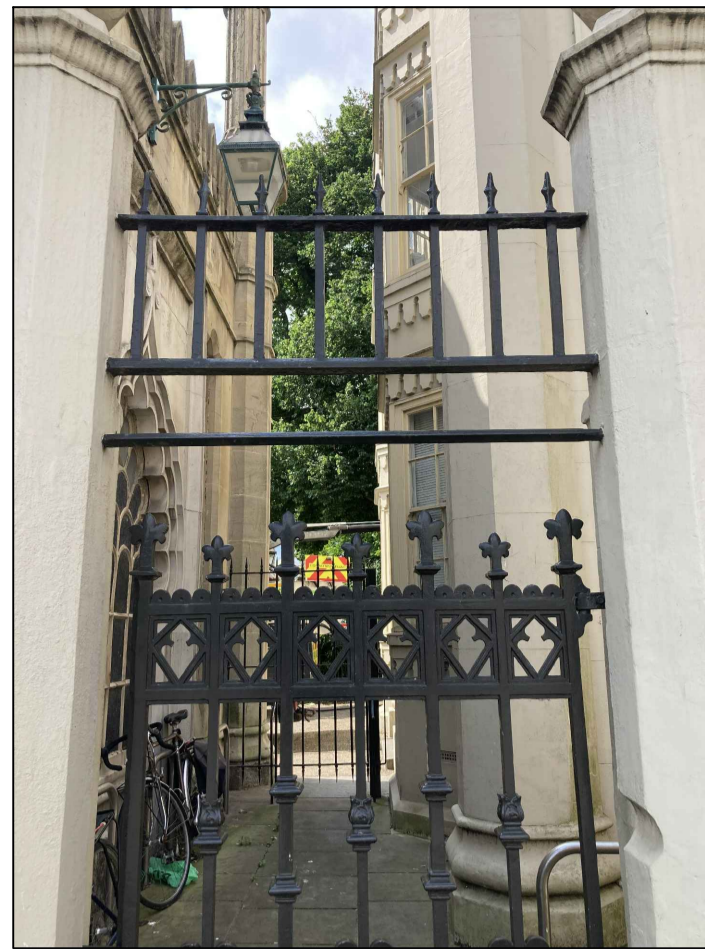
2 Elevation of North Gate Pedstrian Gate NG1  
5040 NTS

Condition poor - subject to further survey when high level access available, allow to carefully remove, fully repair and re-install and make good around fixing points in lime mortar.

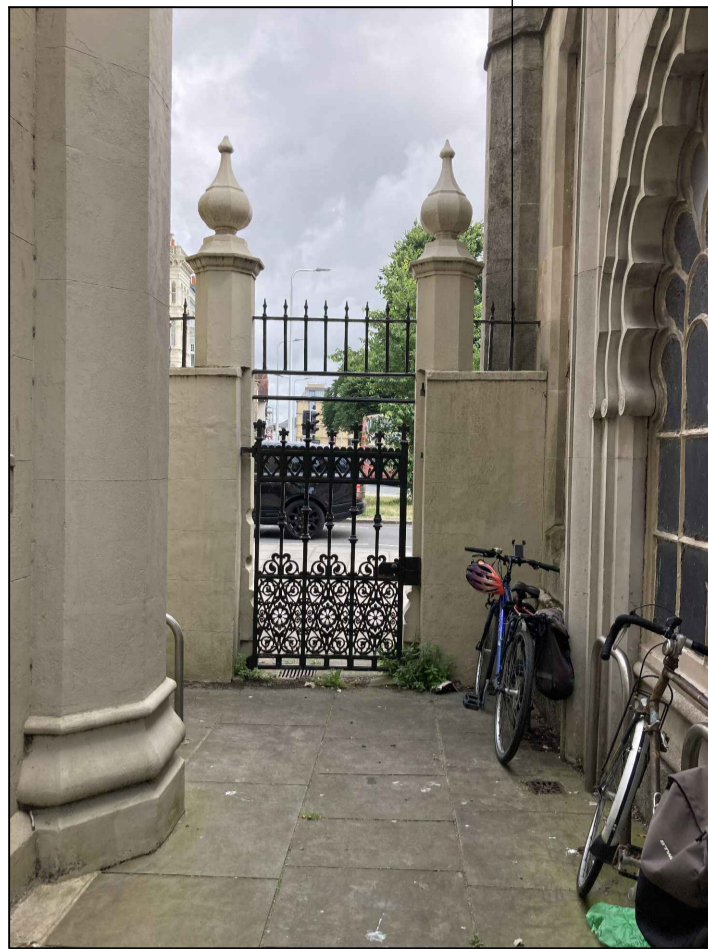
3 Elevation of North Gate Pedstrian Gate NG1  
5040 NTS

Existing painted modern galvanised steel gate.

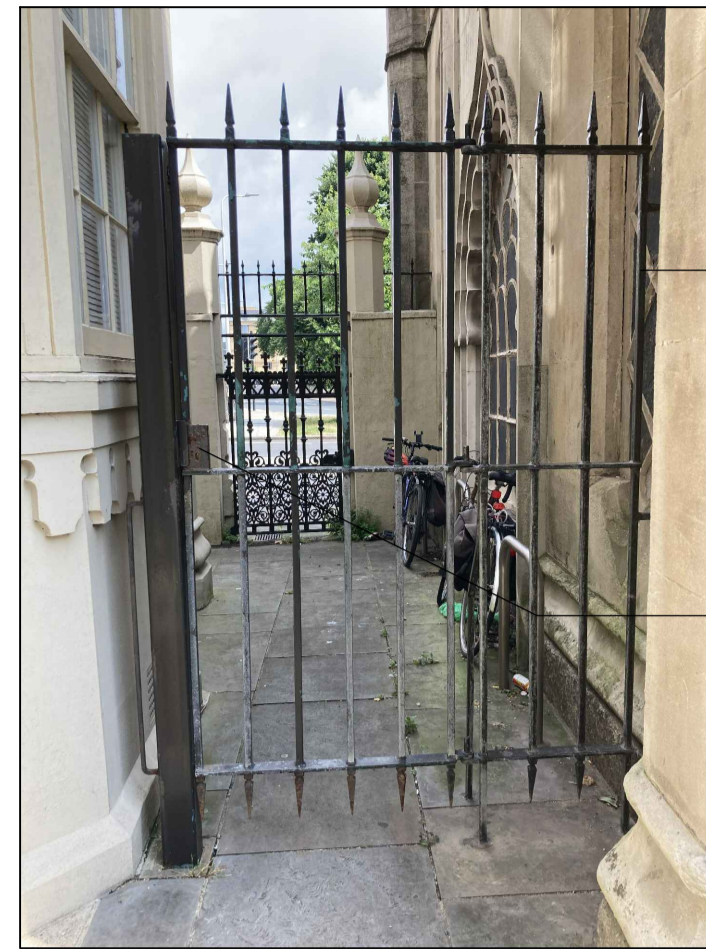
4 Elevation of North Gate Pedstrian Gate NG2  
5040 NTS

Lock box has significant corrosion. Allow for full replacement to make fully operational.

Gate is listed, ensure all paving and stonework is suitably protected during Gate repair and re-decoration works.
