Project  
Reawakening Brighton Royal Estate  
Phase 2

Drawing  
McLaren Boundary Wall Details

Job Ref	Dwg No	Revision
P1154-RHP-ZZ-00-DR-A-5022	P1

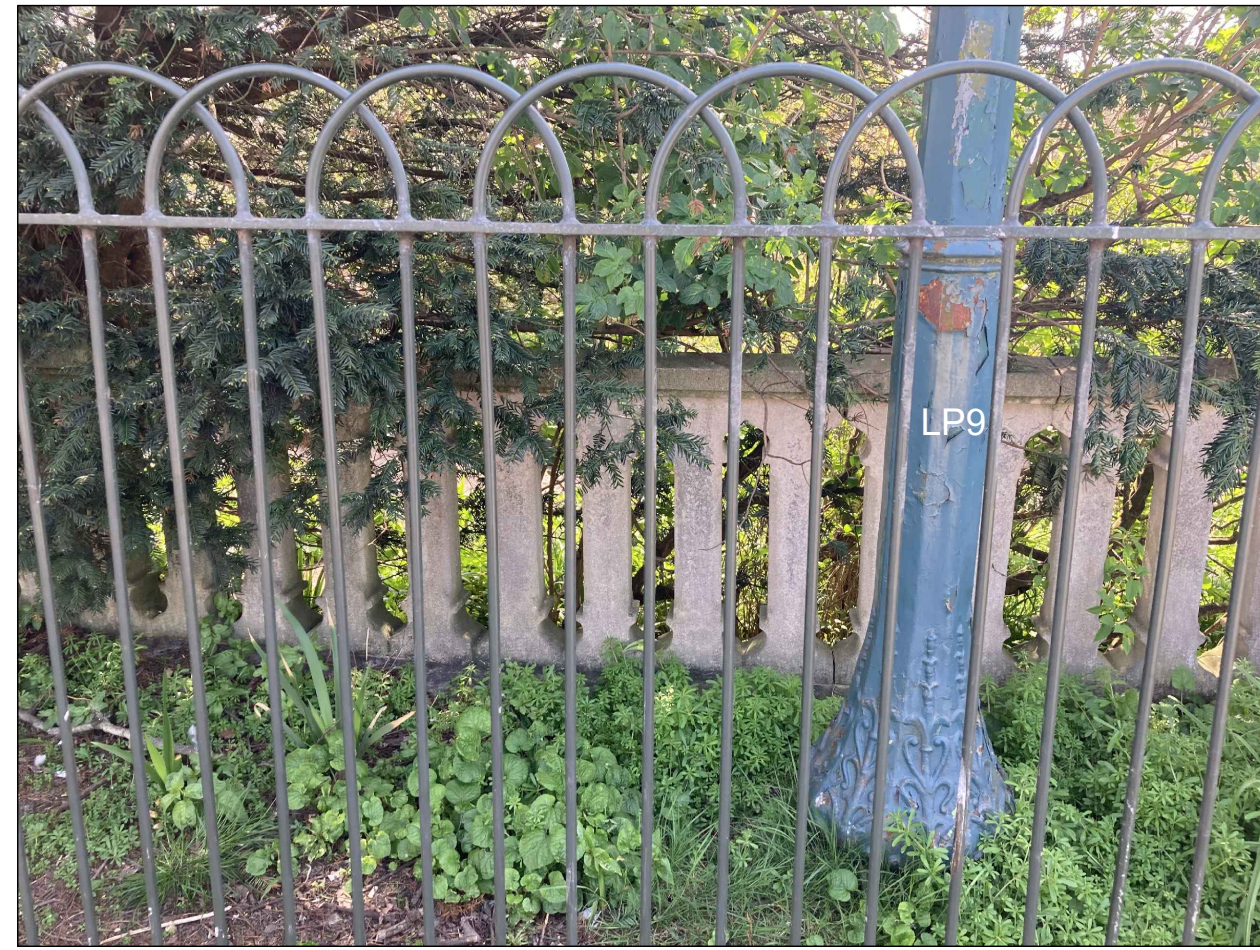
1 Part Elevation of McLaren Wall  
5022 NTS

These drawings show the elevation of the McLaren Wall on the outside of the park boundary. Refer to drawings 5001 to 5016 for details of the repairs.
