These drawings show the elevation of the McLaren Wall on the outside of the park boundary. Refer to drawings 5001 to 5016 for details of the repairs.

Reawakening Brighton Royal Estate Phase 2

<sup>Drawing</sup> McLaren Boundary Wall Details

Job Ref		Dwg No		Revision
P1154-RHP-ZZ-00-DR-A-5020 P1				
Scale(s)		Size	Drwn	Chkd
Varies	P1154	A1	TP	PN
Status

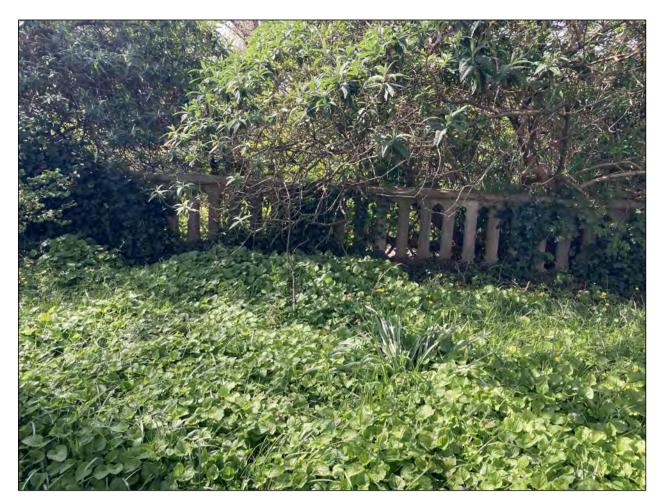
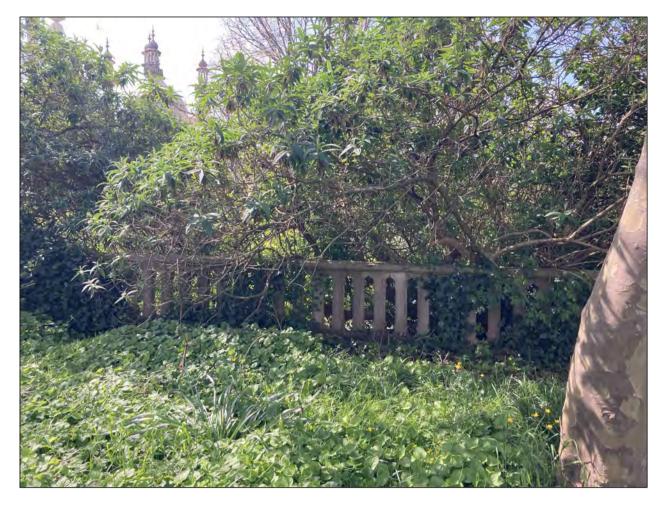
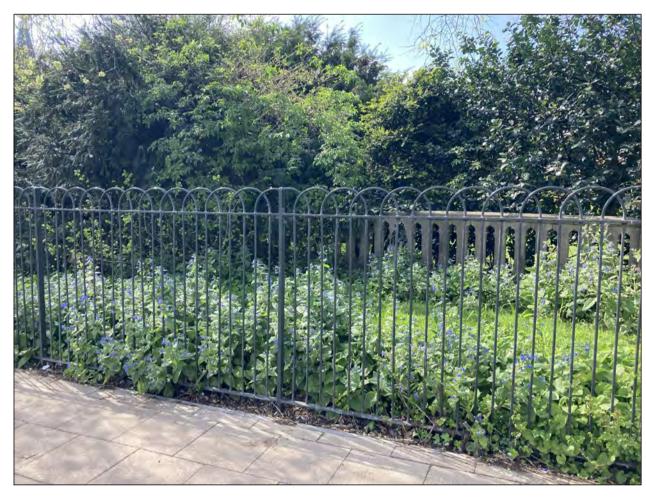
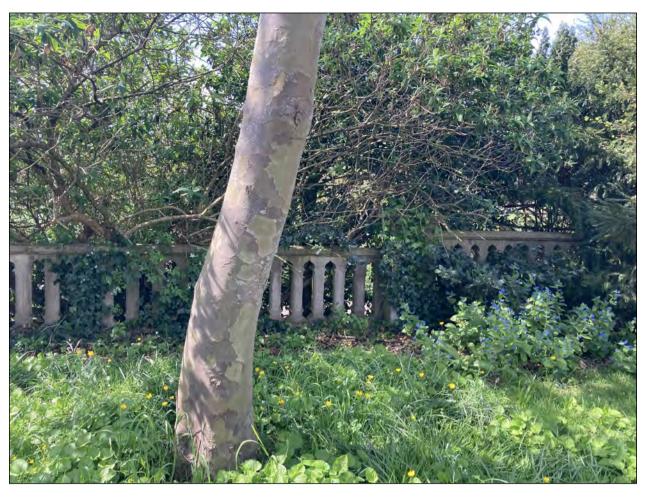
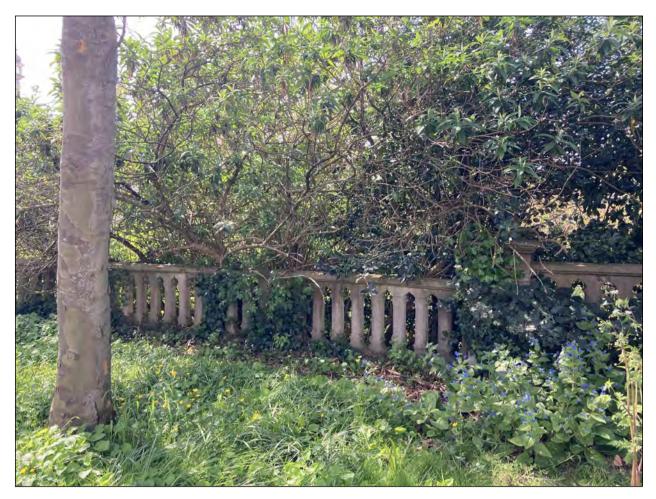
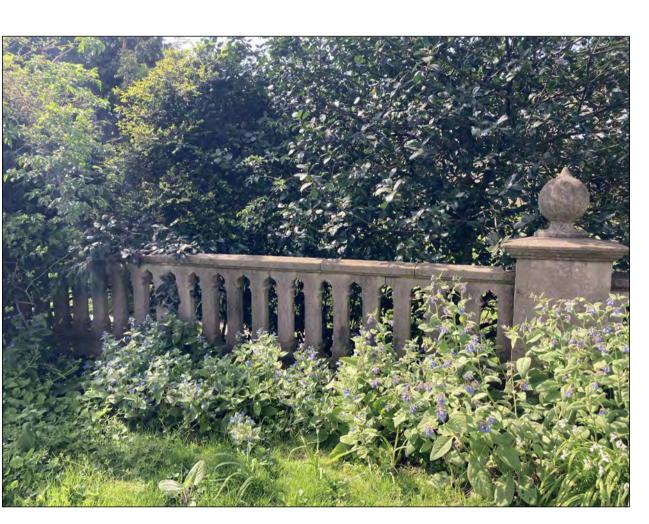
- 3. It is likely that the majority of the McLaren wall has horizontal cracking due to the contentious render and lime mortar to brickwork core. Allow for repairing cracks and new sacrificial coat throughout. Where more intrusive repairs than this are likely to be carried and can be seen, these are noted on the drawings.

- 1. Refer to drawing P1154-RHP-ZZ-00-DR-A-1000 Site Key Plan for locations.
- 2. Condition varies and in some cases, extensive plant growth has prevented full access and survey. It may be that the condition deteriorates further.

- Remove cracked render, carry Α out brickwork repairs and new lime render render.
- Lime leeching from retaining wall behind. Consider new french В drainage system behind. See drawing
  - P1154-RHP-ZZ-00-DR-DR-A-5000 for typical details.
- Lime render patch repair and С sacrificial coating

Cut out existing cracked/ damaged stone and carry out stone indent repair. Sized to suit, D profile and type to match existing. Provide stone sample for each type of stone sample for approval.

Localised motar patch repair profiled and colour matched to existing. Provide sample for F approval.
