BAT SCOPING SURVEY FROGGATS ANCILLIARY BUILDINGS

The Gym, Annex, Garage & Workshop

Froggats Cottage

SEPTEMBER 2023

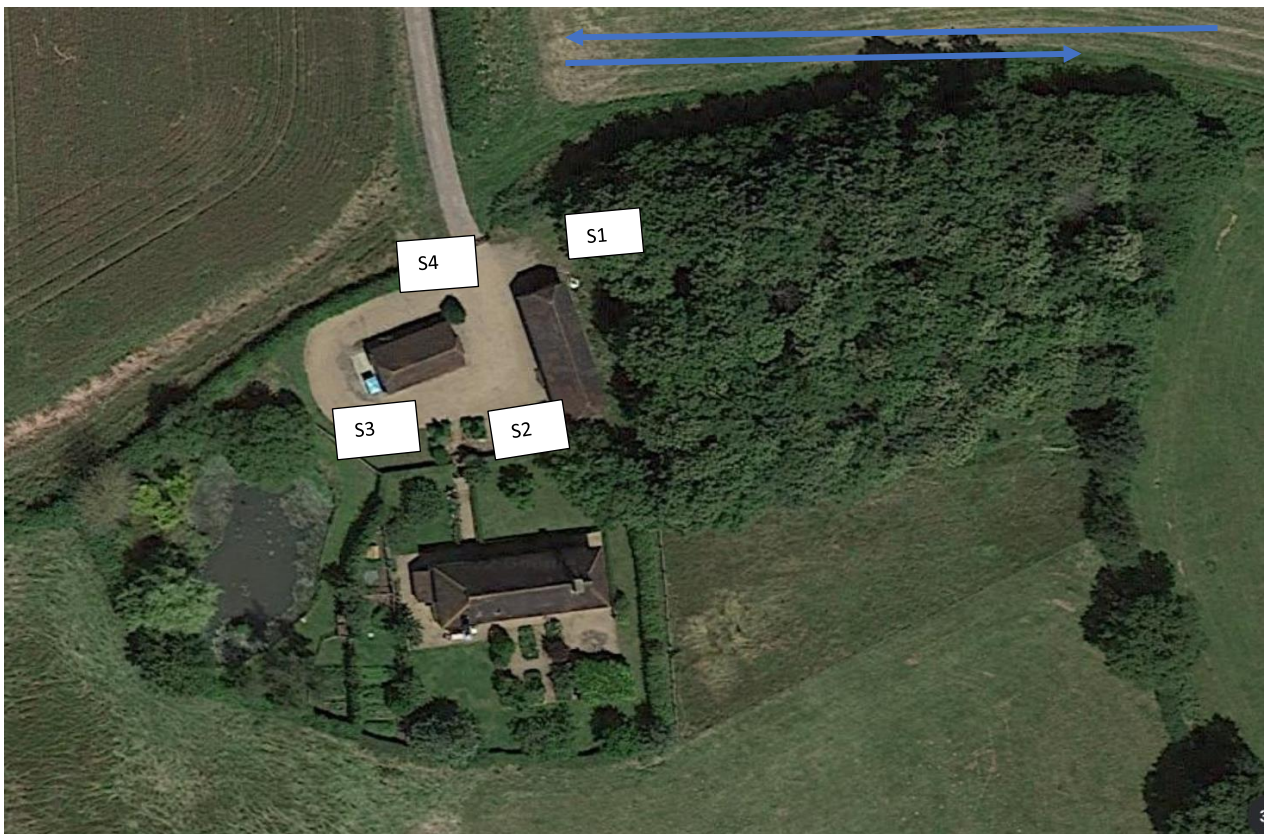
- 4.5.4 Position of surveyors on emergence surveys are shown below by S1, S2, S3 & S4. The white arrows show the flight paths used by foraging and commuting bats on the surveys. **See Figure 7** below.

Figure 7. Site plan showing positioning of the surveyors throughout the emergence surveys and recorded flight paths of foraging and commuting bats during the surveys.

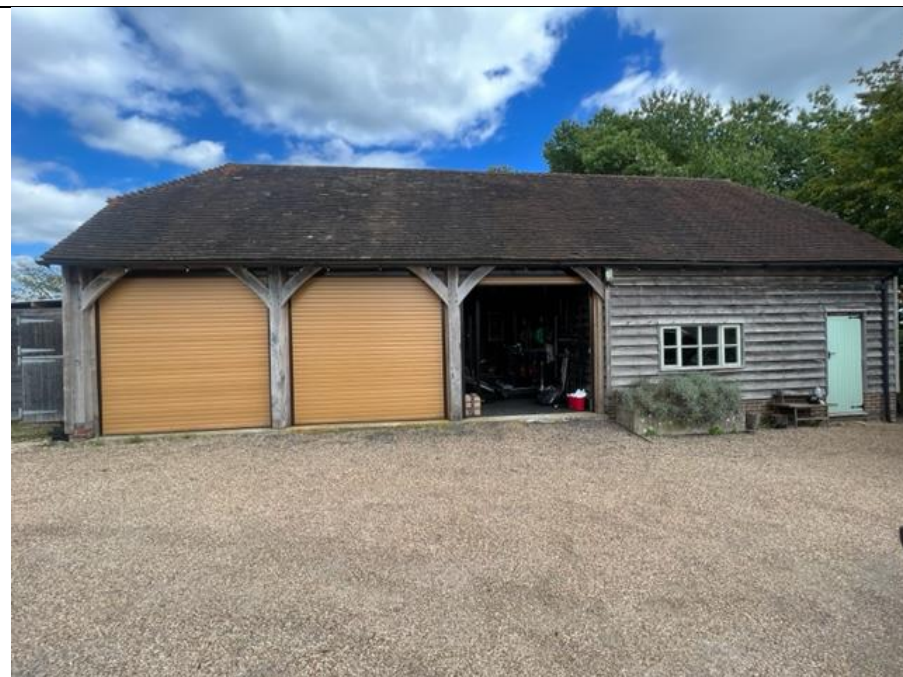
PHOTOGRAPH 1:

The front west facing elevation of the Gym and Annex showing the timber frame construction of the building and the roller shutter door to the Gym.

- 4.3.5 The gym, garage and workshop are single skinned and as such do not possess any internal cladding. **Photograph 20**
- 4.3.6 The gym has a roller shutter door on both bays which would effectively prevent bats from entering. No droppings or urine splashes were found on any of the equipment within the building, internally it showed no evidence that it had been used previously by roosting bats **Photograph 1**

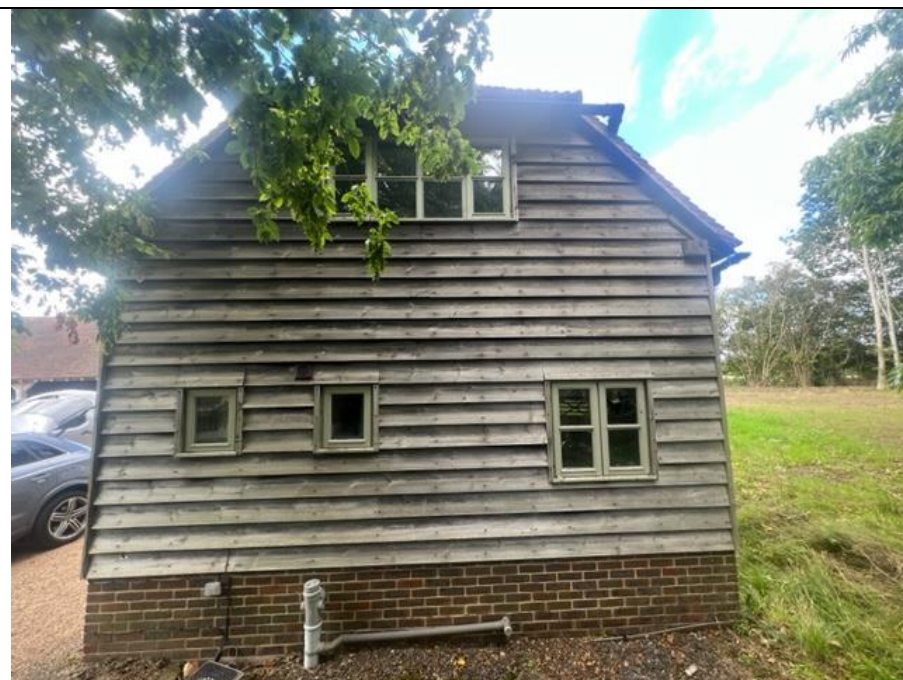
PHOTOGRAPH 2:

The rear, southern elevation shows the weather boarding, to the Annex.

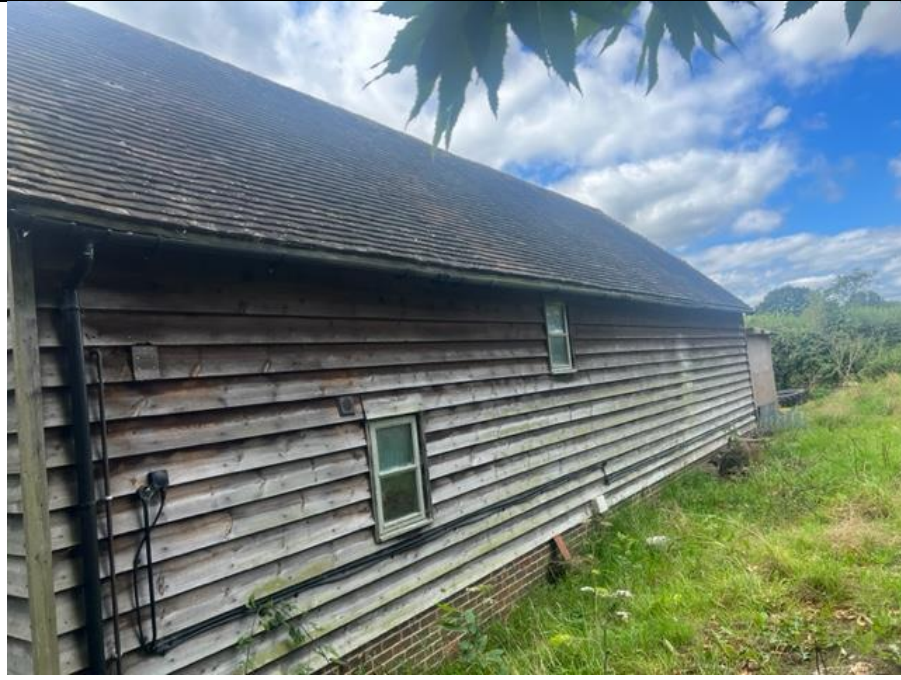
PHOTOGRAPH 3:
The eastern elevation of the Gym and Annex with weather boarding.

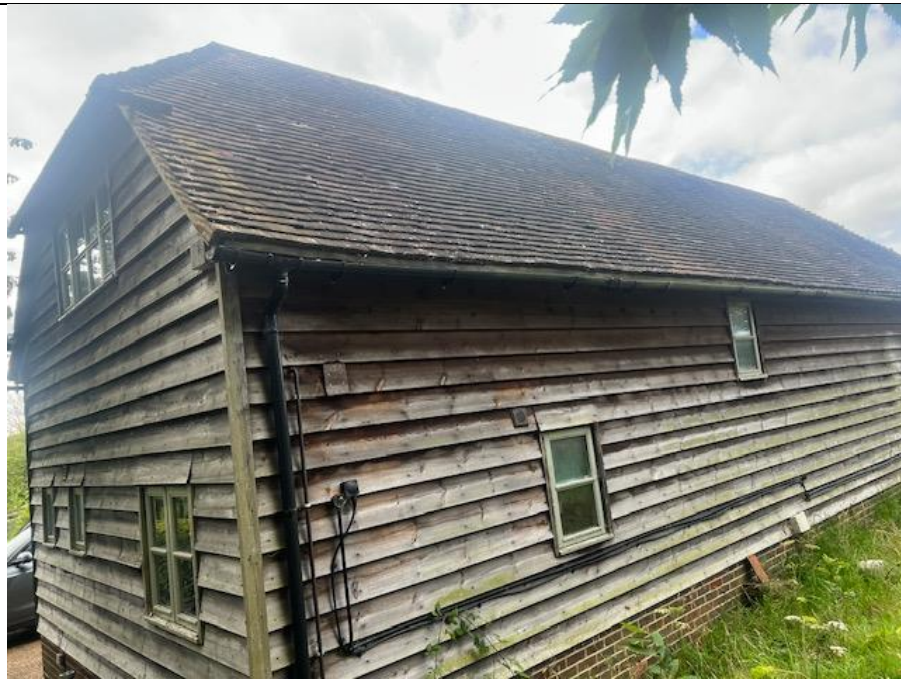
PHOTOGRAPH 4:
View of the east and south elevation of the Gym and Annex.

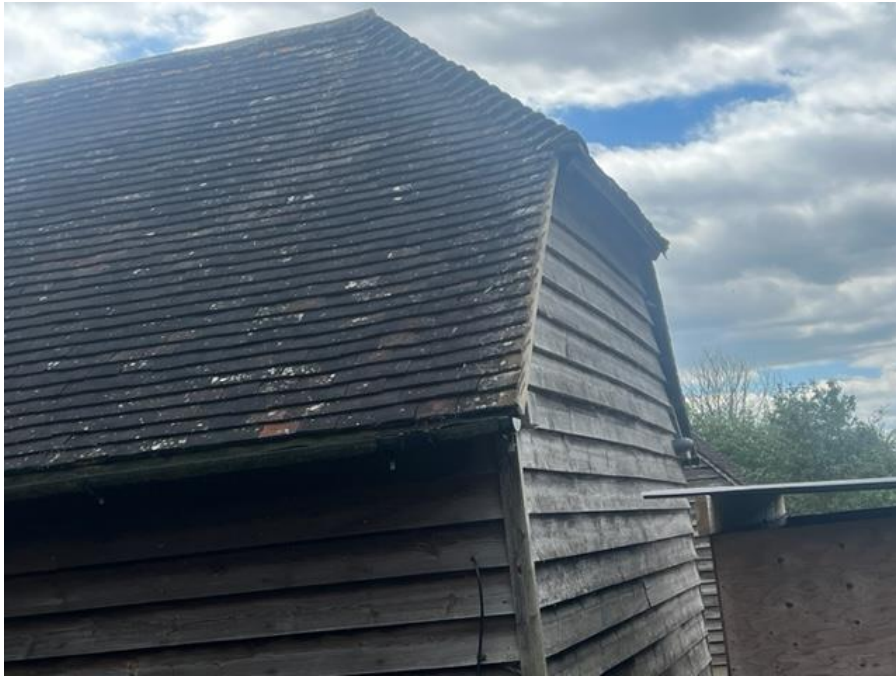
PHOTOGRAPH 5:
North facing elevation of the Gym.

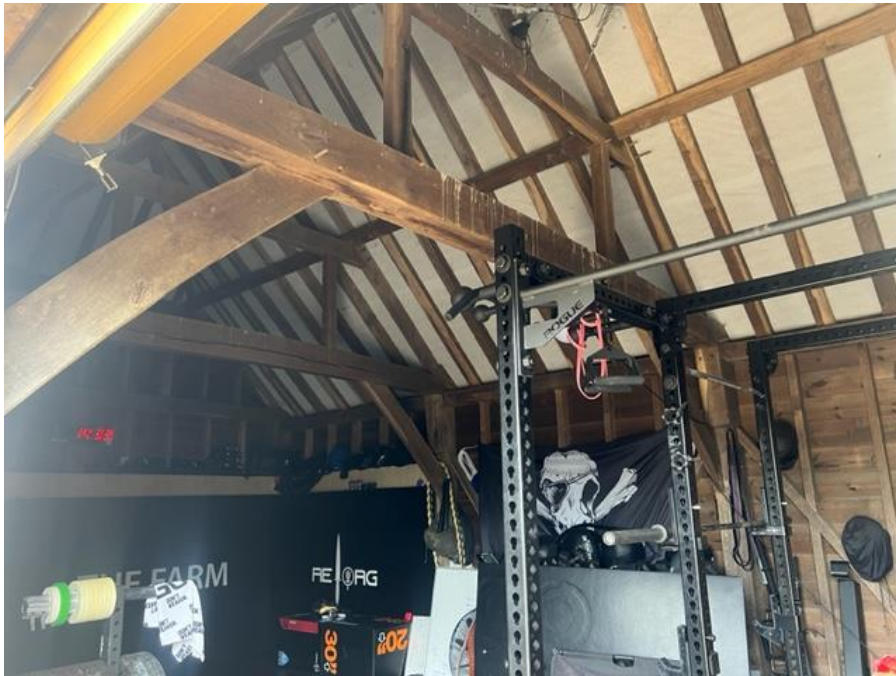
- 4.3.7 A roofing membrane is present under the roof tiles and is in good order. **Photograph 6.**
- 4.3.8 The Annex which is attached to the gym is double skinned and has Celotex insulation between the oak weather boarding and the internal skin.

PHOTOGRAPH 6:
Internally the Gym is single skinned and has a roofing membrane beneath the tiles.

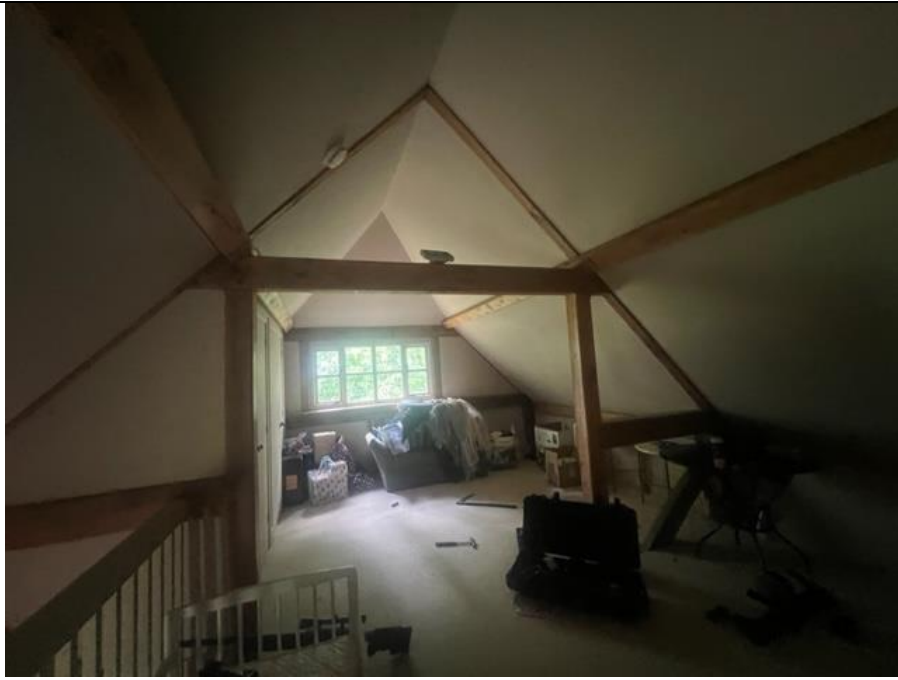
PHOTOGRAPH 7:

- 4.3.9 It has a vaulted ceiling on the 1st floor with no loft void as such. **Photograph 7.**
- 4.3.10 The roof is modern in construction with Celotex insulation. The roof is well sealed at the eaves with timber inserts between each joist, **Photograph 14.** A roofing membrane covers the underside of the tiles.

First floor of the Annex showing the vaulted ceiling.

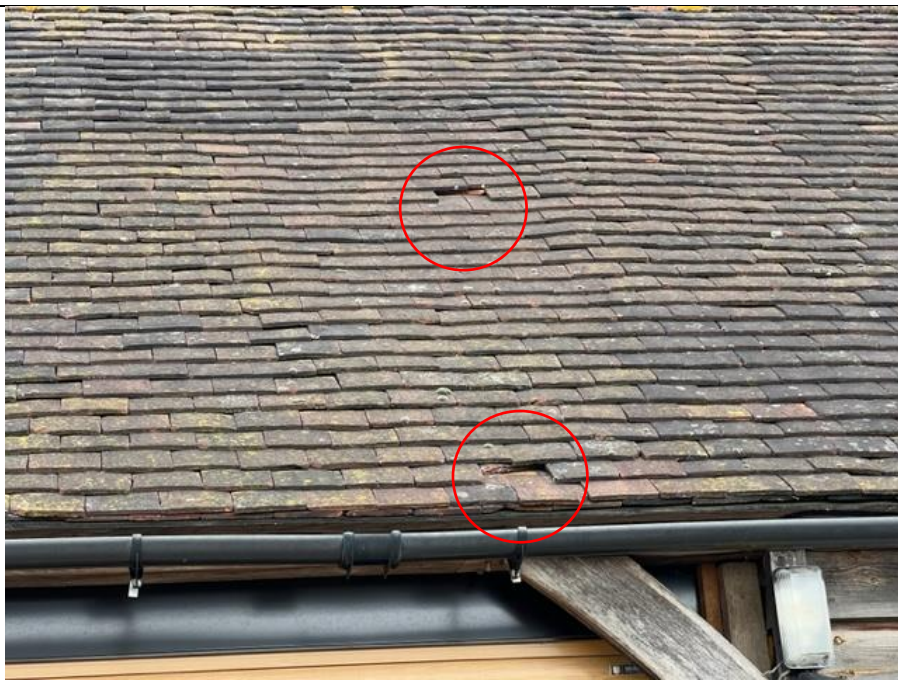
PHOTOGRAPH 8:

4.6.6 Internally the buildings showed no evidence of bats. A number access points were observed during the potential roost survey, namely the gaps between the overlapping hand made tiles roof tiles and 2 broken tiles **Photograph 8**. allowing potential access to the area behind and between the tiles and the roofing membrane. Constant vigilance was paid to all the roof areas during the dusk emergence surveys. However, throughout all the dusk emergence and return to roost surveys no bats were seen to emerge from any part of the building.

The west facing roof of the gym above the roller shutter door showing two broken tiles circled in red and also a number of potential access points to the void between the tiles and the roofing membrane via the gaps where the handmade tiles overlap.

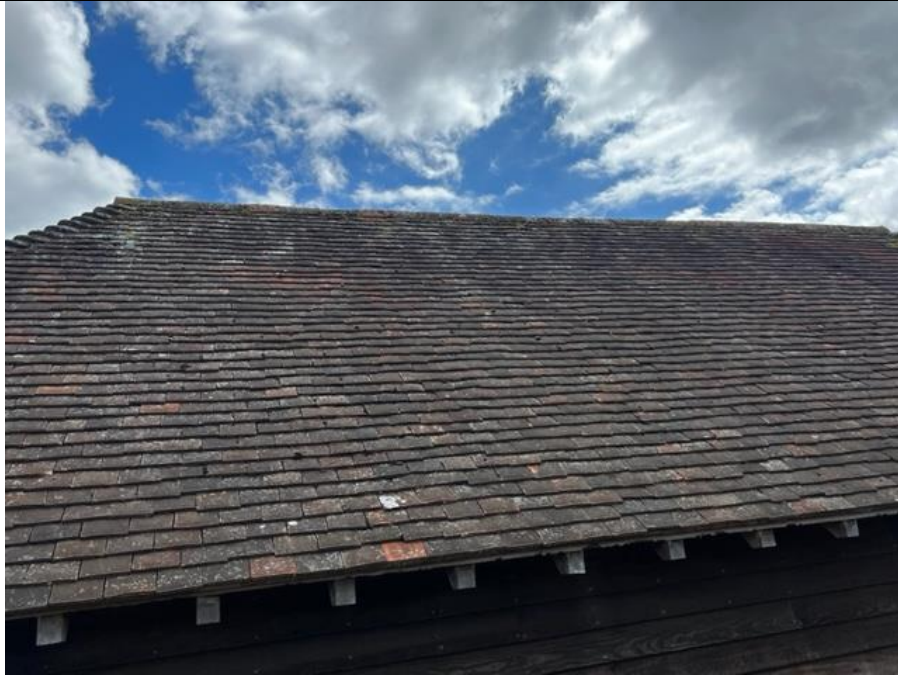
PHOTOGRAPH 9:

The east facing roof is in good order.

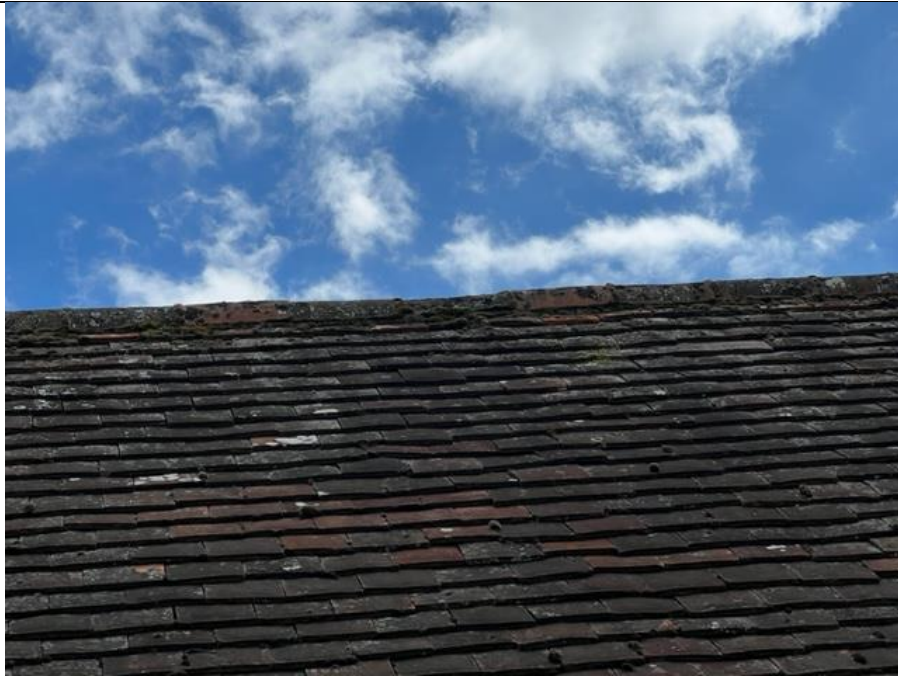
PHOTOGRAPH 10:

- 4.3.11 The ridge and hip tiles were subject to a ground survey, but they appeared in good order with no missing mortar and were not considered to be of roosting value. **Photograph 10 & 16**

The ridge tiles of the annex and Gym are also in good order.

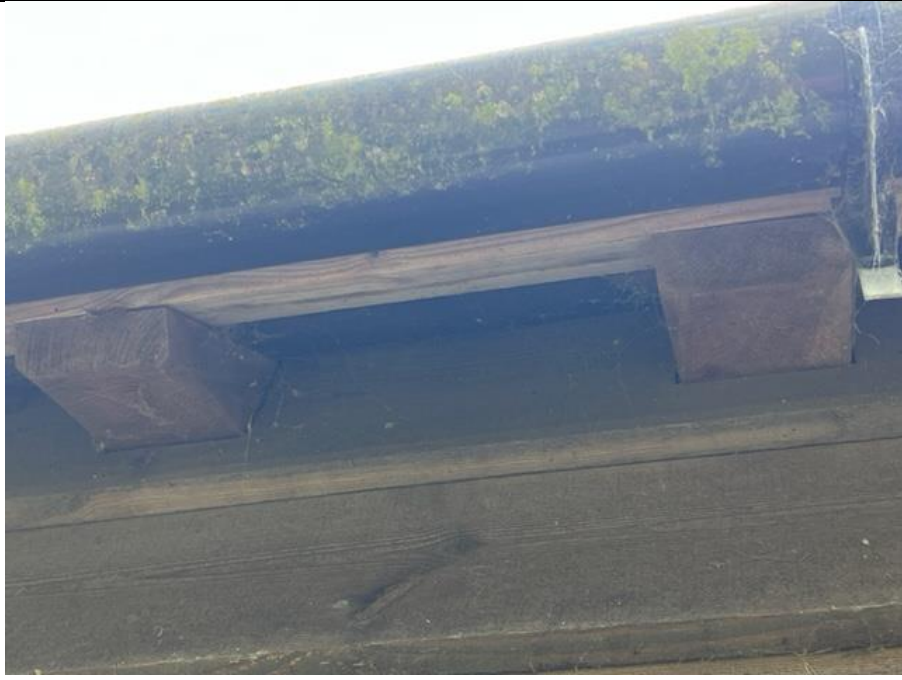
- 4.3.17 Both buildings are sealed at the eaves between the roof joists. **Photograph 11 & 18**

PHOTOGRAPH 11:
The eaves of the Annex and Gym are sealed.

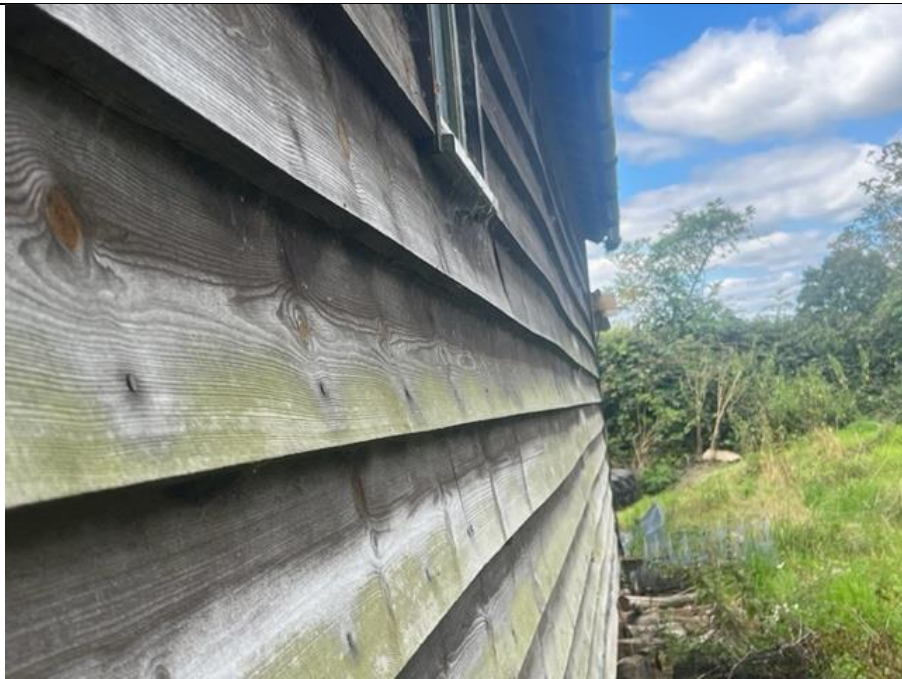
- 4.3.16 The weatherboarding on both buildings was in good order and tight fitting with little opportunity to allow access to roosting bats. **Photograph 12**

PHOTOGRAPH 12:
A close up photo of the weather boarding of the Annex and Gym.

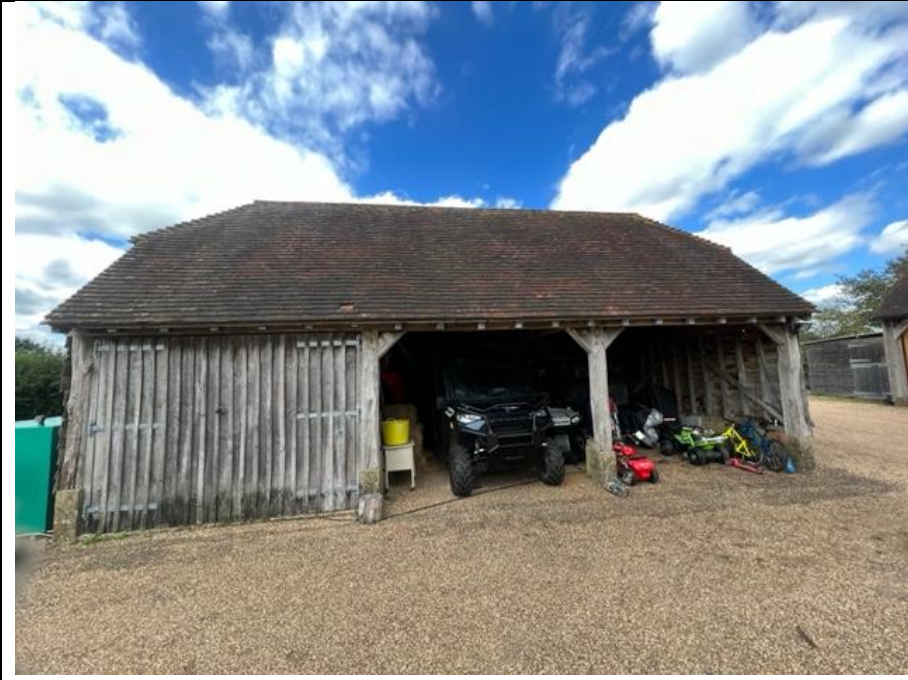
PHOTOGRAPH 13:

The front south facing elevation of the Garage and Workshop showing its timber construction. With an open front to the Garage and a Locked double door to the Workshop.

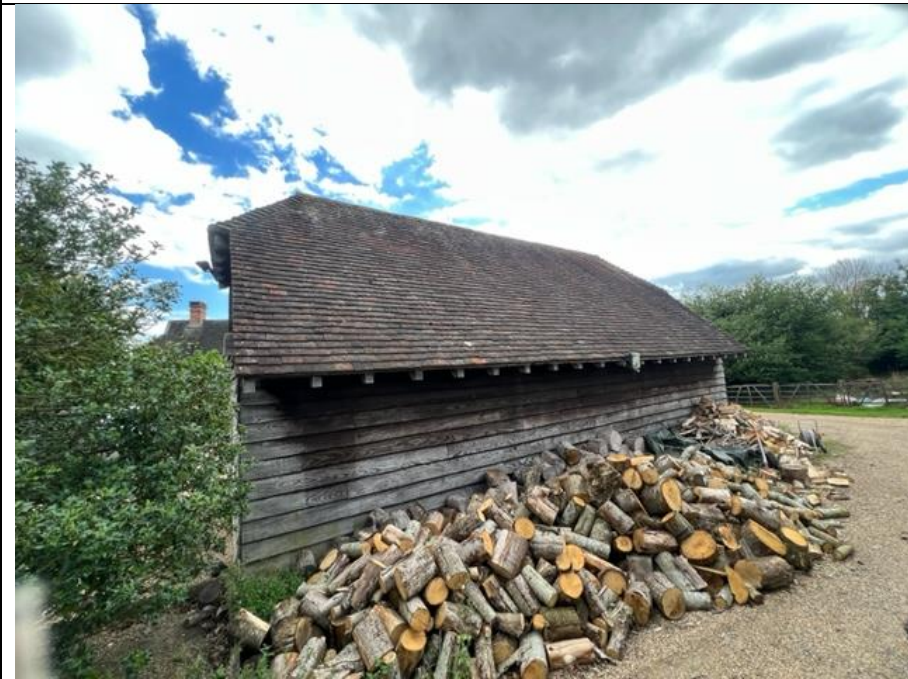
PHOTOGRAPH 14:

Rear north facing elevation of the Garage and Workshop.

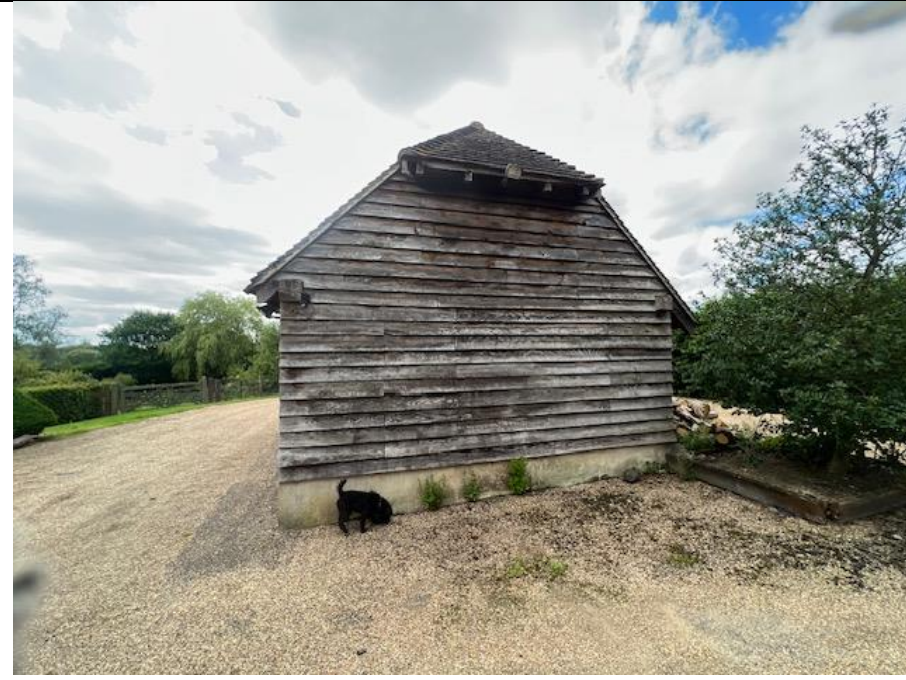
PHOTOGRAPH 15:
East facing elevation of the Garage showing the weather boarding.

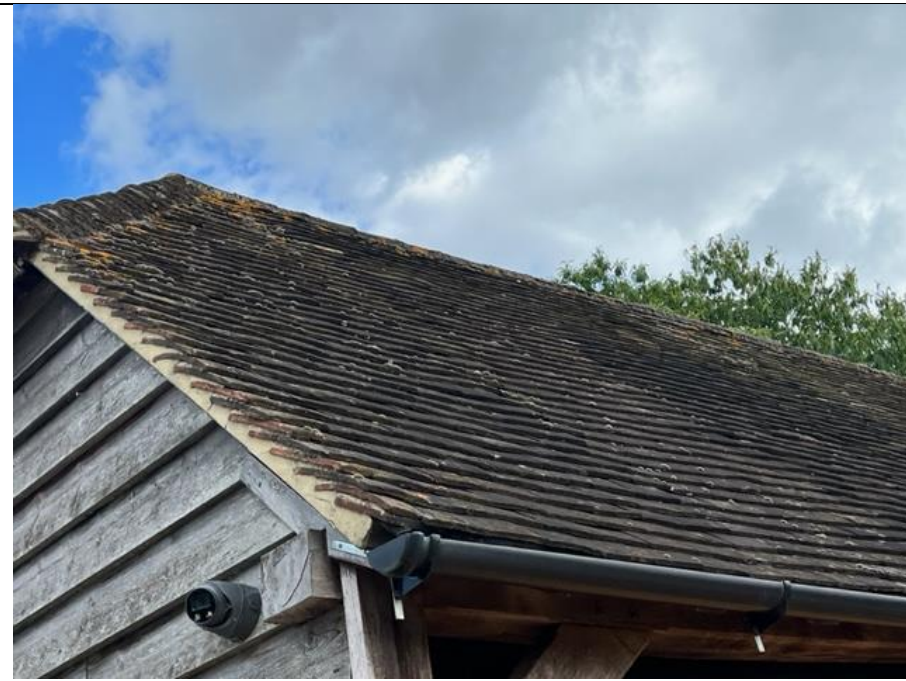
PHOTOGRAPH 16:
The east facing gable of the Garage showing the weatherboarding and the sealing of the tiles.

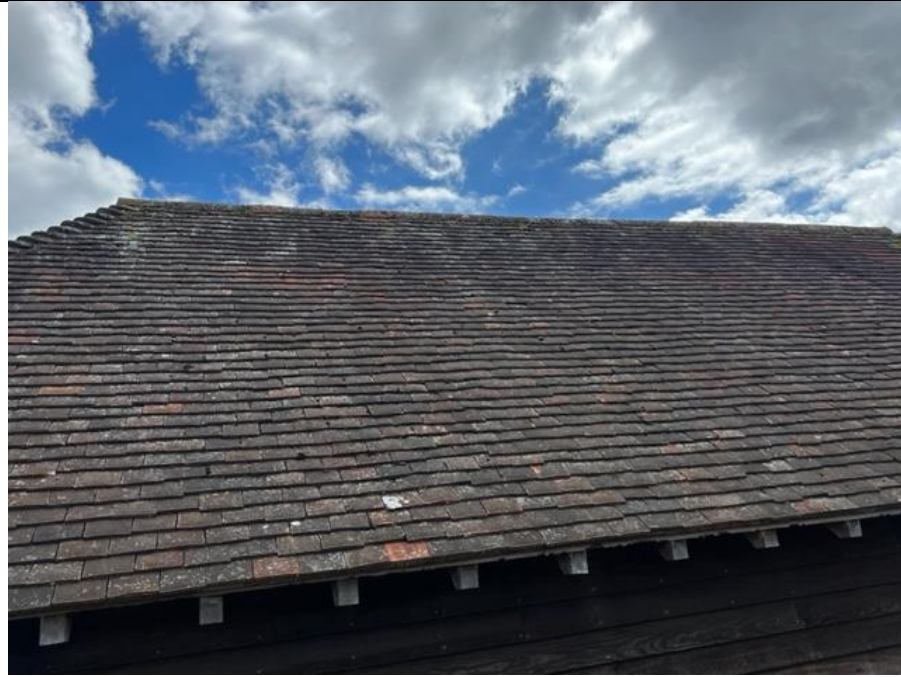
PHOTOGRAPH 17:

- 4.3.14 Both the roof on the Gym /Annex and the Garage/Workshop consist of clay hand made tiles and as such they could present a number of roosting opportunities where the tiles overlap and natural openings appear throughout roof. **Photograph 17.**

The north facing roof of the Garage and Workshop is in good order but the hand made tiles do provide the occasional access point to crevasse dwelling bats.

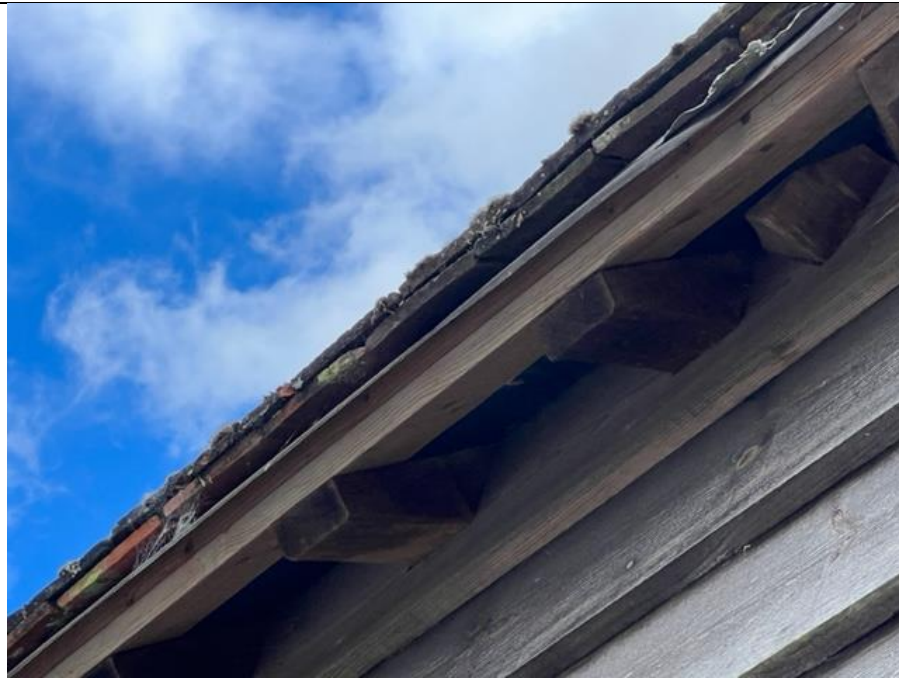
PHOTOGRAPH 18:
The eaves are sealed throughout the Garage and Workshop.

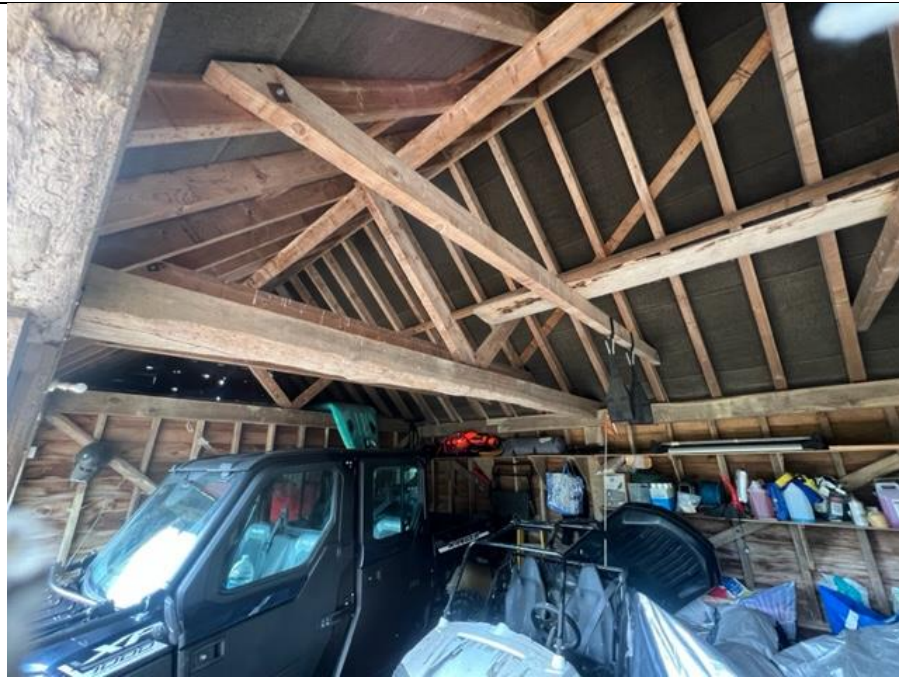
- 4.3.12 The Garage and workshop are of a similar construction but felt is used under the tiles in this instance as opposed to the roofing membrane used on the other building. **Photograph 19 & 20**

PHOTOGRAPH 19:
The underside of the Garage roof showing the traditional black under felt.

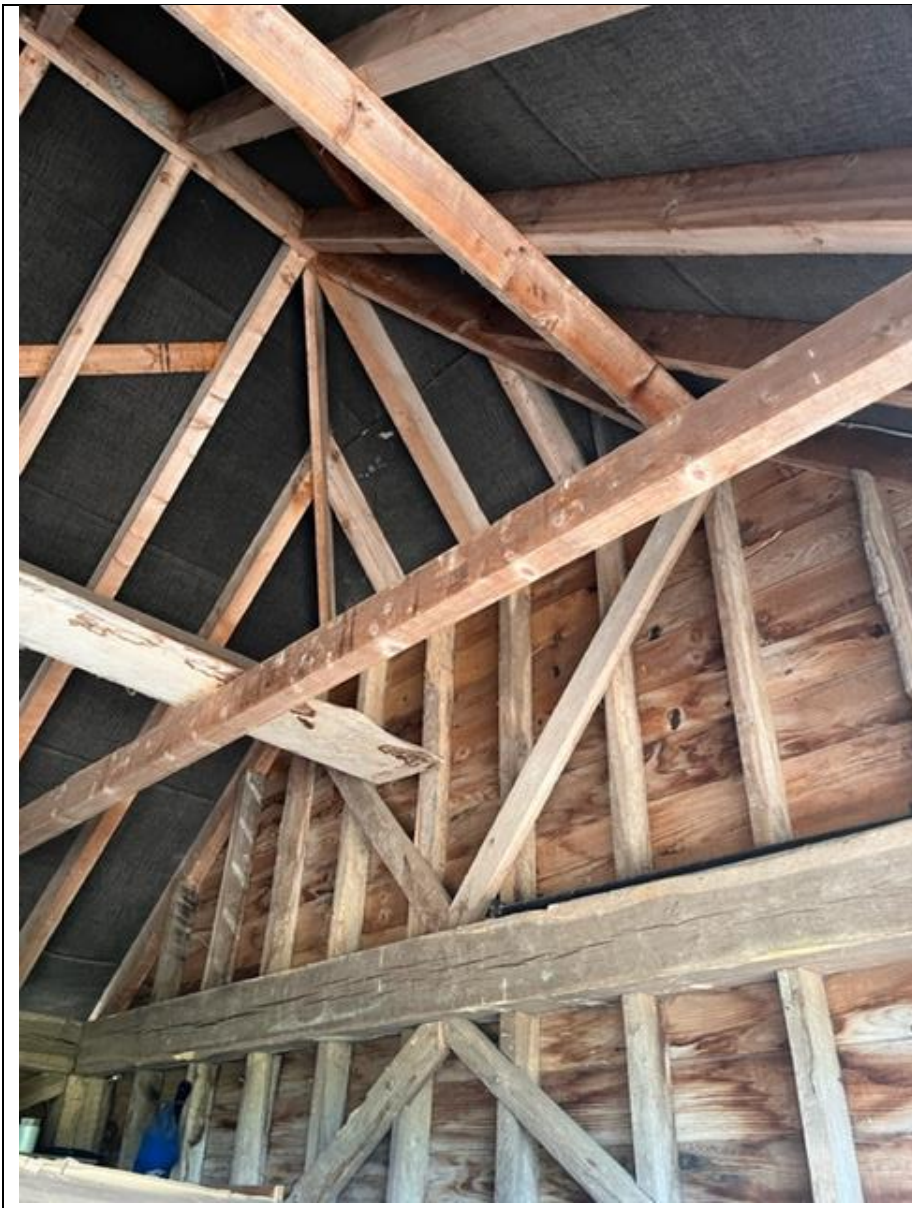
PHOTOGRAPH 20:
Close up of the underside of the Garage roof showing the roof trusses and the black under felt.
