# Woodview, Witney

## Ecological Appraisal Survey Report

August 2023

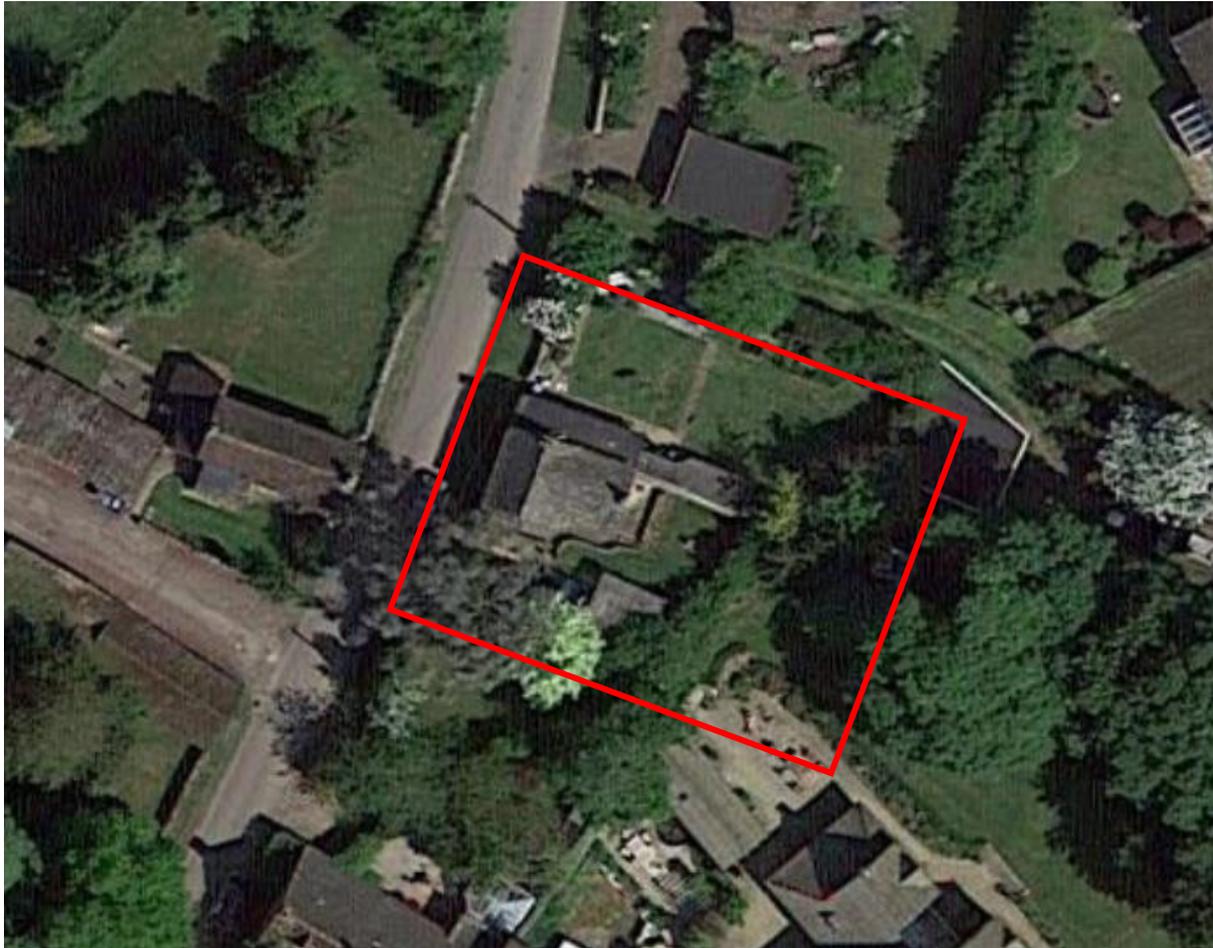
Figure 1. Site location with the red line boundary.

- 1.2.1. Wood View Cottage and its surrounding land, hereafter referred to as 'the Site', measures approximately 0.066 ha (0.001km<sup>2</sup>) and was situated on Wood Lane, to the south east of the village of Hailey (approximate OS grid reference: SP 35282 13315), see Fig. 1 below.
- 1.2.2. The Site is composed primarily of, improved grassland, bare ground and introduced shrubs. There were two buildings on site; one main house and one attached outbuilding. The property at the time of the visit was in a good state of repair, however the roof void had evidence of damage, where the lyme / plaster coating had come away.
- 1.2.1. The proposed developments and alterations to the site are as followed:
- Demolition of buildings.
  - Construction of a property.
  - Clearance of vegetation.
  - Disturbance of the land.

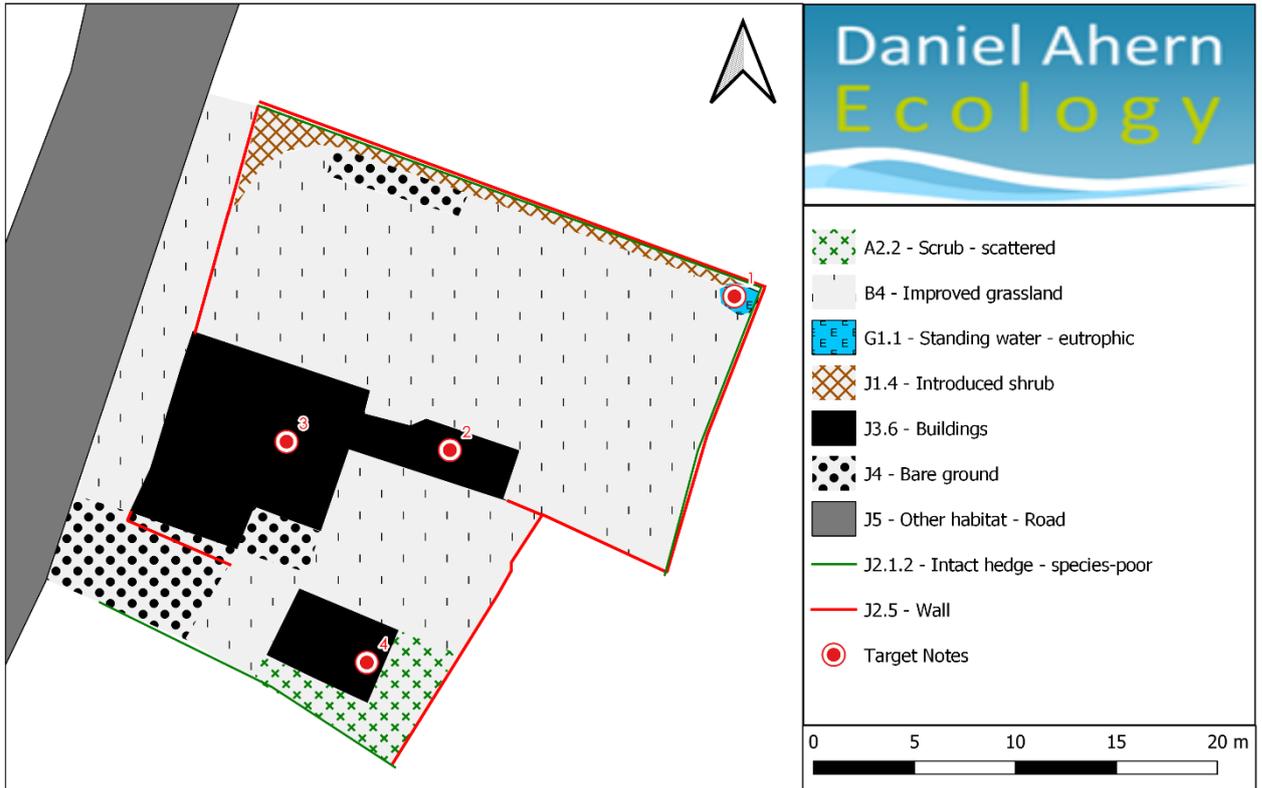
Figure 3. Phase 1 habitat map, including numbered target notes.

4.2.1. A Phase 1 habitat map of the site is set out in Figure 3 below.

- 4.2.4. To the northeastern corner, was a small garden pond, no larger than 2m<sup>2</sup> (Target note 1).
- 4.2.5. To the southeastern corner of the site, behind a wooden lean too (Target note 4) which serves a car port, there was an area of scrub forming, with bramble *Rubus fruticosus* present.

- 4.2.6. Target note 2, the main house, was a two-storey cottage in a moderate state of repair. The house was constructed from Cotswold stone, with the roof constructed from slates. There were potential roost features (PRF's) recorded externally, where slates had slipped. Internally the roof void was in state of disrepair, with the plaster which previously covered the wooden sarking having come away. There was gaps and holes visible in the apex of the roof structure. There were no droppings found internally. The house has MODERATE potential for bats with two surveys recommended between the 1<sup>st</sup> May and 31<sup>st</sup> August 2023.

- 4.2.7. Target note 3 represented a single storey adjoined garden building. The building had a single pitch roof of similar construction to the main house. The tiles were more uniform and there was no evidence of bats found internally or externally.

<b>Target note</b>	<b>Target note comments</b>
1	A small garden pond less than 2m <sup>2</sup> , a maximum depth of 50cm.
2	A single storey attached outbuilding, which was used as garden storage / garage. NEGLIGIBLE bat roost potential.
3	A two storey Cotswold cottage, with MODERATE bat roost potential. Two bat activity surveys between 1 <sup>st</sup> May and 31 <sup>st</sup> August are recommended.
4	A wooden lean-to which was used as a car port. NEGLIGIBLE bat roost potential.

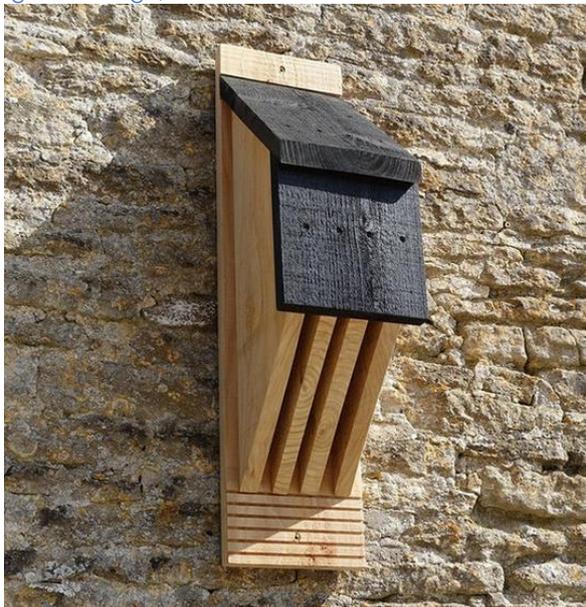
Figure 4 – Large, multi-chamber bat box.

- 1.1.4. A single multi-chamber bat box will be installed on Site. the bat box will need to be installed at least 3m above the ground and in unlit location on a northern or western elevation.
- 1.1.5. There will be no external lighting installed which will cause spill within 5m of the boundary vegetation. This will ensure a dark corridor is maintained for bat use.

- 1.1.1. Briefing to contractors – A toolbox talk will be delivered to contractors in advance of works commencing on site. This will include information on relevant legislation relating to birds and contractor's responsibilities. A bat box will be installed on a pre-agreed structure before any works start, see Figure 6 for the location.
- 1.1.2. Pre-clearance Check – A pre-demolition survey will be undertaken in advance of works commencing on site. Any trees to be removed will be checked by a suitably qualified ecologist on the day of clearance prior to any works taking place.
- 1.1.3. If the PRFs in trees on site cannot be fully checked during the pre-demolition survey the tree should be soft-felled. All limbs with PRFS should be felled and left grounded overnight to allow any bats present to leave before the timber is then further processed.

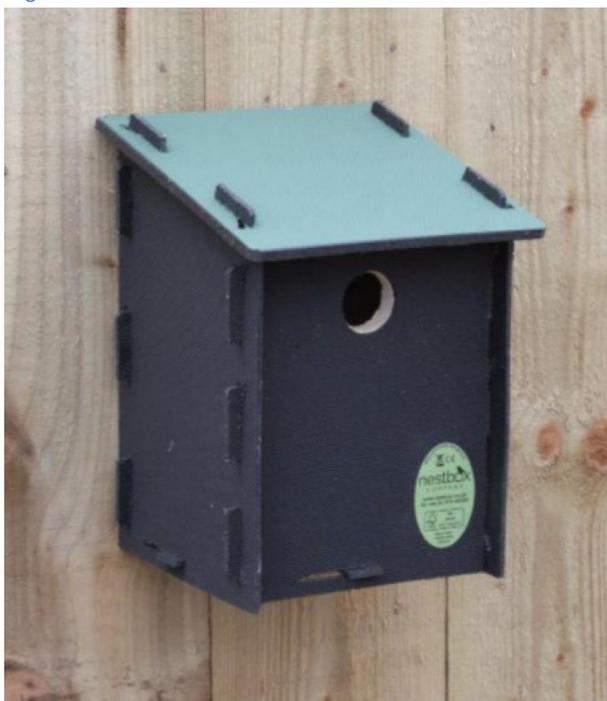
Figure 5 – A bird box.

- 1.1.10. Two bird boxes will be installed within the site, either on trees or the buildings. These should be installed at least 3m above the ground and NOT on a southern elevation.

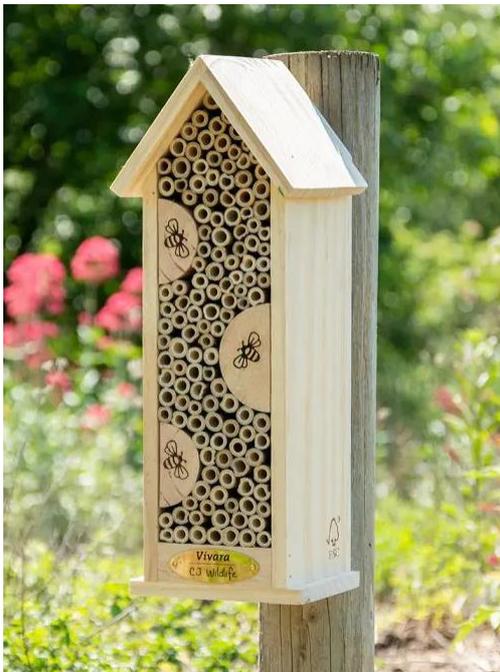
Figure 6. Bug “hotel”.

1.1.12. A single invertebrate “hotel” will be installed on Site. See Figure 6 below.

1.1.13. These should be installed at a height of 1.5m above ground level on a southern elevation.
