Woodview, Witney

Bat Activity Survey Report

Colony Architects

August 2023

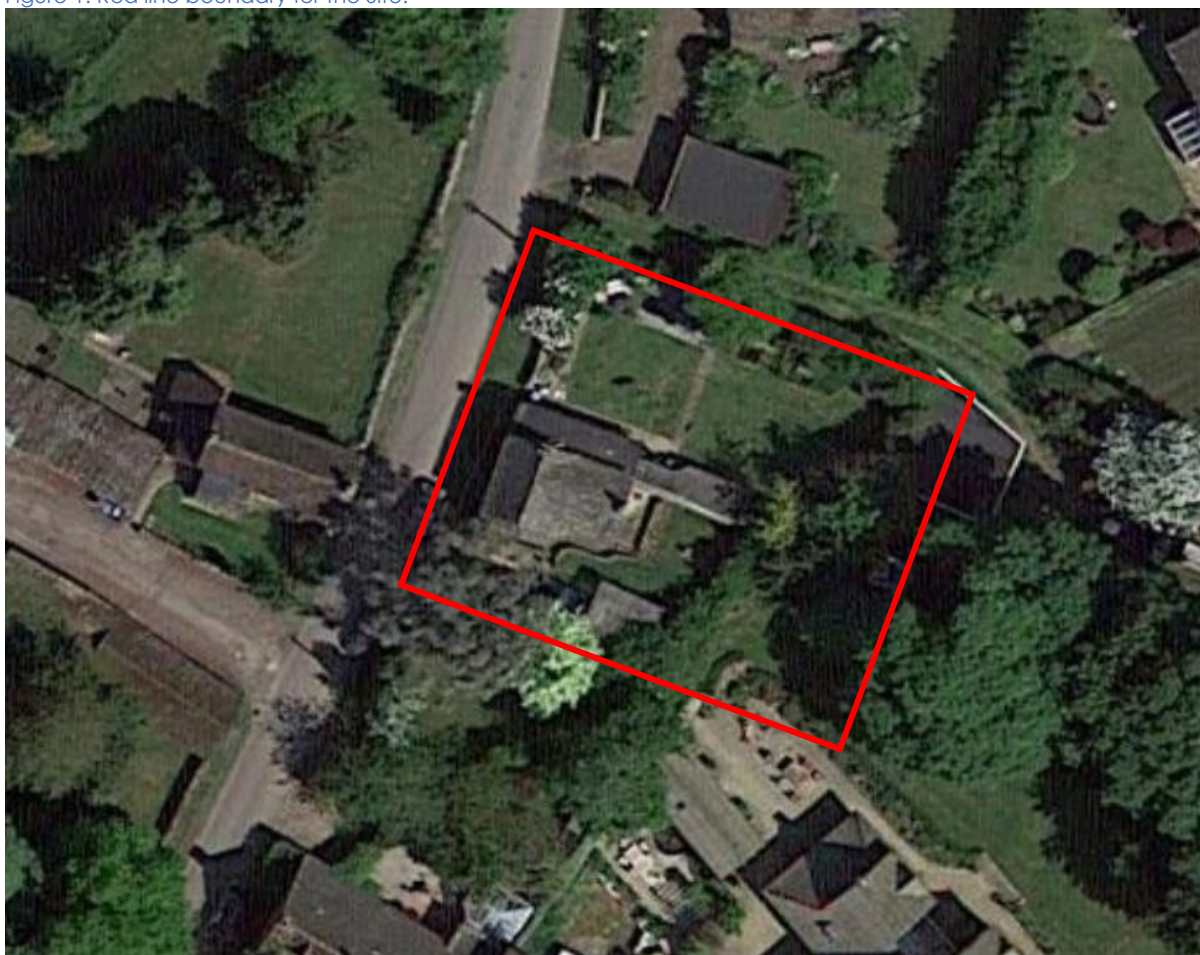
Figure 1. Red line boundary for the Site.

Wood View Cottage and its surrounding land, hereafter referred to as 'the Site', measures approximately 0.066 ha and was situated on Wood Lane, to the south east of the village of Hailey (approximate OS grid reference: SP 35282 13315), see Fig. 1 below.
