Within our approved planning application, we had included to retain an old disused chimney including the stack on the existing kitchen wall side (lefthand side when viewed from the street). Our builder has recently discovered that the original disused chimney is not properly supported and therefore has structural support problems. See the photo below: -

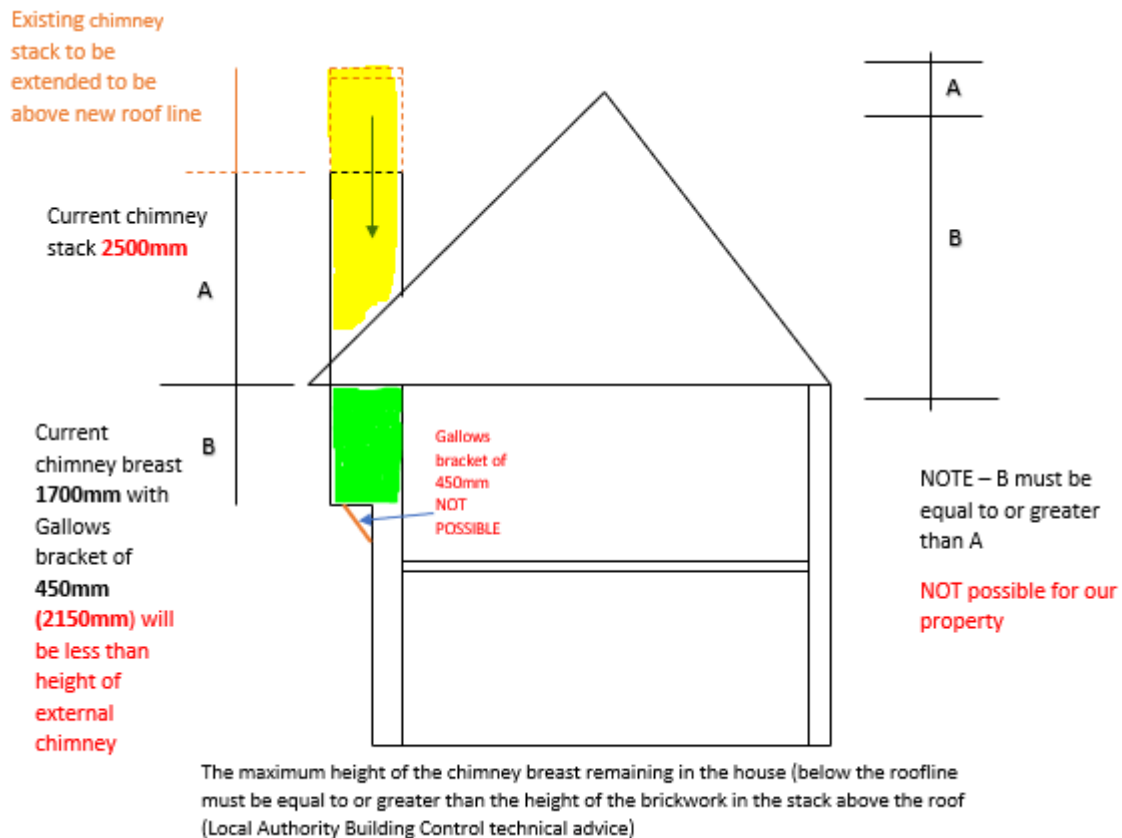
The builder has very strongly advised us that for structural and safety reasons, it would be advisable to remove the chimney completely as there is no longer a need for this old chimney in the kitchen. This is because the fixed height of the internal chimney breast detailed in green will not be able to support the much larger external chimney stack in yellow, which must be extended as shown within the diagram below:

The diagram is showing that the **external** chimney stack is currently approximately 350mm greater than the **internal** chimney breast and will need to be increased even further to go above the new roof line as per planning approval. The height of the current chimney is further confirmed by the photos below: -

Therefore, the newly extended chimney stack will **not** be adequately supported below and will be structurally unstable **not** only from insufficient base but also from wind and rain, even if the gallows bracket were installed to support the base.

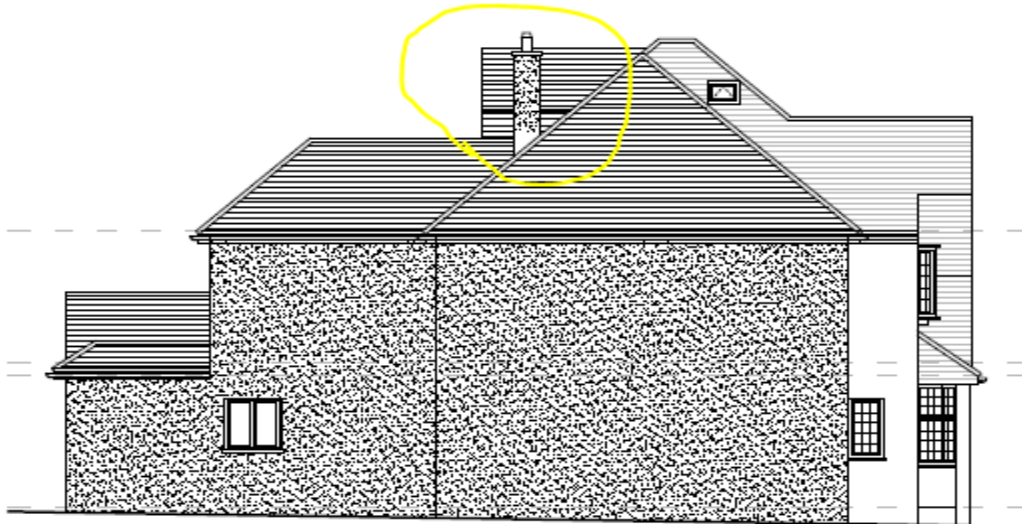
PROPOSED SIDE ELEVATION

In addition to this, the positioning of the chimney stack being very close to the side valley of the roof, will result in water penetration within the roof structure from the rain water gushing down the roof valley, causing leaks and damp. This problem of the valley and close proximately to the chimney is becoming very apparent as we are shortly to commence the new roof structure construction.

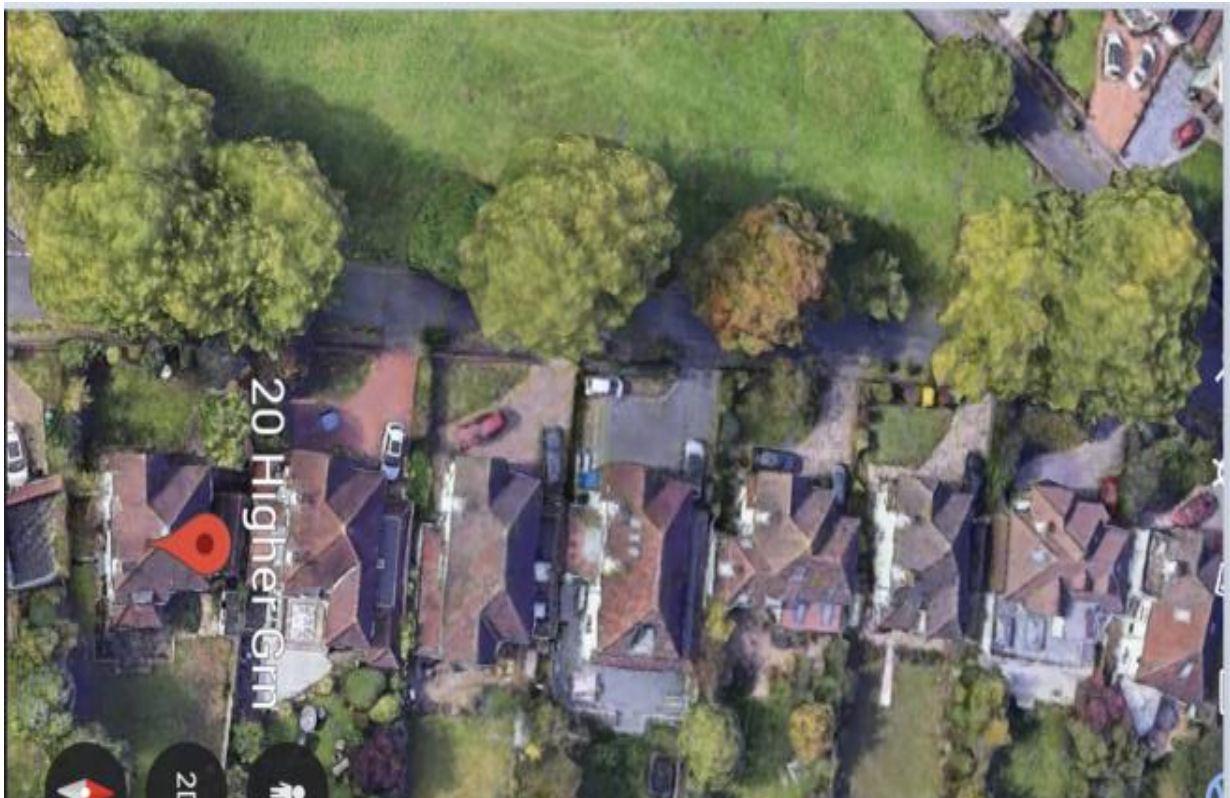
Further to this, the below ariel photograph of the Higher Green area shows that at least 6 properties on the same side of the road of our property have had their kitchen side chimneys removed completely, possibly due to a similar problem to what we are having.
