**Mill Barn, Wrington
Preliminary Roost Assessment
October 2023**

Report Title: Mill Barn, Wrington: Preliminary Roost Assessment

Report reference: MBWPRA23.01

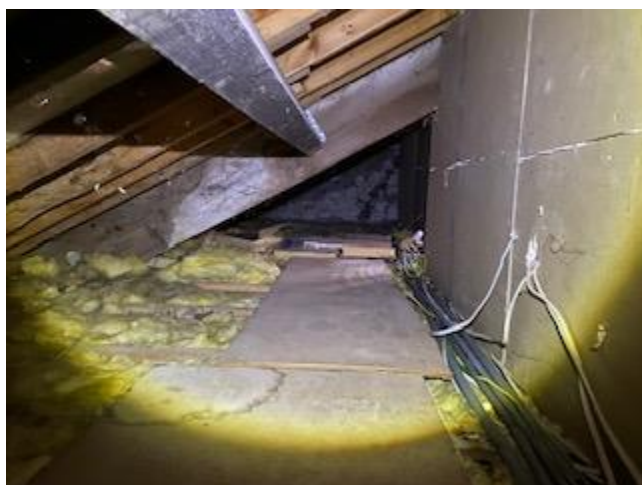
The dwelling to be developed is currently the residential dwelling of the client. The main part of the building is a single pitch, two storeys build with a single storey extension on the western elevation which connects them to the neighbouring dwelling. The building is stone and mortar in structure with a pan tiled roof structure which extends in length on the southern elevation. There are two Velux windows on the southern elevation roof also. There is lead cladding on both gable ends onto the tiles. Wooden fascia boards are present along both the northern and southern elevations with plastic guttering. There is a loft space along the southern side of the building which was inspected and found to have

Photograph 1 – internal loft space.

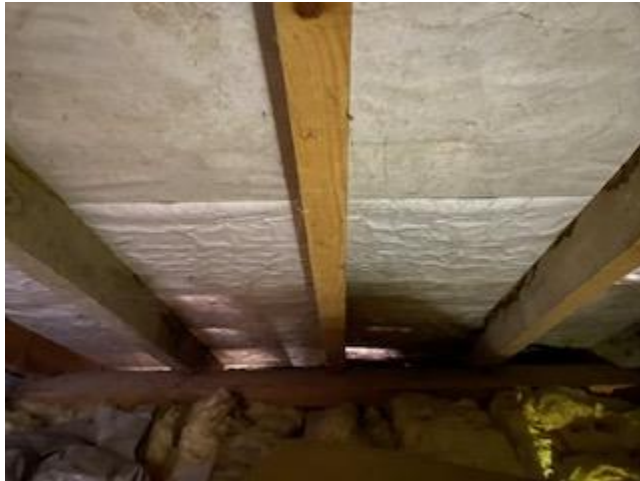
500+ rodent droppings but also 20+ old possible bat droppings no more than 3mm in length attached to one of the timber beams (see photo below). There were several points within the loft space where light was coming in from outside. From the outside, the southern elevation (parallel with the loft space) had numerous slipped or raised tiles across the whole elevation. The fascia boards on both the southern and northern elevations are not flush with the main building creating crevices throughout. There was also one raised tile and lifted lead flashing on the northern elevation too. Considering the above, it is considered that the building has confirmed bat roost potential. No evidence of nesting birds or opportunities for nesting birds was observed within or externally on the main dwelling and as such it is considered that the building has negligible nesting bird potential.

Photograph 2 – internal loft space continued. Light coming through.

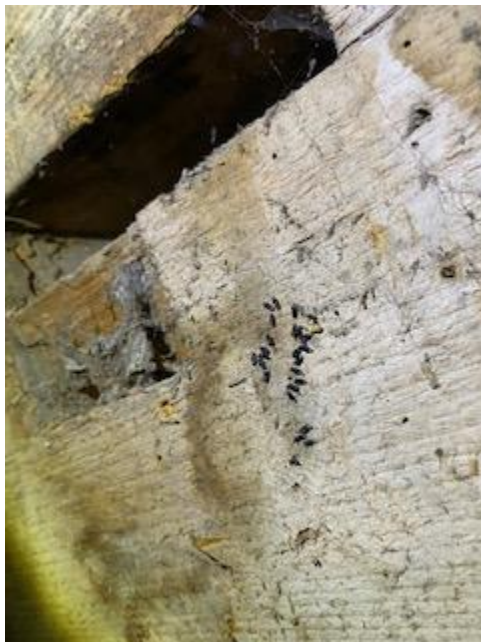
Photograph 3 – old bat droppings found attached to timber beam in loft space of building.

The residential dwelling has **confirmed** bat roost potential with the droppings identified within the loft space – the droppings were collected but have not been DNA analysed to determine species. Although the building has been identified to have bat roosting potential the proposed works will not result in disturbance to any possible bats using the loft space or any of the features identified on the building. The proposed garage/workshop will be in the garden curtilage not connected to the building and the proposed porchway on the northern elevation will not require any significant construction works – only battening onto the stonework for stability. Therefore, no further surveys are recommended. However, any future construction/modification works on the building should be subject to a minimum of three bat activity surveys and a mitigation license from Natural England. The residential dwelling has **negligible** nesting bird potential and no further surveys for nesting birds are recommended.

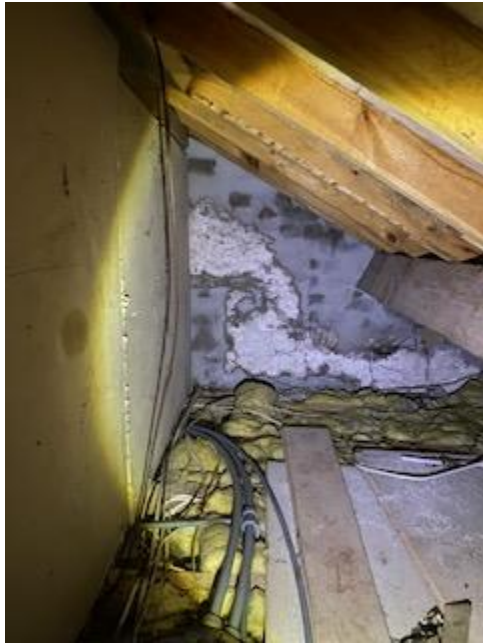
Photograph 4 – loft space continued.

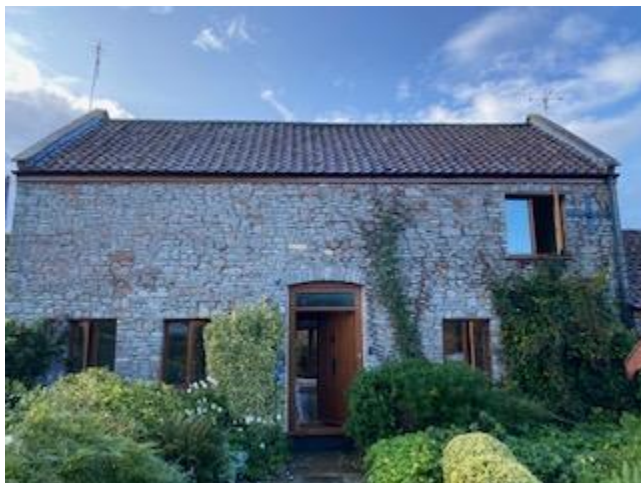
Although the building has been identified to have **confirmed** bat roosting potential the proposed works will not result in disturbance to any possible bats using the loft space or any of the features identified on the building. The proposed porchway on the northern elevation will not require any significant construction works – only battening onto the stonework for stability.

Photograph 5 – northern elevation where proposed porch way will be located.

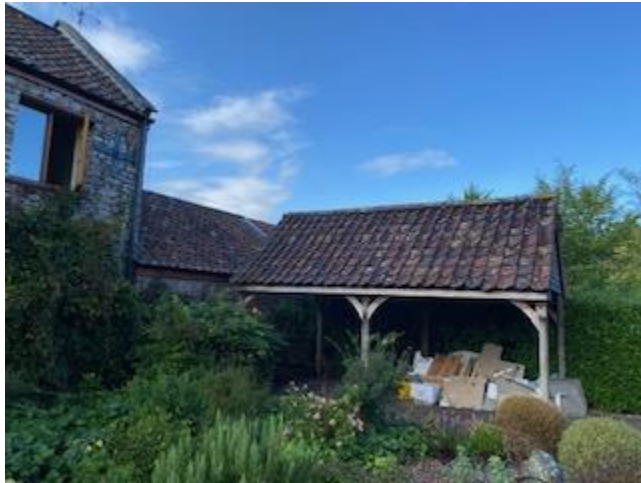
There is also a car port on the northern elevation immediately adjacent but not connected to the main dwelling. This has a timber structure, single pitched roof with matching pan tiles and felt lining. The car port had two standard small bird nest boxes on the northern elevation and a swallow cup on the internal southern elevation of the building. Evidence of swallow nesting was identified just above where the cup was located. The car port is considered to have negligible bat roost potential due to its open structure and good condition roof. The car port is considered to have confirmed nesting bird potential due to the evidence already on site for swallows and the added nest boxes encouraging the species to the building.

Photograph 6 – northern elevation with car port.

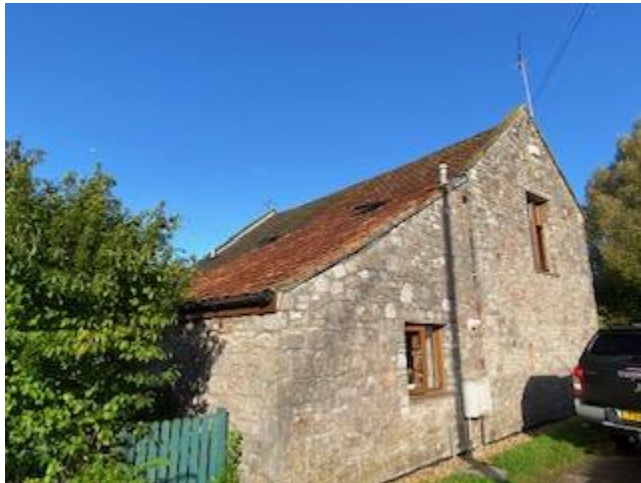
Photograph 7 – southern and eastern elevations of building.

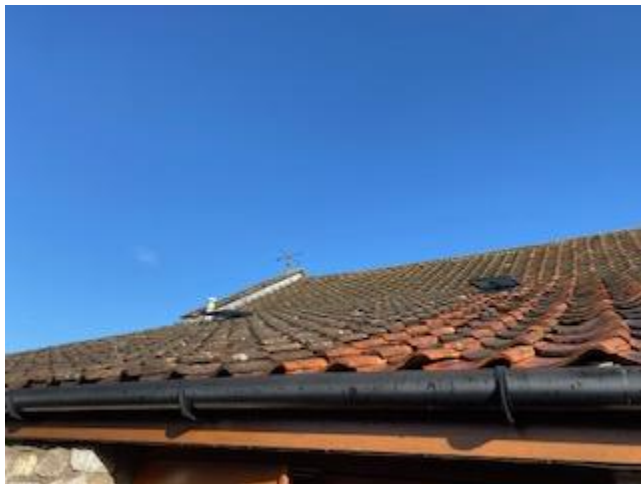
Photograph 8 – southern elevation on building.

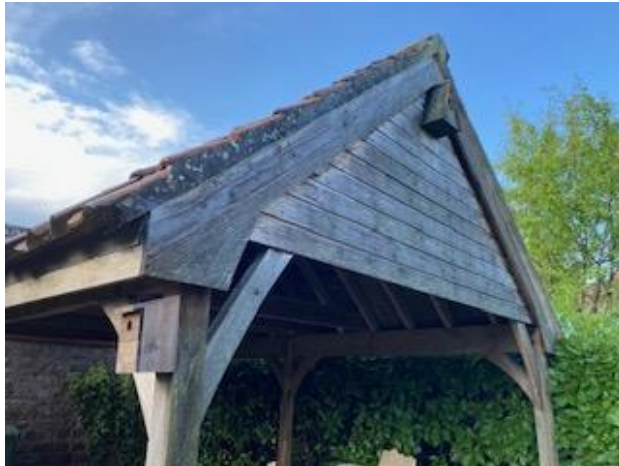
Photograph 9 – northern elevation of car port with two bird nest boxes.

The car port has **negligible** bat roost potential and there are no proposed works to the car port at this stage. No further surveys on the building are recommended for bats. However, the building has **confirmed** nesting bird potential and any future construction/modification works to the car port should be completed outside of the nesting bird season (March -August inclusive) and the bird boxes/swallow cup re located nearby.

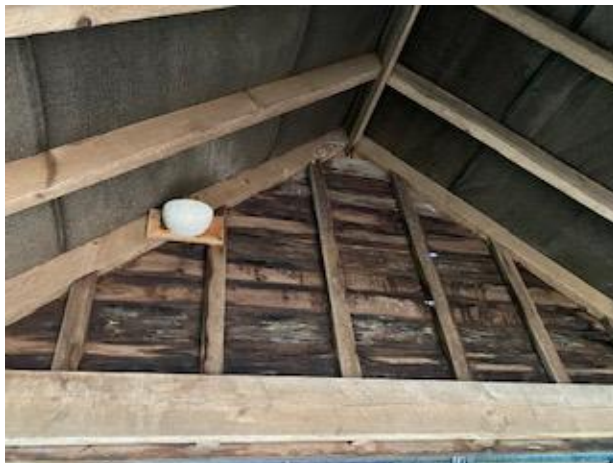
Photograph 10 – internal of car port with swallow cup and part of a natural swallow nest at the pitch of the roof.

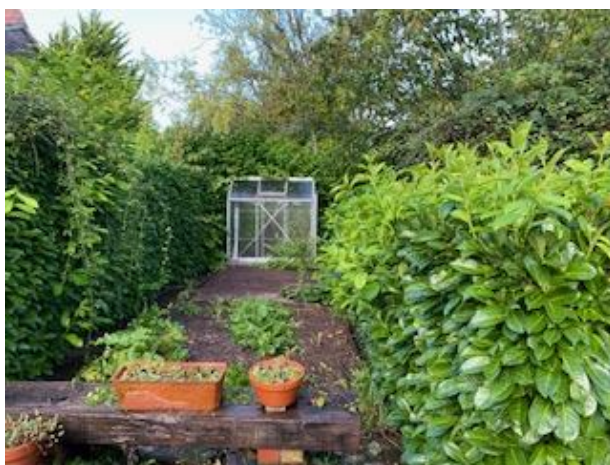
The garden curtilage is a combination of amenity grassland, intact laurel hedging, bare ground vegetable patches and introduced shrubs. None of the garden curtilage had any features that would attract roosting bats. The garden, therefore, has negligible bat roost potential but could be use by foraging and commuting bats within the wider landscape.

Photograph 11 – garden curtilage for proposed garage/workshop location.

The garden curtilage has **negligible** bat roost potential and no further surveys for bats is recommended. The introduced shrub and laurel hedge have **high** nesting bird potential and their removal should be completed outside of the nesting bird season. If this cannot be done, then a nesting bird check by a competent ecologist should be undertaken immediately prior to the vegetation removal. If a nesting bird is identified, then works will be postponed until the ecologist is satisfied that the chicks have fledged, or the nest has become naturally abandoned.
