13/1484

REPAIR BRICK
PIER WALL
BETWEEN No 9 & 10
THE SQUARE

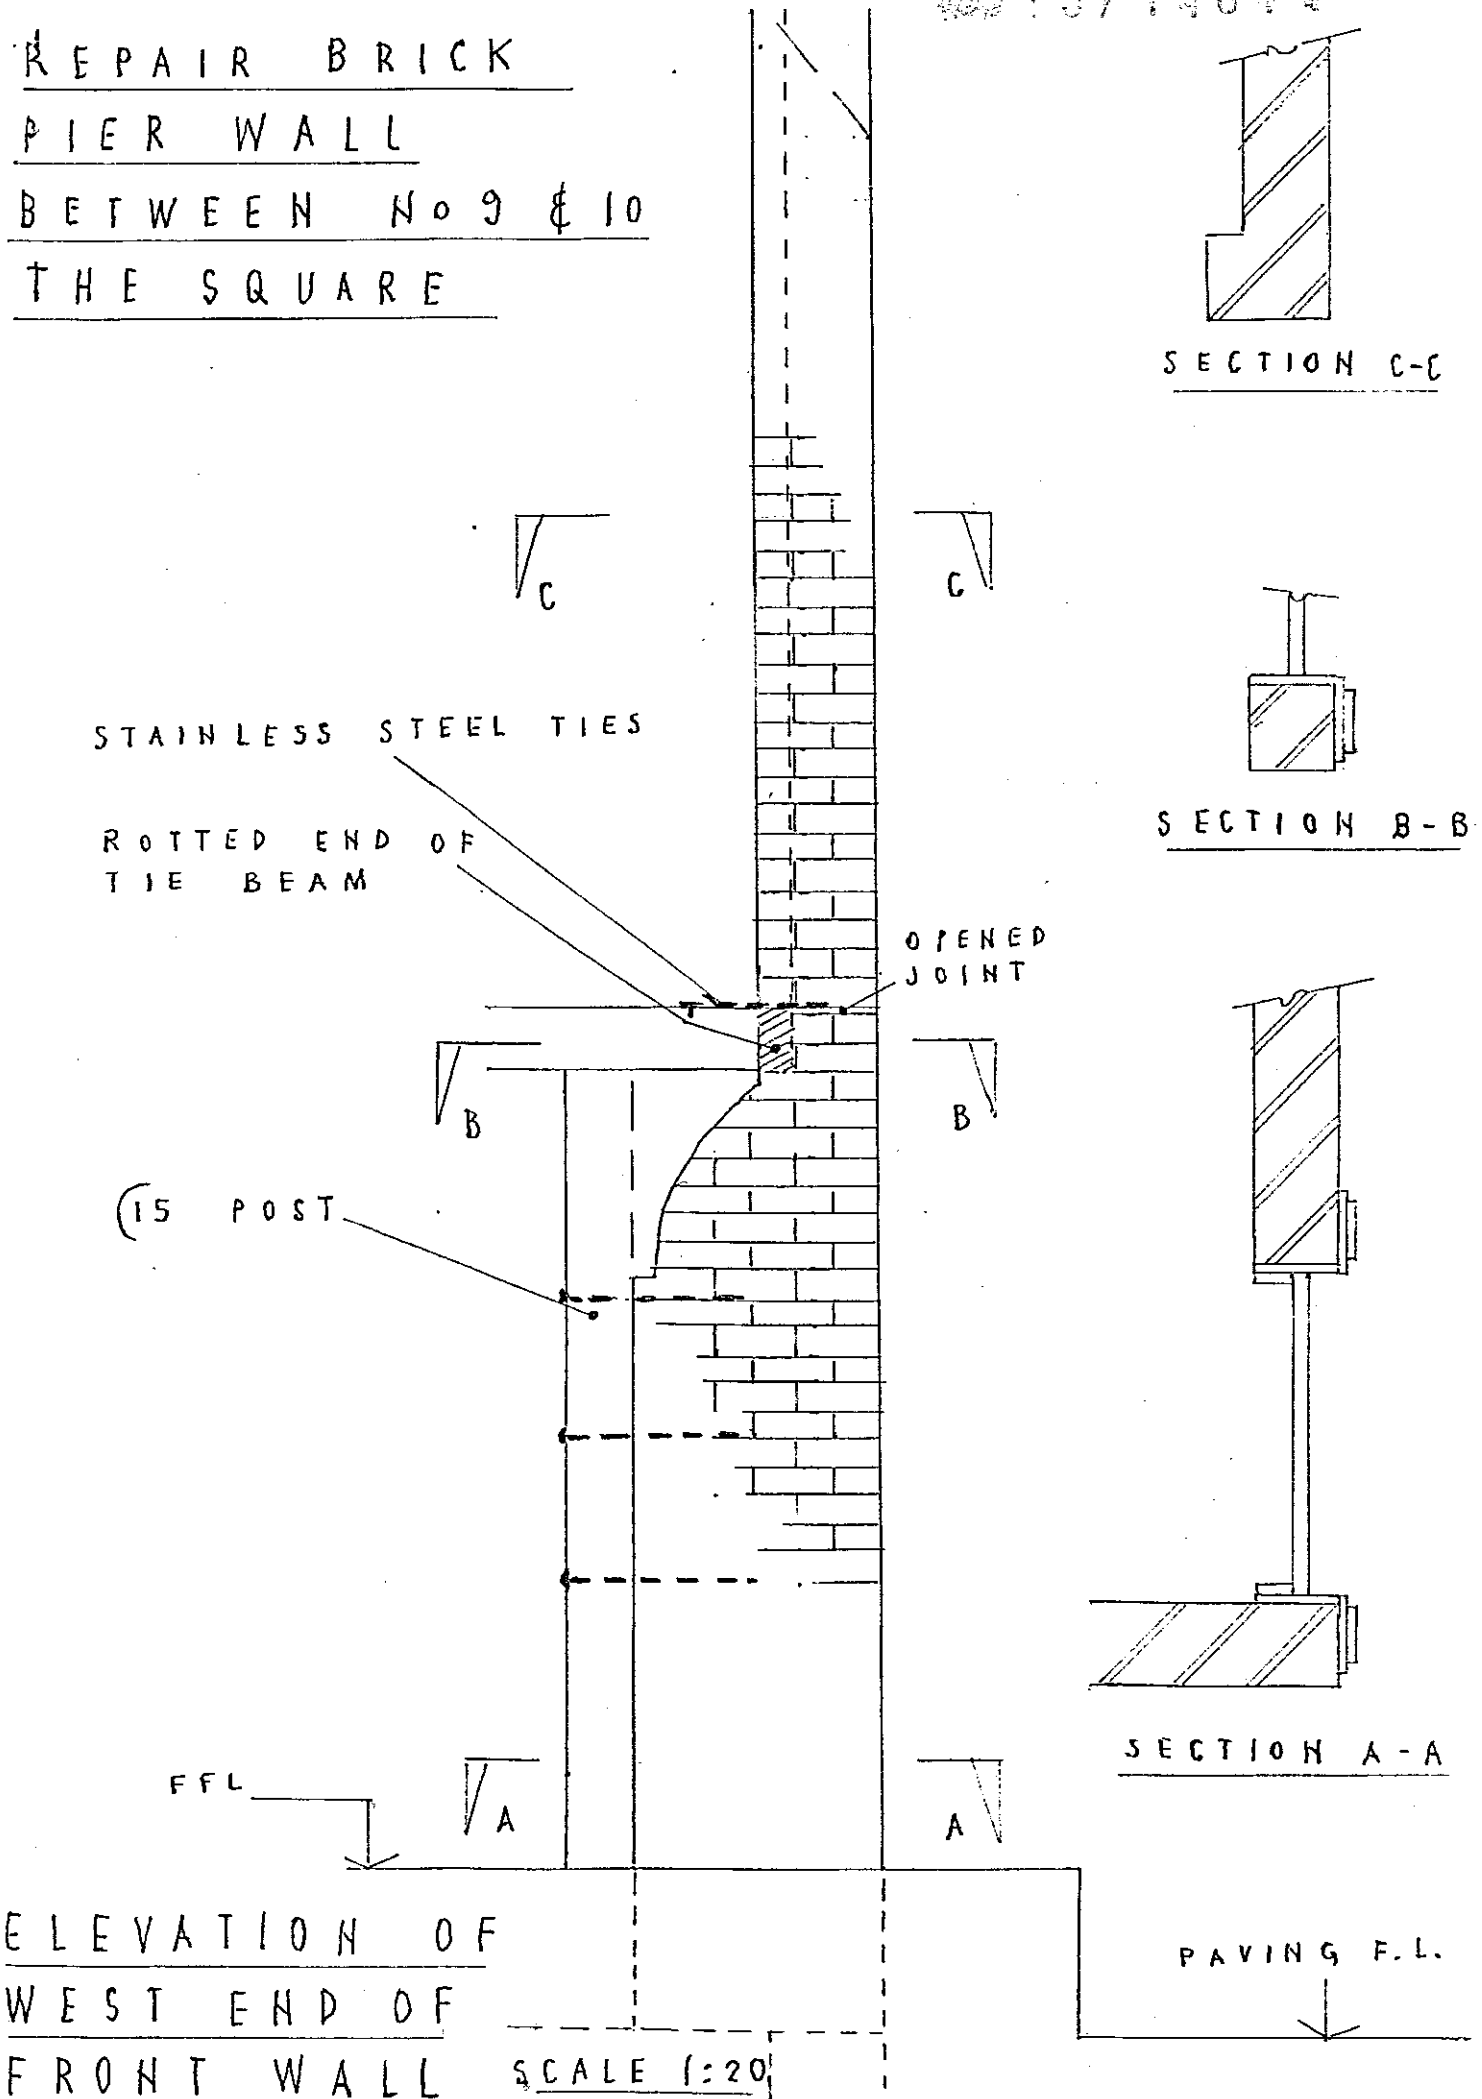
ELEVATION OF
WEST END OF
FRONT WALL

STAINLESS STEEL TIES

ROTTED END OF
TIE BEAM

OPENED
JOINT

(15) POST
