Preliminary Bat & Bird Assessment

The Mowhay, Wood Hill, Penryn, TR10 9AE

13<sup>th</sup> November 2023

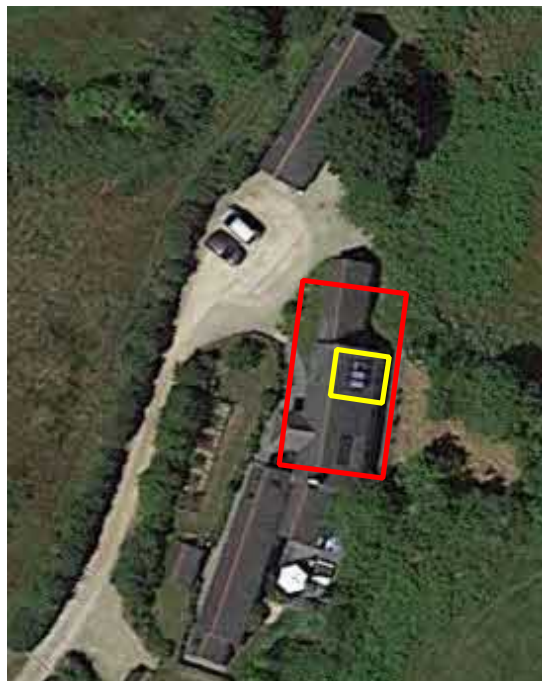
Figure 1: Aerial view of the extent of the property at 'The Mowhay', red outline shows the area surveyed; the yellow outline shows the approximate location of the proposals, which comprise of a new dormer window on the eastern elevation.

The visual assessment was undertaken on 11<sup>th</sup> October 2023, of the northern section of the two-storey building found at 'The Mowhay' (red outline in Fig 1); the proposals affect only the eastern pitch of the northern section (yellow outline in Fig 1).

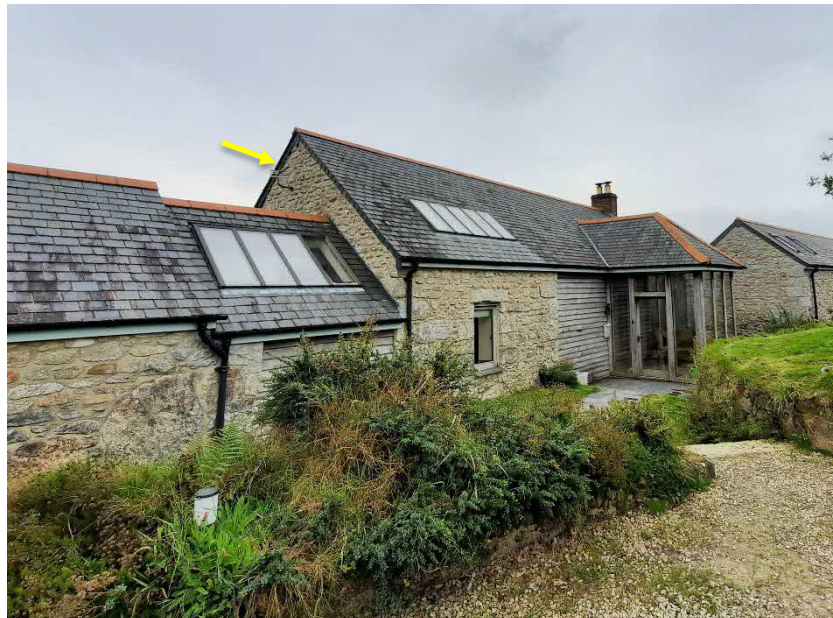
Figure 2: View of the northern and western elevations of the wider building at 'The Mowhay'; the yellow arrow indicates the approximate location of the proposals on the eastern pitch.

The part of the building surveyed is a two-storey former barn conversion (c. 2010) now in use as a residential dwelling. The property is of concrete block and stone construction with no render (Figs 2-3). The building supports a pitched roof of traditional slate tiles and concrete ridge tiles (Figs 4-5). Wooden fascia boards were present on the east and west elevations of the dwelling with plastic guttering and downpipes on the exterior of the building. On both sides of the pitched roof were roof lights, which were well sealed with no obvious gaps to the slate tile roof. Hanging slate tiles

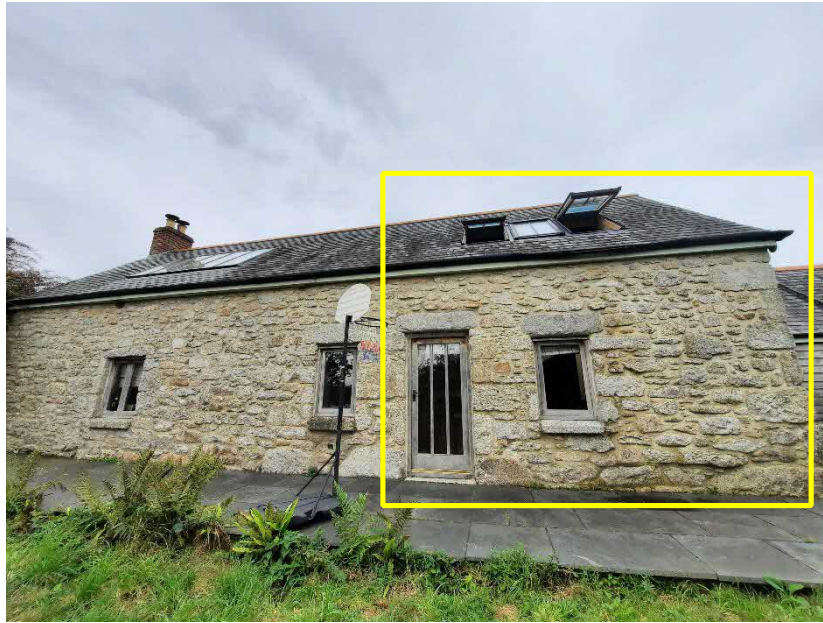
Figure 3: View of the eastern elevation at 'The Mowhay'; the yellow outline indicates the approximate location of the proposals.

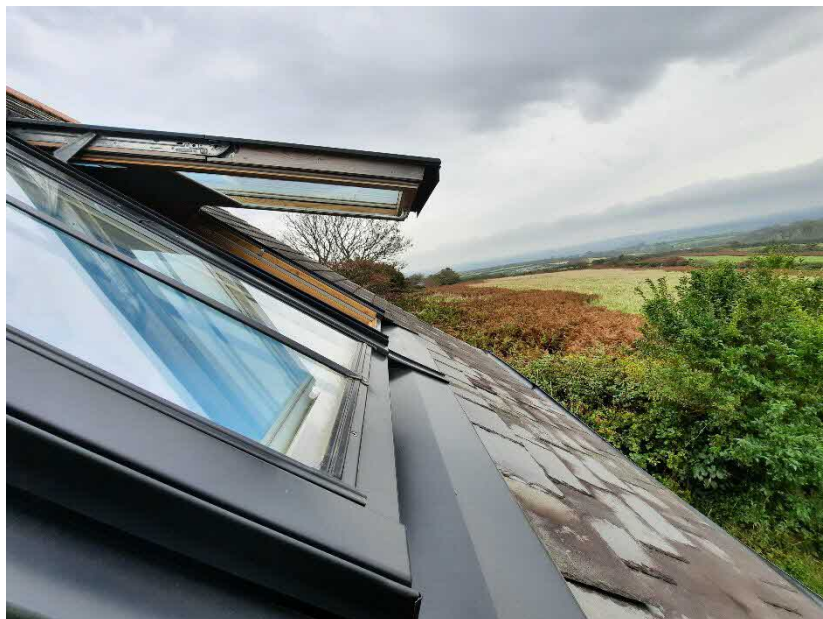
Figure 4: View north from within the first-floor room (vaulted with no roof space) of part of the east pitched roof at 'The Mowhay'.

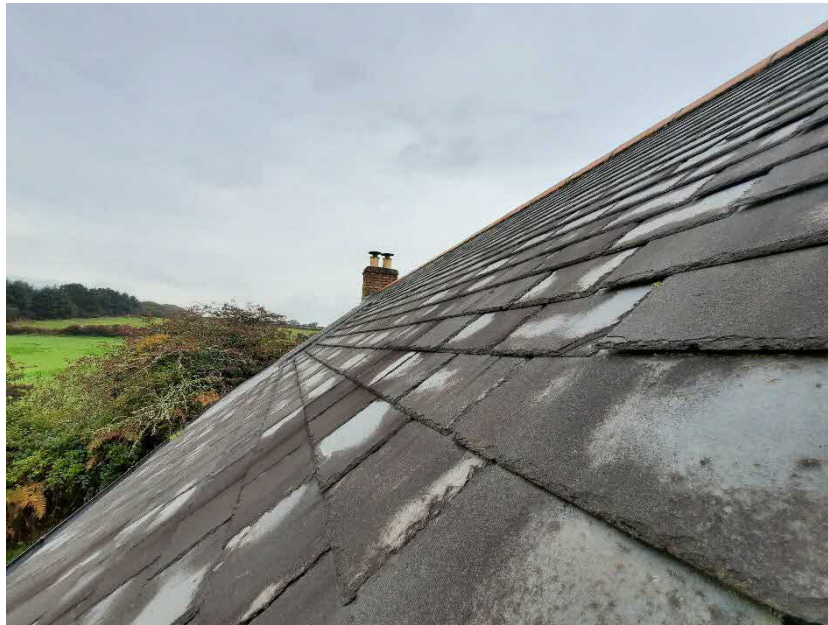
Figure 5: View south from within the first-floor room (vaulted with no roof space) of part of the east pitched roof at 'The Mowhay'.

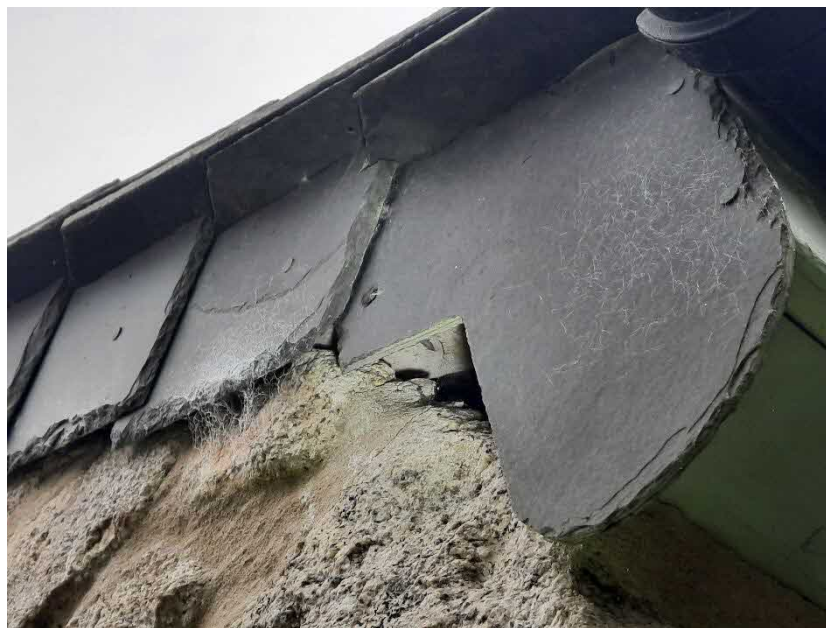
were present on the north-western end of the building. One small gap (a PRF) was observed between the slates and the wall top, but the gap does not extend beyond the timber fascia board (Fig 6). Whilst this gap provides a PRF for crevice dwelling bats, it does not extend beyond the fascia board, and the proposals which impact the eastern elevation only, will not impact the northwest elevation of the building on which the PRF is located (Appendix 1). Internally, the space is vaulted and, therefore, the PRF does not extend or provide access into an impacted roof space. With the exception of the PRF described above, the building had no notable features that could support roosting bats.

Figure 6: View of a small gap beneath the hanging slate tile and the wall top on the north-western corner of the building at 'The Mowhay, located on the opposite side of the property from where new dormer windows are proposed'.

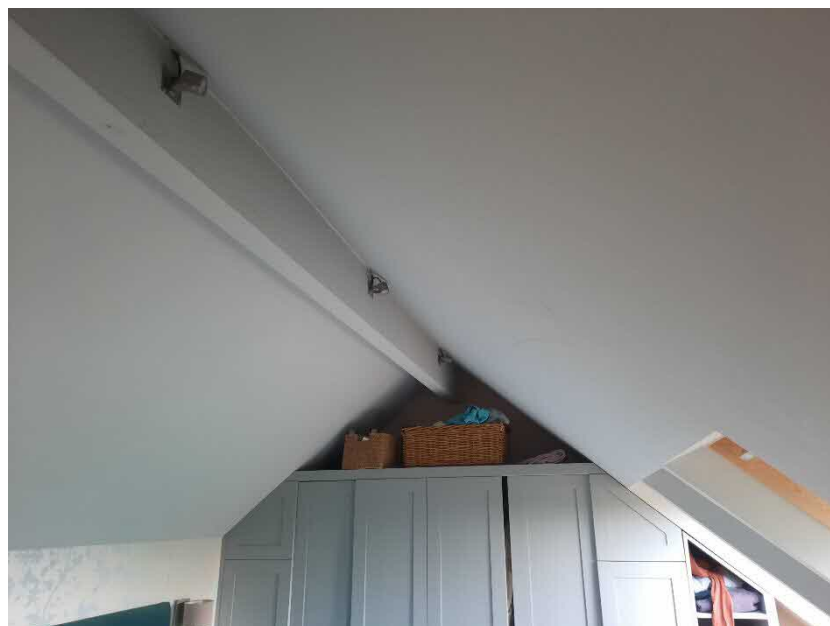
As outlined above, internally, the section of the property to be impacted is vaulted with no roof void (Fig 7). No evidence of bats was found within the interior of the dwelling.

Figure 7: Interior view of the room to be impacted by the proposals within 'The Mowhay'.

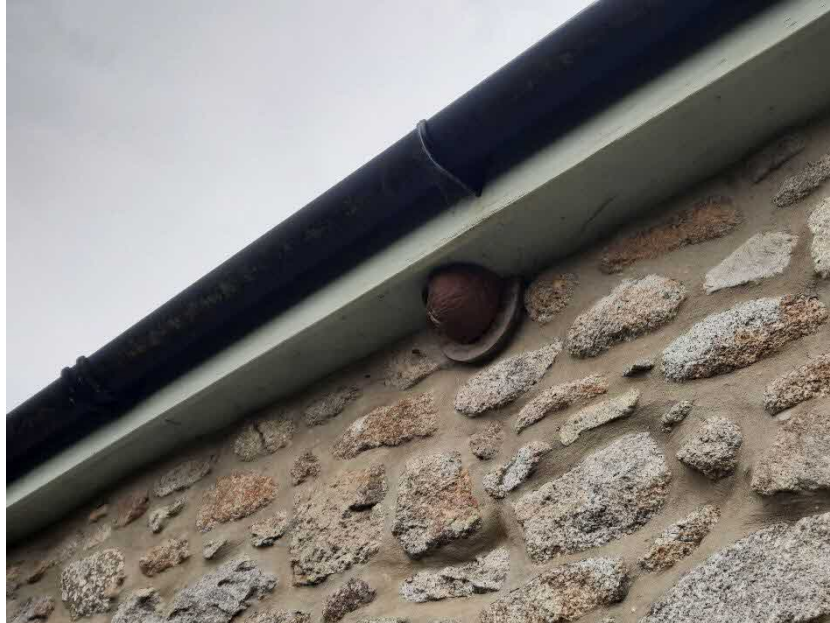
No evidence of current nesting birds was observed within the interior or on the exterior of 'The Mowhay'. A nest box (likely for a *Hirundo* sp.) was observed beneath the soffit on the eastern elevation (Fig 8). This habitat has potential to support nesting birds between March and August/September.

Figure 8: View of the nest box (likely for a *Hirundo* sp.) beneath the soffit on the eastern elevation of the 'The Mowhay'.

No evidence of nesting birds, including barn owl, was found within the interior of the building. However, a nest box (likely for a *Hirundo* sp.) beneath the soffit on the eastern elevation on the building exterior has potential to support nesting birds between March – August/September. The building was assessed as being of negligible suitability for barn owl.

If works are proposed during the breeding bird season (March – August/ September), then it is recommended that the bird box be temporarily removed between October and February, when birds will not be nesting. The bird box must be reinstalled following completion of works. If it is not possible to temporarily remove the box in advance of the nesting season, and works cannot be timed to avoid the bird breeding season then it is recommended that the box be thoroughly searched for nesting birds (to be undertaken by a suitably qualified person) prior to commencement of works. If, immediately prior to or during construction works, an active bird nest is uncovered, works within at least 5m of the nest must stop immediately (as soon as it is safe to do so) and delayed until nesting activity has ceased. Works are most likely to be delayed between April and July.

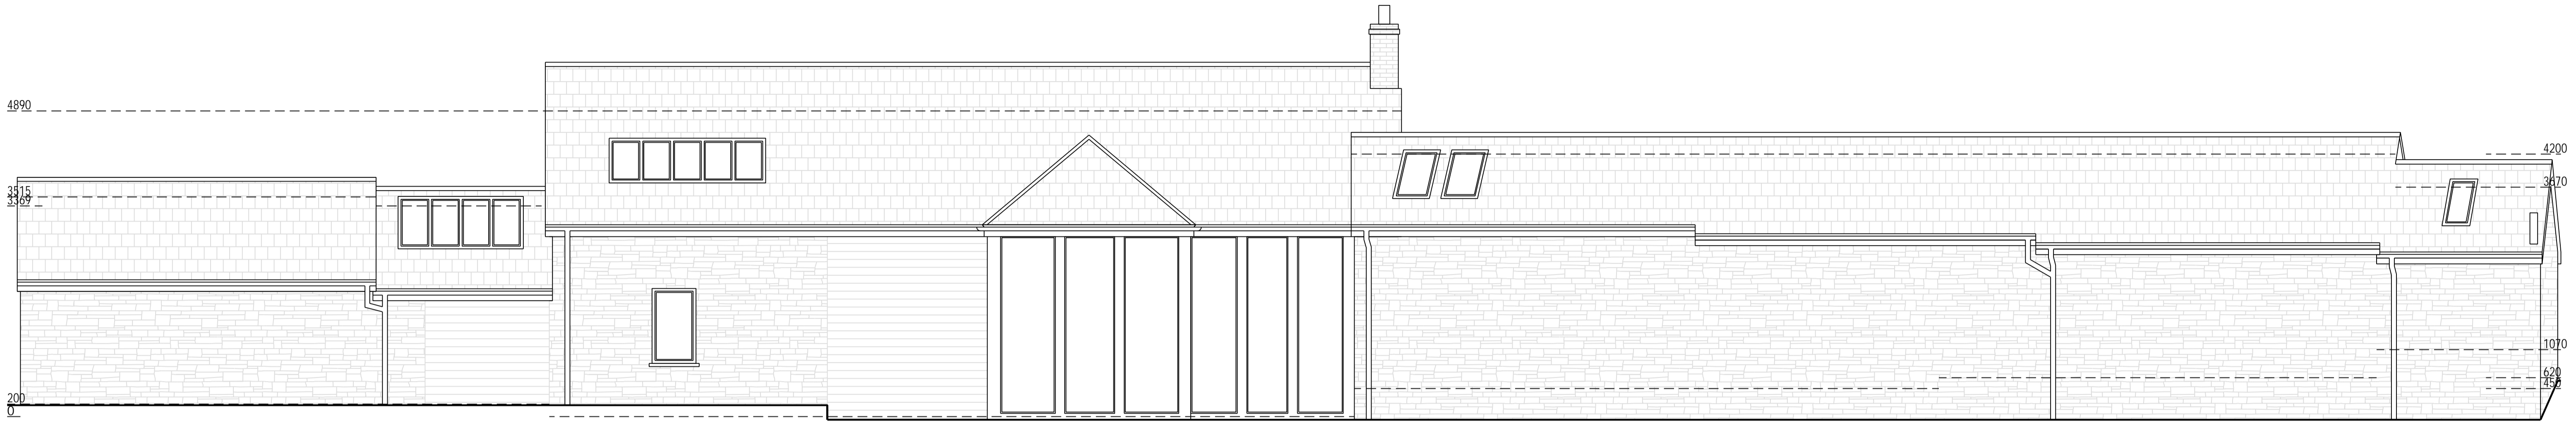
**Proposed East Elevation**

Proposed Materials:  
 Walls: Oak cladding (to match existing)  
 Flat roof: EPDM  
 Windows: Double glazed (to match existing)

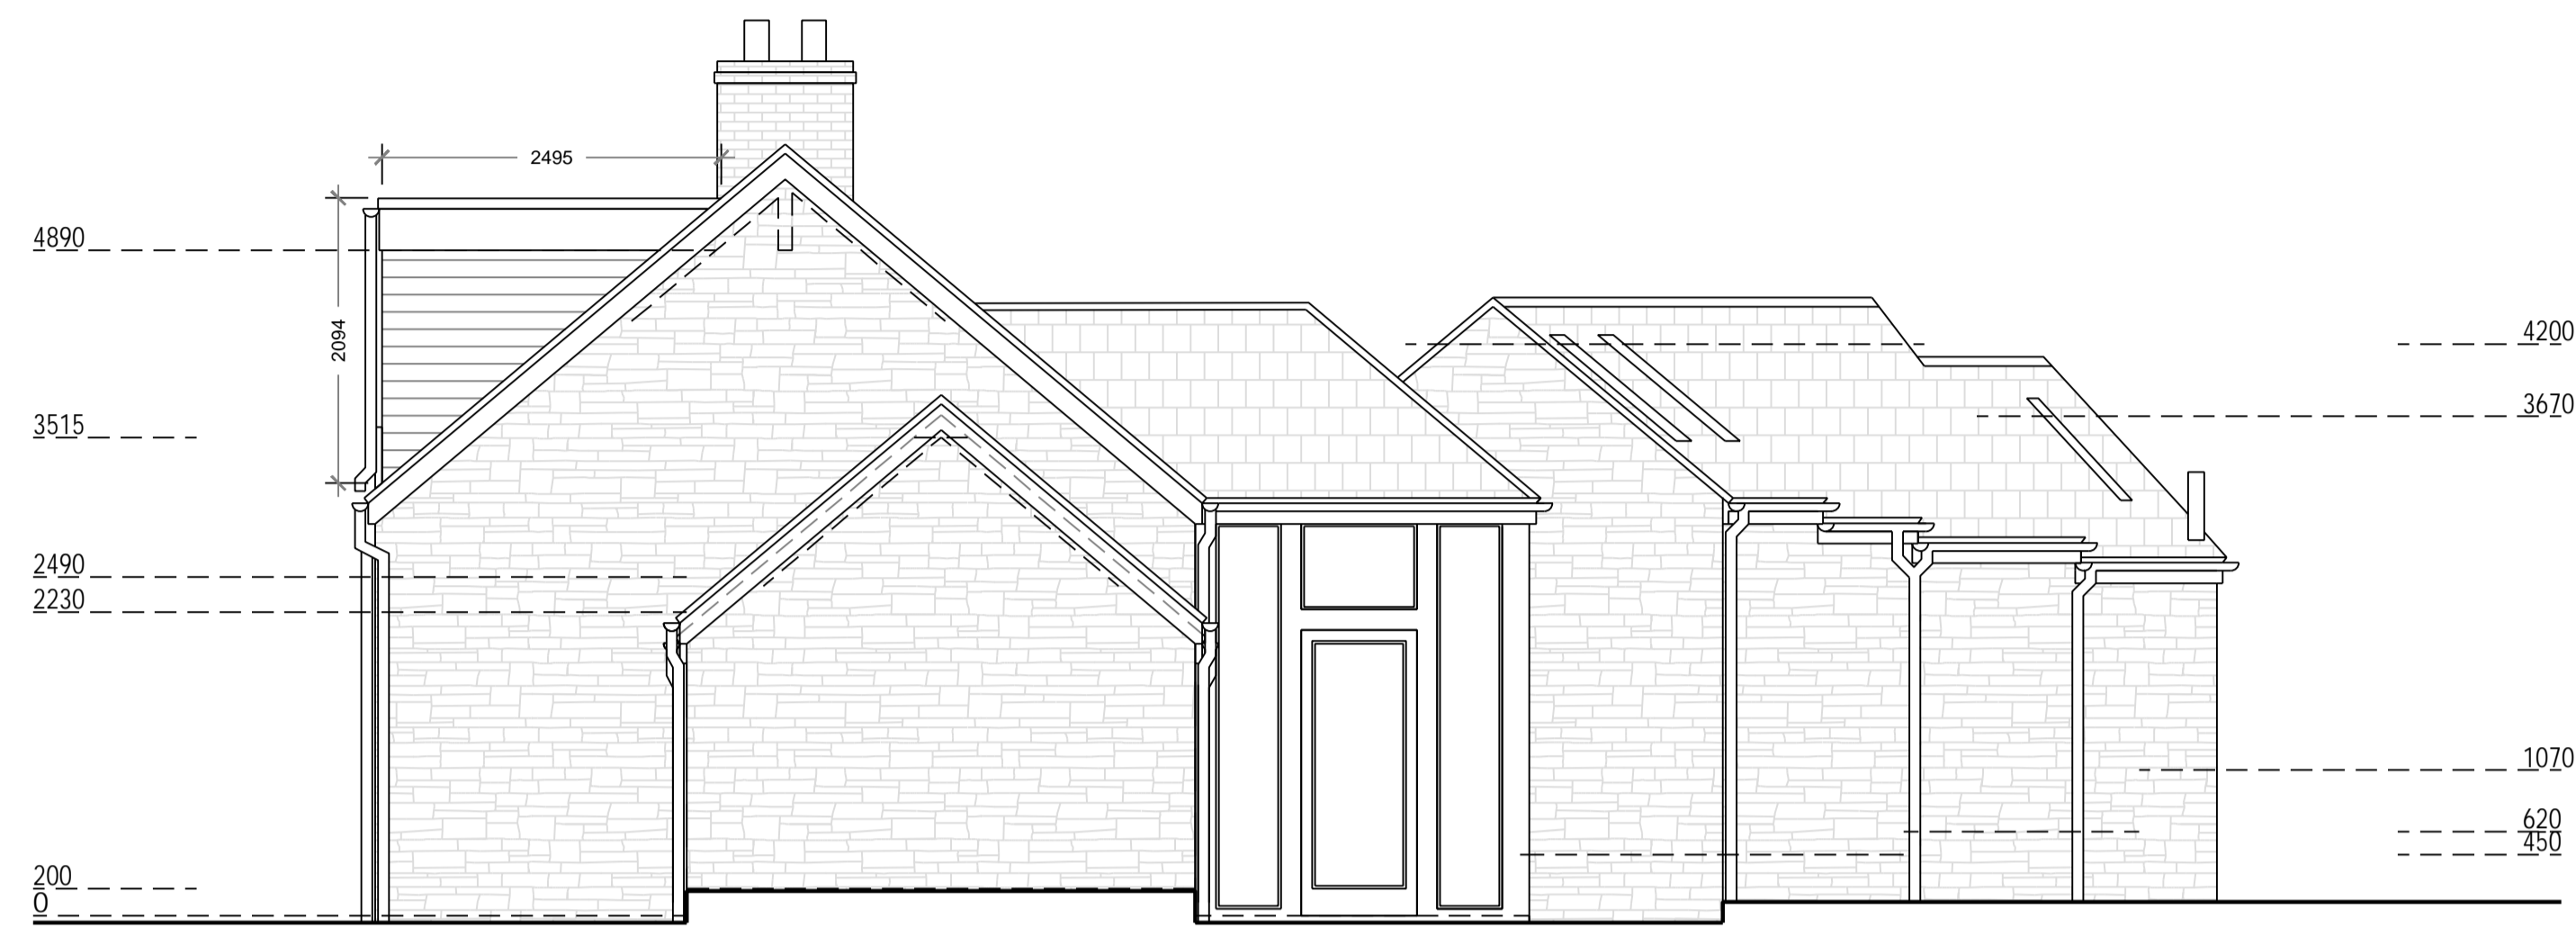
**Proposed South Elevation**  
 Scale 1:50

Proposed Materials:  
 Walls: Oak cladding (to match existing)  
 Flat roof: EPDM  
 Windows: Double glazed (to match existing)
