<b>HBC-ALDERHOLT</b> Historic Buildings Consultant 56 Chalkern Drive Barton on Sea Hampshire BH25 7LD 07875 166824 Richard@hbc-alderholt.co.uk	<b>JOB</b> 31 SOUTHLANDS PENNINGTON, SO41 8EE	<b>SCALE</b> 1:100 @ A3 1:50 @ A1	<b>No.</b> 2301
	<b>DRWG.</b> EXISTING LAYOUT	<b>DATE</b> 25.10.2023	<b>03</b>

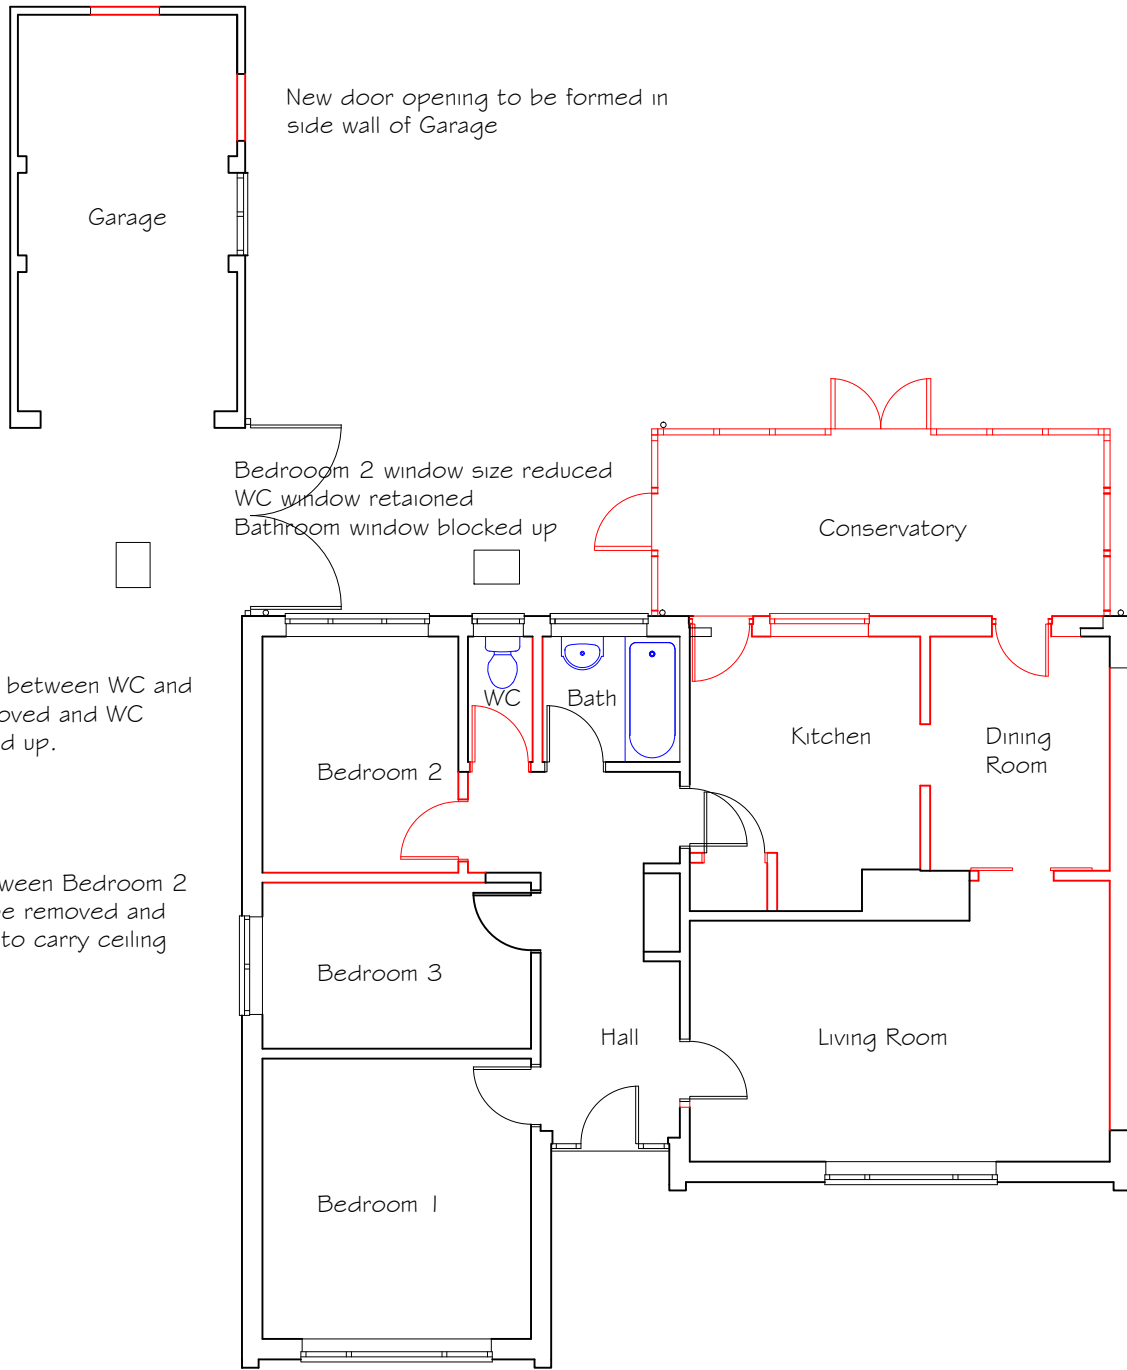
New window opening to be formed in back wall of Garage

New door opening to be formed in side wall of Garage

Non-loadbearing wall between WC and Bathroom to be removed and WC door opening blocked up.

Loadbearing wall between Bedroom 2 and Bedroom 3 to be removed and steel beam inserted to carry ceiling joists.

Bedroom 2 window size reduced  
WC window retained  
Bathroom window blocked up

Conservatory to be removed including slab and foundations

Loadbearing external wall to rear of Kitchen/Dining Room to be removed and steel beam inserted to carry hipped roof

Non-loadbearing partition between Kitchen and Dining Room removed

Airing cupboard in corner of Kitchen to be removed

Loadbearing wall between Lounge and Dining Room to be removed and steel beam inserted bbearting on wall and new beam

Loadbearing external wall to side of Living Room to be removed and steel beam inserted to carry hipped roof

Hall/Living Room door opening widened to 900mm for 830mm door
