OXPENS RIVER BRIDGE
Site Location Plan

Appendix B Baseline and post intervention indicator scores

Appendix E Fish habitat photos and descriptions

Oxpens bridge, Oxford
Fish habitat photos and descriptions

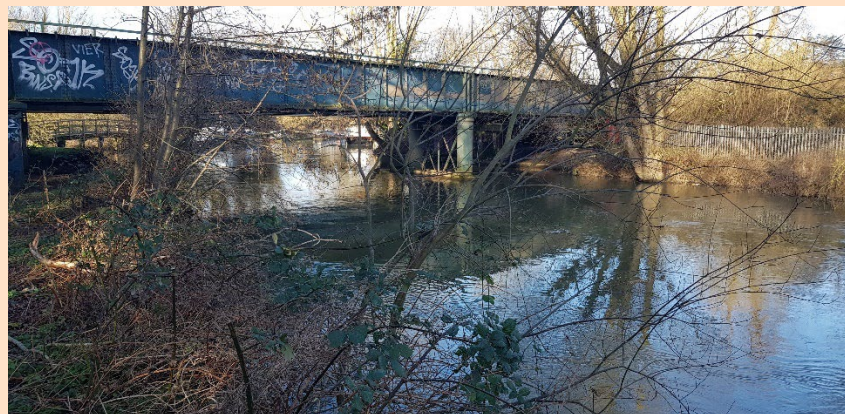
Railway bridge narrows river channel and centres flow. Some marginal cover on LHB, concrete and sheet piled RHB provides no cover for fish. Channel depth is circa 3m.

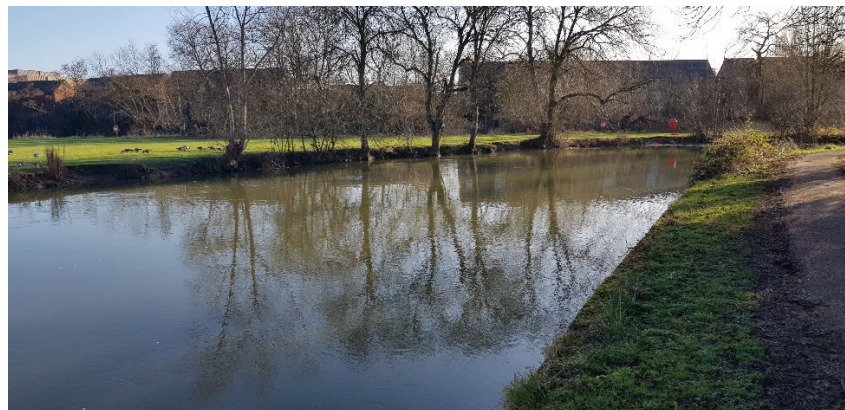
Localised erosion on LHB just upstream of meander. Some areas of fine sediment deposition present on RHB margins. Trees and scrub present on LHB margins.
