ASTERLEIGH FARM,
KIDDINGTON

Ecological Assessment

October 2023
10623M.EcoAss.VF

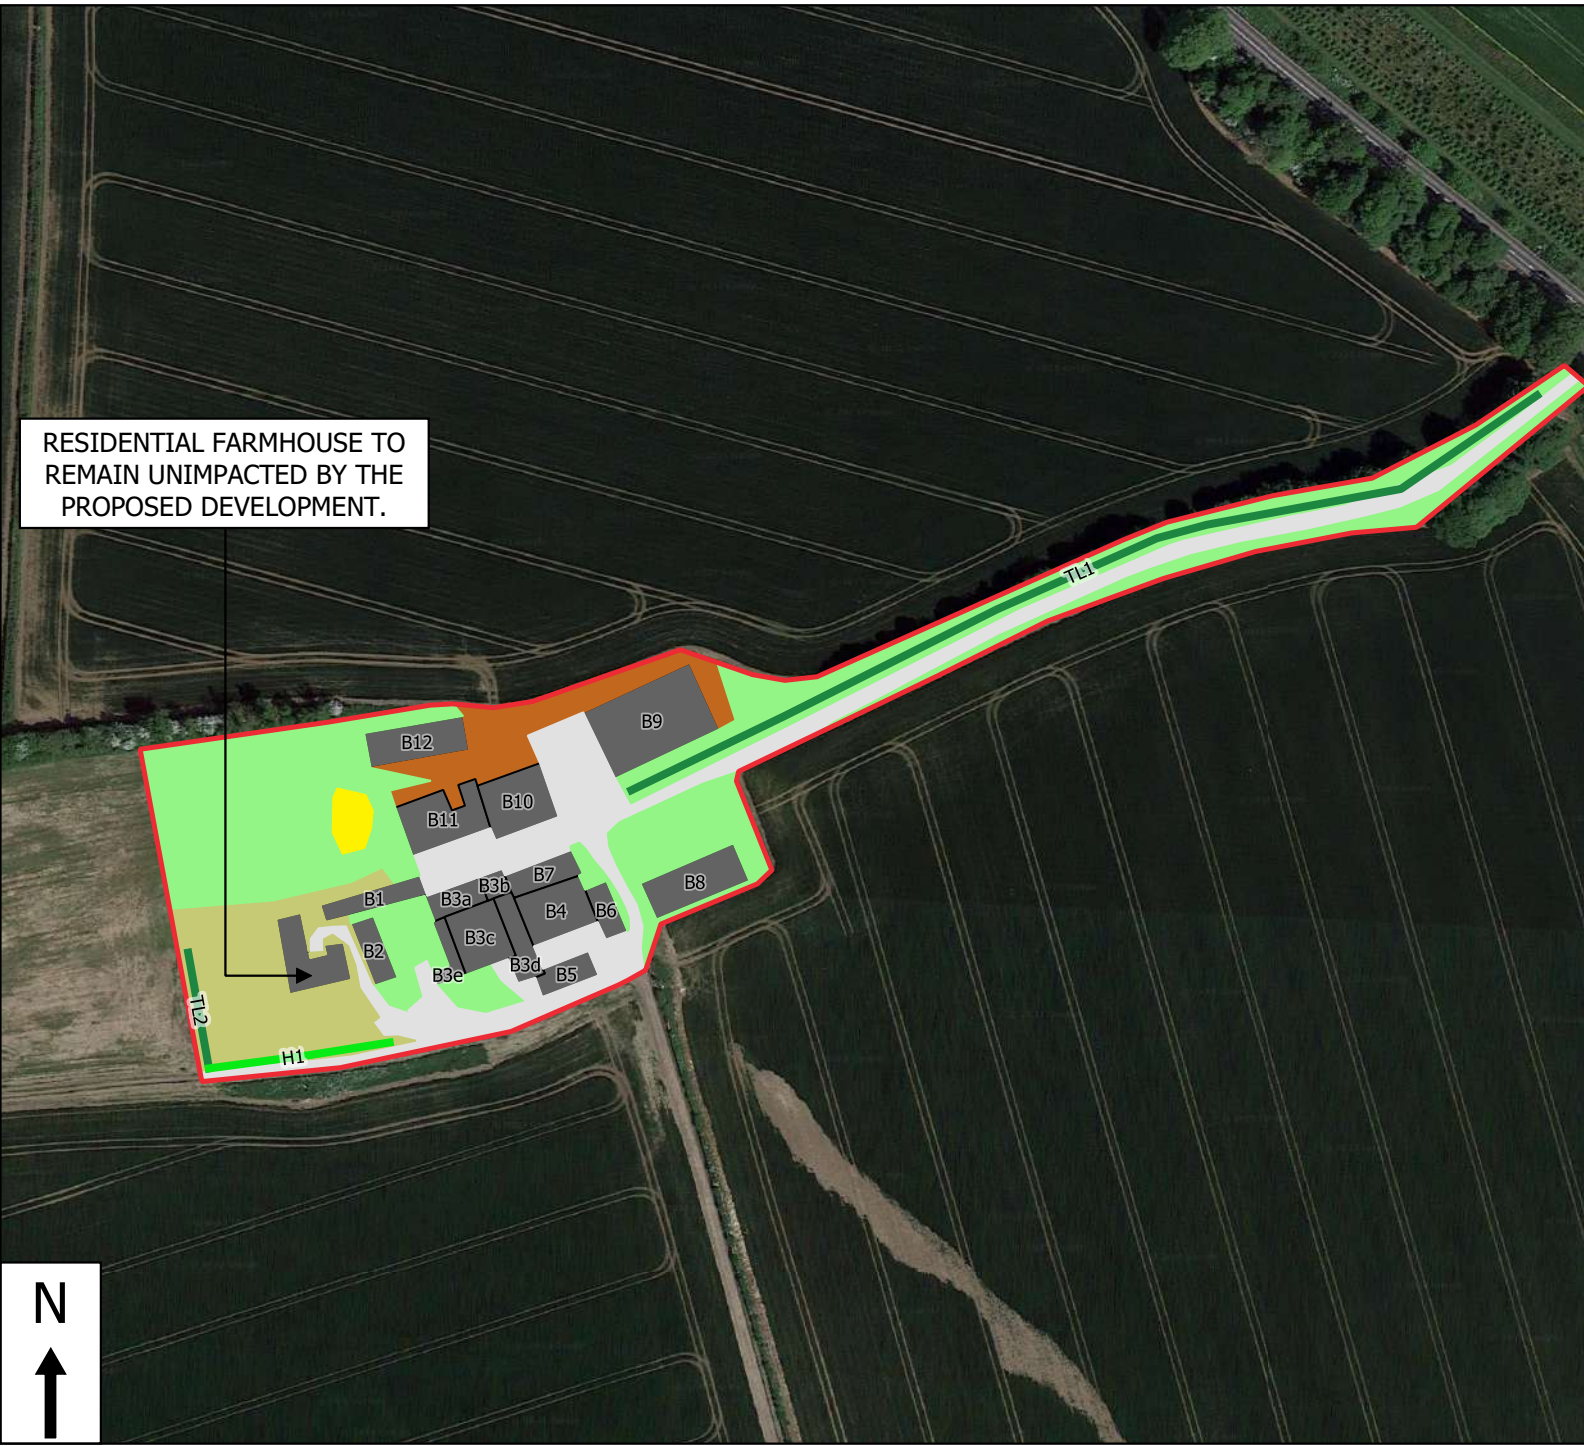
PLAN ECO2
Ecological Features

RESIDENTIAL FARMHOUSE TO REMAIN UNIMPACTED BY THE PROPOSED DEVELOPMENT.

- 3.7. Each of these buildings are described below, and their locations are illustrated on Plan ECO2.
- 3.8. **B1** and **B2** are single storey stable blocks, with thick stone and brick walls. They have pitched slate tile roofs, with many slipped and hanging tiles present. There is no internal roof lining, and the tiles are laid directly on timber struts and beams forming the roof's structural components. The stone walls are in poor condition, with gaps and crevices in the brick work. There is no loft void present.

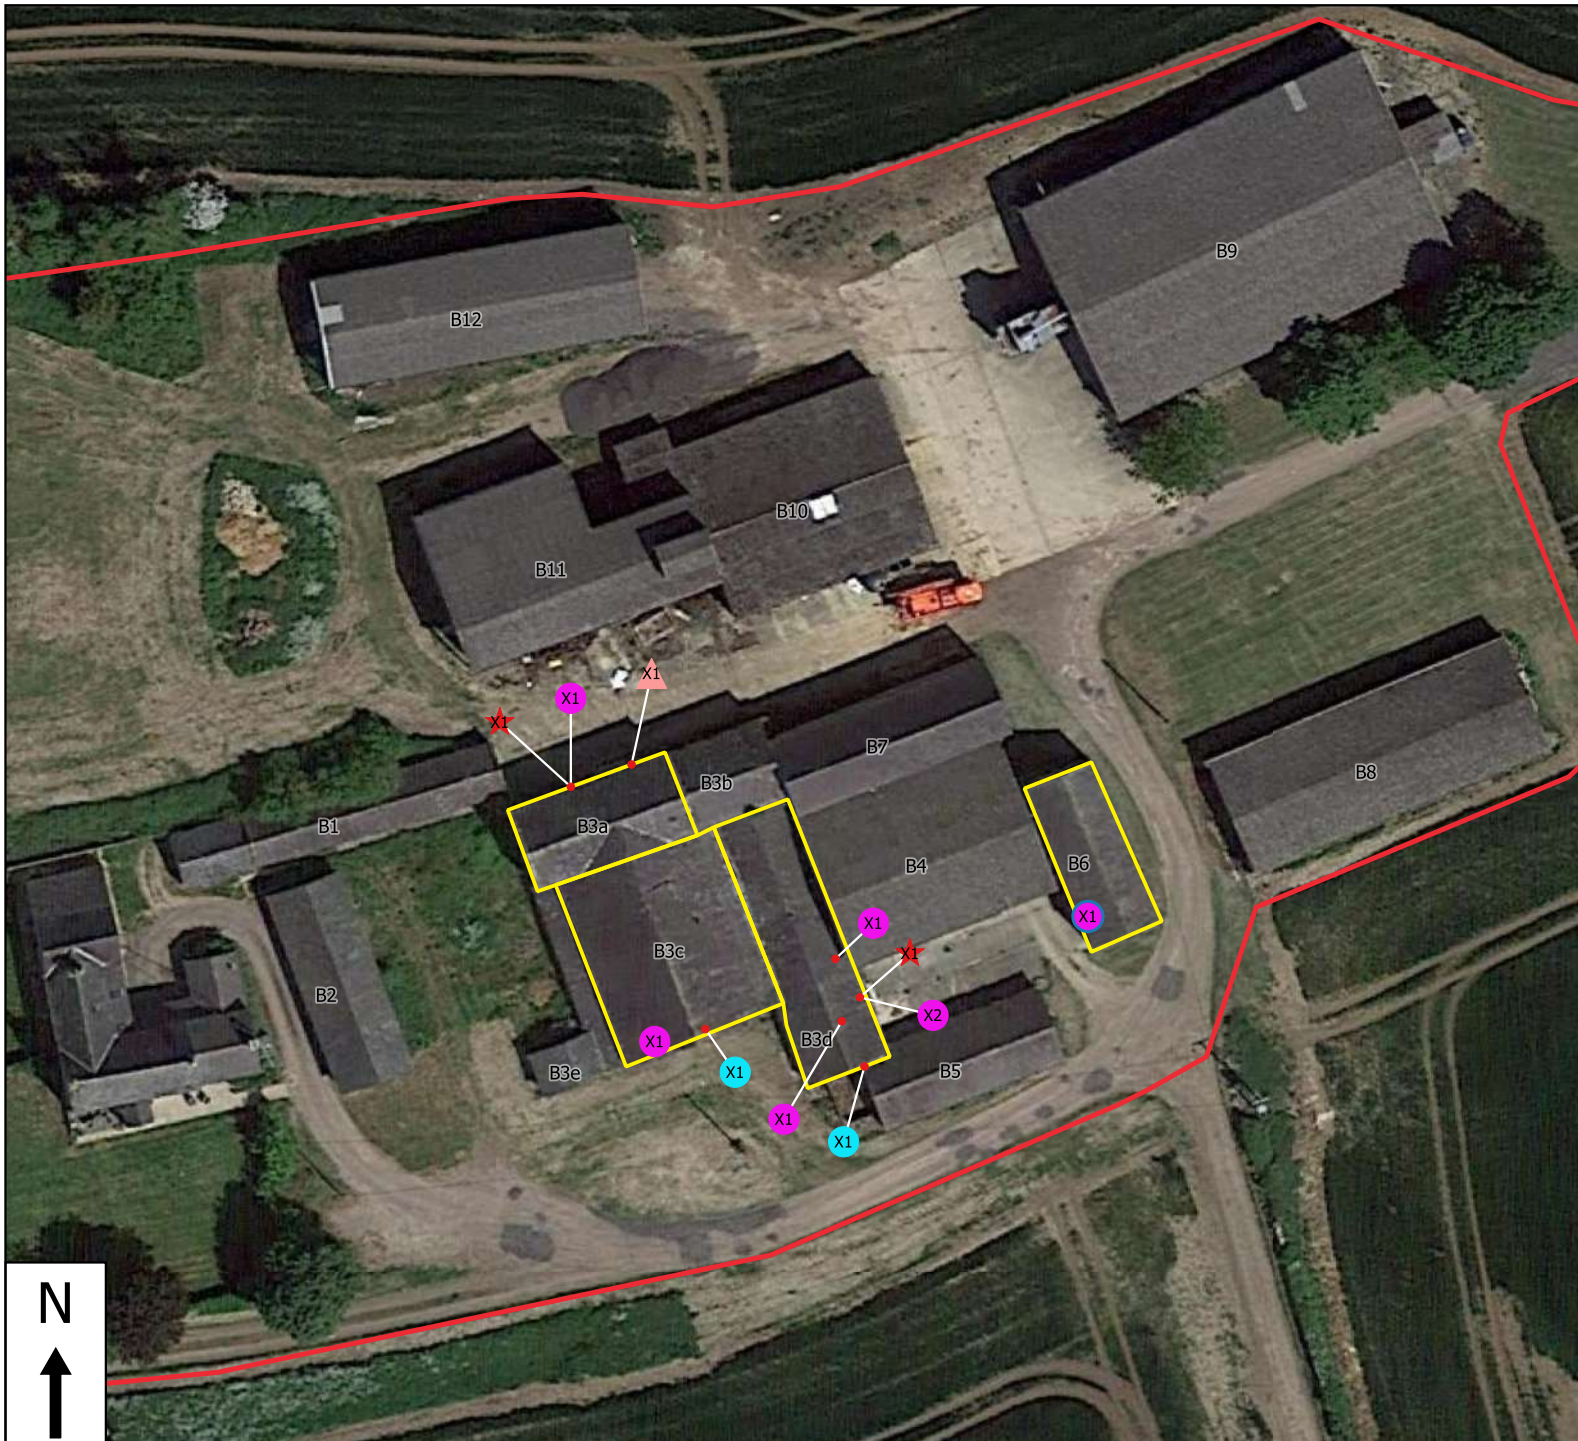
PLAN ECO3
Protected Species
(Bat Roost Locations)

- Application Site
- Building With Bat Roost
- ★ Brown Long-eared Bat (Emergence)
- Common Pipistrelle (Emergence)
- Common Pipistrelle (Re-entry)
- Soprano Pipistrelle (Emergence)
- ▲ Whiskered Bat (Emergence)

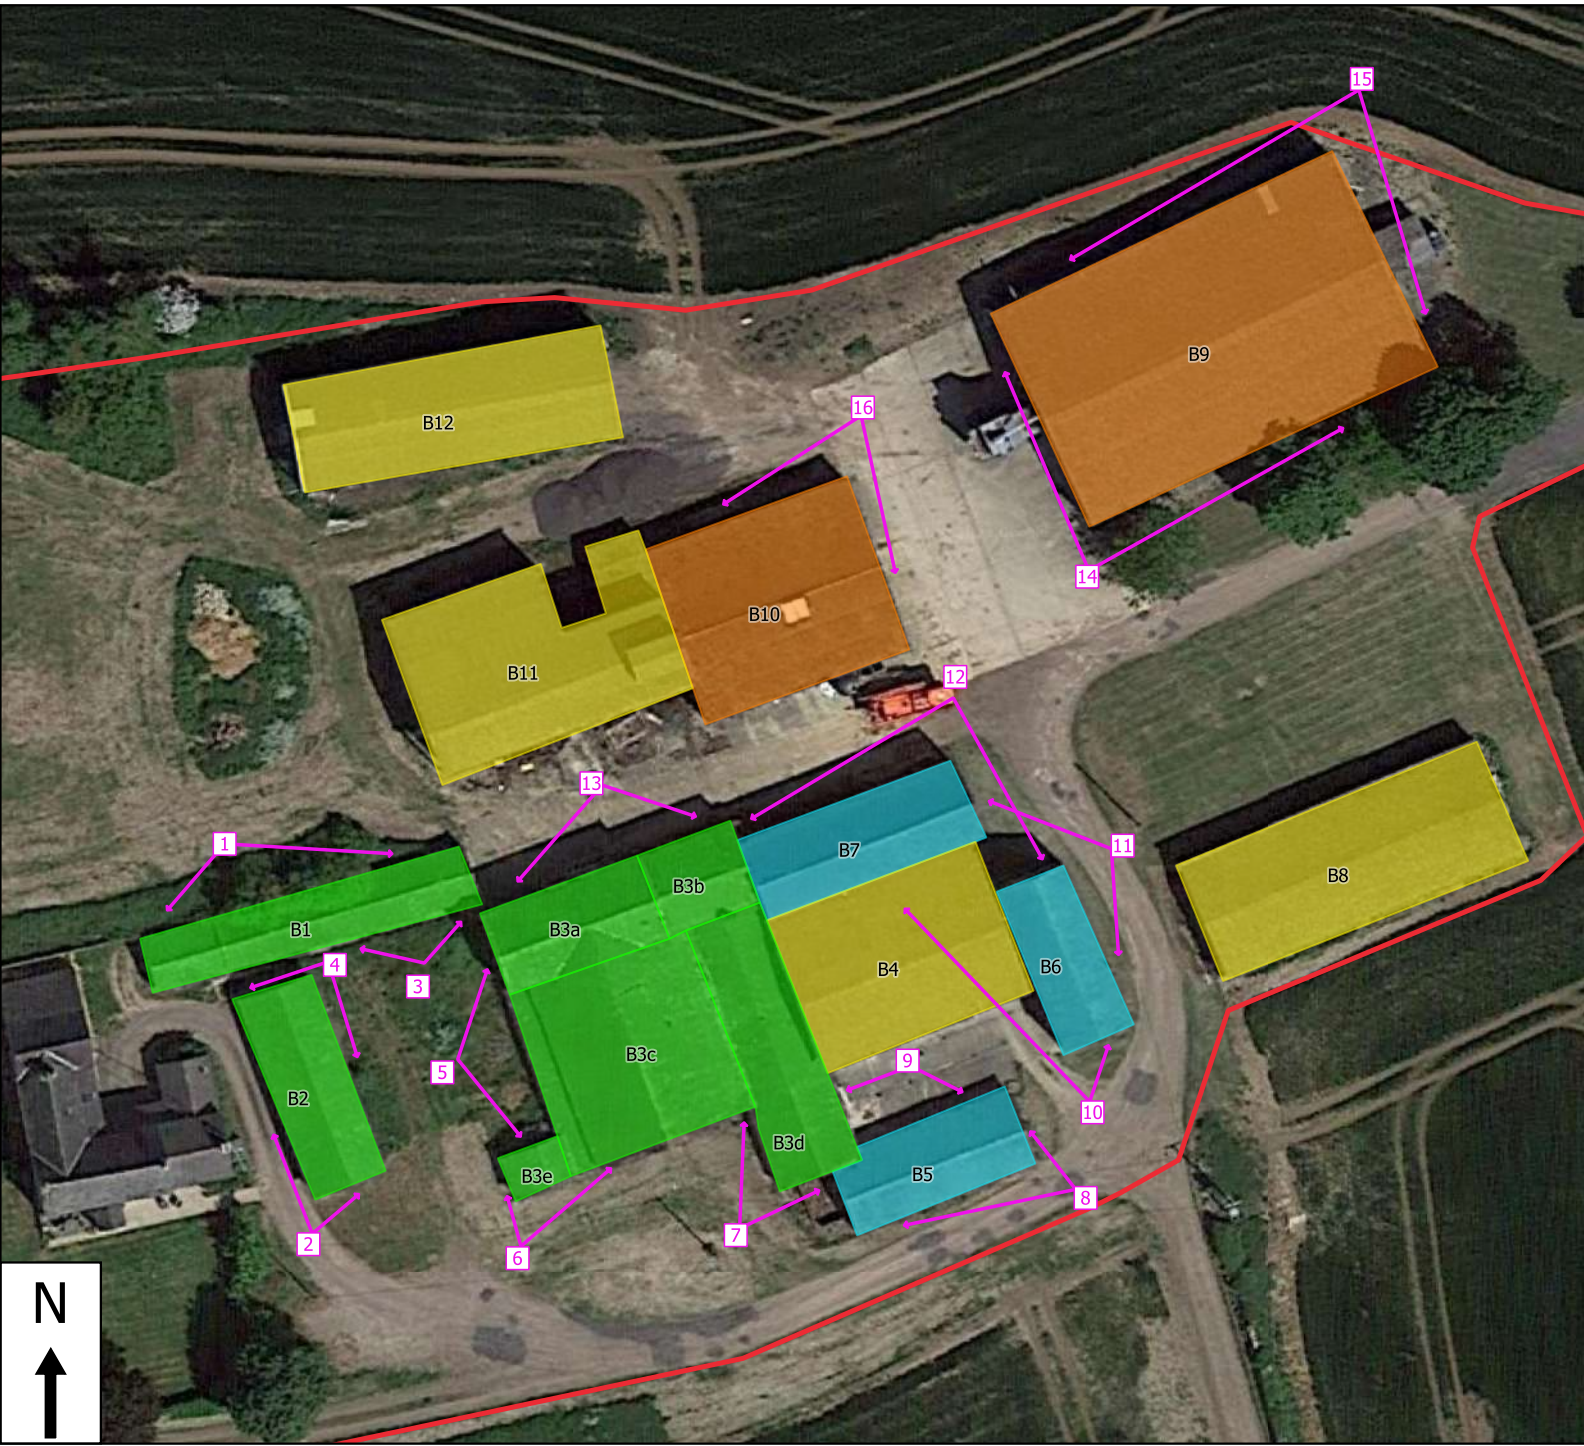
PLAN ECO4
Bat Roost Potential
(Buildings)

- Application Site
- Indicative Surveyor Location
- Building No Bat Potential
- Building Low Bat Potential
- Building Moderate Bat Potential
- Building High Bat Potential

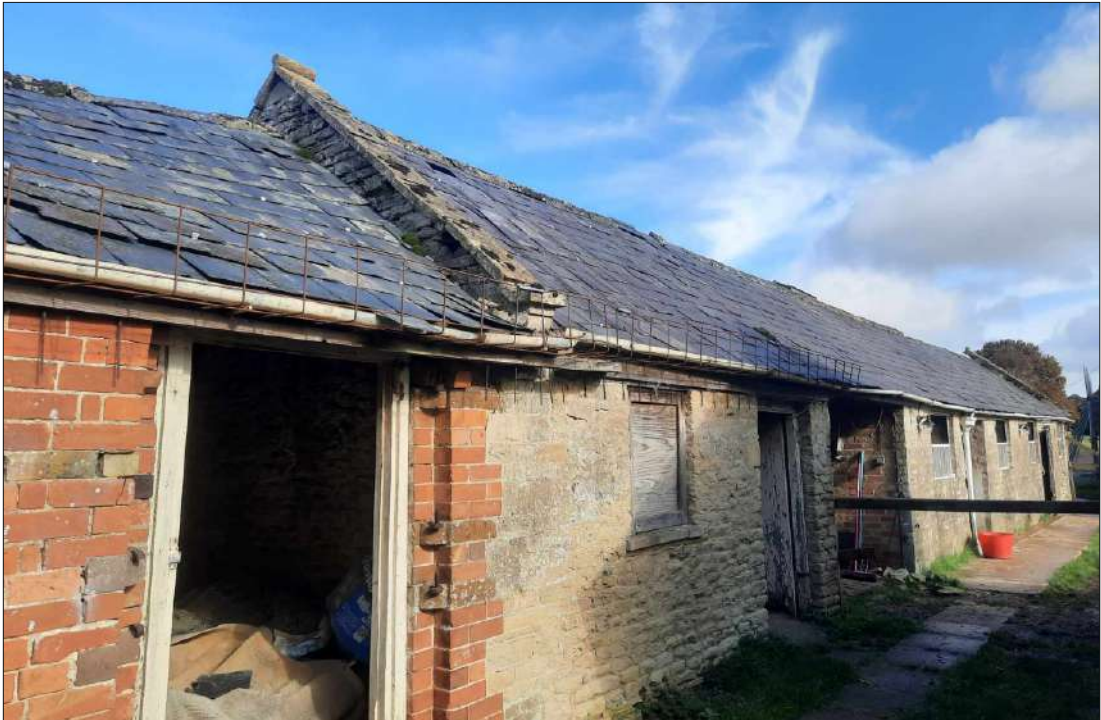
PHOTOGRAPH 1: BUILDING B1

4.2.3. **B1** and **B2**. As above, no evidence of roosting bats was recorded during the internal and external inspections of **B1** and **B2**, either in the form of droppings or other signs, such as scratches or staining. Notwithstanding the absence of any evidence, it was noted the buildings supported a moderate number of features suitable to support roosting bats, such as slipped or broken tiles, gaps at eaves, gaps between roof tiles, and crevices in the stone walls. Due to the lack of an enclosed void or roof lining (considered to temper opportunities for both void and crevice dwellers), **B1** and **B2** were deemed to be of moderate potential suitability to support roosting bats.

4.2.17. With regards buildings **B1 and B2**, no bats were observed emerging from these buildings during either the emergence or re-entry survey. These surveys were conducted in optimal weather conditions with two surveyors covering each building.

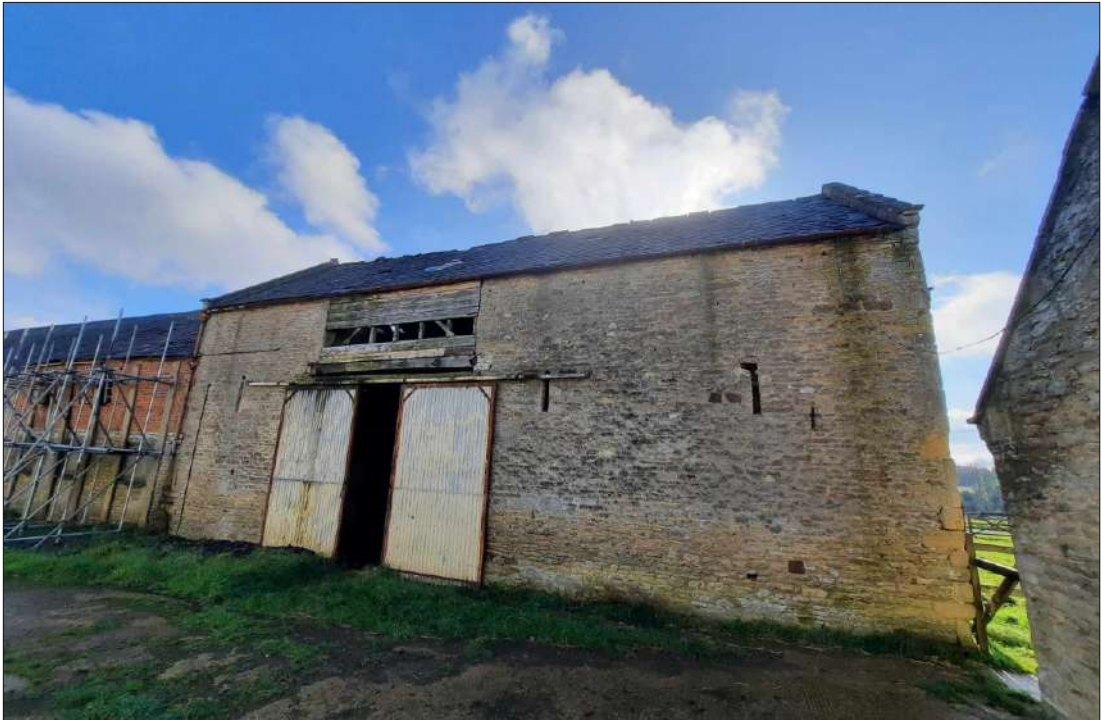
PHOTOGRAPH 3: BUILDING B3A

aspect, two to the west of the door and one to the east of the door. These windows are approximately 5cm wide and 50cm long. The eastern gable end attaches directly onto B3b. The roof is in poor condition with multiple missing and broken tiles, including missing and broken ridge tiles. There is no loft void in B3a.

4.2.24. On 26 August 2022 at 20:55, one Common Pipistrelle and a Brown Long-eared bat *Plectous auritus* was observed emerging from the interior of B3a, through a gap in horizontal wooden boards approximately 3m from the ground, on the northern aspect of the building.

4.2.25. A *Myotis* sp. bat was observed emerging from a window slit in the stone wall of the northern aspect of building B3a, approximately 2m from the ground, at 20:36 on the 26 August 2022. The gap is approximately 5cm wide and 50cm long. Detailed call analysis of this registration was undertaken to further assist species identification. On the basis of sound analysis, alongside consideration of the ecological preferences of the species, it is concluded the emergence likely pertained to Whiskered bat *Myotis mystacinus*.

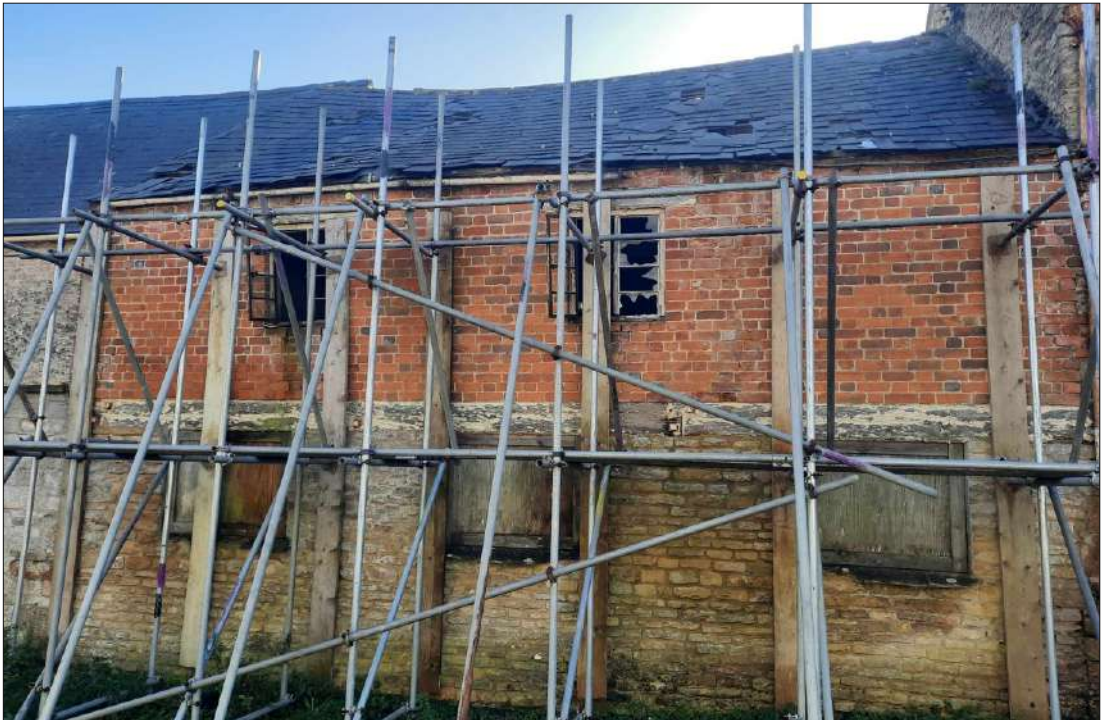
PHOTOGRAPH 4: BUILDING B3B

- 3.12. **B3b**, directly adjacent to B3a, is a two-storey agricultural barn, also historically used as a threshing barn. It has a pitched slate tile roof and walls comprising half stone (ground storey) and half red brick (second storey). There are three square windows on the northern aspect of the ground floor, these are boarded over, and two smaller rectangular windows in the second storey, northern aspect. B3b is in poor condition and, due to being structurally unsound, the second storey of the building was not directly accessed during the survey.

- 3.13. The interior of B3b on the ground floor is considerably darker than B3a, with the boarded windows allowing almost no natural light to enter. A dead Barn Owl carcass (suspected juvenile) was found on the floor of B3b. Hundreds of Barn Owl pellets were noted on the floor.

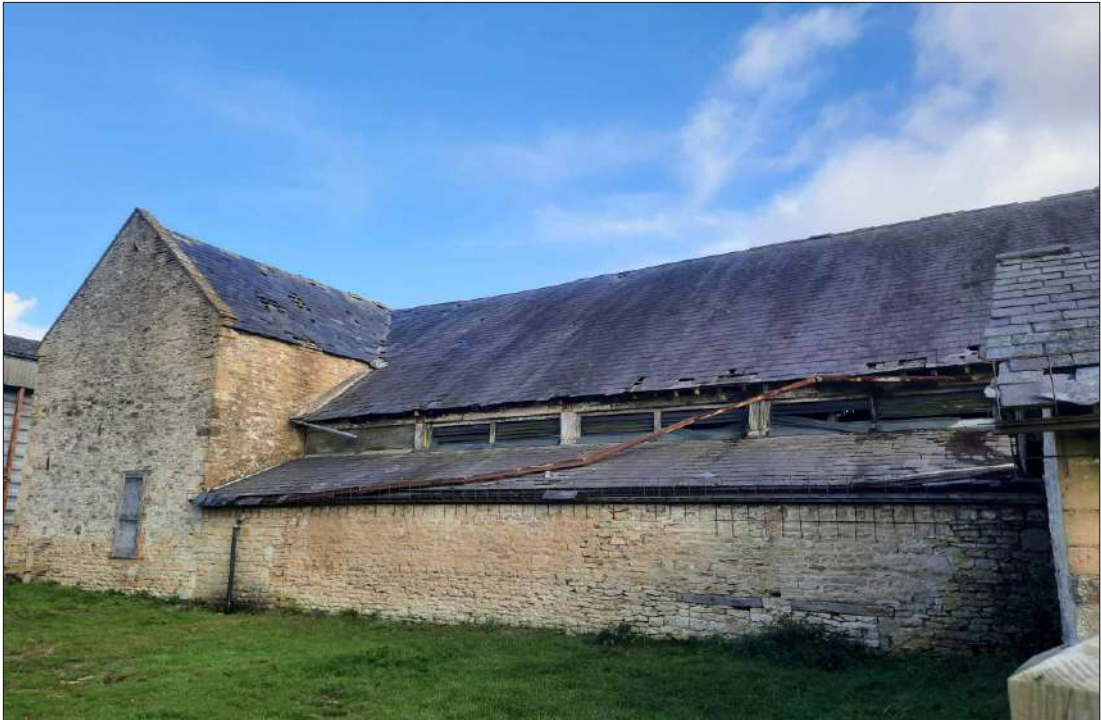
PHOTOGRAPH 5: BUILDING B3C

- 3.16. The interior of B3c is bright, open, and airy. It was historically used as an agricultural shed, and although it is two storeys tall has no internal second storey. It possesses a vaulted ceiling with many wooden and steel beams criss-crossing the internal space. It is currently used for informal storage and recreational purposes (sport and gym equipment present).

4.2.23. One Soprano Pipistrelle *Pipistrellus pygmaeus* was observed emerging from B3c, from beneath a tile above the southern aspect of the building, on the 4 August 2022 at 21:13.

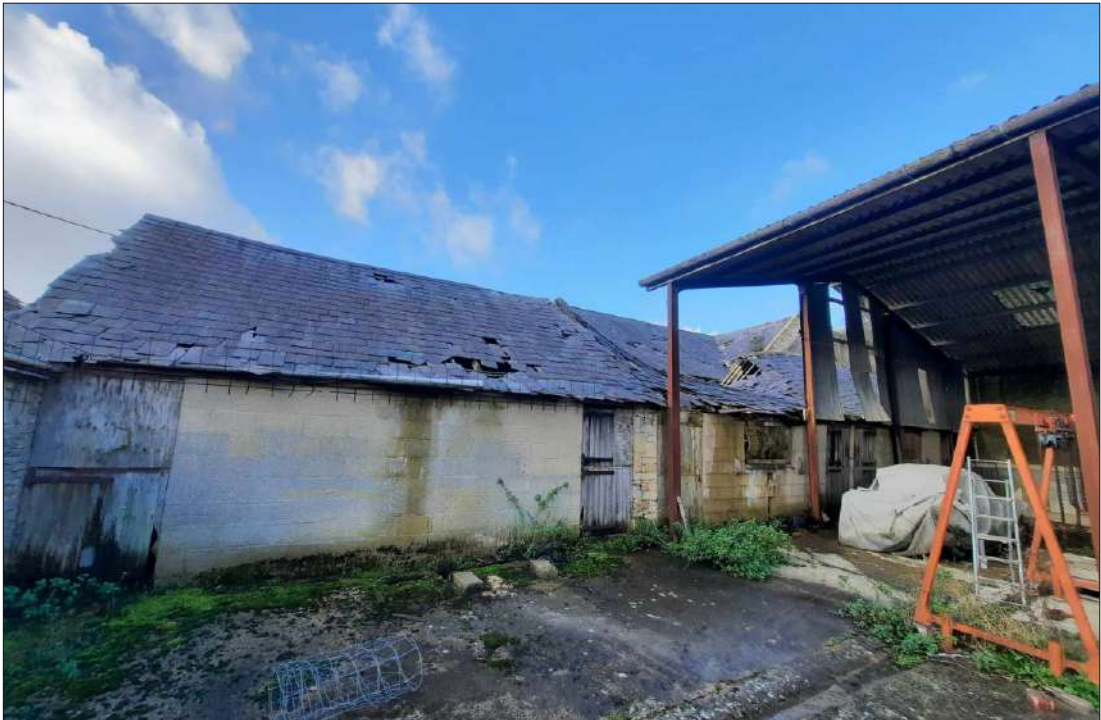
PHOTOGRAPH 6: BUILDING B3D

- 3.17. **B3d** is a single storey, agricultural barn constructed in the same style as B1 and B2. It has a stable door and one rectangular window (boarded up) on the eastern aspect. A large section of the roof on the eastern aspect has collapsed and thus the interior is almost completely exposed to the elements. On account of its poor condition the building was only partially accessible. It is understood there is no loft void in B3d.

4.2.22. One Common Pipistrelle *Pipistrellus pipistrellus* was observed emerging from B3d, from beneath a tile at the edge of the roof at the southern aspect of the building, on the 4 August 2022 at 21:36.

4.2.27. One Common Pipistrelle was observed emerging at 18:47 from a gap under a slipped tile on the roof of B3d, approximately 5m from the southern aspect of the building, approximately 20cm from the apex on the eastern aspect of the roof.

- 4.2.28. One Brown Long-eared bat was observed emerging at 18:51 from a gap between broken and slipped tiles on the eastern aspect of the roof of B3d, approximately 15cm from the edge of the roof.
- 4.2.29. Two Common Pipistrelles were observed emerging from the same location as the above at 18:53 and 18:59 respectively.
- 4.2.30. A Common Pipistrelle was observed at 18:51 emerging from a gap in slipped and broken tiles located midway up the eastern aspect of the roof of B3d, approximately 10m from the southern aspect of the building.
- 4.2.31. A single Soprano Pipistrelle was observed emerging at 18:55 from beneath a broken tile at the gable end of the roof of B3c.
- 4.2.32. On the basis of this survey work B3a, B3c and B3d are considered to support summer day roosts for low numbers of Common Pipistrelle, Soprano Pipistrelle and Brown Long-eared bats.

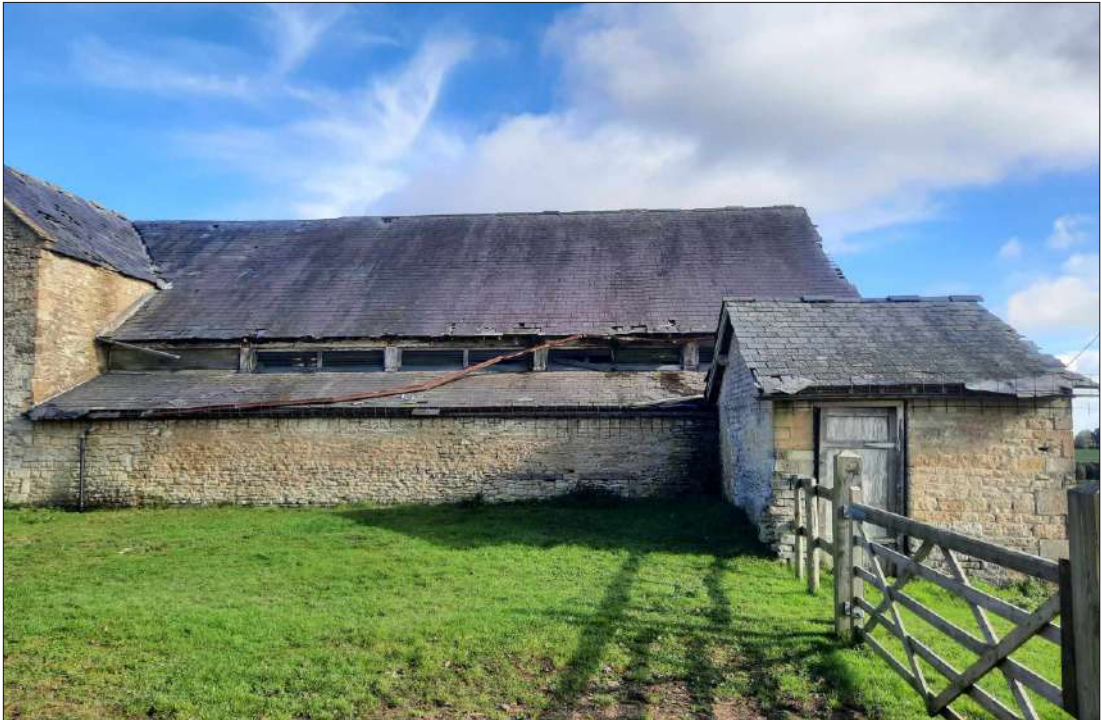
PHOTOGRAPH 7: BUILDING B3E

- 3.18. **B3e** is a small single storey outhouse with a pitched slate tile roof attached to the west wall of **B3c**. There are many slipped and missing roof tiles, and multiple cracks and crevices in the stone walls on each aspect. An internal examination was not possible at the time of survey.

- 3.19. The interiors of B3d and B3e were inaccessible at the time of survey due to concerns over structural soundness.
- 3.20. **B5** is a single storey agricultural barn (formerly a piggery), now disused. It has stone walls and a pitched slate tile roof, as per B1 and B2. Four wooden stable doors are evenly spaced along the northern aspect of the building, which faces the courtyard framed by B5, B3d, B7 and B6. There are no windows. The building is in moderate condition but, as with the other stone buildings, has many slipped and missing tiles from the roof. The interior of B5 was inaccessible at the time of survey but it is understood there is no loft void present.

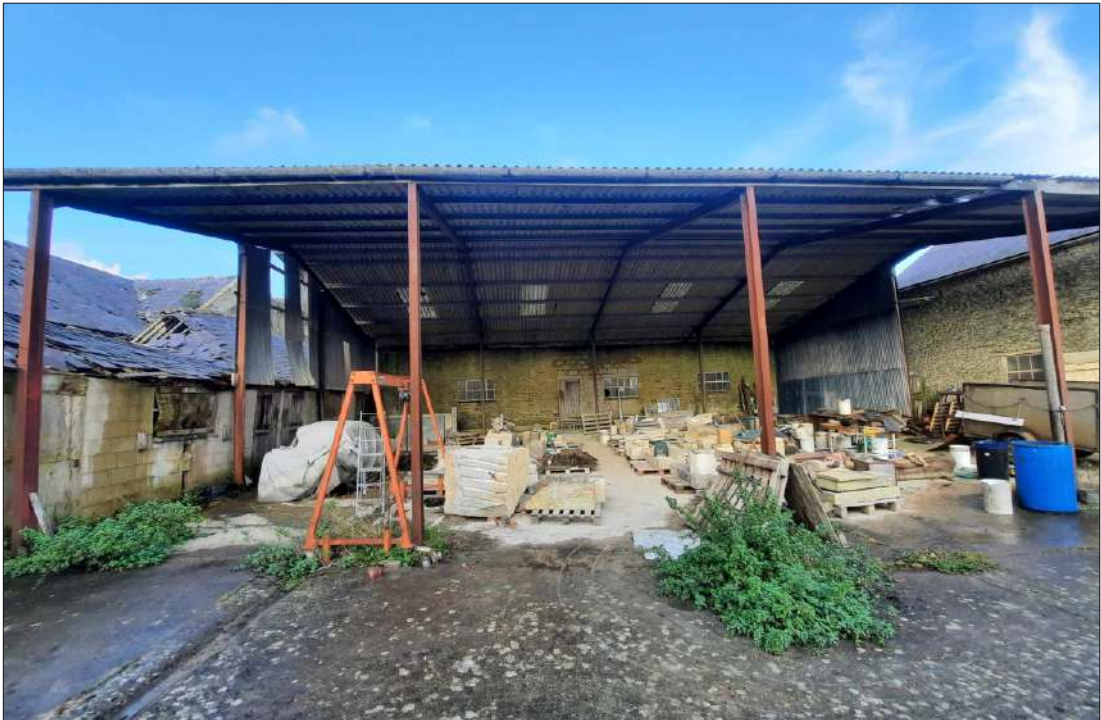
PHOTOGRAPH 8: BUILDING B4

- 3.25. **B4, B8, B11** and **B12** are all open sided modern barns with metal or asbestos corrugated roofs. They all have open, exposed interior spaces with no interior walls. They are all in generally good condition with some limited damage to the roofs and walls.

- 4.2.8. **B4, B8, B11 and B12.** Showed no evidence of roosting bats during the internal and external surveys. They are all modern, open and exposed barns, generally in good condition, with a distinct lack of crevices or other potentially suitable roosting features. The metal-based fabrication means the buildings can be expected to fluctuate greatly in temperature, contributing to them being unsuitable for roosting bats. For the aforementioned reasons these buildings were deemed to have no bat potential.

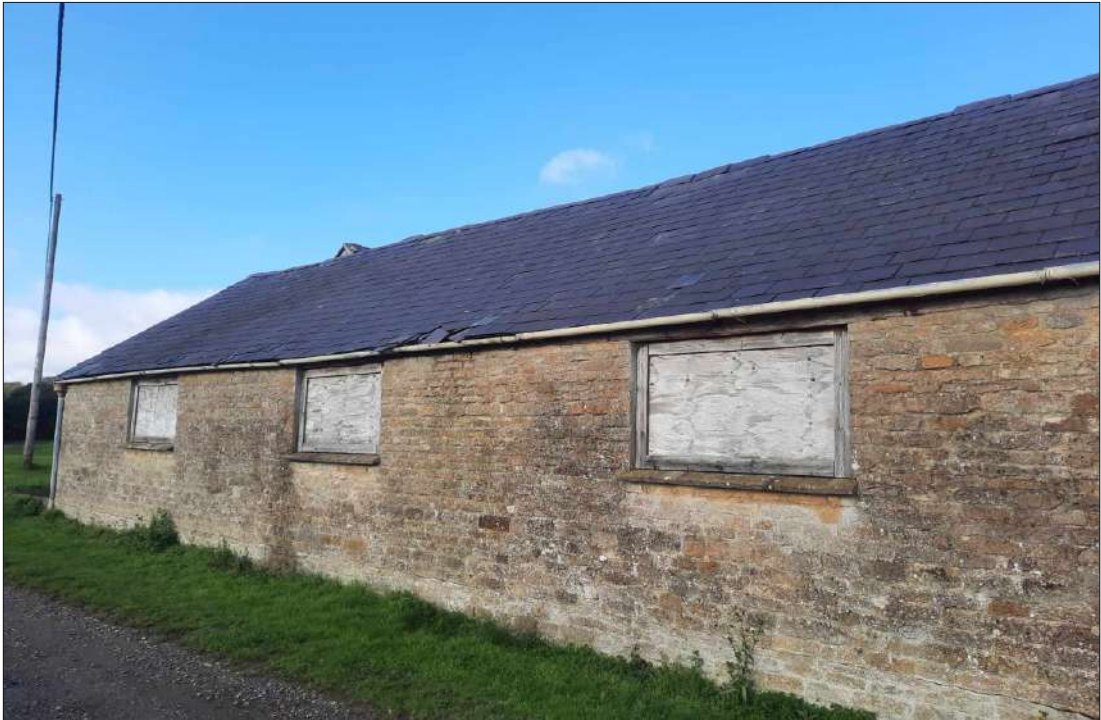
PHOTOGRAPH 9: BUILDING B5

4.2.5. **B5**, **B6** and **B7**. Whilst no evidence of roosting bats was observed during the internal and external surveys, these buildings support many features suitable for bat roosting. They each have slipped and broken tiles, as well as gaps beneath the apex tiles. These buildings all have overhanging tiles and gaps in the eaves. The stone walls have many cracks and crevices present throughout. Due to the frequency of these features **B5**, **B6** and **B7** were all deemed to have a high potential for roosting bats.

- 4.2.33. No bats were observed emerging from B5 during either emergence or re-entry. These surveys were conducted in optimal weather conditions, with two surveyors covering the building.
- 4.2.34. On the basis of this survey work, **B5** is not considered to support roosting bats.

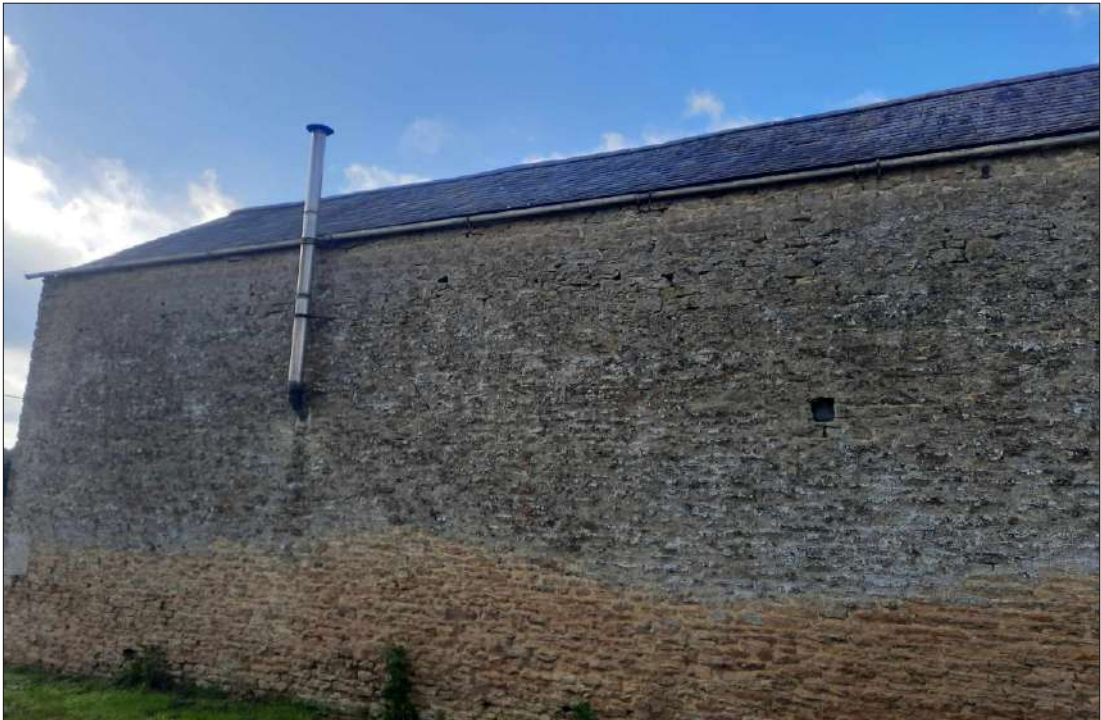
PHOTOGRAPH 10: BUILDING B6

- 3.21. **B6** is a two-storey agricultural barn, formerly a hay barn, now utilised as a stone mason storage unit with temporary lighting. It has stone walls and a pitched slate tile roof. There are two small windows in the southern gable end of the building, and a wooden door and small, second storey window in the western aspect of the building. There is a rectangular wooden door set into the second storey of the northern aspect. As per B5, the roof is in generally poor repair with many slipped and missing tiles. There are also several cracks and crevices in the stone work of the walls on each aspect. The interior of B6 was inaccessible at the time of survey.

- 4.2.35. A single Common Pipistrelle was observed re-entering building **B6** at 05:34 on the 17 August 2022. It re-entered a small crevice, approximately 2cm wide, in the stone wall of the western aspect of the building, approximately 2m from the ground.
- 4.2.36. No other emergences or re-entries of this building were observed during the course of the surveys. On the basis of this survey work, **B6** is considered to support a summer day roost for low numbers of Common Pipistrelle bats.

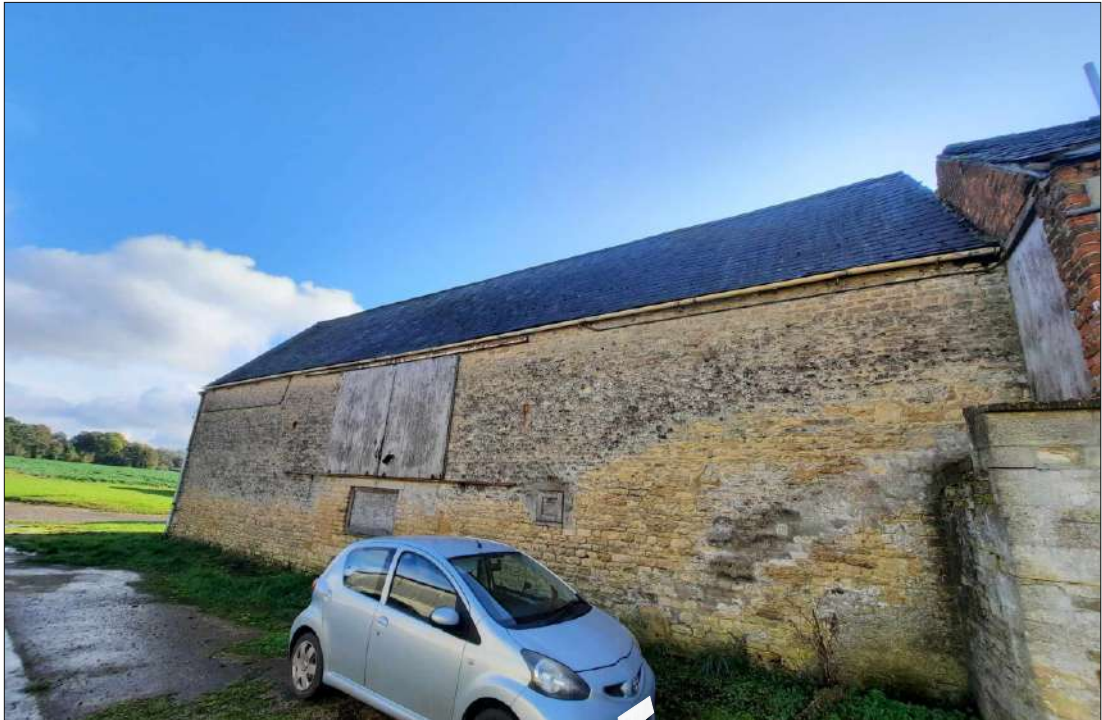
PHOTOGRAPH 11: BUILDING B7

- 3.22. **B7** is a large two-storey stone walled barn with slate tile pitched roof. The walls support many gaps and crevices in the stonework exterior. The roof has many slipped and missing tiles and gaps beneath the apex ridge tiles. B7 was also formerly used as a threshing barn, it contains a hay door on the northern aspect of the building which is covered with a wooden sliding door, approximately 2m above the ground.

- 4.2.37. No bats were observed emerging from **B7** during either emergence or re-entry. These surveys were conducted in optimal weather conditions with two surveyors covering the building.
- 4.2.38. On the basis of this survey work, **B7** is not considered to support roosting bats.

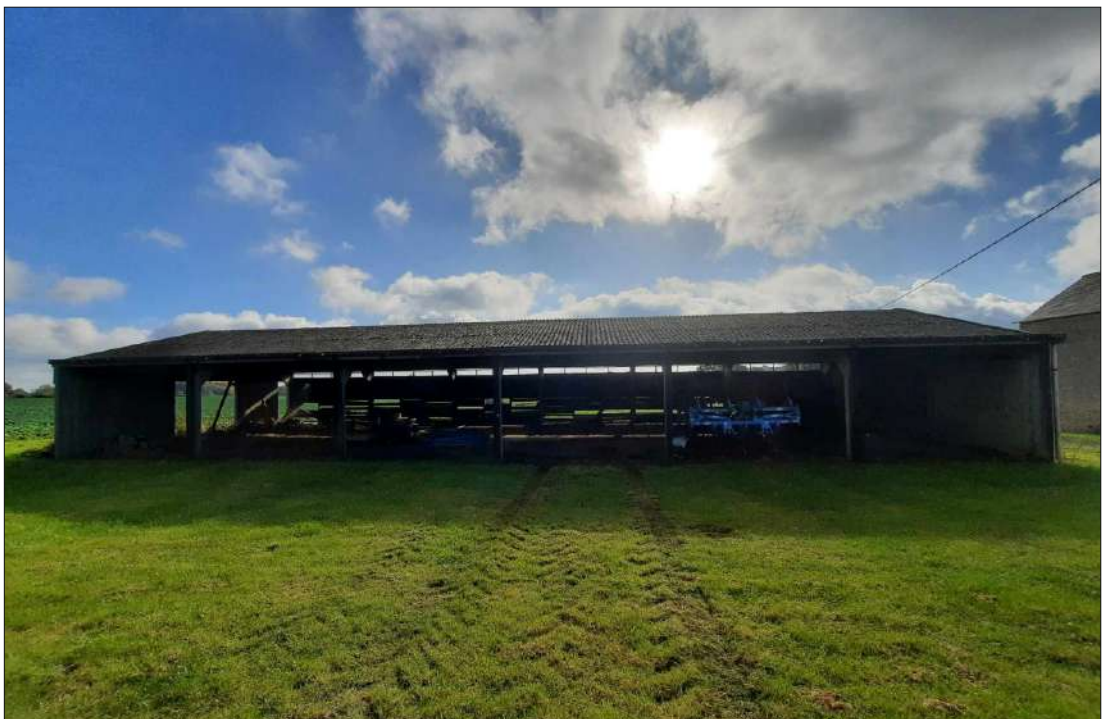
PHOTOGRAPH 12: BUILDING B8

- 3.26. It was noted during the internal survey within **B8** had a large number of Owl pellets located on the floor.

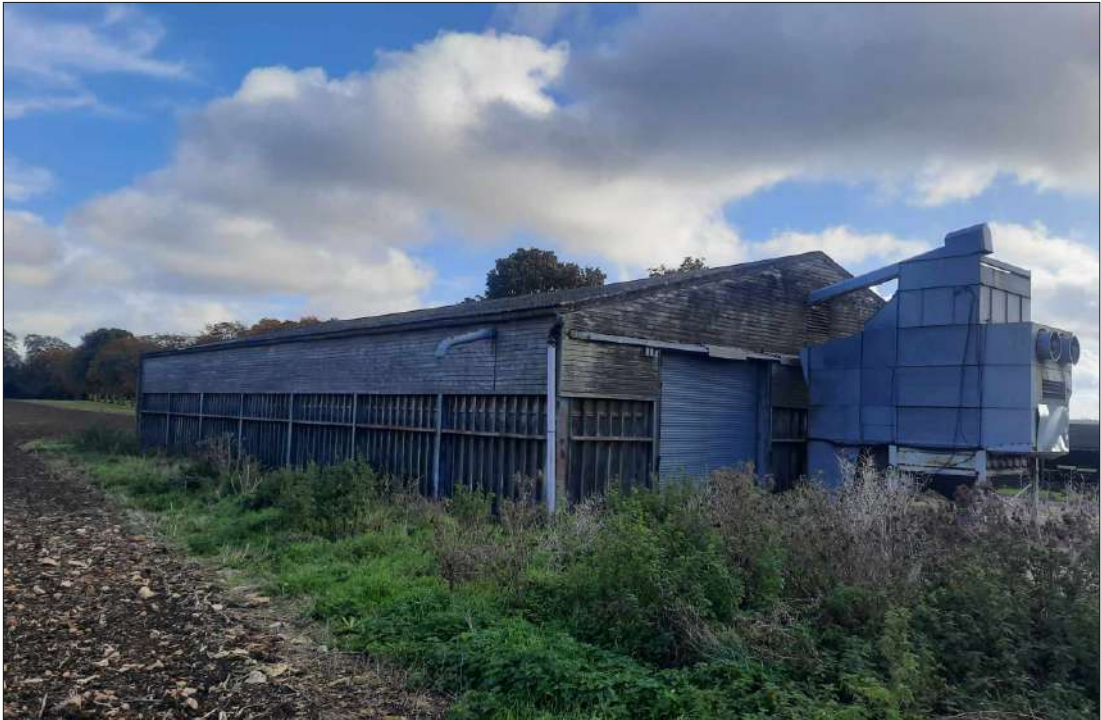
PHOTOGRAPH 13: BUILDING B9

- 3.23. **B9** is a modern single-storey agricultural barn, approximately 5m tall, with metal panel walls and an asbestos corrugated roof. There is wooden cladding on the upper section of exterior walls, many of the planks are damaged and have warped. Overall the building is in good condition. The barn is currently used for storing farm machinery. There is no loft void present.

- 4.2.6. **B9.** Showed no evidence of roosting bats during the internal and external survey. This building is comprised of metal girders, breeze blocks with exterior wood cladding, and a corrugated roof with no lining. It has some limited features suitable for roosting bats. The upper half of the external walls has lengths of wooden plank panelling, with some damage and warping allowing for crevices. These spaces, however, are still more exposed than would be suitable for bats. On a precautionary basis, **B9** was deemed to have low potential for roosting bats.

- 4.2.39. No bats were observed emerging from B9 or B10 during either emergence or re-entry surveys. These surveys were conducted in optimal weather conditions, with two surveyors covering the building.

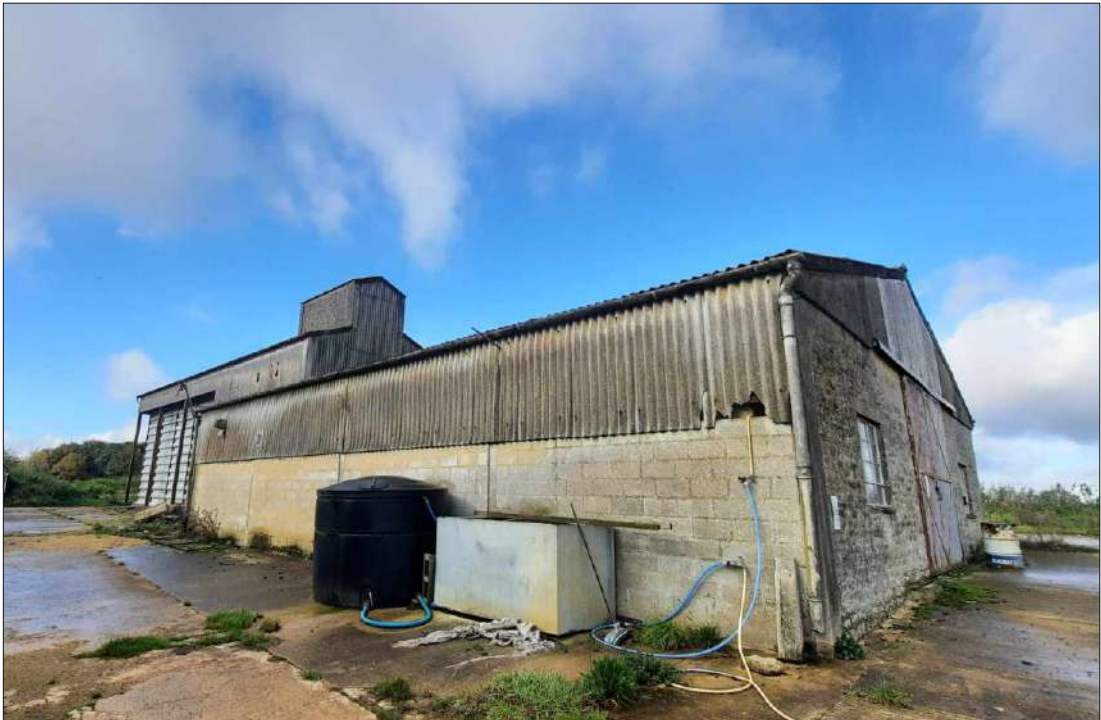
PHOTOGRAPH 14: BUILDING B10

- 3.24. **B10** is a modern, single storey agricultural building, approximately 4m tall, with a stone gable end, breeze block walls and corrugated asbestos cladding. Insulation is packed behind the asbestos cladding on the walls. The type of insulation could not be discerned due to the presence of asbestos. The roof appears to be corrugated asbestos. The building is used for grain storage. There is no internal loft void. There were some cracks in the asbestos cladding but otherwise the building appeared to be in generally good condition.

- 4.2.7. **B10.** There were no signs of bat roosting found during the internal and external survey, and the building supports only a limited number of sub-optimal features suitable for roosting bats. The external corrugated asbestos cladding offers some access to the crevices and packed insulation behind it. Due to this feature **B10** has been deemed to have a low potential for roosting bats and, as with **B9**, underwent one precautionary night-time survey.

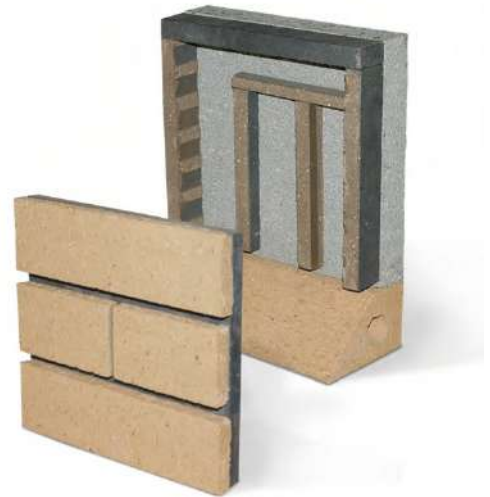
Habibat Bat Access Slate

The Bat Access Slate consists of a standard sized slate, with a capped vent which allows access to roof felt (for roosting Pipistrelles) or roof space (for Serotine, Leisler's, Daubenton's and Barbastelle Bats). We can supply either a standard slate or custom slate that is coloured and sanded to match your roof exactly.

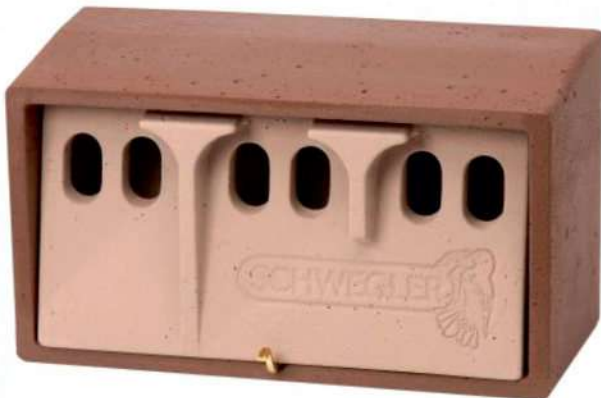
1SP Schwegler Sparrow Terrace

A Woodcrete bird box which allows for several Sparrow pairs to nest in a single location. The box can either be integrated within the fabric of a building or otherwise fitted to the exterior of the building walls.

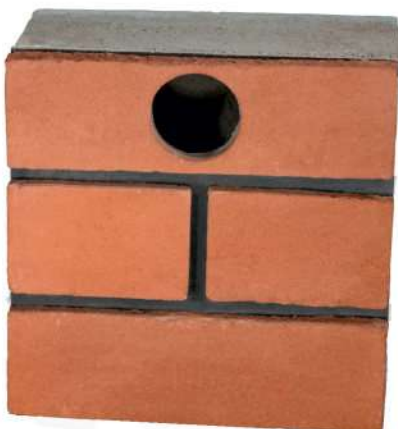
Habitat Starling Nest Box

This box provides an insulated concrete nesting chamber with a hole that is specifically designed to attract Starlings.

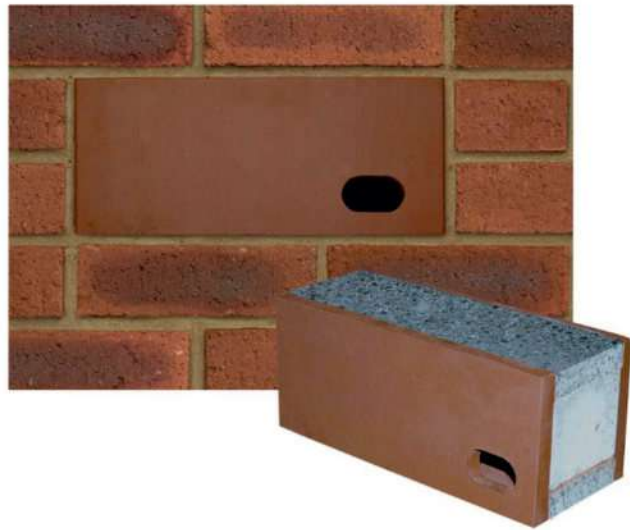
Schwegler Type 25 Nest Brick

Designed for installation into the fabric of a building, this box is suitable for swifts.

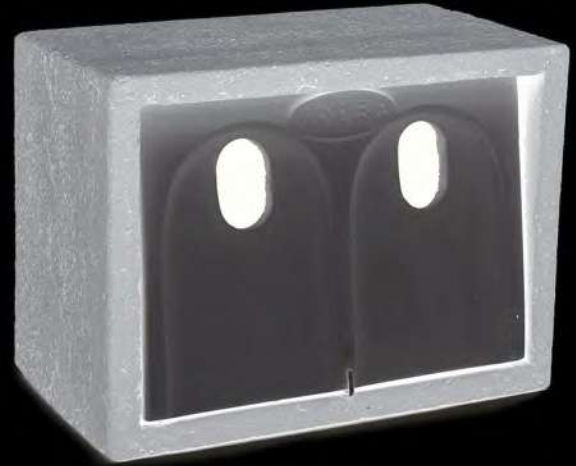
Vivara Pro WoodStone Build-in Swift Nest Box

The Vivara Pro WoodStone Swift Nest Box is an attractive, hardwearing bird box that will provide nesting space for Swifts, and should ideally be placed on the north or east elevations, at least 5m up and beneath an eave.
