# Heritage Statement

Asterleigh Farm  
Barns, Kiddington

October 2023 | Project Ref 7942A

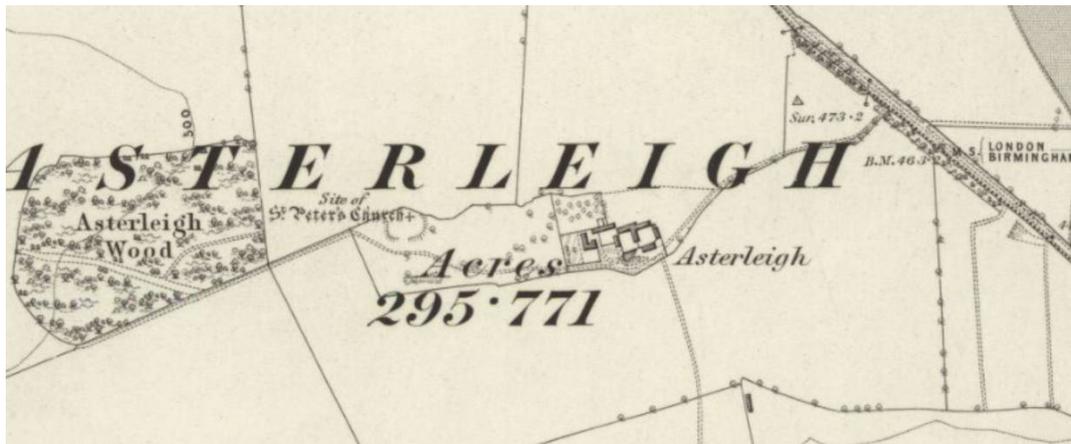
**3.7** The farm is not detailed on the tithe map for Kiddington (dated relatively late in 1850), the area is simply labelled as 'part of Kiddington Manor' and the earliest detailed map is the Ordnance survey six inches to one mile map of 1884, based on a survey of 1876 (figure 6). Further detail is given on the broadly contemporary but larger scale 25 inches to one mile map edition published in 1881 (Figure 7). The farm at this point is divided into three yards, a smaller yard directly east of the farmhouse with a narrow range on its north side, and two larger square yards divided by an 'E' shaped arrangement of buildings to the north and free standing structure and pond on the southern edge between the yards and the track running to the southern side of the farm. The farm house has gardens depicted to the south and west and the area of the former medieval settlement is marked, as well as being a site of quarrying.

Figure 6: 1884 six inches to one mile map (National Library of Scotland Maps collection)

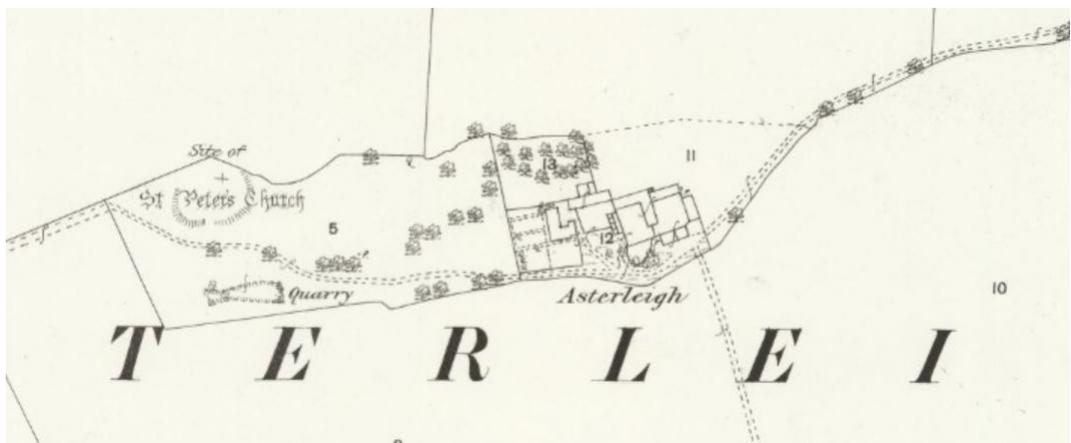
Figure 7: 1881 25 inches to one mile map edition (National Library of Scotland Maps collection) Note the suggested pond on the southern side of the central yard indicated by its irregular shape to contrast it from buildings.

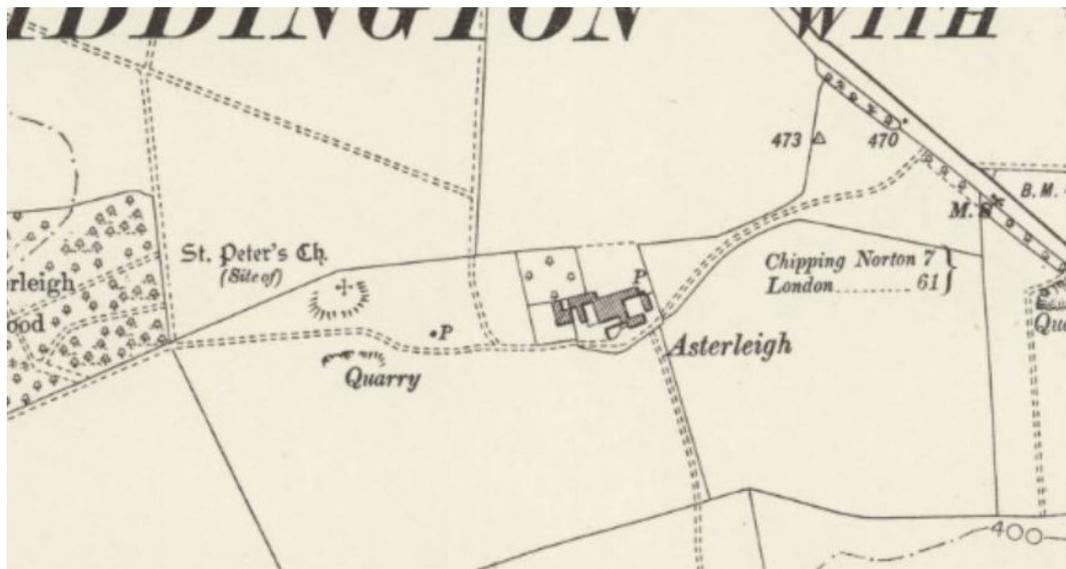
At the turn of the 20<sup>th</sup> century, by the 1900 six inches map the central of the three yards had been infilled, and additional structure added to the western side of the western yard east of the farmhouse. The farm developed further with a long range added to the north in the early 20<sup>th</sup> century and after 1955 further large buildings added to the east of the historic core, the later 20<sup>th</sup> century also saw the route of the access road altered to extended directly into the group to the north of the historic barns. The official footpath route today follows the line of the historic approach drive, but the diagonal route to the south has been built over with one of the open portal barns and the track now runs parallel to the easternmost historic structure.

Figure 8: 1900 six inches to one mile map extract (National Library of Scotland Maps collection)

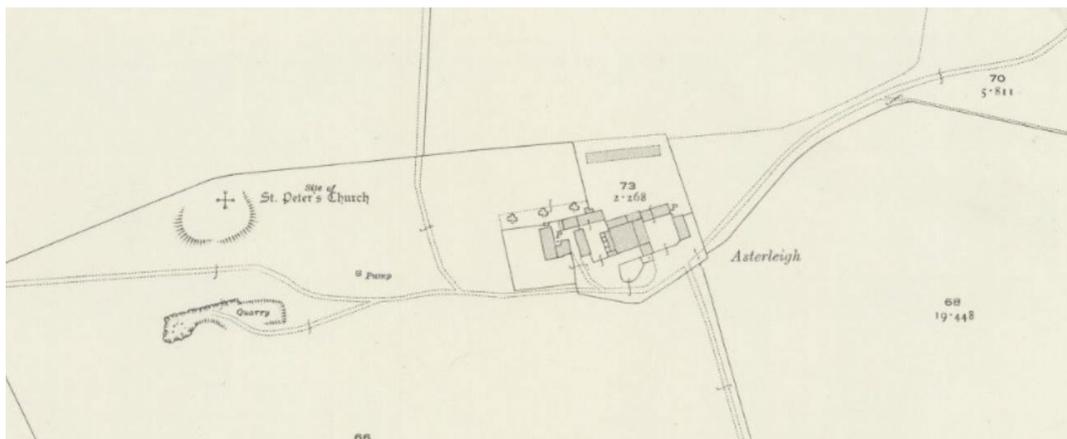
Figure 9: 1925 25 inches to one mile map extract (National Library of Scotland Maps collection) Note the stable on the southern side of the eastern yard (Barn 6) is not shown

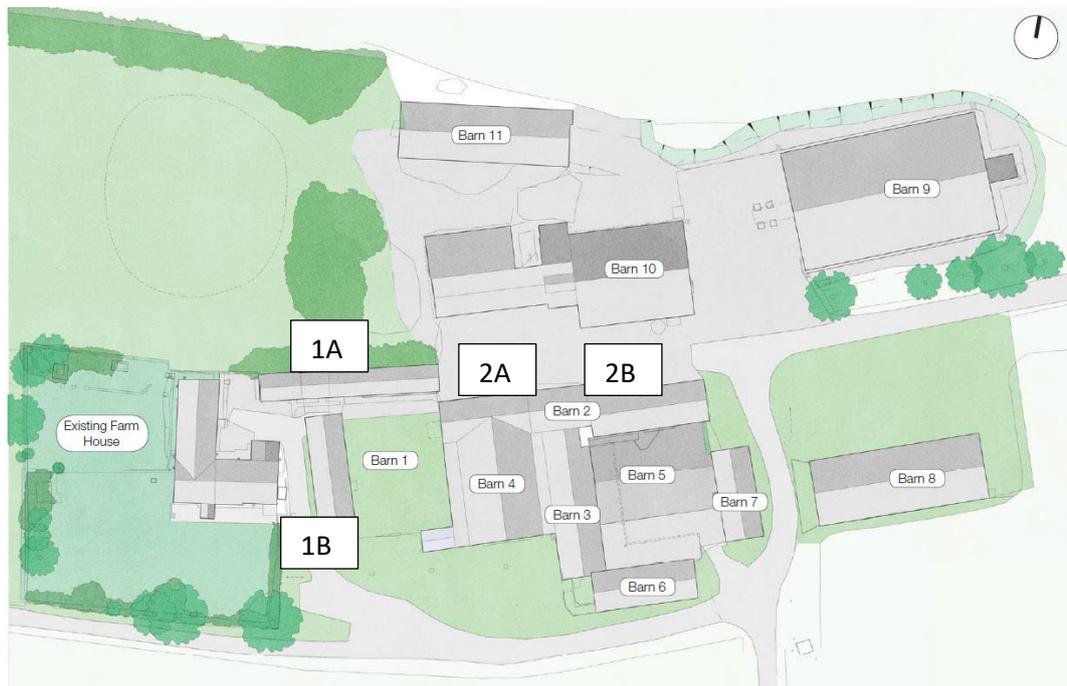
Figure 10: Building identification, where the numbers cover two structures, letters A and B have been assigned to assist in understanding in the following text.

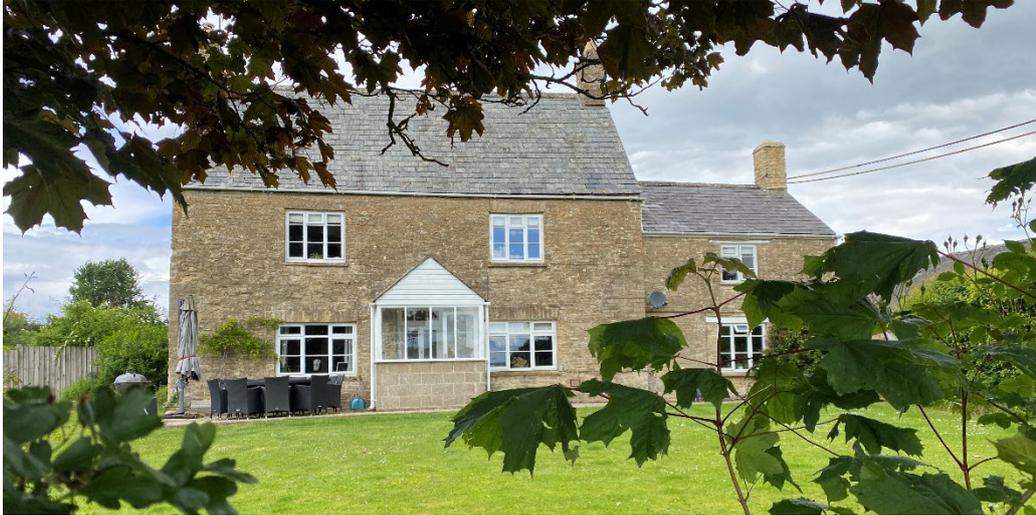
*Figure 11: southern façade of the farmhouse.*

**3.11** The farmhouse is a solid building of local stone beneath a grey slate roof, almost certainly a much later replacement of what would most likely have been a local stone slate roof originally. The windows are all modern, though some splayed stone

lintels survive. Various additions with lean-to roofs have expanded the footprint with a two storey addition added to the eastern gable of the southern range.

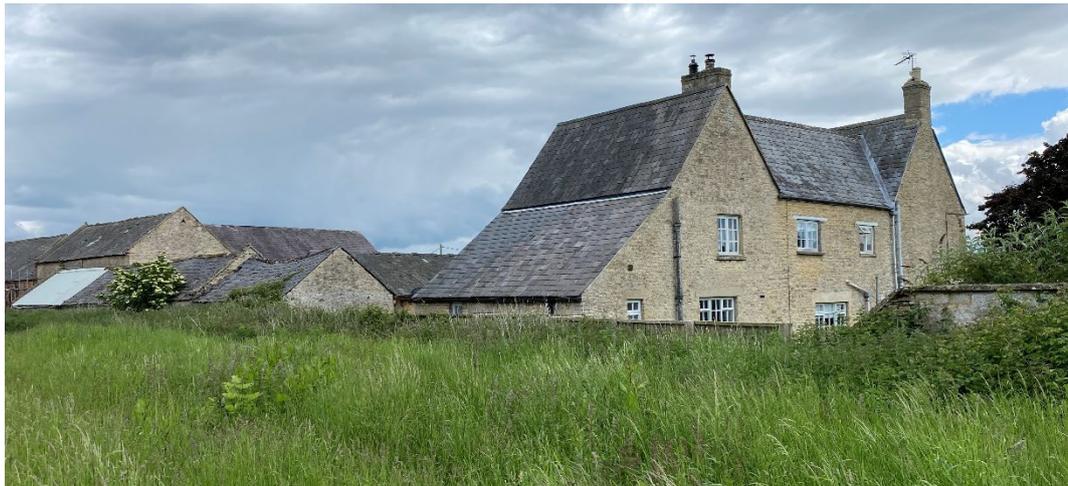
*Figure 12: Western façade of the farmhouse with roofs of the historic farm buildings behind.*

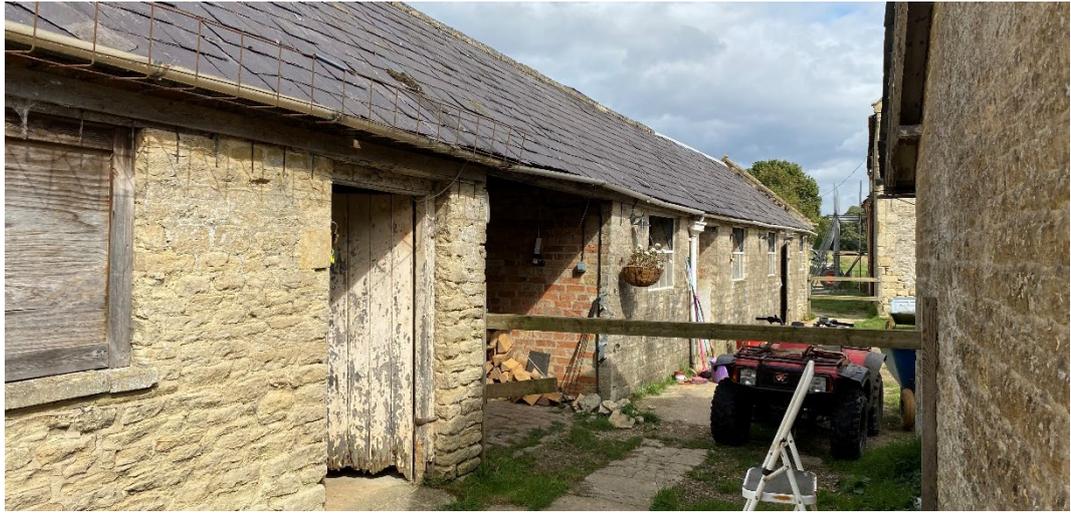
*Figure 13: Building 1A, the northern range of stables.*

**3.13** The northern range is slightly earlier, dating to the first half of the 19<sup>th</sup> century to appear on later 19<sup>th</sup> century maps; it does not seem to be indicated on the Ordnance Surveyors drawing but is in place by the 1880s. It is a stable, a use

which it retains, with subdivisions into individual cells entered from the southern side. The materials are again a mixture of red brick and stone with slightly more ornamental features such as carved kneeler blocks at the gable ends and moulded blocks in some of the doorways. The moulded blocks at the gables are a match to those seen on the main threshing barn suggesting the buildings are contemporary.

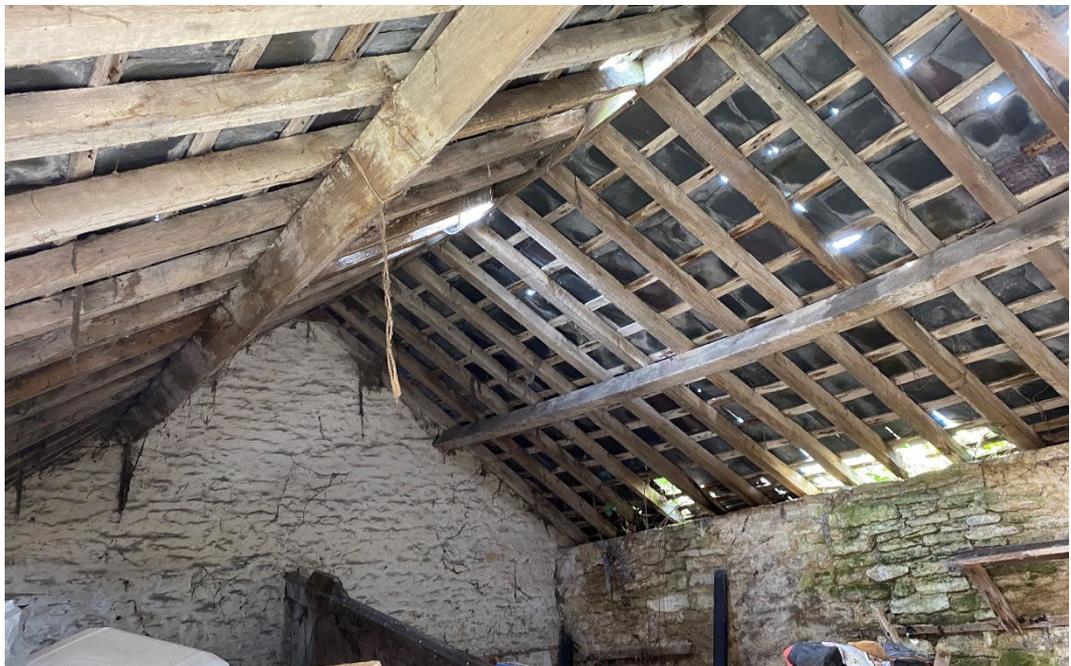
*Figure 14: internal view of one of the stables at the western end the roof has been renewed here.*

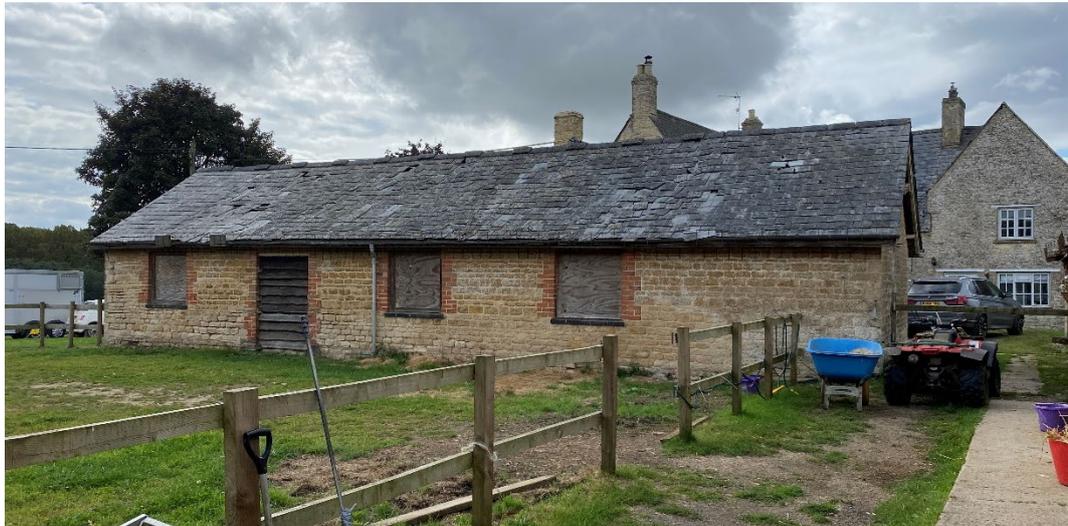
Figure 15: Building 1B: the western stable, a later addition.

The western range (Building 1B) was inspected through a window in the southern gable revealing a single open space divided with concrete rendered stalls beneath a regular sawn roof structure of iron reinforced king post trusses. The map regression shows this structure as being built in the last two decades of the 19<sup>th</sup> century. A blocked doorway is legible on the southern gable, now filled in to form a window.

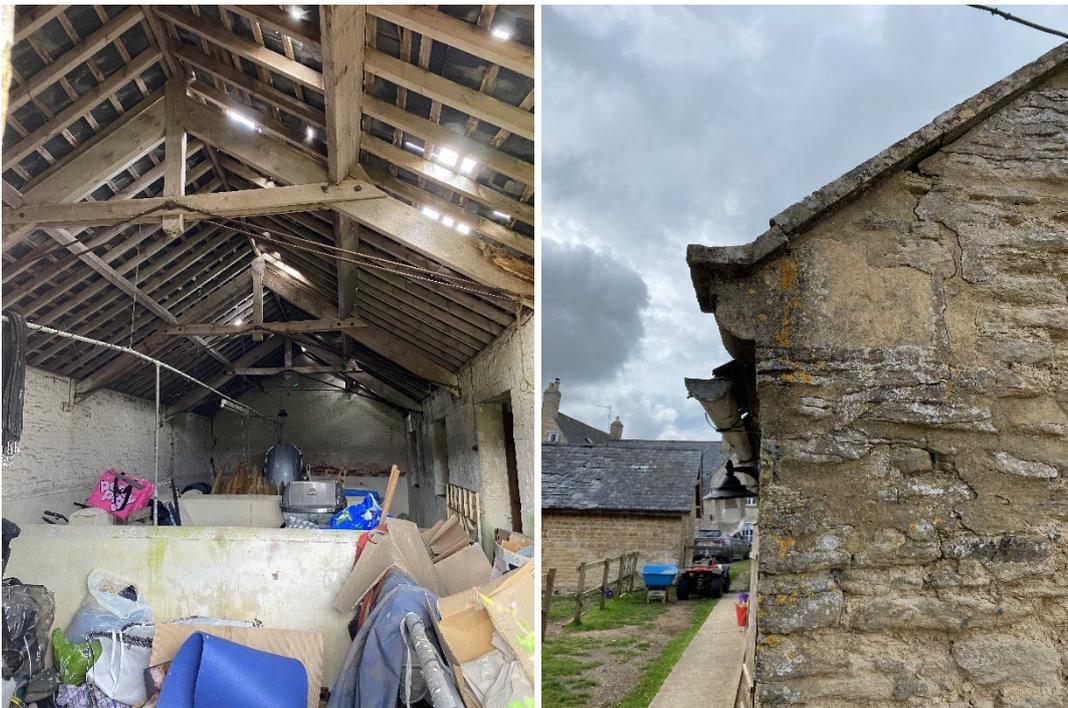
Figure 16-17: (left) interior of the western range of Barn 1; (right) view of the stone kneeler at the end of the northern stable, a matched detail to one of the two threshing barns making up building 2.

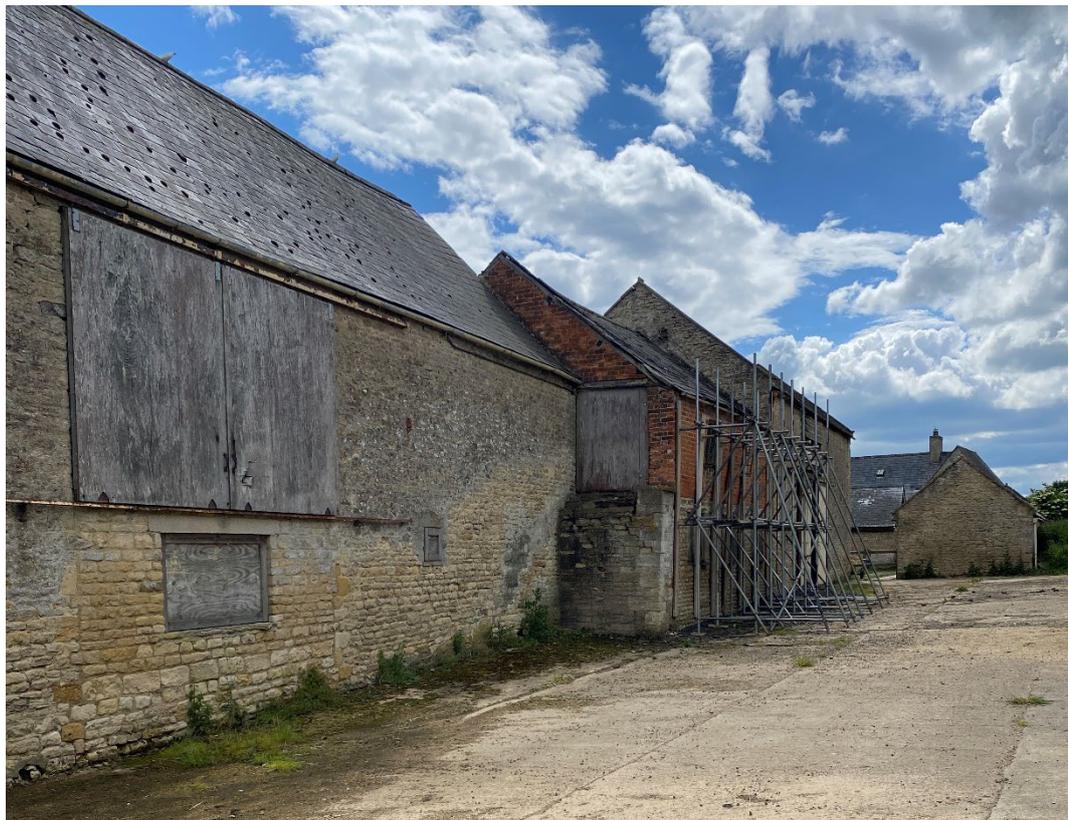
*Figure 18: View along the northern edge of Building 2 looking towards the chimney and roof of the farmhouse and gable end of Building 1, the left hand structure is earlier, the far right one a later addition with later infilling structure in red brick.*

A long range forming the northern edge of the historic group Building 2 actually covers two historic threshing barns with a linking section (Figure 18). The eastern of the two barns (2B) has been heavily adapted with a floor inserted throughout and brick, concrete block and cement lined pigsties inserted beneath but the roof structure, and the early Ordnance Surveyor's drawing suggests it is the older of the two structures. The threshing doors are blocked, though their outline remains legible in the external walls. The walls of the barn also feature several blocked triangular ventilation holes. Wide metal framed windows have been inserted through the southern façade lighting the pigsty feeding passage. The first floor area was viewed through the opening in the northern elevation revealing a single open space with four very simple tie-beam and collar trusses and strings of butt purlins with through tenons.

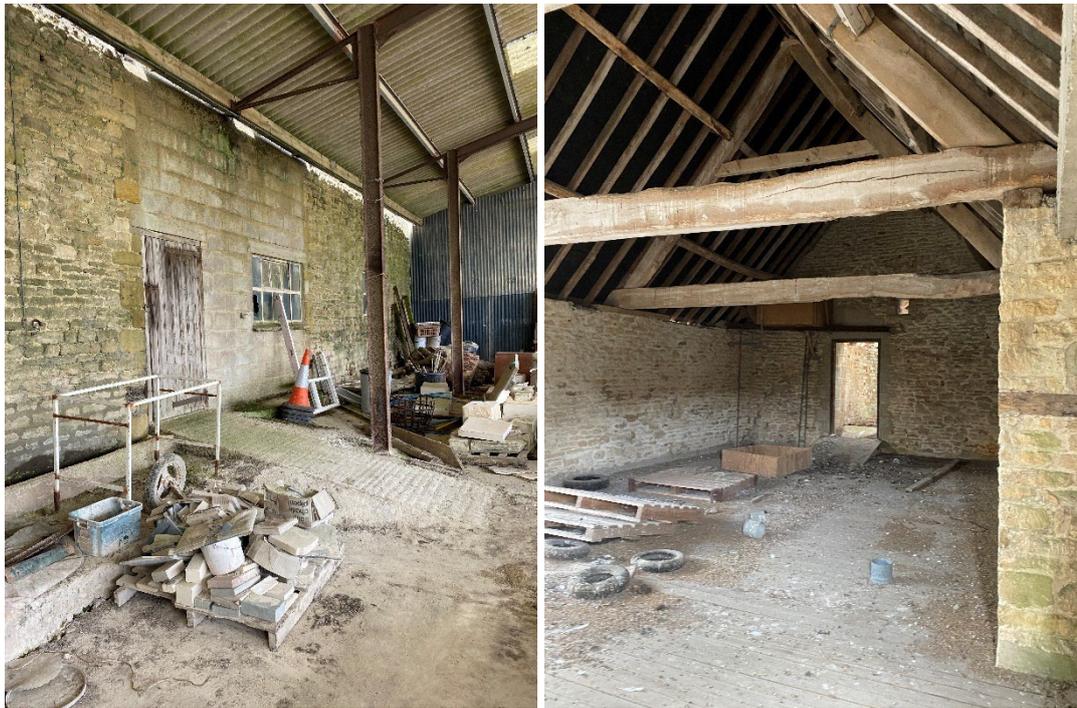
*Figures 19-20: the blocked threshing door and one of the windows inserted in the southern elevation of Barn 2B with internal view of the open first floor area and link through to the intermediate structure.*

**3.16** The adaptation of this barn, and Barn 3, for internal accommodation of pigs appears to be in line with trends from the later 19<sup>th</sup> and early 20<sup>th</sup> centuries for mass 'piggeries' sometimes called 'Scandinavian Piggeries' which included long rows of low pens with a narrow passage for feeding and drainage.<sup>10</sup>

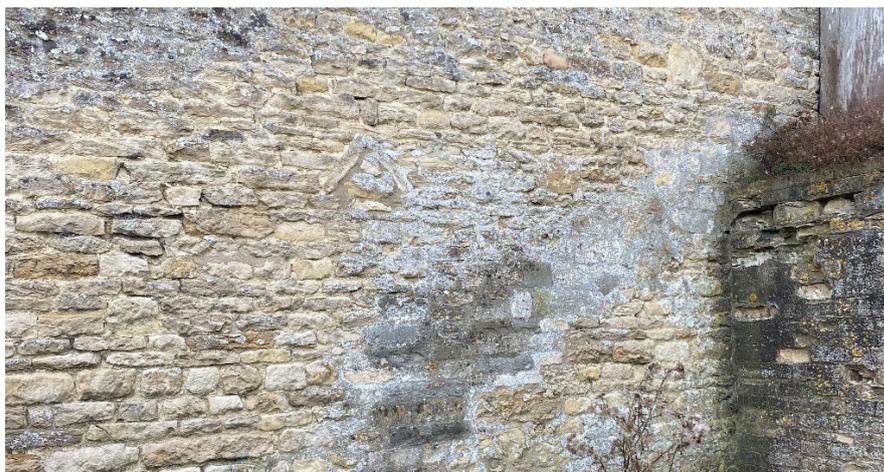
*Figure 21: blocked triangular ventilation hole in the northern elevation of Barn 2B with scar from removed tallet steps beneath.*

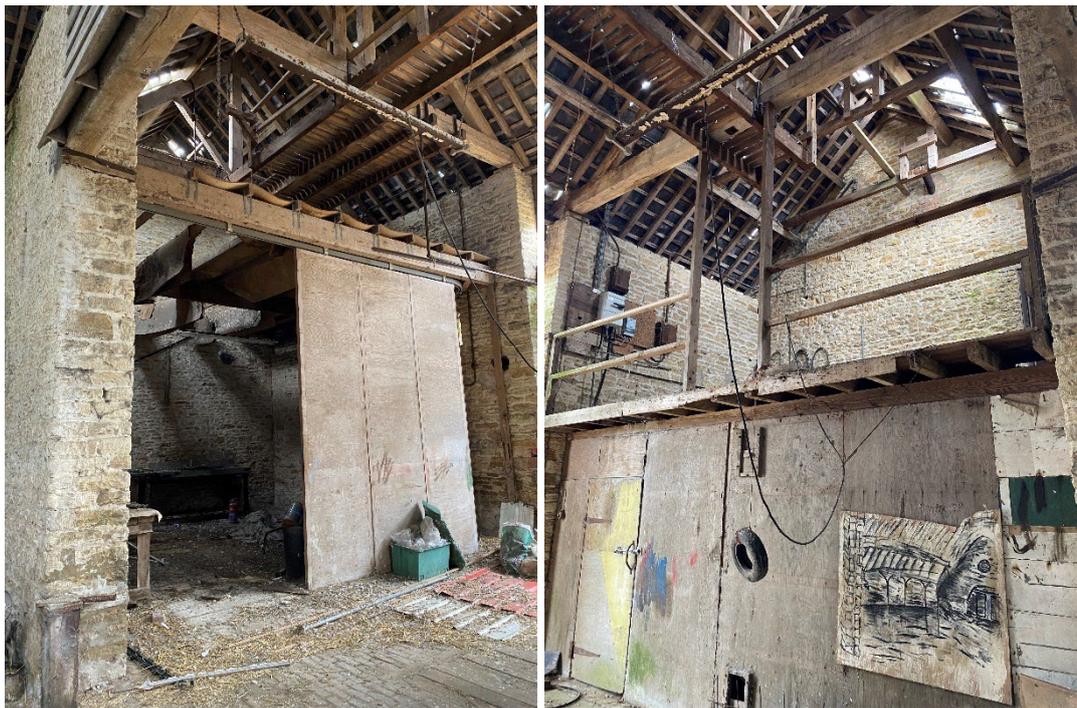
*Figures 22-23: (left) internal view within western part of Barn 2 and (right) the eastern side of the barn showing substantial king post trusses and floor structures in the end bays flanking the threshing doors.*

**3.17** The western barn (2A) retains paired threshing doors with high floor structures to either side with some machinery and equipment retained. The trusses are substantial and well formed king-post trusses with concealed coach bolts and slightly expanded heads against which the principal rafters thrust. The barn is probably mid 19<sup>th</sup> century in date based upon the map evidence and nature of the trusses.

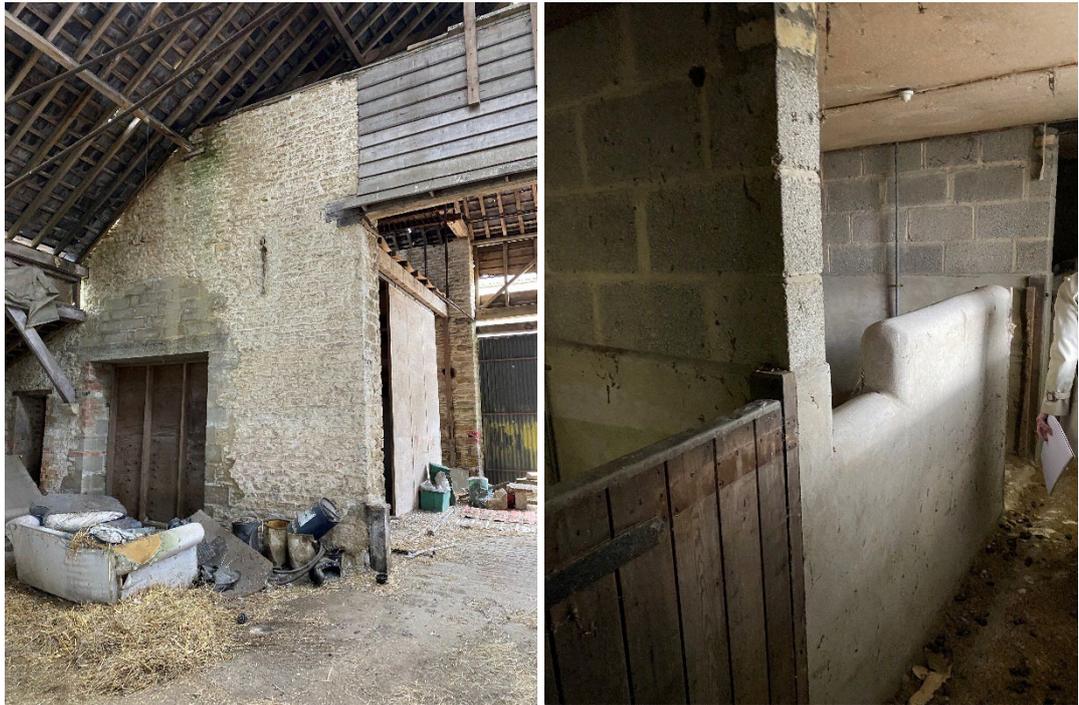
*Figures 24-25: (Left the south western elevation of the threshing barn 2A with inserted opening and narrow 'candle' ventilation slit and, (right) concrete block subdivisions in the lower part of the linking structure.*

**3.18** The barn is enclosed on the south side by Building 4 and openings have been created into this space to either side of the threshing door opening. Smaller narrow ventilation slits are present in this barn as well – historically necessary to secure ventilation around any stored grain – but in this barn they are tall and narrow with a diagonal hole at the top, like a candle.

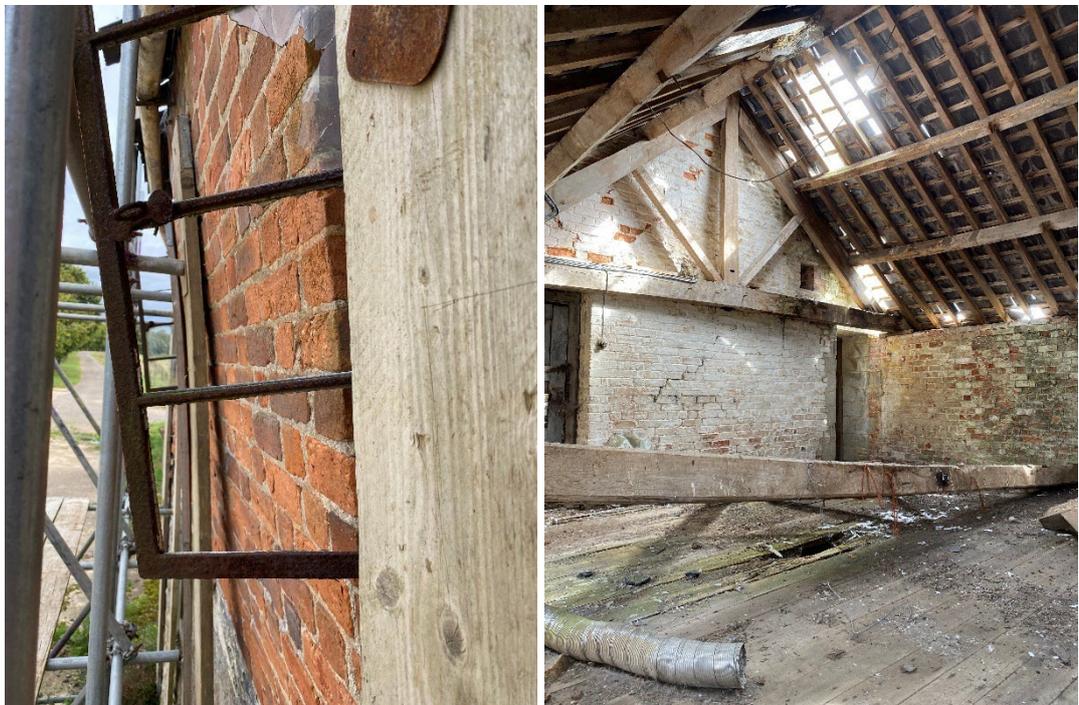
*Figure 26-27: Metal framed window in linking structure, note lean on red brick wall (image view point constrained by scaffold access) and, (right) interior of the linking structure with central truss collapsed on the floor and no longer supporting the roof.*

**3.19** The connecting structure features a series of small sub-divisions at ground level in a similar pig sty style to the adjacent barn and at first floor an open area with iron windows and collapsed trusses, this structure is near collapse and the seriously displaced walls are propped against collapse by boards. The roof structure is collapsed into the space.

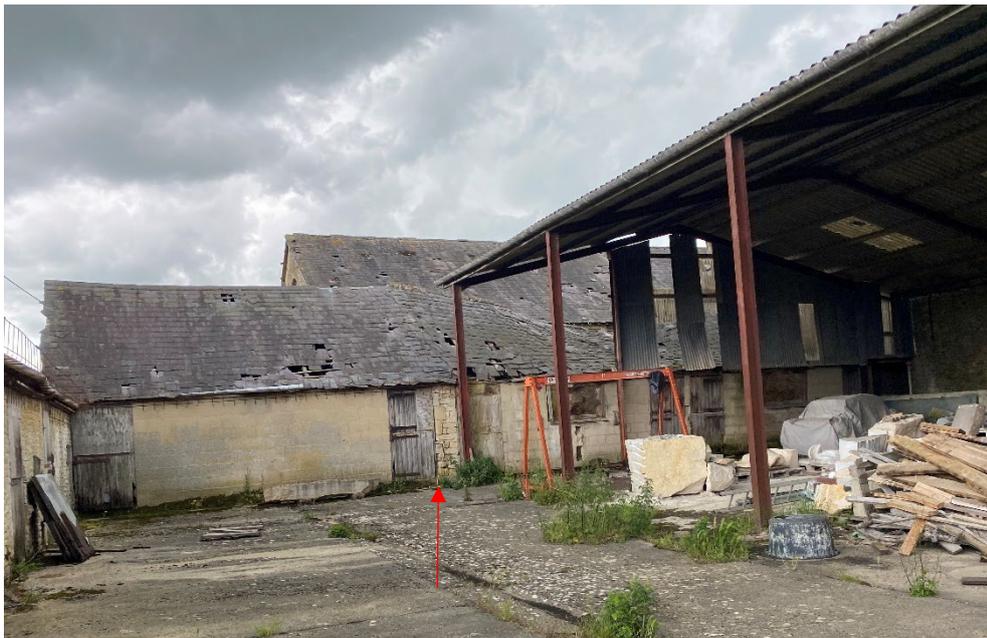
*Figure 28: Looking across eastern yard towards Barn 3 with later blockwork walling, stone pier (arrowed) marks end of older structure, possibly open sided, the roof is partially collapsed but a consistent structure spanning older and later portions.*

**3.20** A north to south single storey range now partly collapsed. Internally adapted to accommodate pigsties there is evidence in the eastern wall of where the structure was extended to join Building 6 in the last decade of the 19<sup>th</sup> century (see historic maps), the consistent roof form of well sawn members and queen-strut trusses (no collars only struts between tie-beam to rafters) suggests it was re-roofed at this time, the character of the roof is in keeping with many of the buildings suggesting a comprehensive programme of renovation or improvement at this time in the latter part of the 19<sup>th</sup> century.

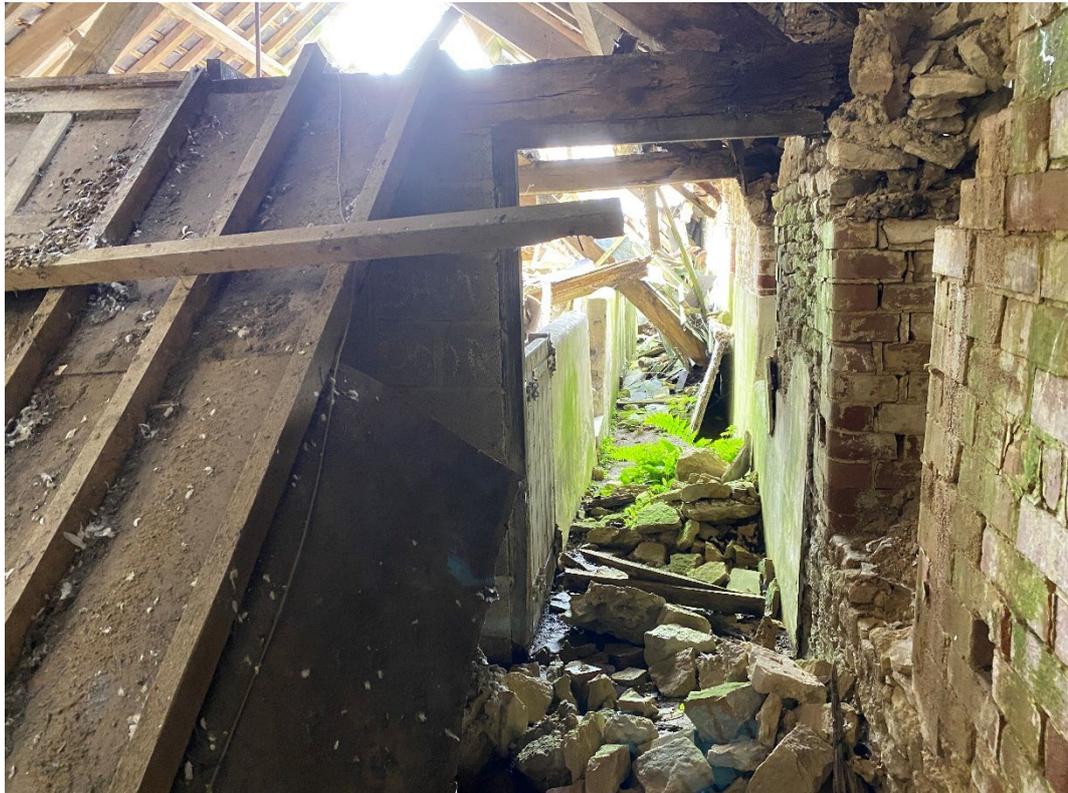
*Figure 29: Partial inspection of the feeding passage within Building 3, the wall with openings on the right is to Building 4, the cement rendered stall partitions are visible in the centre of the picture, a blockwork partition visible to the left of the doorway.*

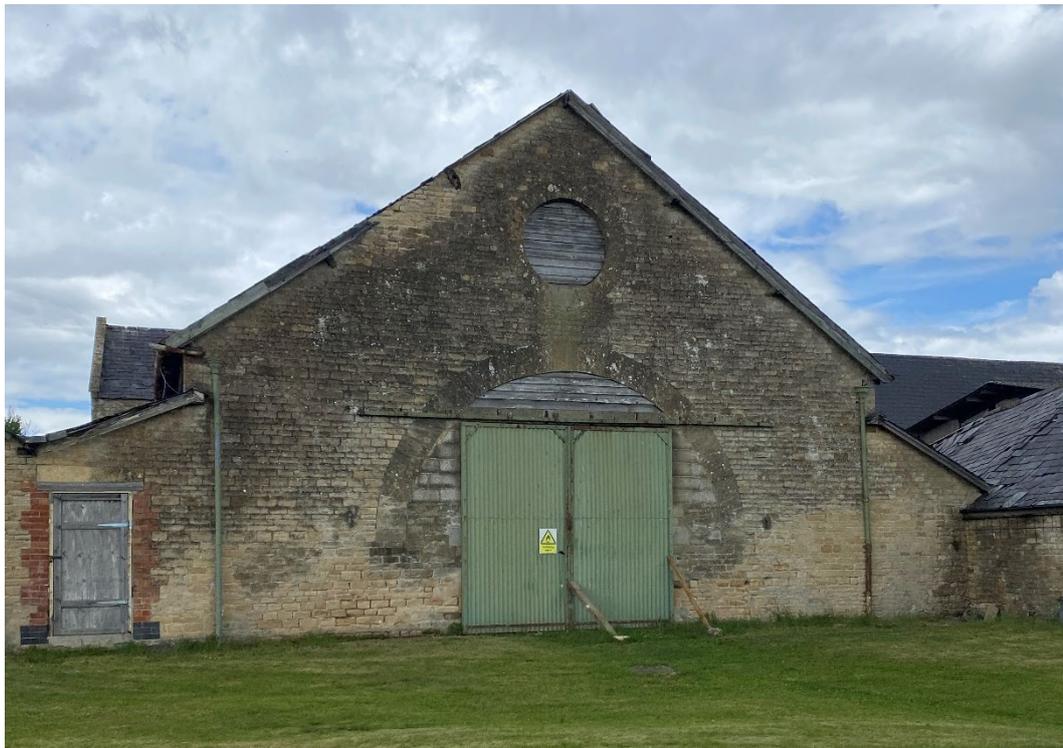
*Figure 30: Building 4, southern façade, infilled arched opening and blocked roundel window. The vertical portions to either side are louvered along the long elevations.*

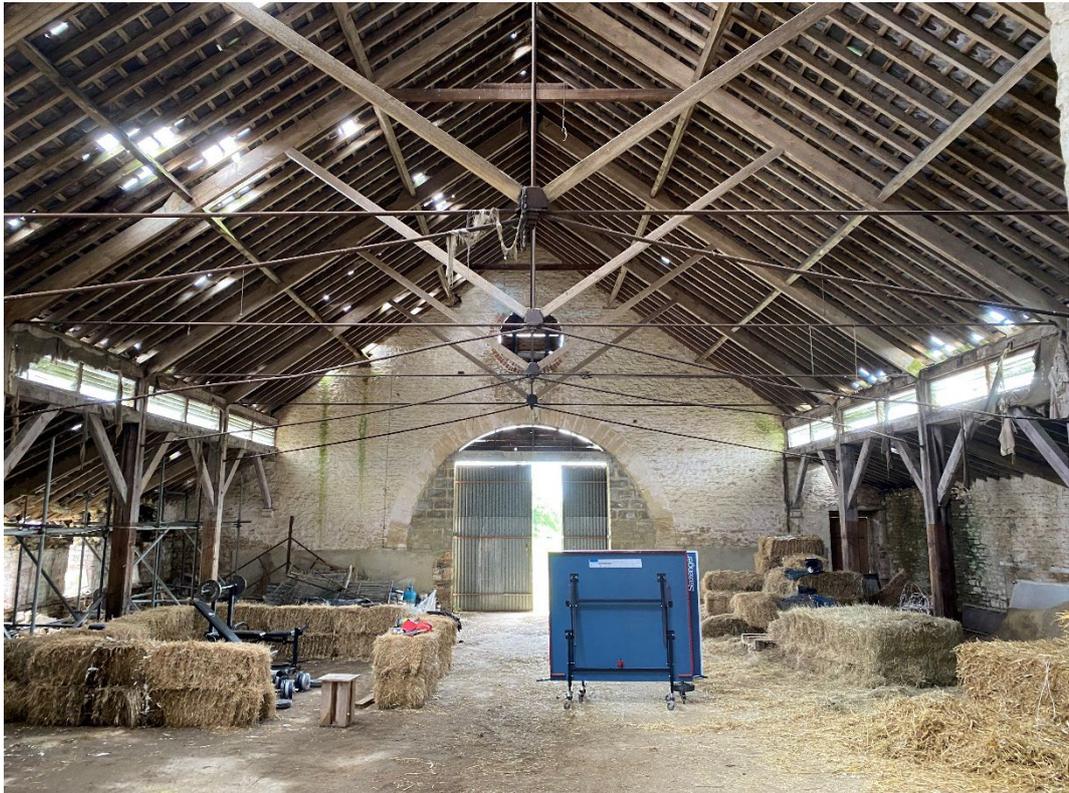
*Figure 31: interior of covered yard looking south with steel tension trusses, the clerestory and posts supporting the peripheral 'aisles'.*

- 3.24** A modern steel structure covering over and infilling a courtyard between older buildings on all sides. Steel posts and truss with corrugated sheet roof over a concrete floor.

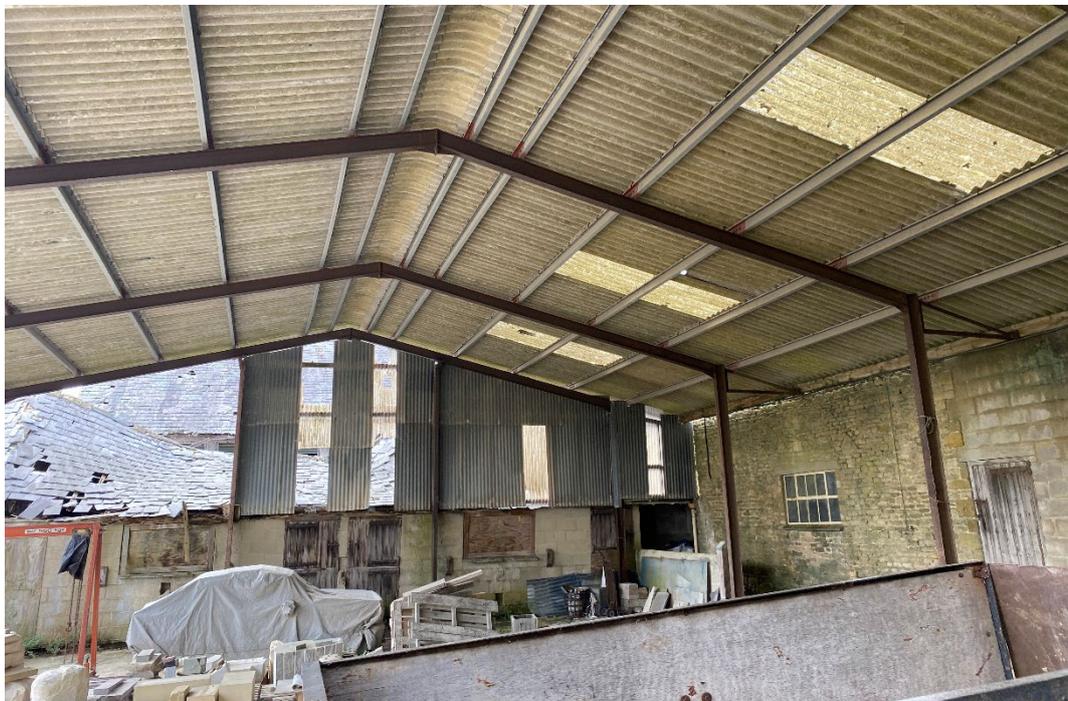
*Figure 32: Interior of Building 5 covering the former yard between Barn 2B on the right and the collapse Building 3 in the centre and left.*

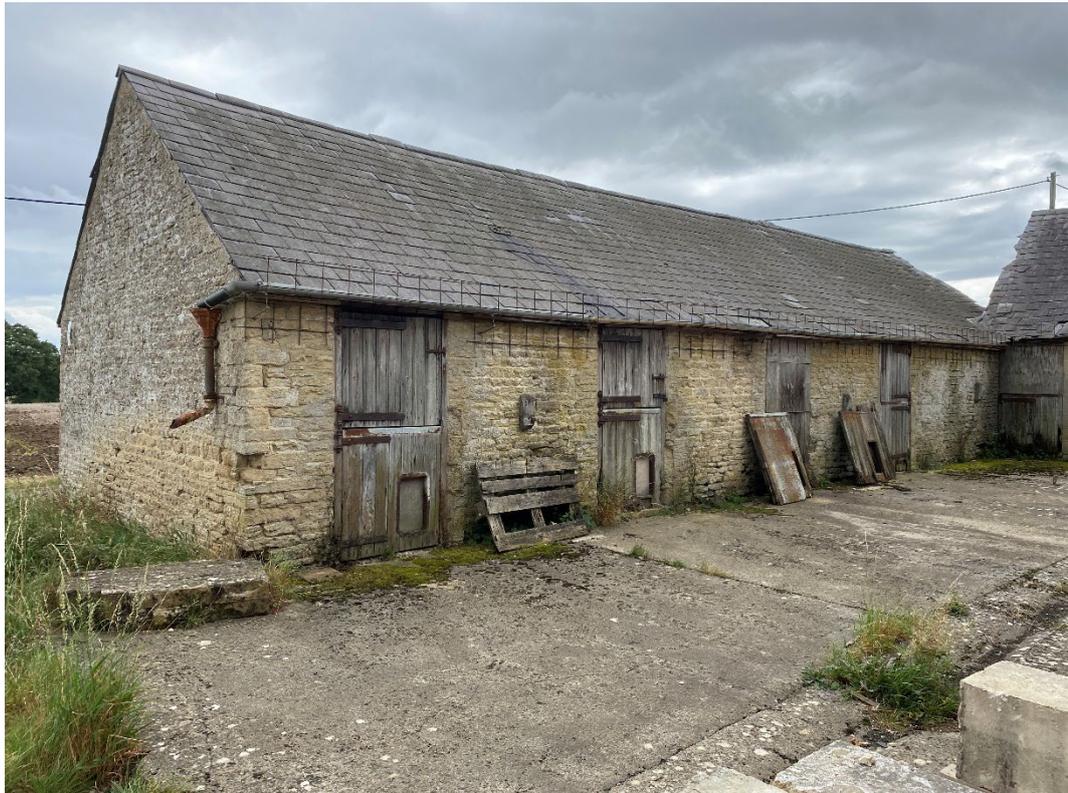
*Figure 33: Barn 6 though on an historic footprint apparently a much later reconstruction.*

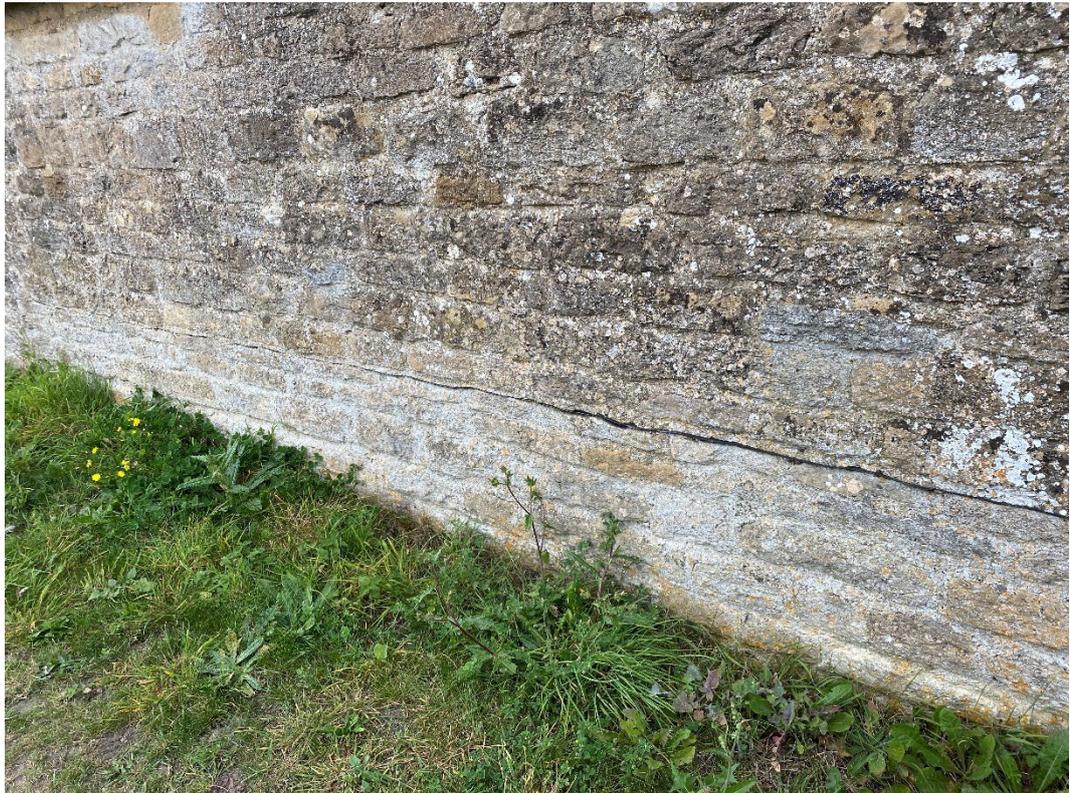
*Figure 34: Rear wall of Building 6 with visible DPC*

**3.26** Internally the structure is divided into low divided cells or stalls, much like the sties seen in Buildings 1B, 2B and 3. The rear wall and internal partitions include areas of concrete blockwork and fletton brick. The roof trusses are relatively light scantling and in two locations are resting over window openings rather than securely onto the main walls.

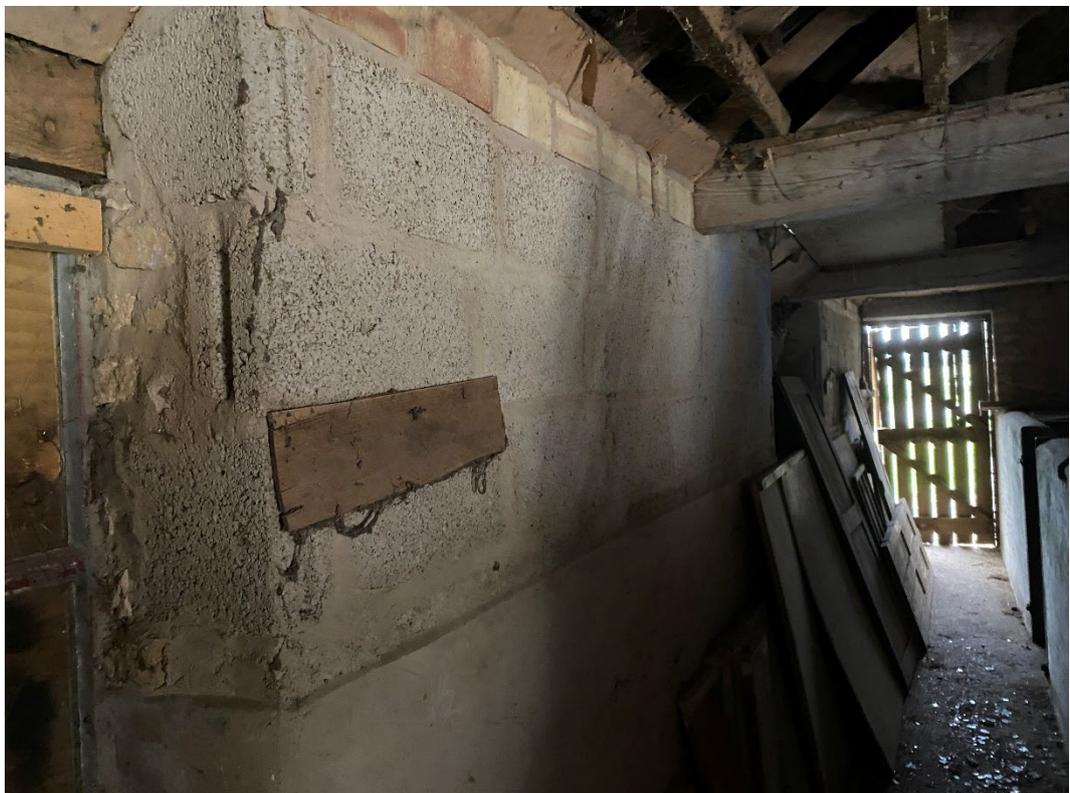
*Figure 35: concrete blockwork internally within Building 6.*

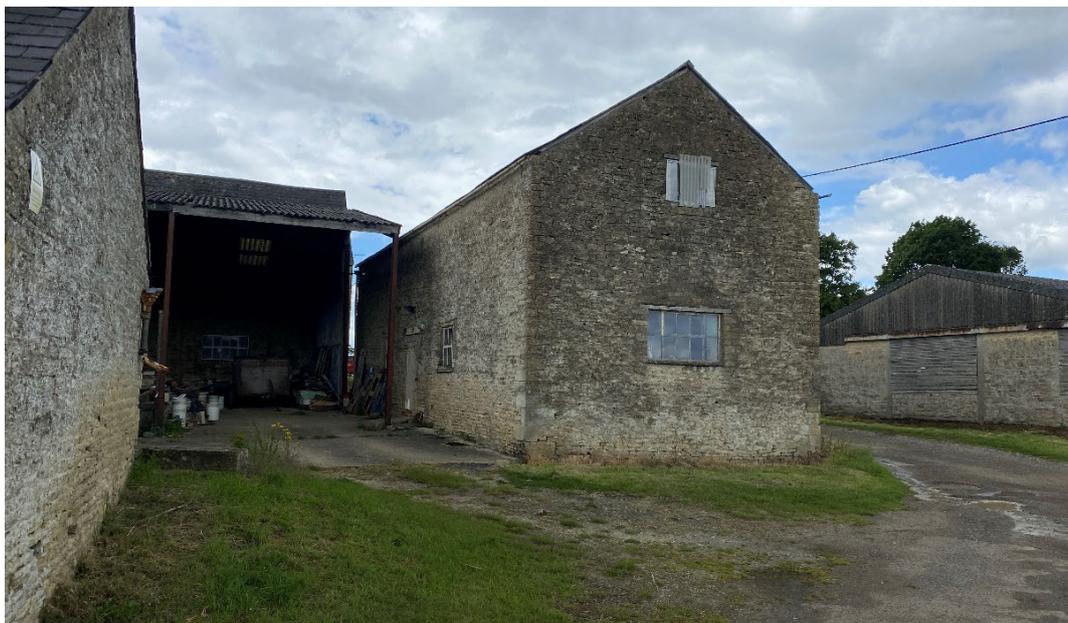
**3.27** A two storey stone built structure with hay loft doors to the north gable. Currently in use as a workshop it was once likely a stable block. The current occupier a stone mason, reported that he had to reinstate the first floor joists to use the upper levels, though the principal joists are remaining historic structure. The roof trusses are king post form as with Building 2A though somewhat lighter weight as are the purlins which are more like planks, the common rafters are also very slender leading up to a ridge plate. No mangers or stall dividers survive in the ground floor area though some areas of brick and stone flooring suggest the former arrangement to a small degree. A hayloft door survives in the northern gable, openings in the southern gable are smaller windows.

*Figure 36: Barn 7 with Barn 8 to the right.*

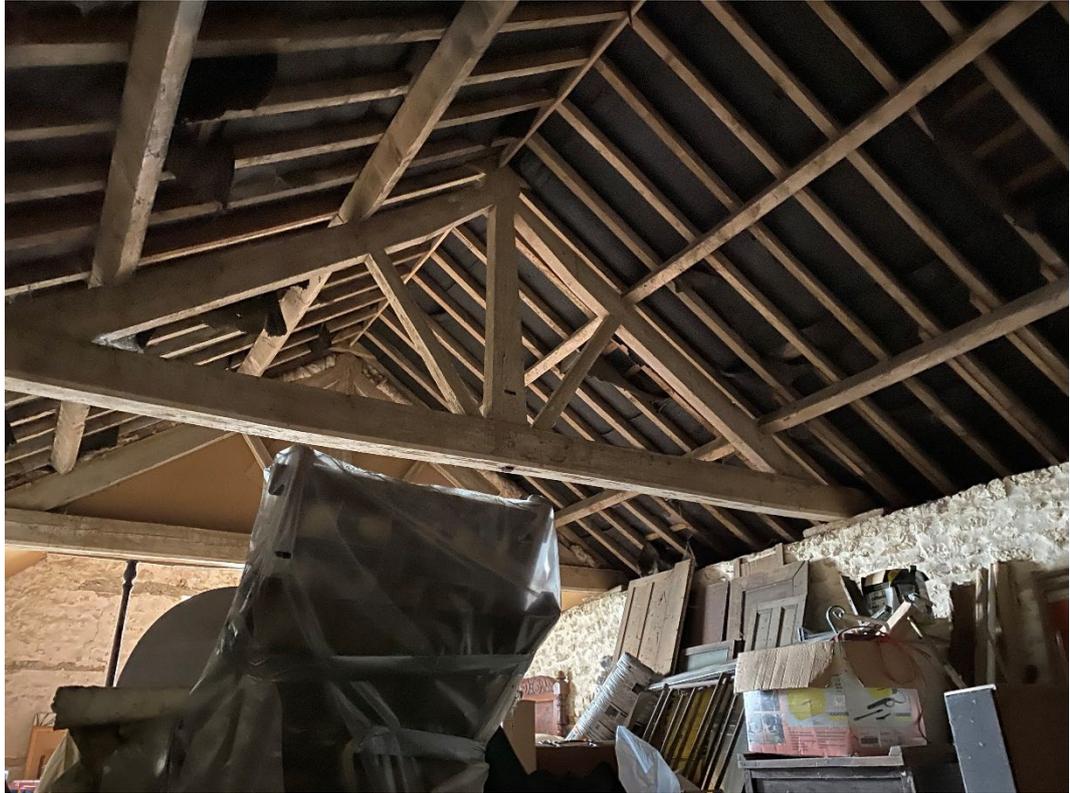
Figure 37: Roof structure in Building 7

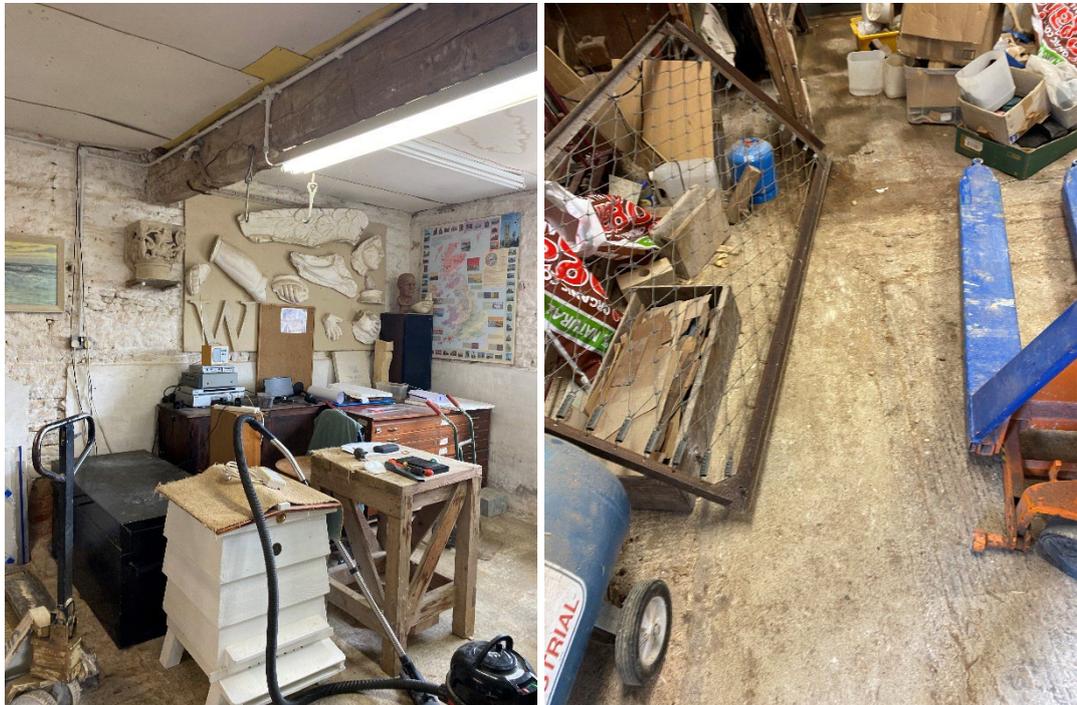
Figures 38-39: The interior of the former stable with the modern ceiling over historic principle joists and fragments of stone flooring with concrete elsewhere.
