# Heritage Statement

Asterleigh Farm  
Barns, Kiddington

October 2023 | Project Ref 7942A

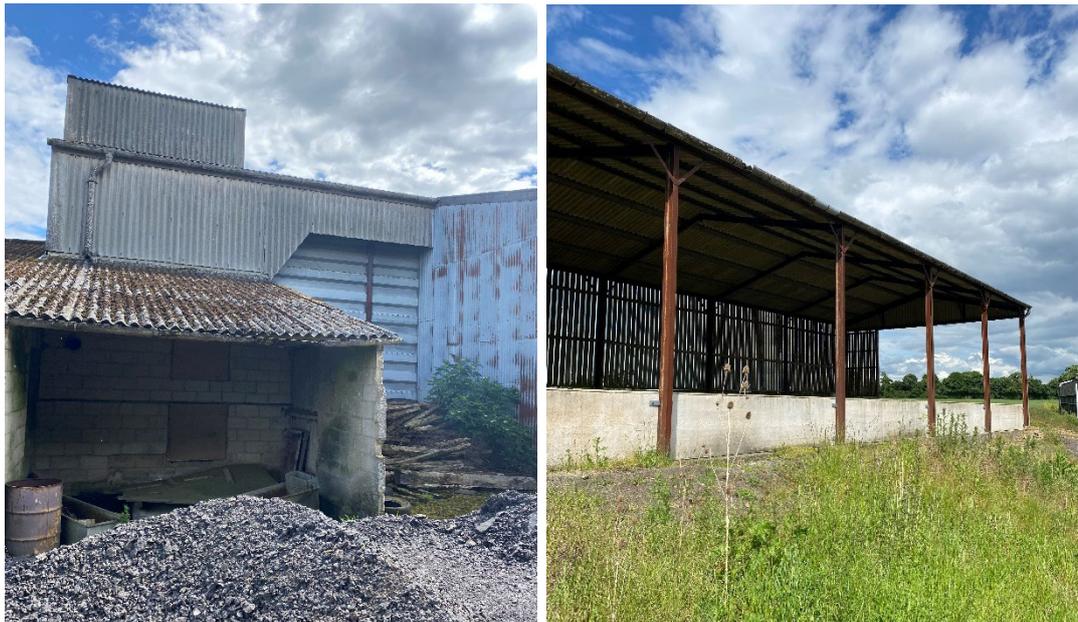
*Figures 40-41: (left) the northern side of Barn10 with (right) Barn 11. None of these structures is of historic interest.*

**3.28** Modern structures constructed from steel beams and posts, concrete, reinforced concrete, prefabricated trusses and corrugated or other sheet cladding material. Barn 11 sits in the approximate location of an earlier linear range shown on early 20<sup>th</sup> century maps but is clearly a more recent structure, an open sided hay store.

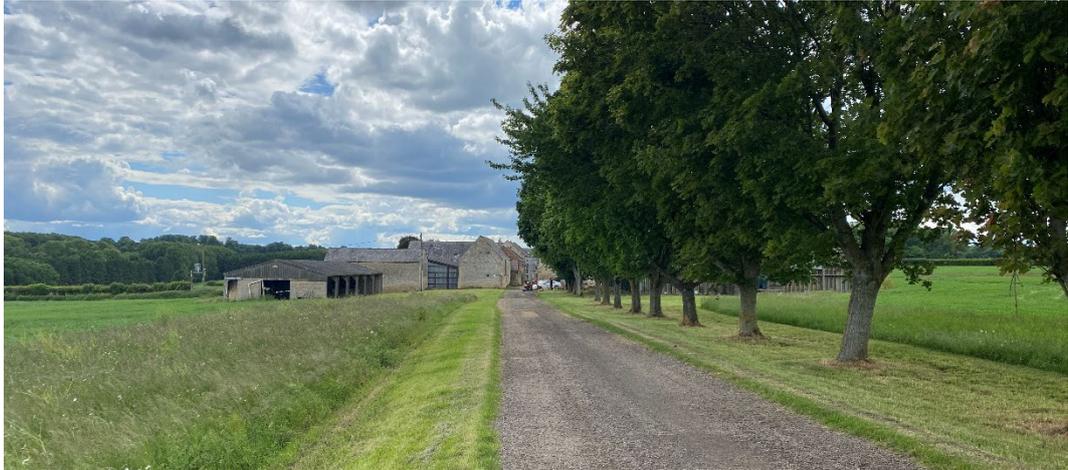
**3.29** The farmstead sits within a relatively open landscape today, with rougher and scrubby overgrowth to the west in the area of the scheduled monument. The farmhouse is furthest away from the approaching drive and the listed building is screened from view until the farm buildings have all been passed. Today there are two approaches, one taking the historic route south of the farm buildings, and a later drive between the historic and more recent buildings running straight on from the drive way. There is no evidence of any historic surfacing within the yard areas, and only fragmentary areas within some of the buildings. Small areas of brick surface remain in Buildings 1, 2A and 7, elsewhere is almost exclusively concrete.

*Figure 42: The approach to Asterleigh Farm from the east. The modern barn (Building 8) to the southeast is most prominent and the farmhouse is not visible at all.*

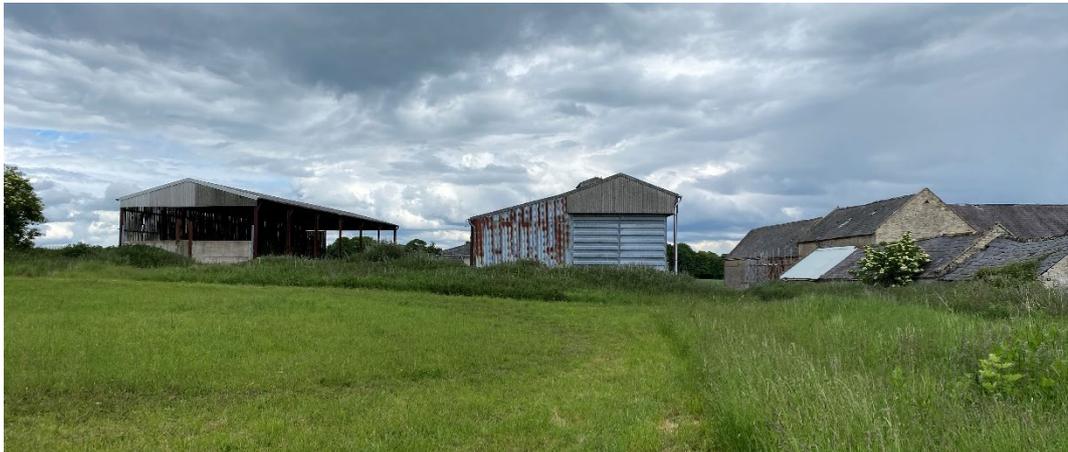
*Figure 43: The farm group from the west and the edge of the scheduled monument, the slightly higher ground on the northern side elevates the prominence of the later 20<sup>th</sup> century structures which dominate the older ranges.*

- 4.15** The even later structures added to the farm in the second half of the 20<sup>th</sup> century are of no innate architectural interest and limited historic interest in relation to the setting of the listed building. Though they show the ongoing use of the farm, they illustrate modern practices not the agricultural practices associated and contemporary with the farmhouse. They are all larger than the historic buildings, in terms of footprint, they are constructed of standardised elements and mass produced materials and cladding. Those buildings to the north of the historic farmyard are also on slightly higher ground and are somewhat visually dominant, particularly from the north and west.

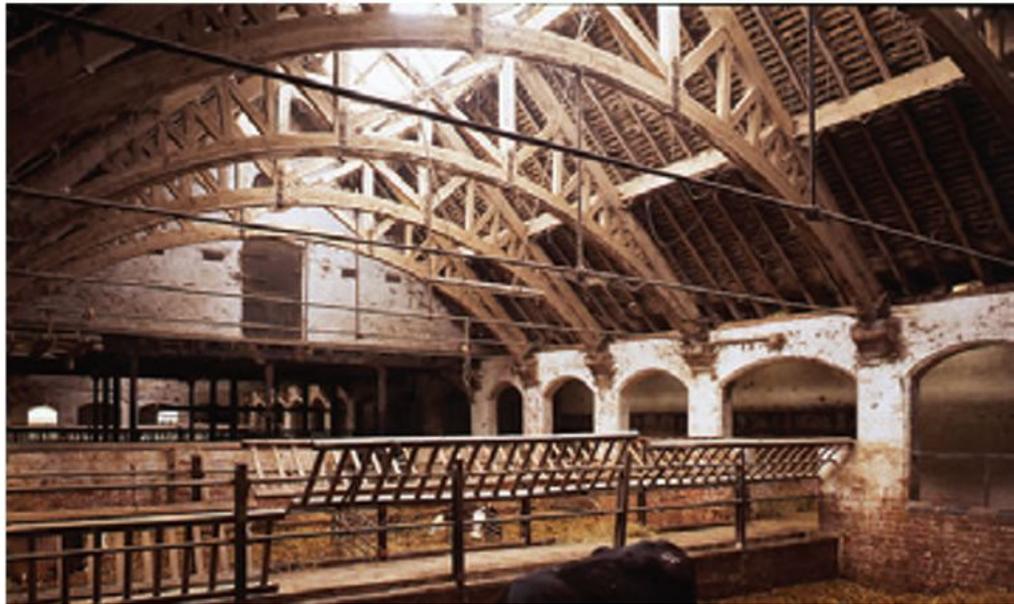
1156480), a second was constructed bespoke as part of the model home farm at the Shirburn Estate, south Oxfordshire (list entry: 1368850) . The Yard was constructed in 1856-7. Though a detailed analysis has not been carried out those entries consulted are overwhelmingly of the middle years of the 19th century and part of a planned farmstead of that era, rather than a later adaptation.

*Figure 44: An example of a listed covered yard, Grade II\* listed covered yard, mid-19<sup>th</sup> century Apley Park, Shropshire (Historic England © Mike Williams) included in Historic England's summary of National Farm Building Types, 2013*
