# Bradford College Future Technologies Centre (FTC)

Bat Survey Report

2484981

AUGUST 2023

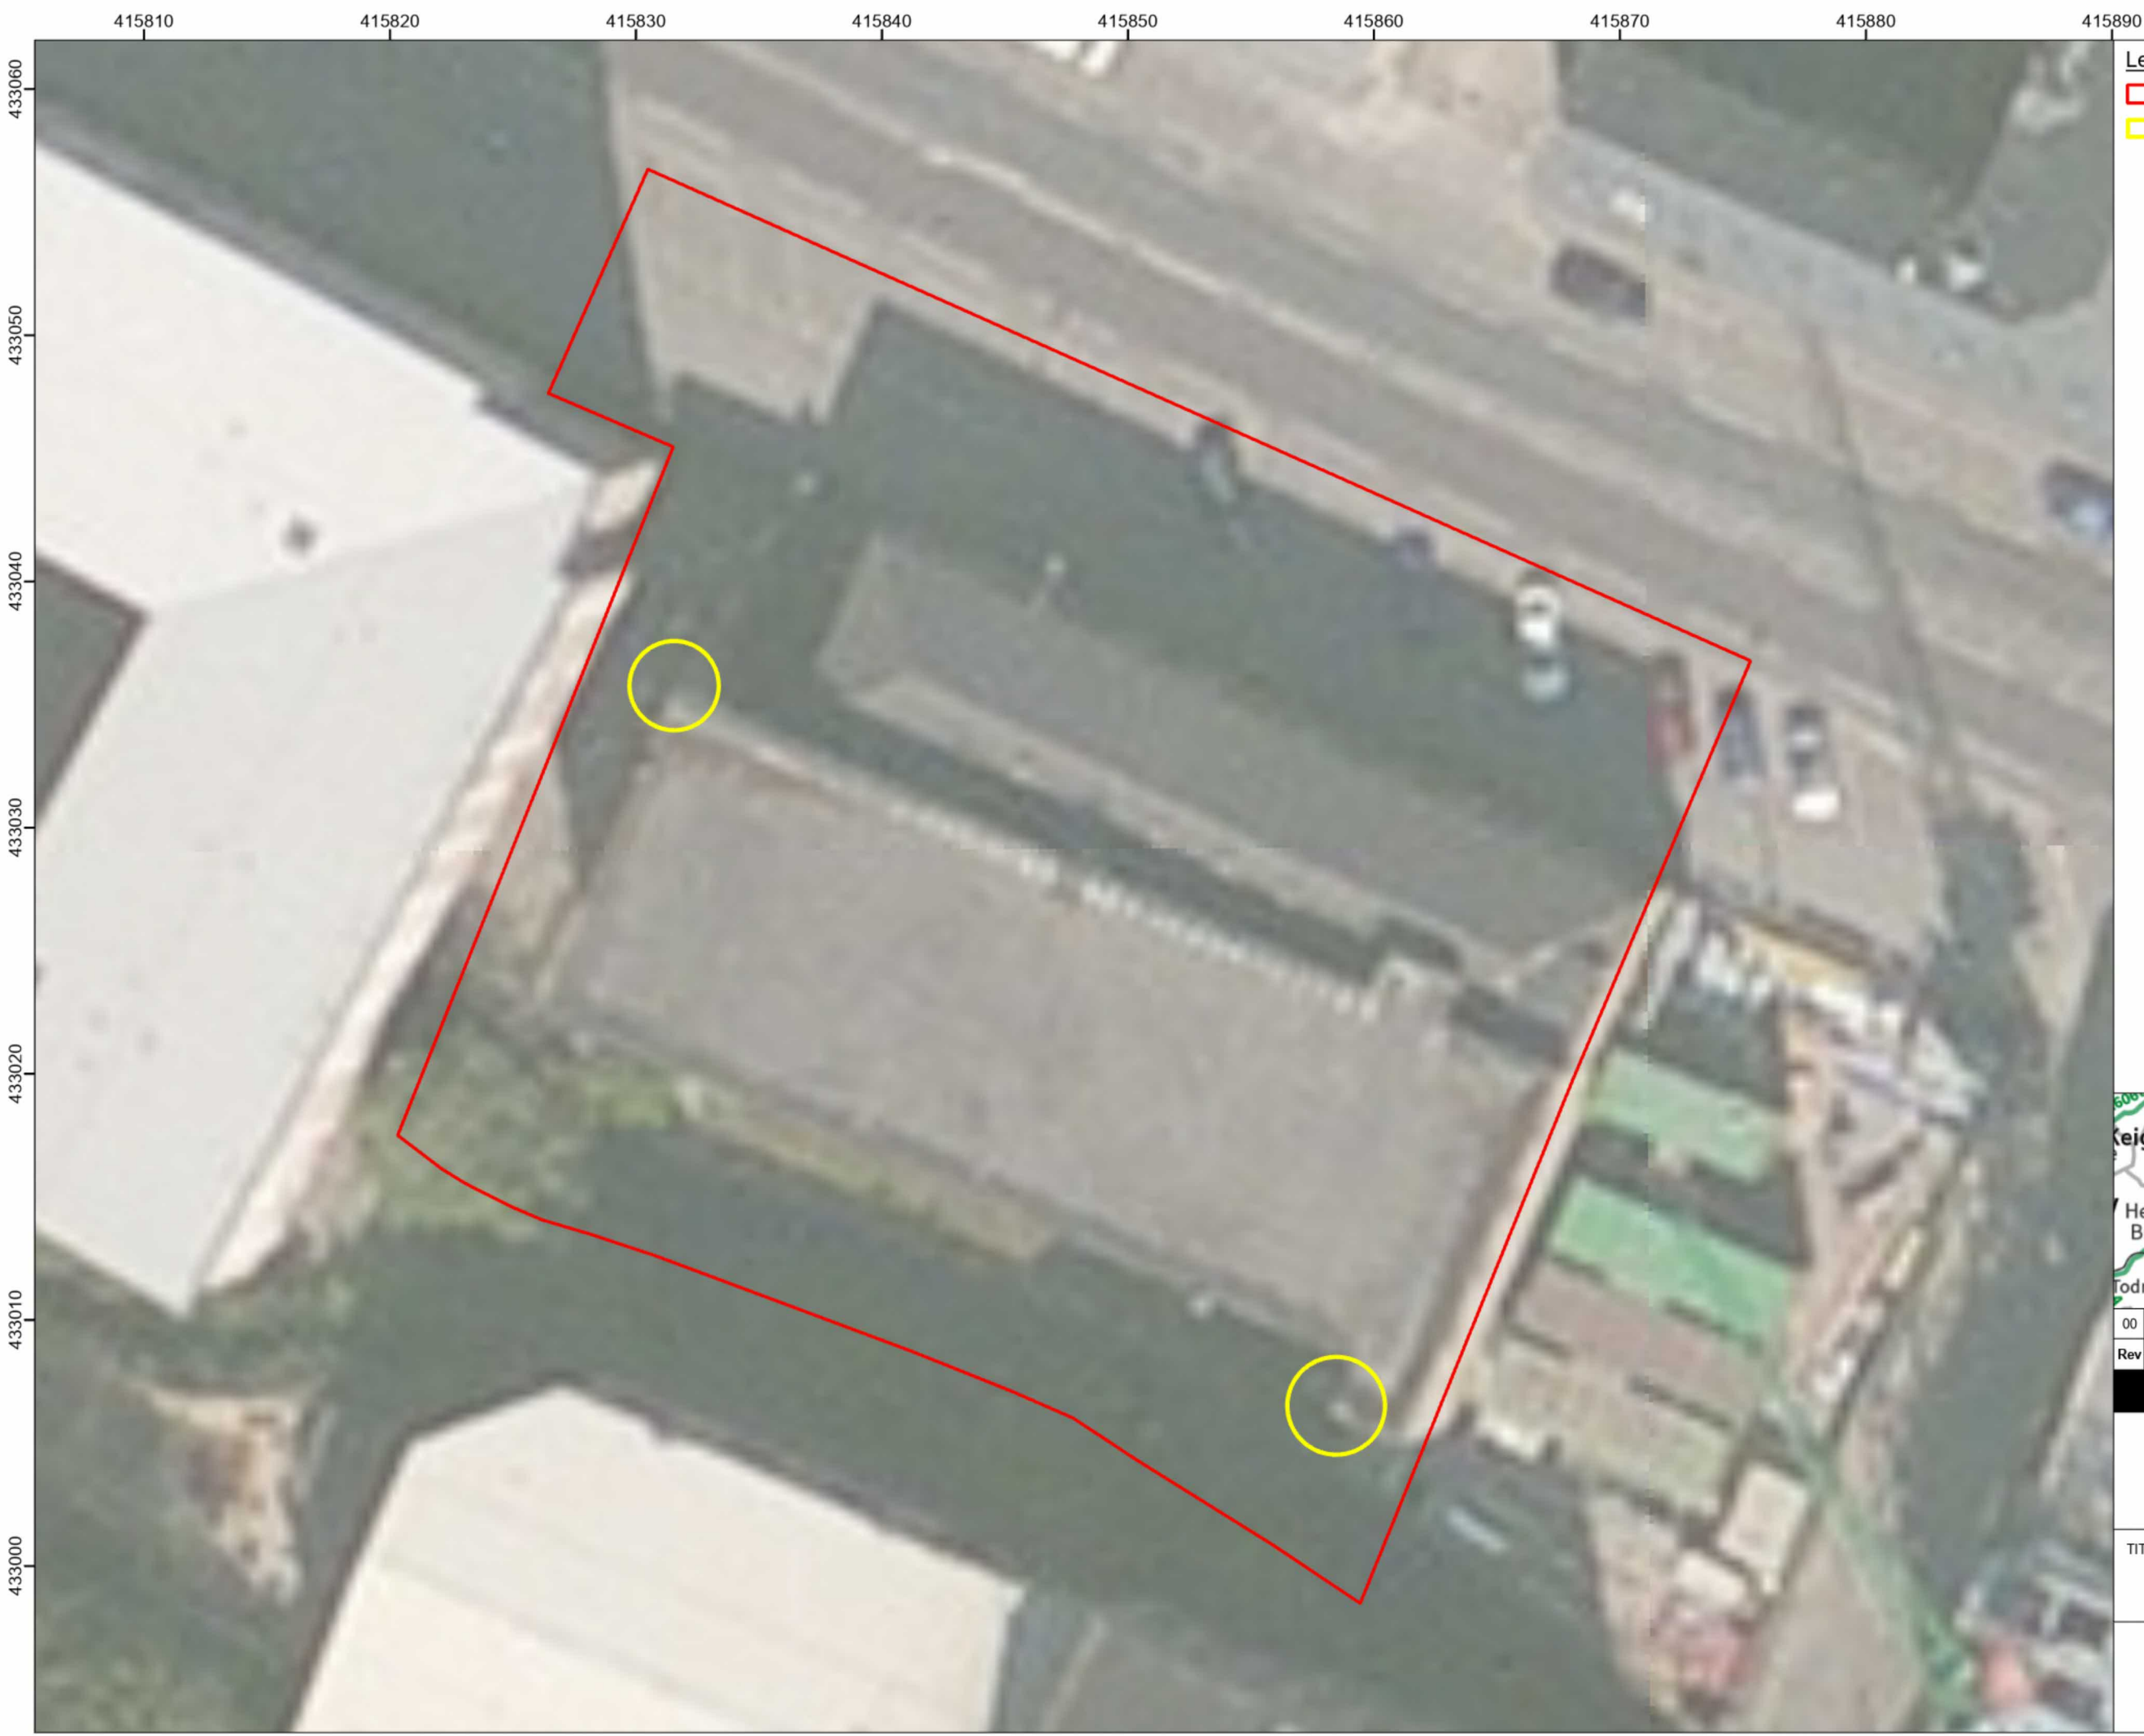
TITLE: Figure 1:  
Confirmed Bat Roost Locations  
- Junction Mills

- 4.1.4 During the surveys, two separate roost locations were identified on the Junction Mills building, both beneath wooden fascia boards at roof level, one on the western aspect and the other on the southern aspect. Up to three common pipistrelles were observed emerging from the roost situated on the western aspect, and a single common pipistrelle was observed returning to the roost situated on the southern aspect.

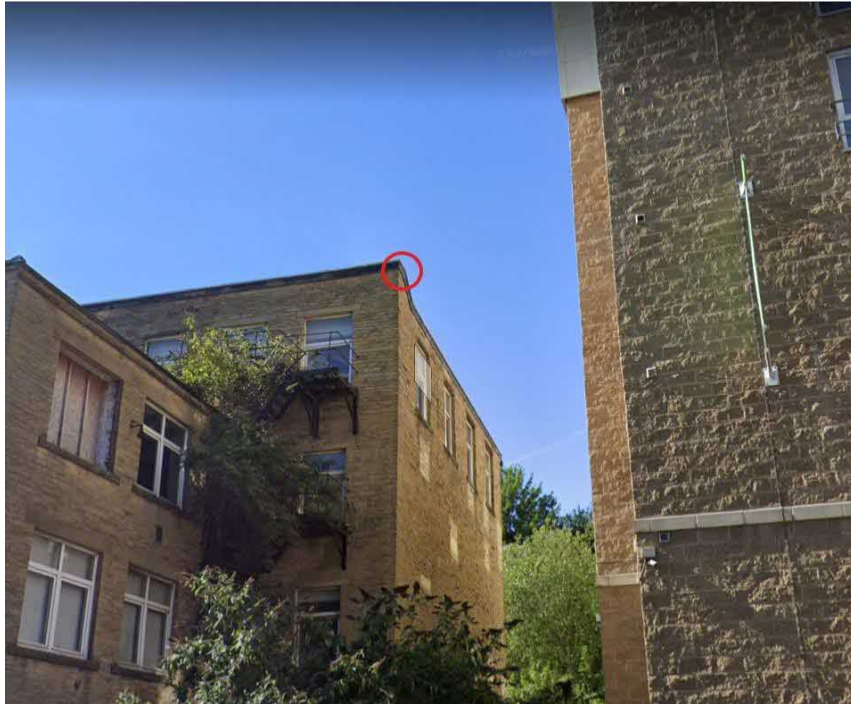
- 3.1.3 An emergence of up to three common pipistrelle (*Pipistrellus pipistrellus*) was recorded from beneath the wooden fascia on the western aspect of the Junction Mills building during the first survey. The location of the roost entrance is shown in (Appendix B, Plate 1 and Figure 1). The first bat emerged, circling several times immediately outside the roost before re-entering in the same place underneath the fascia. This emergence was followed by at least two others, including the likely re-emergence of the same bat, however as discussed in the limitations, changes in lighting because of passing traffic made it difficult to keep track of the flight paths of individual bats in the vicinity of the emergence site.

Plate 1: Roost location on western aspect of the Junction Mills building

Sensitive areas of Junction Mills, such as end roof tiles and wooden fascia boards, are to be removed by hand, under the direct supervision of a licensed bat ecologist. If a bat is discovered during the works, the bat will be captured by hand by the supervising ecologist and transported to the bat box. If the bat is harmed or emaciated, it will be taken to the nearest animal hospital or bat carer if deemed necessary by the onsite ecologist.

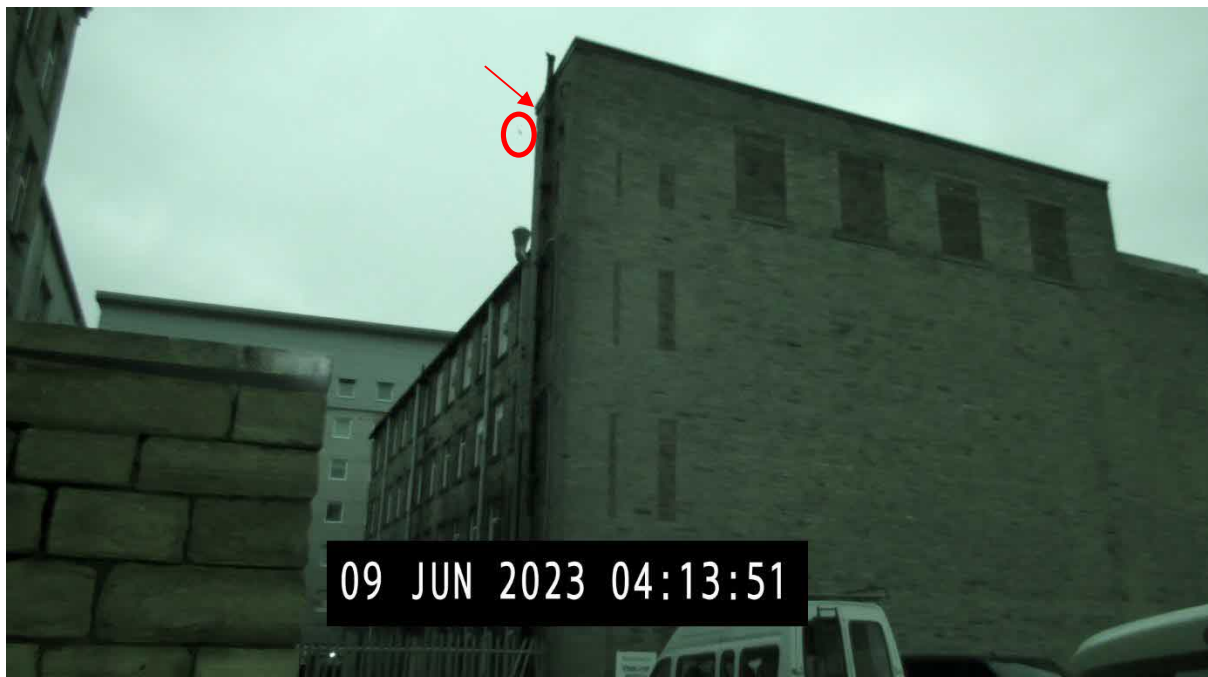
- 3.1.4 A single common pipistrelle bat was observed returning to a roost site beneath a wooden fascia on the southern aspect of the Junction Mills building during the dawn re-entry survey on 9 June 2023. This single bat was observed circling the roost for 1-2 minutes prior to re-entry, briefly landing on the wall and taking off again several times before finally settling on the building beneath the fascia, after which it was not seen in flight again. The roost location is shown in the IR camera screen capture in (Appendix B, Plate 2 and Figure 1).

Plate 2: Roost location on southern aspect of the Junction Mills building showing returning bat during dawn re-entry survey on 9 June 2023
