~line of previous kitchen extension (damaged in fire, and since removed)
Rear elevation - south east

Rev Scale: 1:50 @ A3

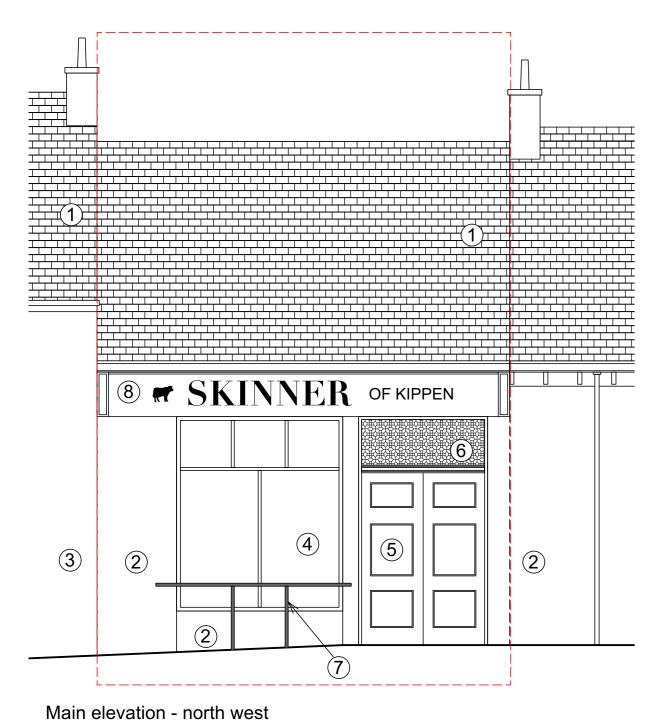
- 1 natural slate tiles
- 2 red sandstone
- 3 white render
- 4 display window
- 5 timber storm doors
- 6 ornamental vent panel
- 7 steel railings
- 8 business signage
- 9 security bars
