7, BRIARS RYN
PILLATON
SALTASH
PL12 6RA

ECOLOGICAL
ASSESSMENT

Description	Ecological Assessment
Produced for	Mr & Mrs Dolley
Issue	1
Report Reference	7, Briars Ryn, Pillaton
Date of Survey Work	7 August 2023
Date of report	21 August 2023
Author	M Pearmain
Checked & reviewed by	C Carter BSc (Hons) MCIEEM Principal Ecologist
Report validity period	12 months from date of survey

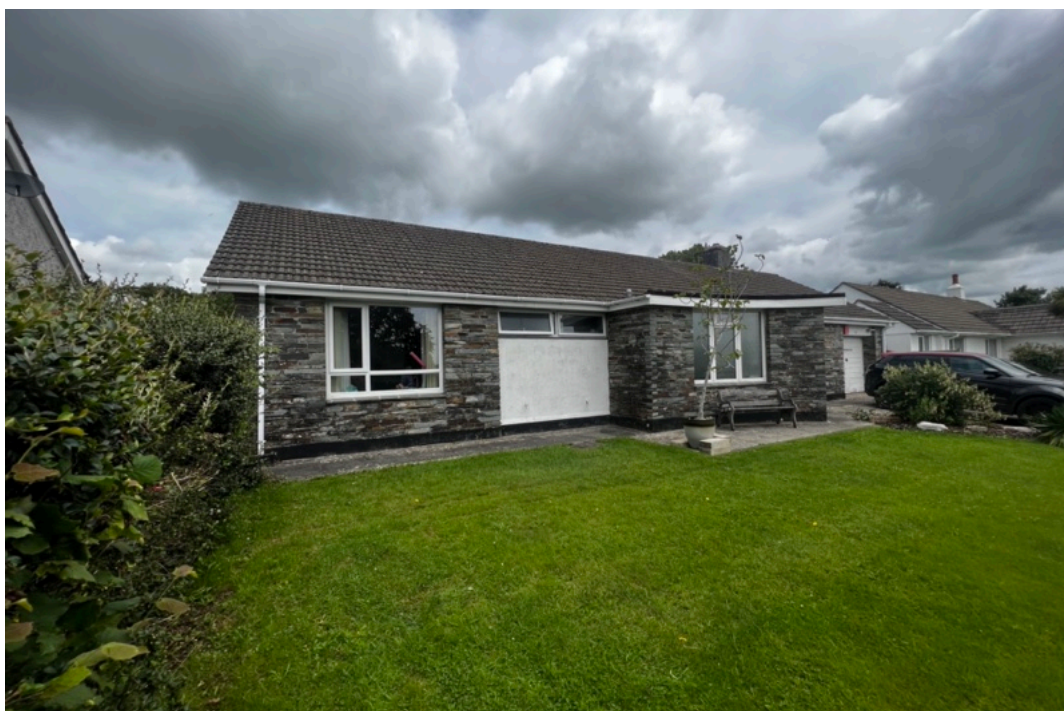
Plate 2. Front southern elevation

19. The building (Plate 2) is a detached, stone and concrete block bungalow under an interlocking cement tiled roof. To the rear, northern elevation (Plate 3) is a double storey extension under flat and mono pitched rooves.

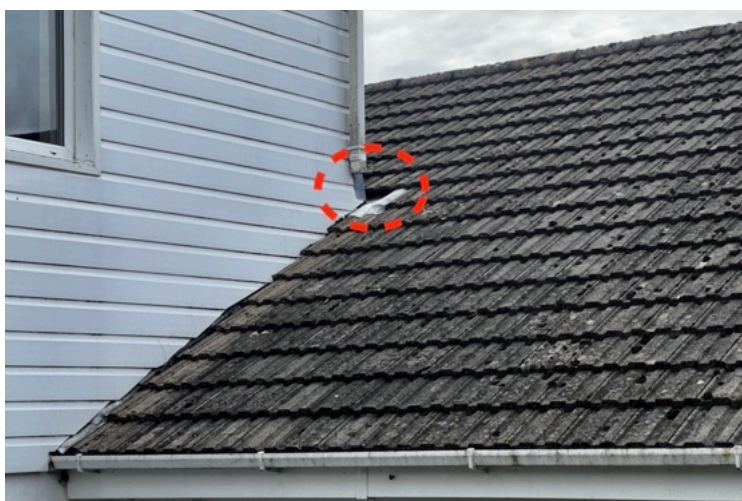
Plate 4. Gaps to tiles close to extension

20. Externally, the walls were well rendered/pointed with tight fitting uPVC fascia and gable end boards. The roof tiles were mainly tight fitting but some small gaps were noted under chimney flashing, occasional lifted roof tiles and around a soil pipe (Plates 4, 5) potentially large enough for bats to access.

29. The dwelling was assessed as having high suitability for roosting bats. There were gaps under roof tiles and lead work that might allow potential bat access internally, either into the attic void below or to small voids between tiles and the inner lining which might be used by crevice roosting bats. Bat droppings found inside the attic, although not fresh, were still intact and in good condition without significant decay. However, bat droppings within attic spaces can remain very well preserved in suitable conditions so it is difficult to confirm age but these were thought likely to be in excess of 12 months old with potential to be much older. The droppings were considered characteristic of *Plecotus* species of bat. The number and distribution of the droppings are not considered strongly indicative of this being a significant or an active roost site for a large number of bats or that the attic has been used over an extended period of years. It may have only formed an occasional roost site for one or two bats over a very short period.

32. It is recommended three bat emergence surveys are undertaken between May and August/September, in accordance with survey practice.

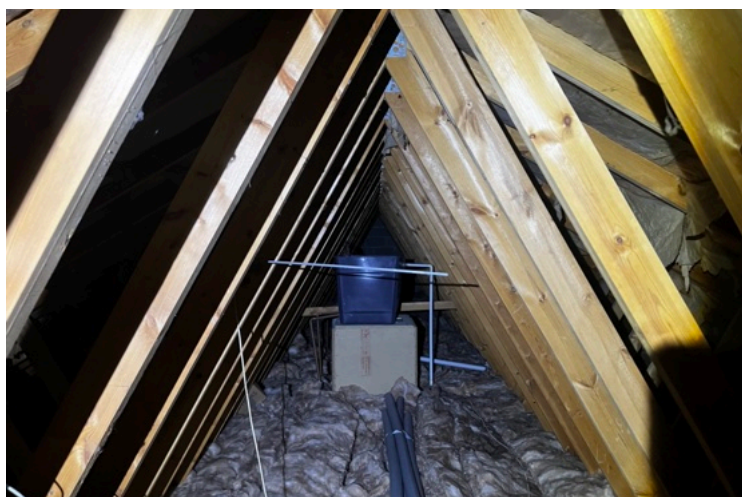
Plate 6. Internal view of attic

21. Internally (Plate 6) the attic was insulated to the floor with mineral wool and the underside of the roof tiles lined with a combination of breathable membrane, bitumastic felt, mineral wool and paper which was torn in places (Plate 7). A search of the attic found two areas of bat droppings (Plates 8 ,9) with approximately 12 droppings to each location (locations shown in Plate 10). One beneath a torn section of roof liner to the centre section of the attic, the other adjacent to the western gable end. The droppings were not considered to be fresh but thought to be +/- 12 months old but all were of a similar age and characteristic of possible

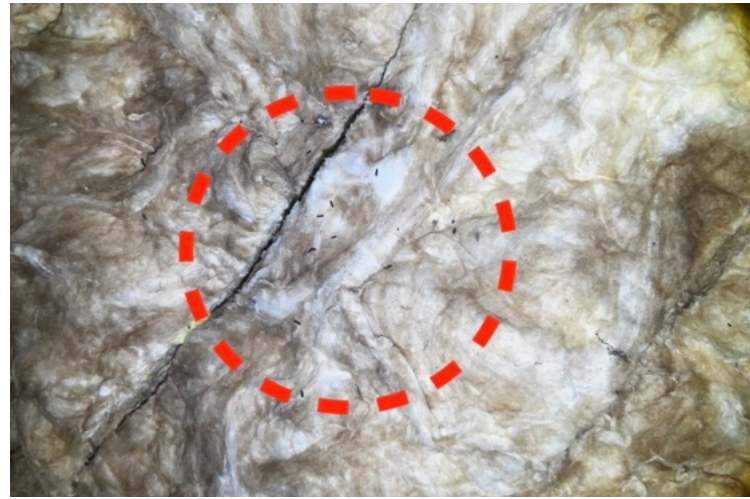
Plate 8. Bat droppings beneath torn section of roof liner

Plecotus species of bat. A further dozen droppings were noted widely scattered across the attic.
