Ampney Park

Preliminary Bat Roost Assessment and Survey

April 2021

Client: Simon Morray-Jones
Architects Ltd
Report Ref: SEB2429_01
Author:
Kate Hayward MCIEEM
www.seasonsecology.co.uk

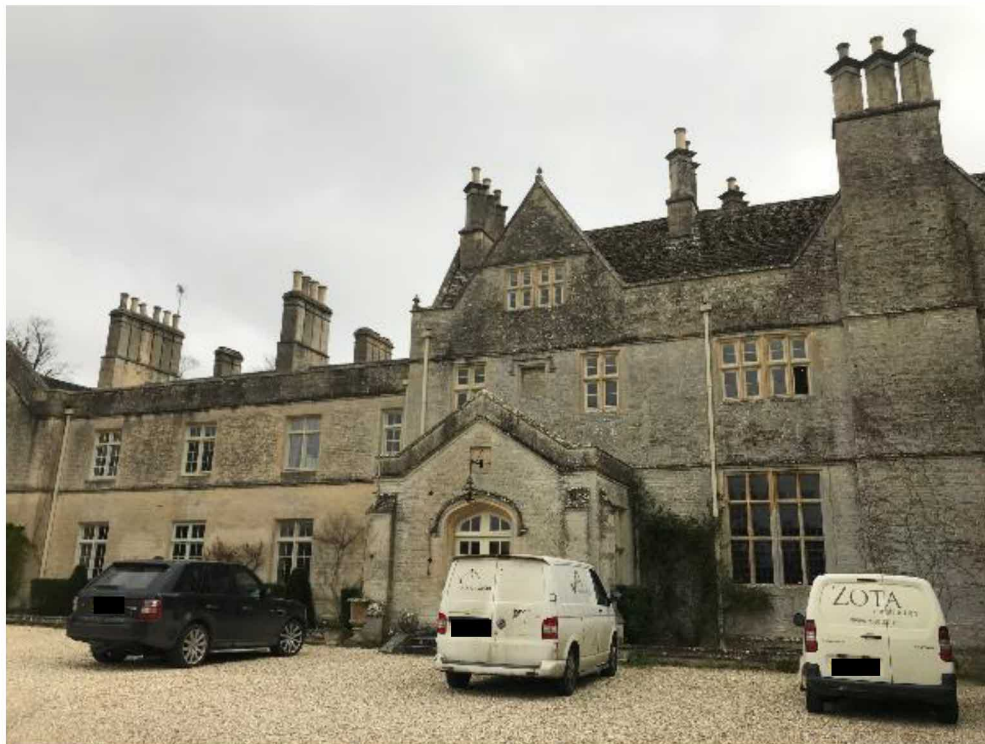
- 4.2.2 The Main House is a large period property, constructed of Cotswold stone with slate and stone-tiled gabled roofs and multiple chimneys (refer to Photographs 1 and 2, Annex 4). There is a North Wing and a South Wing. The two-storey North Wing has an M-shaped, slate-tiled roof. The three-storey South Wing has a gabled, stone-tiled roof with a slate-tiled roof to the two-storey element attached to the east (rear) elevation. There are single-storey sections attached to the north elevation (North Wing) and east elevation (South Wing), all constructed of Cotswold stone with slate-tiled roofs with shallow pitches.

- 4.2.4 The slate tiles on the North Wing roofs have few gaps evident and there are few gaps in stonework evident on the external walls. The north aspect of the North Wing has several gaps in coping stones and stonework near the roofline.

- 4.2.5 The stone tiles on the South Wing roof feature several gaps beneath and there are a number of gaps in the stonework on the external walls, mainly on the east and west aspects.

Photograph 1. The front (west) aspect of the Main House, showing the two-storey North Wing and three-storey South Wing.

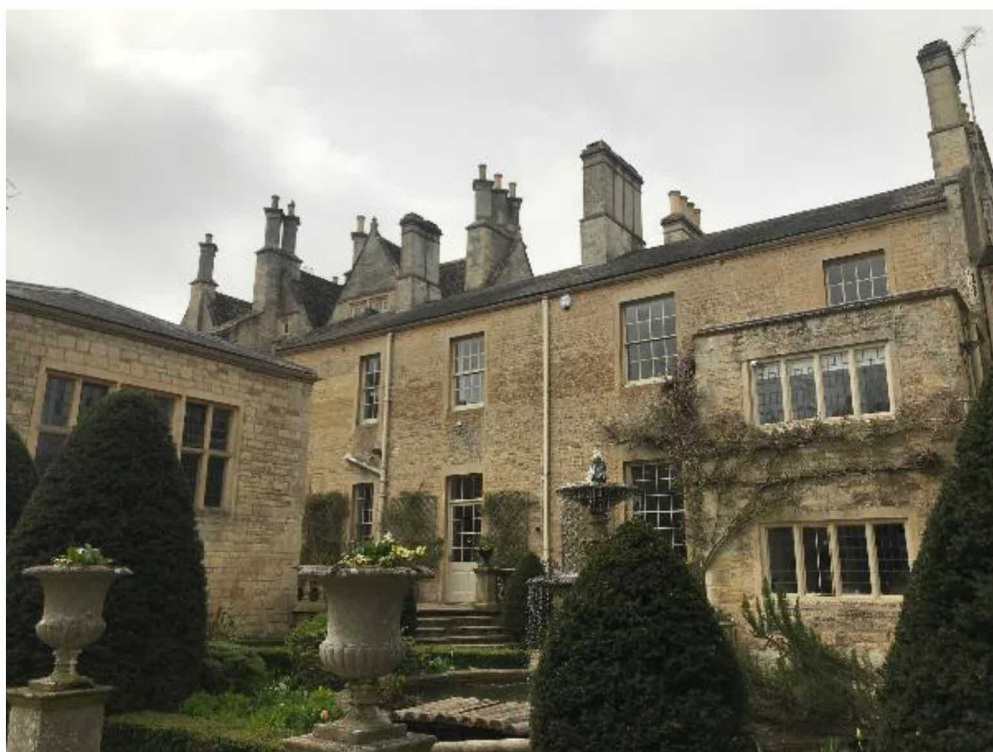
Photograph 2. The rear (east) aspect of the Main House.

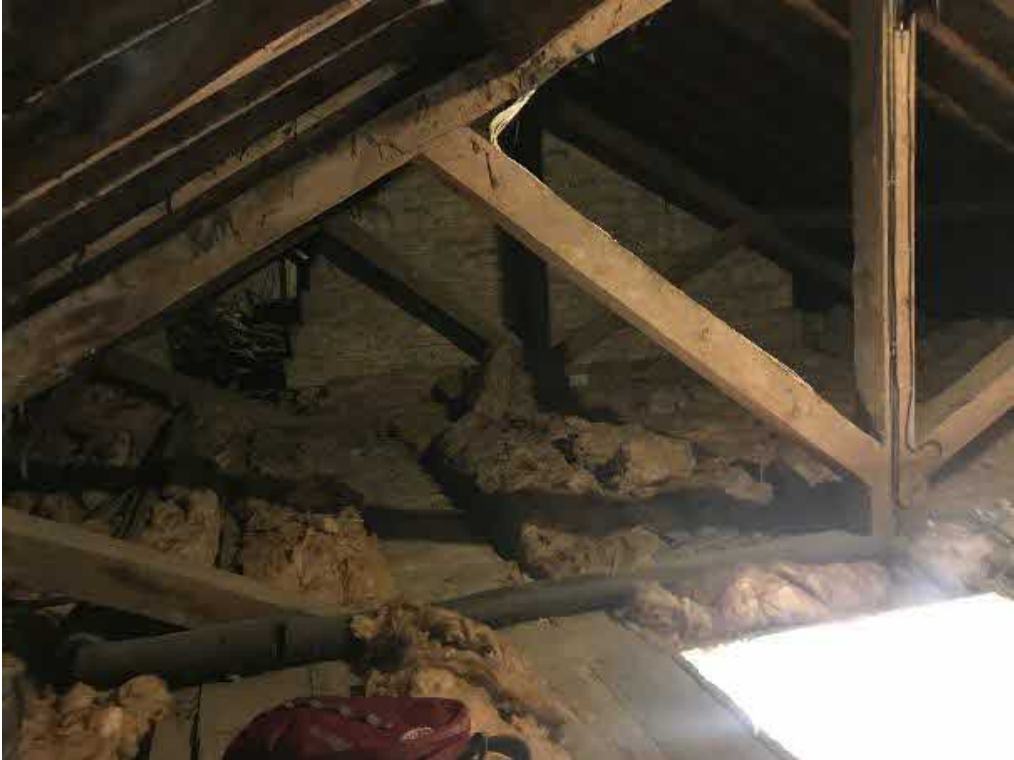
- 4.2.10 Roof space 4 is accessed off the first floor of the North Wing and is located beneath the M-shaped, slate-tiled roof and occupies both sides of the valley. Only the eastern half of the roof space was accessed, to the east of the valley, due to the small gap between the two spaces. This eastern half of the roof space is approximately 2.5m high to the apex, 6m in width and 15m in length. There is a door at the southern end, which opens out onto the lead valley roof. Evidence of bats was found in the form of bat droppings, located in four distinct piles near to the chimneys, as well as scattered bat droppings throughout, numbering several hundred (refer to Photograph 3, Annex 4).

Roof Space 4, North Wing – Lesser horseshoe and common pipistrelle

Photograph 3. Part of Roof Space 4 of the Main House (North Wing). Confirmed lesser horseshoe and common pipistrelle roosts.

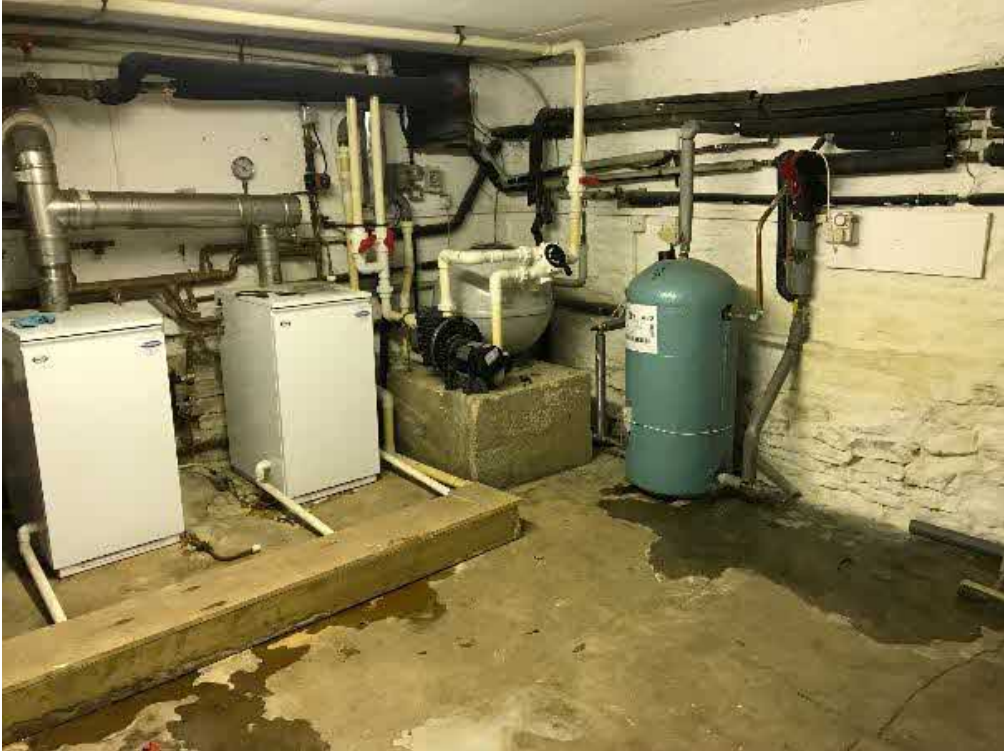
- 4.2.12 The plant room contains the heating system for the Main House (refer to Photograph 4, Annex 4). It has a warm and stable environment but is heavily disturbed from noise and vibration from machinery. It is well-lit from one window opening onto the stairwell. No evidence of bats was found in the plant room.

Photograph 4. View of the Main House Cellar, Plant Room.

- 5.1.9 Occasional access to the plant room in the cellar is required for maintenance purposes. It is recommended that the door between the plant room and the rest of the cellar is blocked off to prevent access to areas where lesser horseshoe bat is roosting.

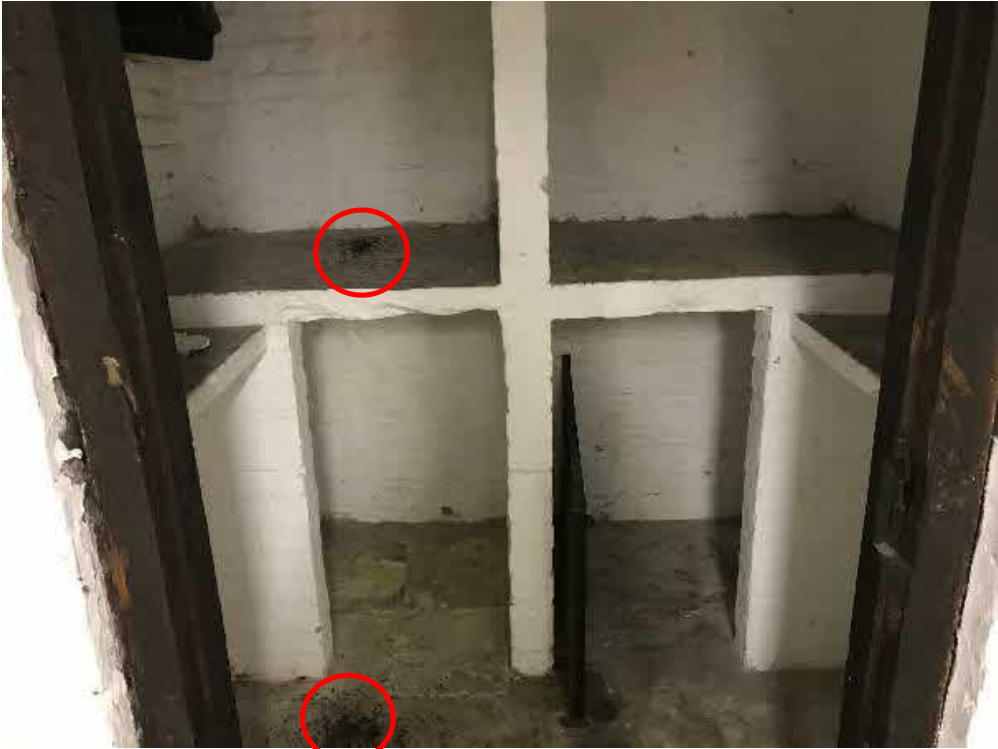
- 4.2.14 Seven distinct piles of bat droppings were identified within the cellar rooms (shown on the cellar plan at Annex 3 and Photograph 5, Annex 4). Bat droppings were also found beneath the stairs leading down to the cellar (Photograph 6, Annex 4). The piles of droppings number between approximately 30 and 100. No bats were present in the cellar at the time of the survey.

Cellar – Lesser horseshoe

Photograph 5. Main House Cellar showing concentrations of lesser horseshoe bat droppings (circled).

- 5.1.4 Upgrading of the heating system throughout the Main House, with the plant room located in the cellar, will impact on the lesser horseshoe roost recorded in the cellar and under the stairs leading down to the cellar, through disturbance during the works. Removal of asbestos cladding around some of the heating pipes leading through the cellar will also disturb roosting bats.

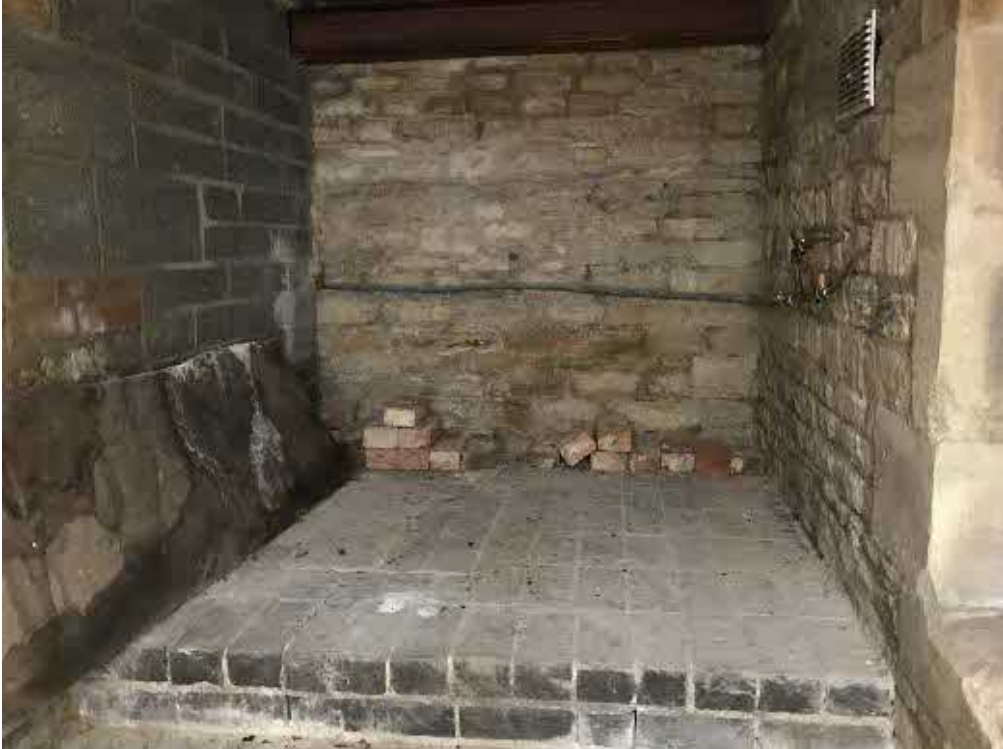
Photograph 6. Area below the Cellar stairs with lesser horseshoe droppings.

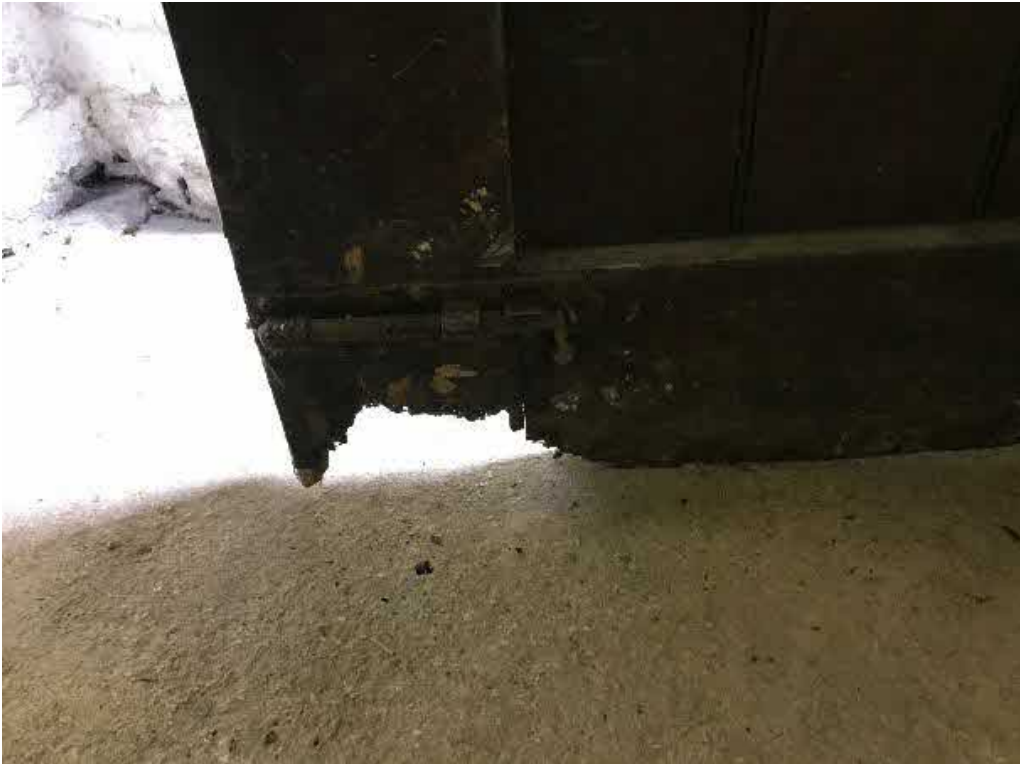
Photograph 7. Probable access point for lesser horseshoe at base of the Cellar door.

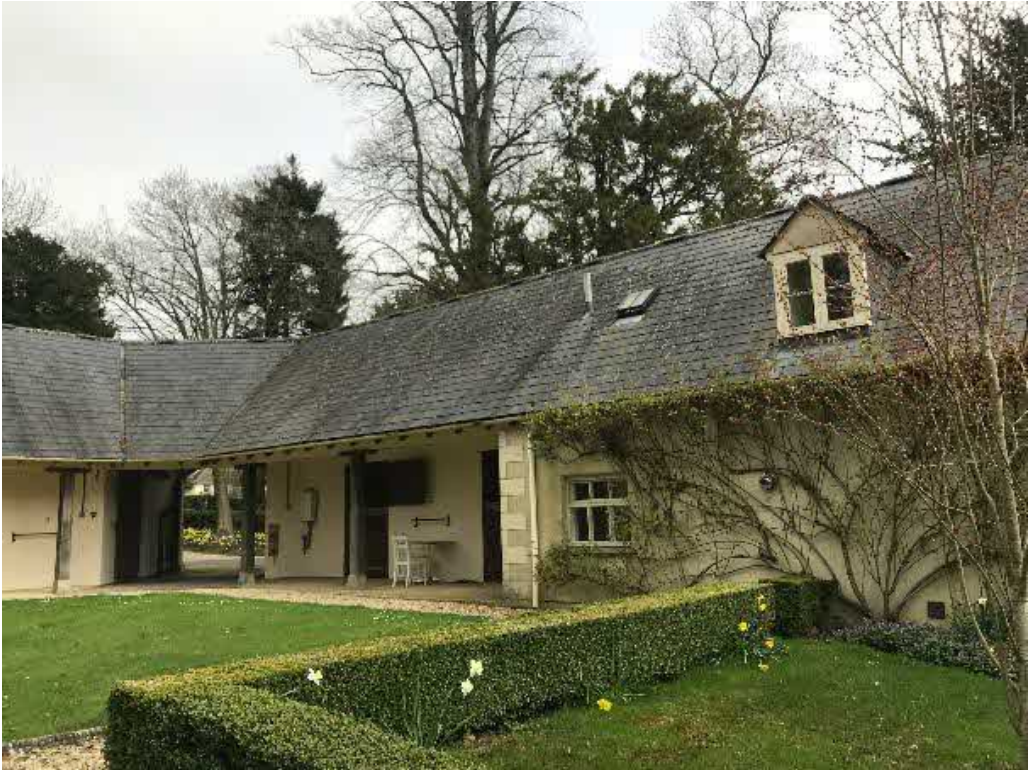
- 4.2.16 The Stables and Grooms Flat is an L-shaped building, with rendered external stone walls and a pitched slate-tiled roof. The Grooms Flat is at the southern end and has a dormer window and a roof light on the west aspect of the roof and two dormer windows on the east aspect of the roof. A car port is located beneath the first floor of the Grooms Flat on the east aspect (refer to Photographs 8 and 9, Annex 4).
- 4.2.17 The rendering of the walls is in good condition with no gaps or cracks presents and the slate tiles are flush and in good condition with no gaps evident. Gaps are present underneath the ridge tiles at equal spacings along the ridge.

Photograph 8. The west aspect of the Stables and Grooms Flat.

- 5.2.1 Various works are proposed for the ancillary buildings, as follows:
- 5.2.2 Stables and Grooms Flat – This building will be converted to guest accommodation. It is assessed as Low suitability to roosting bats. Therefore, one dusk emergence or dawn re-entry survey is recommended.
- 5.2.3 Stable Cottage – This building will be converted to provide breakfast/catering with the eastern end opened up to the roof, losing the roof space. This building is assessed as Low suitability to roosting bats. Therefore, one dusk emergence or dawn re-entry survey is recommended.

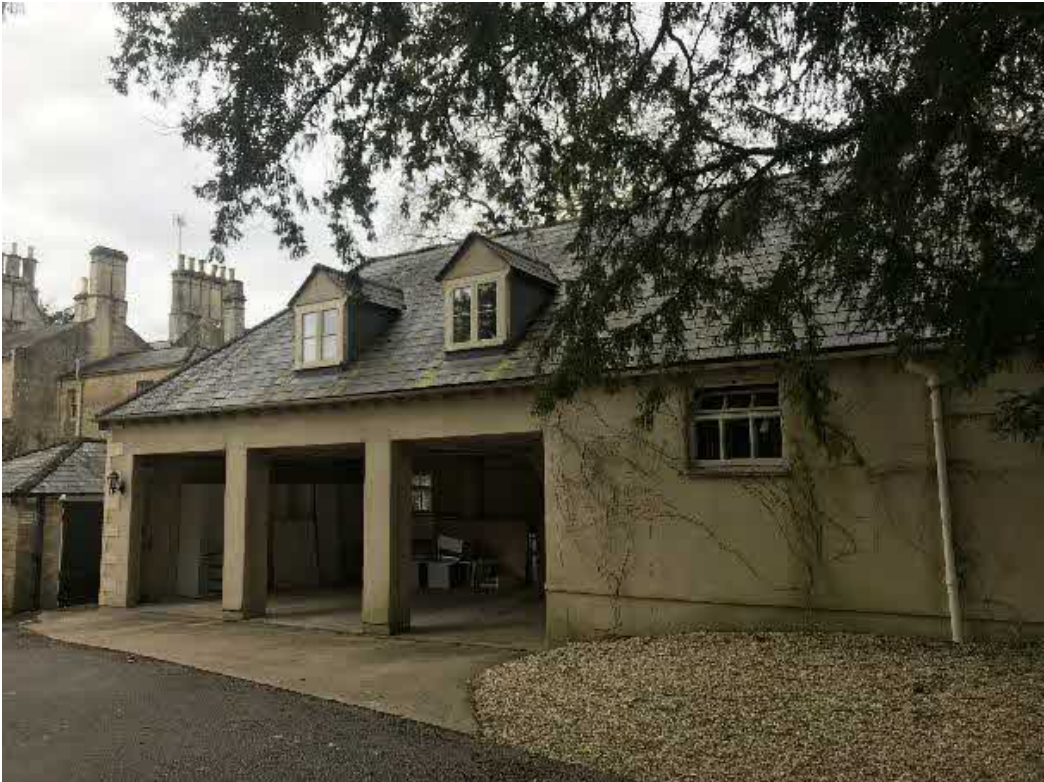
Photograph 9. The east aspect of the Stables and Grooms Flat showing the car port below the flat.

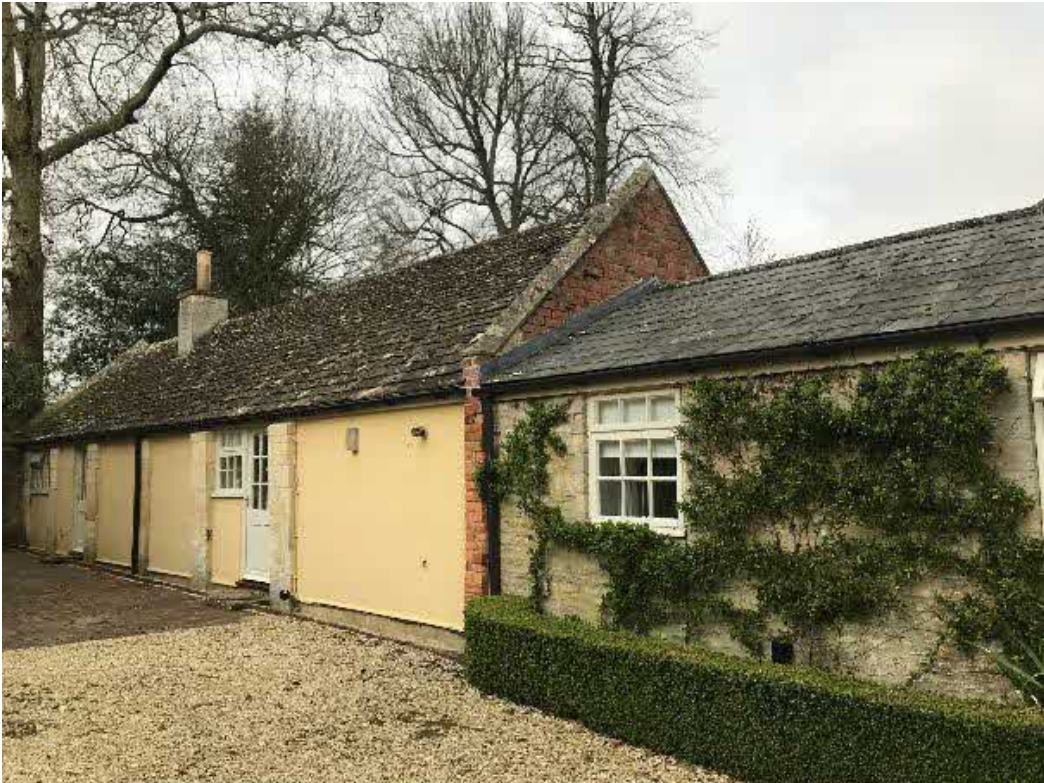
- 4.2.19 The Stable Cottage is a single-storey building, formed of two sections. The western section is has rendered stone walls and a gabled stone-tiled roof. The eastern end has stone walls with a gabled, slate-tiled roof (refer to Photograph 10, Annex 4).
- 4.2.20 There are several gaps evident under stone tiles on the western section. The slate tiles on the eastern section are in good condition and appear tight and well-sealed.

- 4.2.21 Internally, the western section is open to the roof with no enclosed roof space. The eastern section contains a small roof space, approximately 1.5m in height, 2m width and 6m length. There is a traditional Bitumen-type liner, which is in good condition. No daylight enters the roof space to indicate potential access points.
- 4.2.22 There was no evidence of bats found within this roof space.

Photograph 10. The south aspect of the Stable Cottage. The area beneath the slate-tiled section contains a roof space. The stone tiles have occasional gaps beneath.

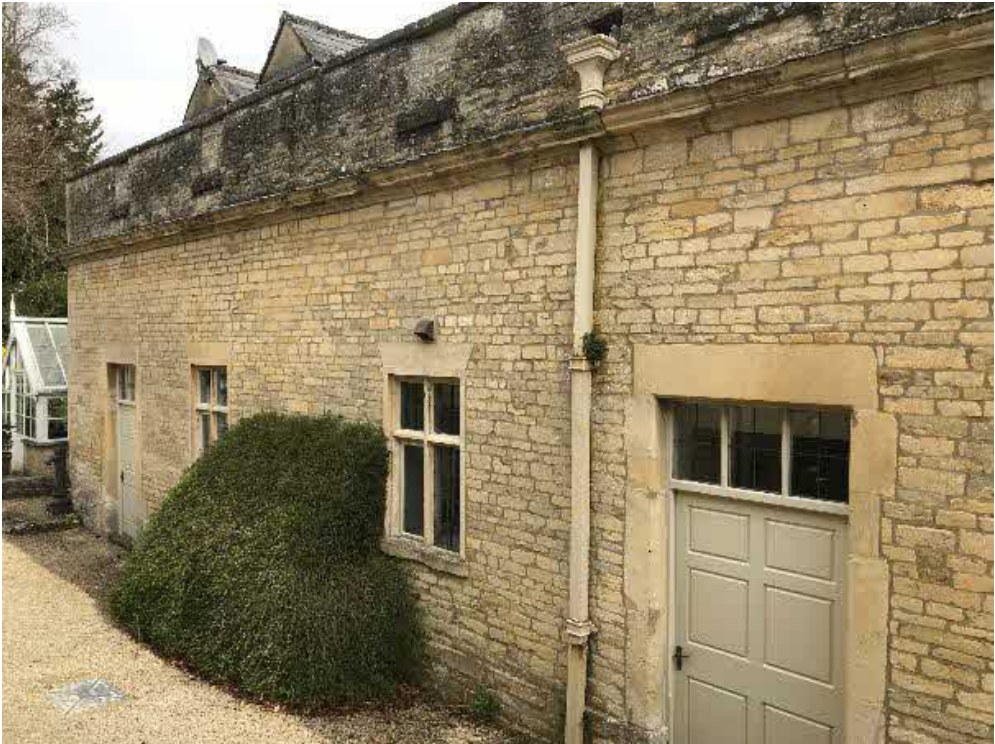
- 4.2.23 The Stone Barn is a two-storey building constructed of Cotswold stone, with stone parapets and a pitched, slate-tiled roof with dormers on the west and east aspects (refer to Photograph 11, Annex 4). The stonework is in good condition with no obvious gaps or cracks. Much of the roof could not be seen from ground level due to the parapets obstructing views, but where slate tiles were visible, these appear in good condition with gaps evident.

Photograph 11. The west aspect of the Stone Barn.

- 5.2.4 Stone Barn – This building will undergo internal alterations and roof repair/re-roofing. It is assessed as Low suitability to roosting bats. Therefore, one dawn re-entry survey is recommended. A re-entry survey of this building is preferable as there is limited views of the roof structure and bats returning to their roosts at dawn tend to exhibit swarming behaviour, which is often easier to observe.

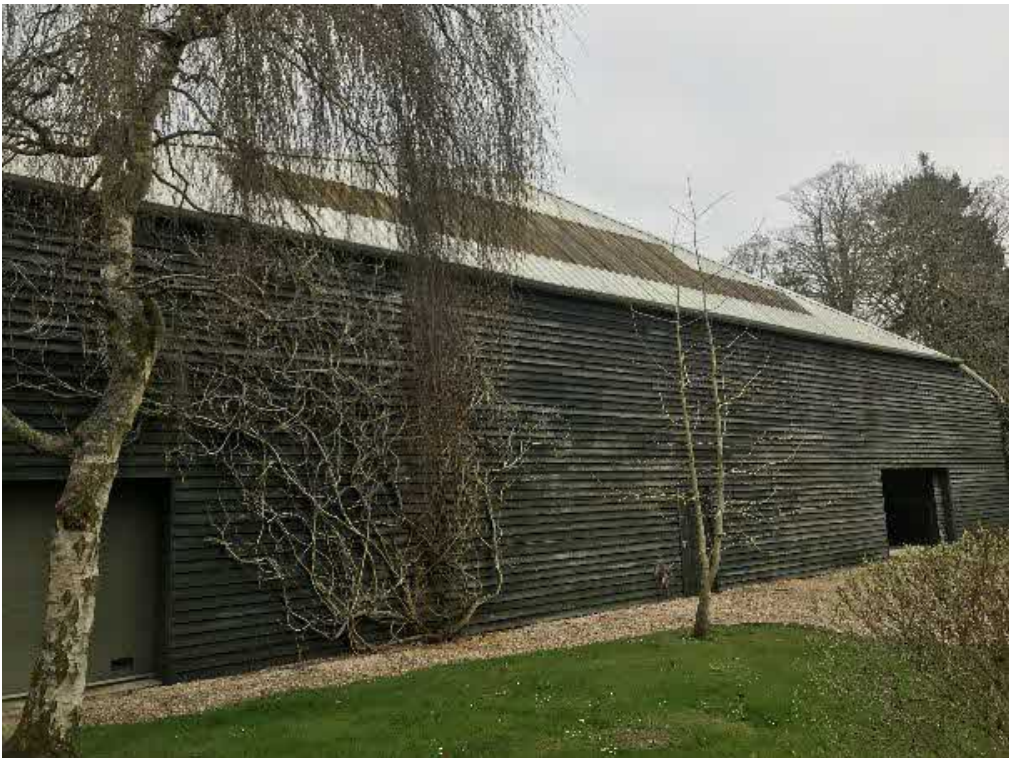
- 4.2.25 The Indoor Horse Arena is a large, steel-framed, wooden-clad structure with a corrugated metal roof (refer to Photograph 12, Annex 4). There are numerous gaps behind the wooden cladding on all aspects. Attached to the building's western elevation is a lean-to structure, also wooden-clad with windows on the east aspect. On the building's eastern elevation is an open-sided machinery store/car port. There is one large metal door on the south aspect, which provides access into the internal area of the arena.

Photograph 12. The Indoor Horse Arena.

- 5.2.5 Indoor Horse Arena – This building will be demolished. It is assessed as Low suitability to roosting bats. Therefore, one dusk emergence or dawn re-entry survey is recommended.

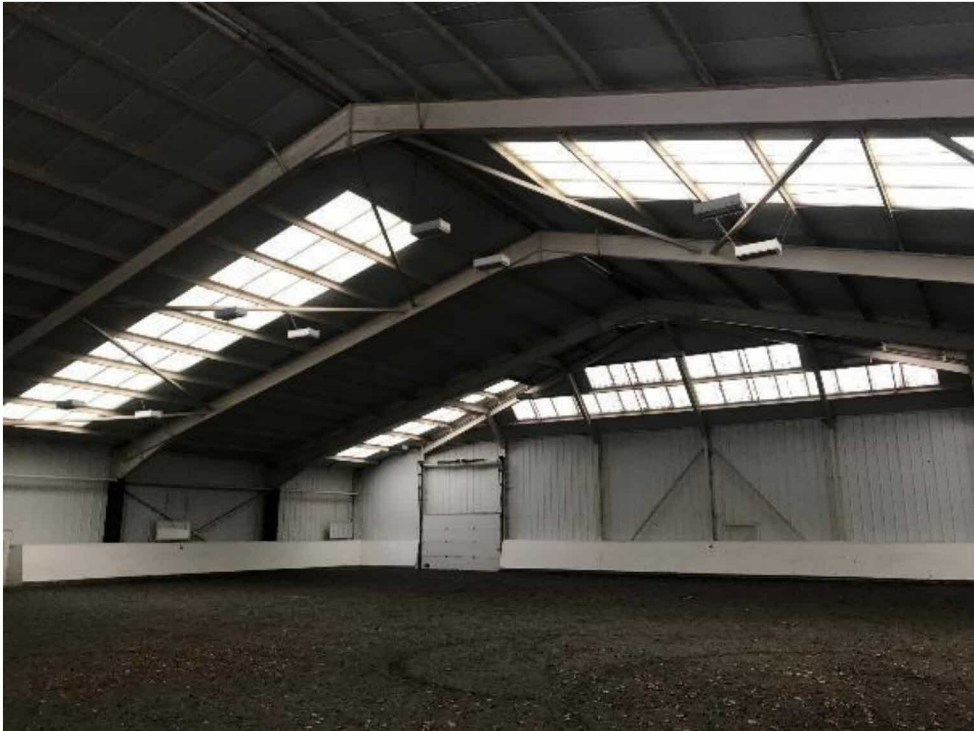
- 4.2.26 Internally, the arena is entirely open to the metal roof and the steel frame is visible (refer to Photograph 13, Annex 4). There are no enclosed spaces and no visible crevices. The interior is well-lit owing to sections of clear corrugated roof panels. One bird's nest was noted to be present on an internal beam.

Photograph 13. The interior of the Indoor Horse Arena.

- 5.3.1 One bird's nest was noted in the Indoor Horse Arena. Other buildings offer low suitability to nesting birds. However, climbing plants growing up some of the buildings and adjacent vegetation are suitable to support nesting birds.
- 5.3.2 Demolition of the Indoor Horse Arena should avoid the nesting bird season, where possible, or a pre-works check is recommended prior to works.
- 5.3.3 A pre-works check for nesting birds should be undertaken in advance of works commencing on the other buildings should works commence during the nesting bird season (generally the nesting bird season is from the beginning of March to the end of August).

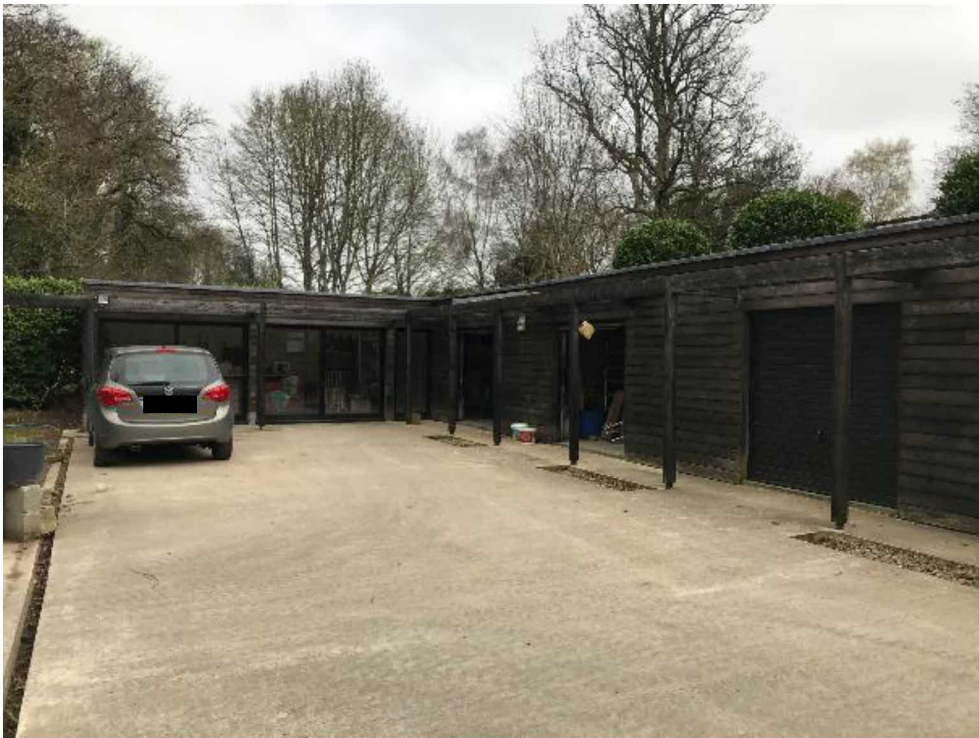
- 4.2.27 The Grounds Building is a modern, single-storey, L-shape building, located within the wider grounds of the estate away from the Main House and other ancillary buildings. It constructed of blockwork walls with wooden cladding and a flat, lead-lined, gravel roof (refer to Photograph 14, Annex 4). Two large windows are present on the east aspect and three large metal garage doors are located on the south aspect. The external wood cladding and lead-lining of the roof are tight and well-sealed.
- 4.2.28 The internal area was not accessed, but there is no enclosed roof space, all areas being living accommodation/storage.

Photograph 14. The Grounds Building.

- 5.2.6 Grounds Building – This building will be converted/modified or replaced to create a ceremony space. This building is assessed as Negligible suitability to roosting bats. No further surveys are recommended.
