BS 5837: 2012 ‘trees in relation to design demolition and construction’ Tree survey and Report and Arboricultural Impact Assessment

Site Address: Ampney Park, Ampney Crucis, GL7 5RY

New events building venue, with associated infrastructure for new parking, vehicular access, conversion of existing buildings for on site guest accommodation, new hard and soft landscaping schemes.

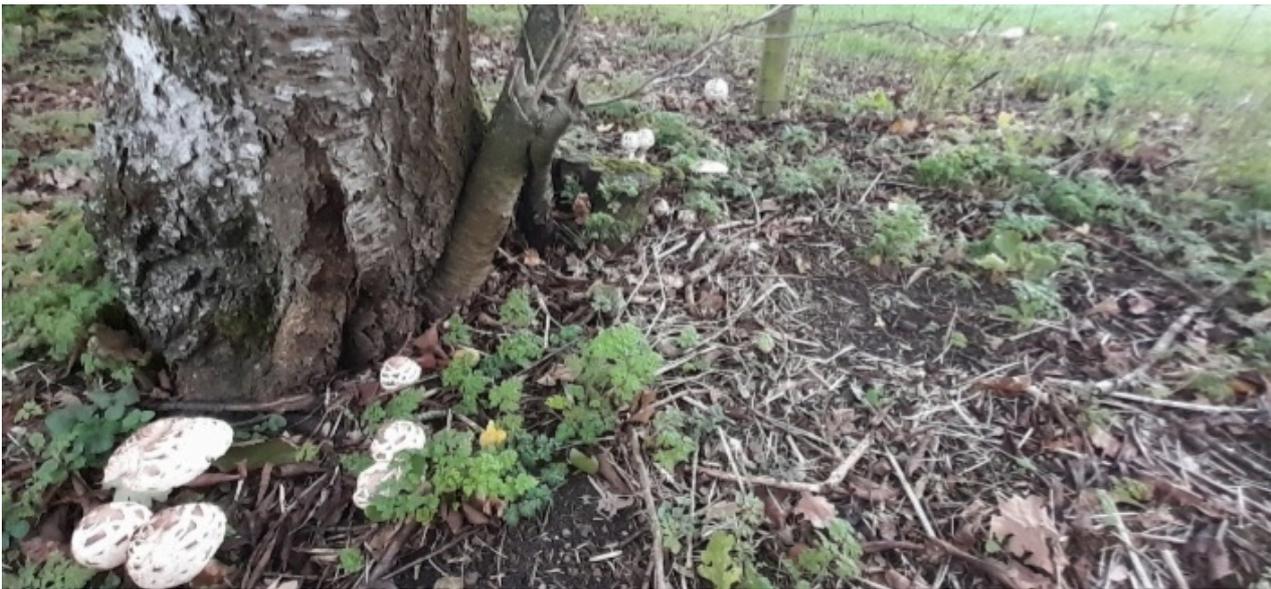
Specifically within the narrow grouped shelter belt planting, running from the north of the ménage to the far west side of the site, by the historic pump houses, this is a fenced off area that has been excluded from historic sheep and horse browsing and has subsequently been allowed to establish the beginnings of an understory, including scrub field maples, hazel, hawthorn and holly along with the retention of fallen dead wood and a consistent natural build up of an undisturbed natural herb layer, as pictured below.

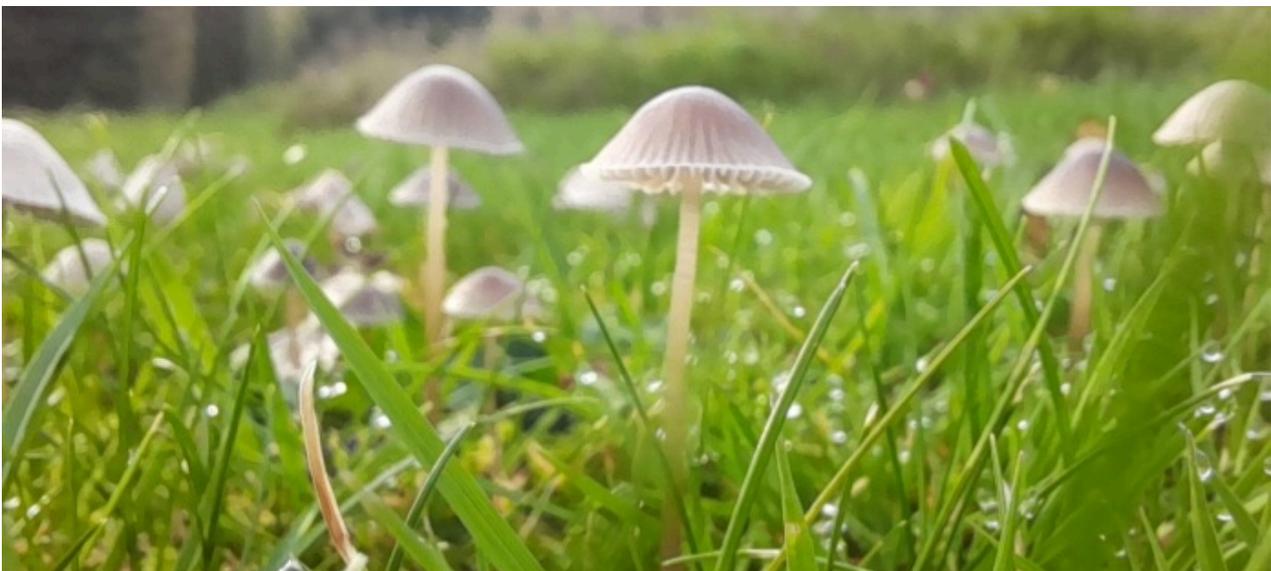
Within the locations where undisturbed grassland surrounding these trees has been excluded from repeated mowing a complexity of fungal networks can be found, often going unnoticed as a unique asset for the promotion of specialist guilds of ecological interactions.

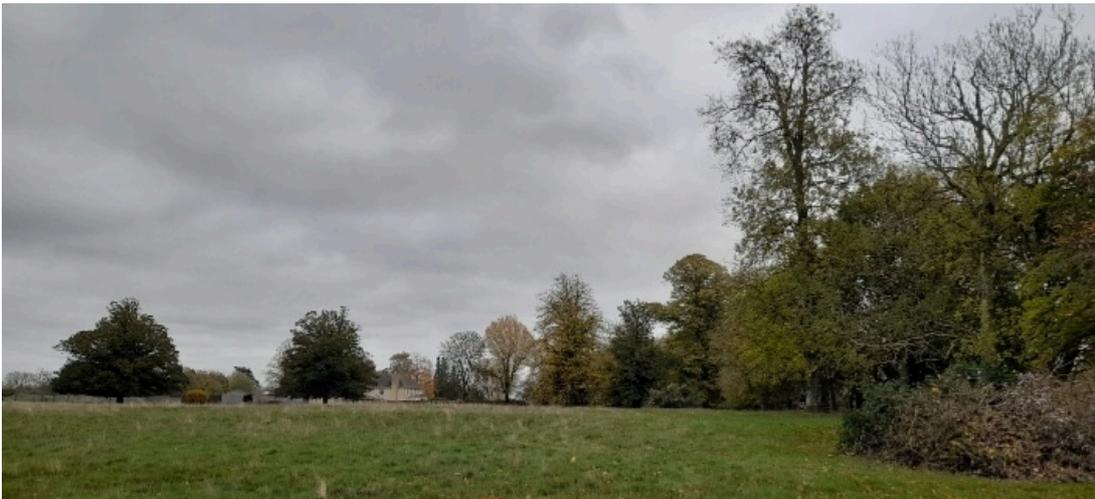
Solitary Limes 2334 and 2333 seen here on the left as a remnant avenue north of the existing ménage. These trees form an existing linear habitat of mixed tree species and age class, running east to west as a connective wildlife corridor, that would benefit from low level enrichment planting of native shrubs within its established Root Protection Area, if it is chosen to be preserved.

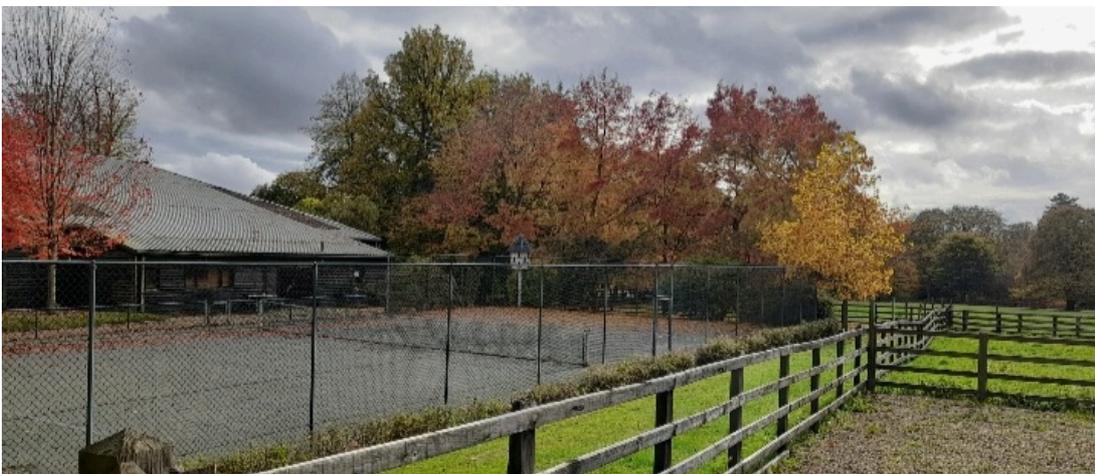
Groups of young ornamental ash and maples form collective landscape value worthy of retention, only if they can be positively designed into and incorporated into the sites future development plans

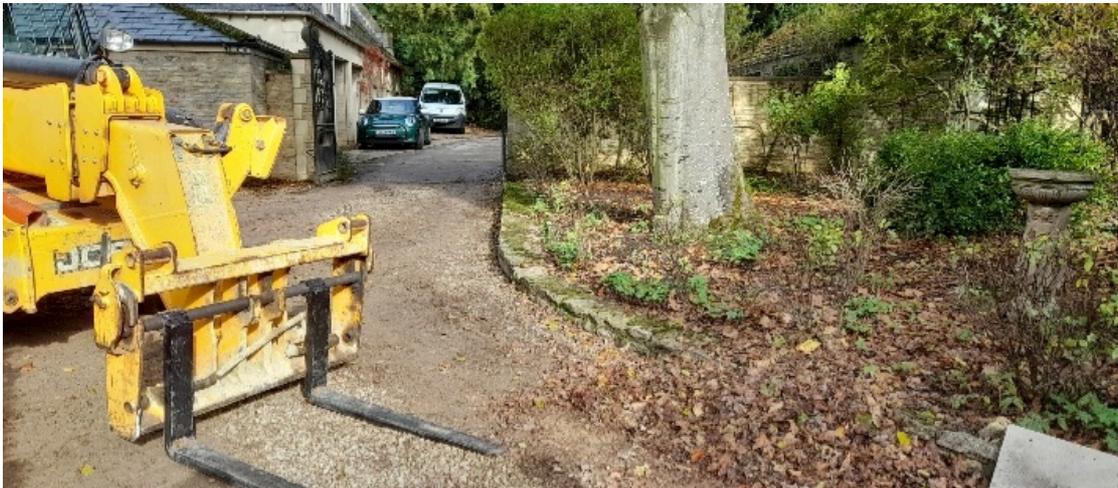
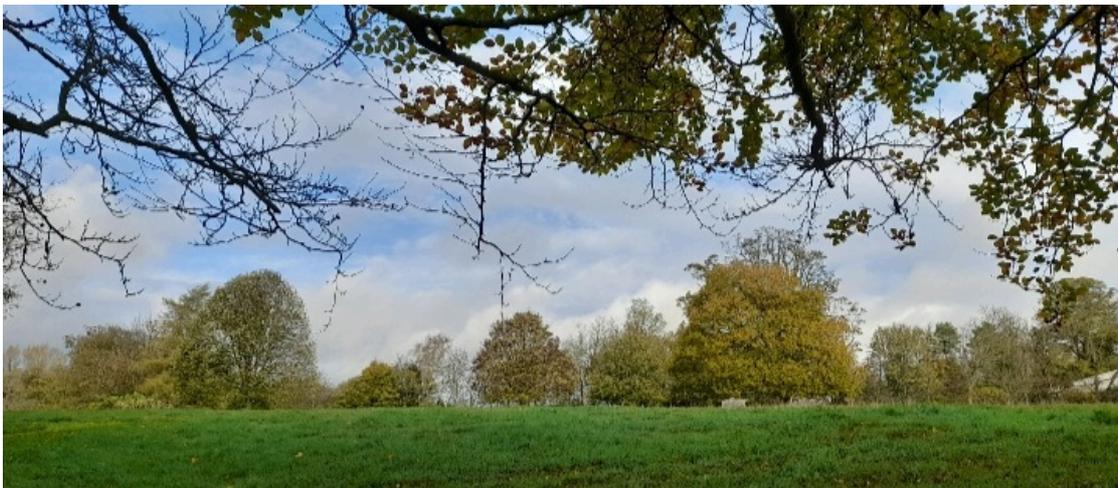
Future proposed plans for construction and redevelopment must factor in holistic appropriate measures of tree protection above and below ground level. Trees must be safeguarded if they are to be retained as existing assets and provided with future growing environments, in which they can be permitted to not merely exist, but to grow and thrive with future vitality.

Individual and grouped trees have short and long term needs and subsequently must be treated with care and consideration, in order that they may compliment any new localised site layouts, in a sustainable way. This means the preservation of all plotted Root Protection areas within our Tree Constraints Plan must be taken into account positively to inform any design changes in the sites future layout.

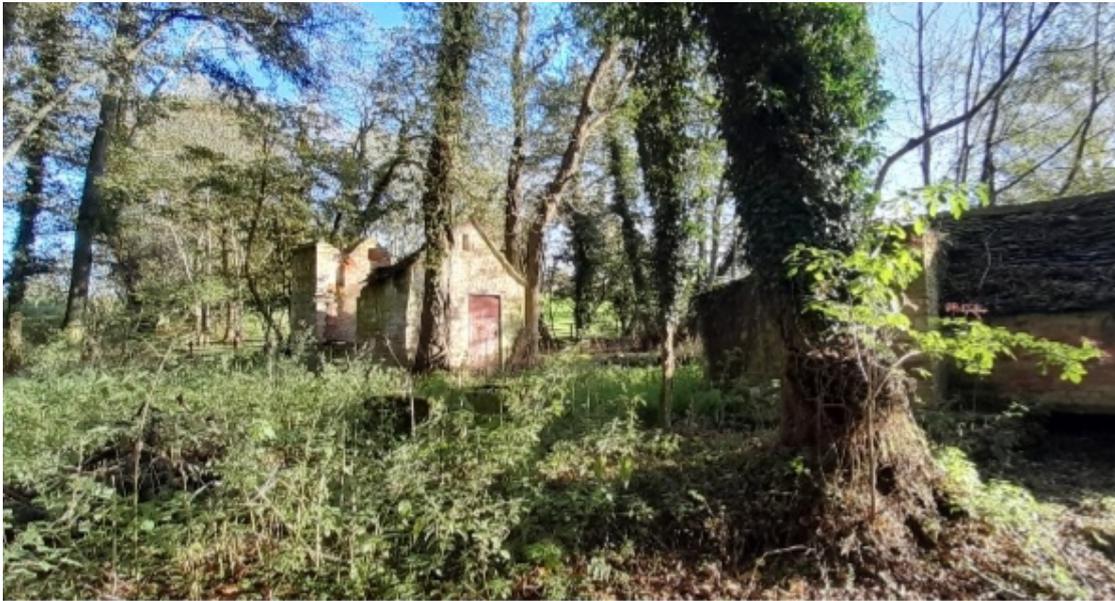
For areas in which trees that have evolved naturally over time in proximity to areas of proposed future renovation and associated activities of construction, it will be necessary to formulate site specific Arboricultural Method Statements (AMS) to ensure both tree retention and outcomes for the preservation of Listed Buildings can be achieved. Such works are likely to require specific on site prescribed duties and responsibilities, which must effectively be managed by an appointed arboricultural clerk of works.

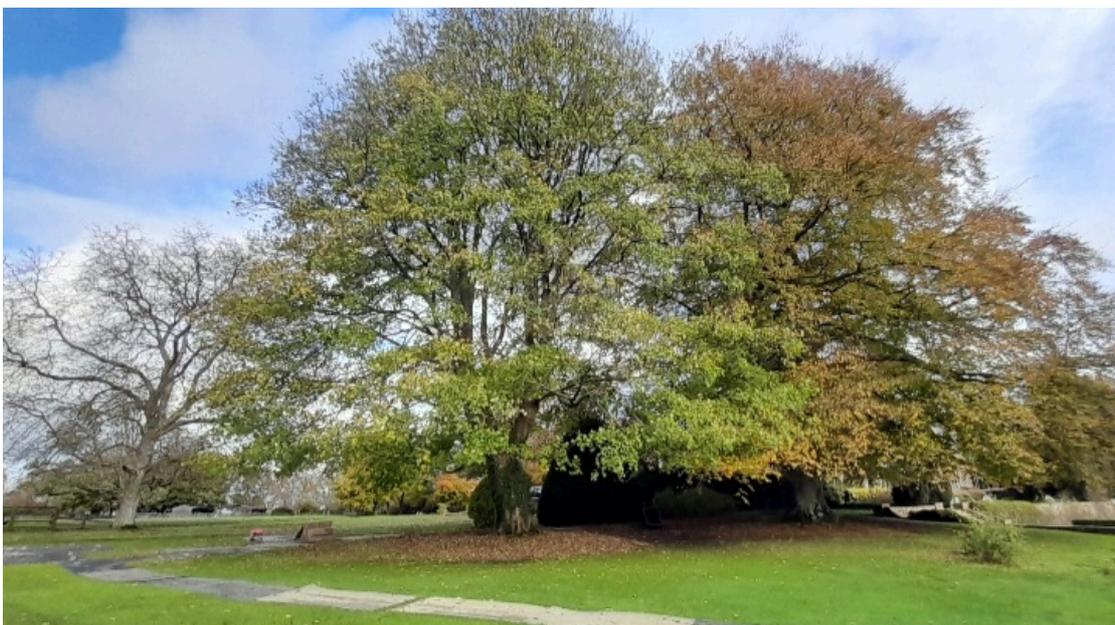
To preserve specimen trees within the proximity of a proposed increase of pedestrian usage, landscape plans should factor in design solutions to promote the frequency of foot fall to outside established root protection areas, up to 15m away from the centre of any mature open grown tree

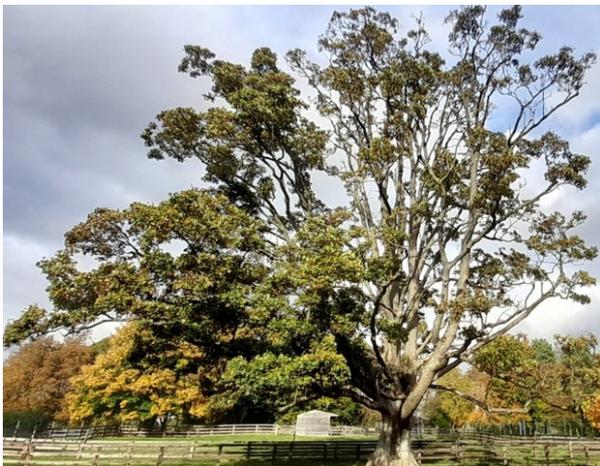
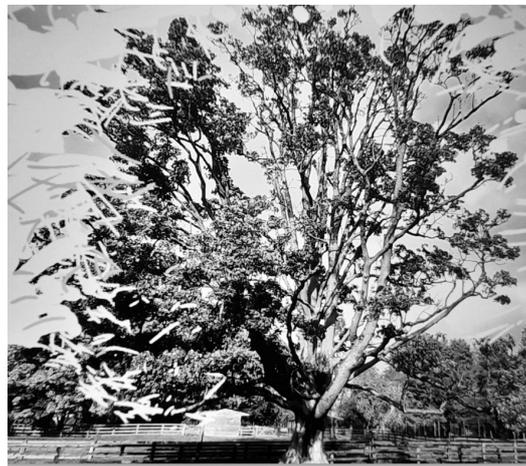
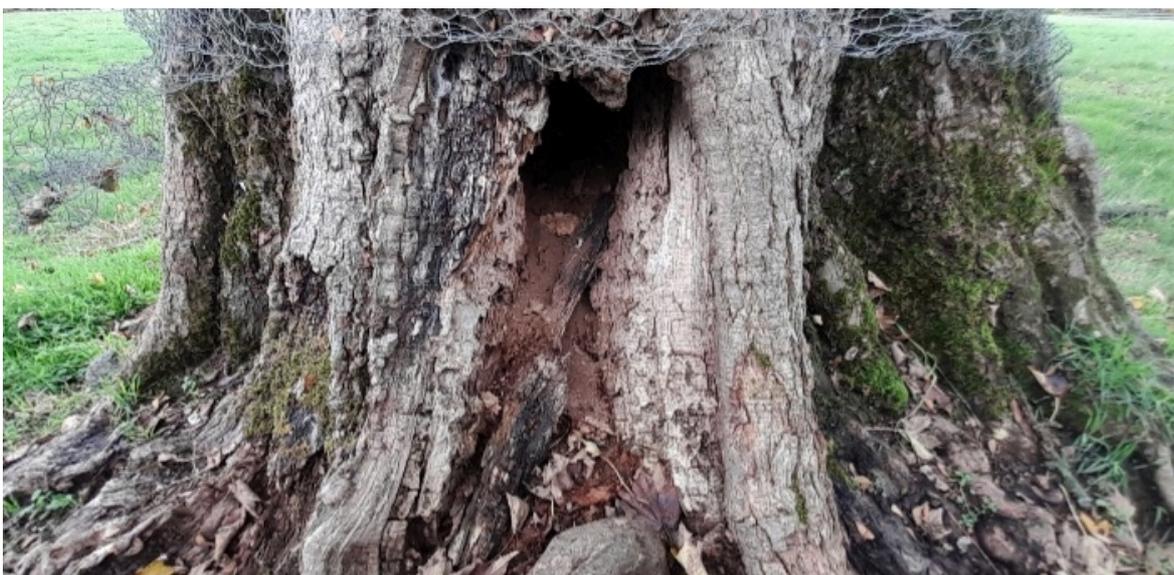
In the case of T 2386 a significant parkland Sycamore, initial proposed remedial works have been proposed to address this trees biomechanics, whereby over extended responsive regrowth continues to develop leverage on its western side, opposed to a significant decline in vigour on its eastern side from historic, consistent browsing of its buttresses from sheep and horses, evident from basal hollowing and premature decay pockets.

Signs of historic repeated browsing evident from iterative basal scarring beneath the attempt of fixing chicken wire over the damage. (Lifted up and away here for the illustration of this photograph)

Currently this tree is proposed to be retained within an area of focal redevelopment with an associated significant increase of pedestrian usage. Therefore a staged management plan should be considered to promote its sustainability, as a 'veteran' styled feature, whereby its height to diameter ratio can be under a continued review and adjustment, to promote an inner central crown of responsive regrowth, with the long term objective of avoiding unnecessary wind throw occurring in severe weather.

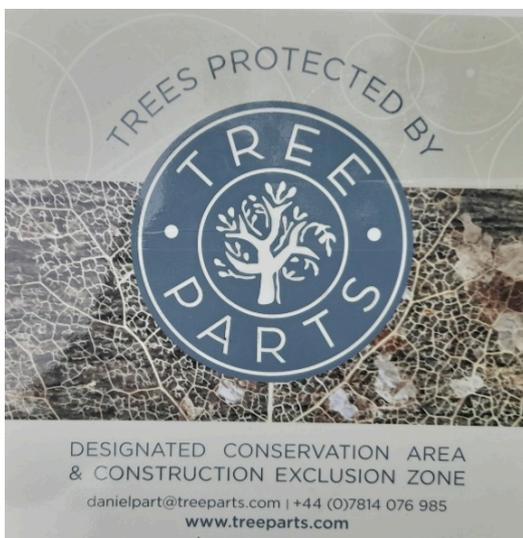
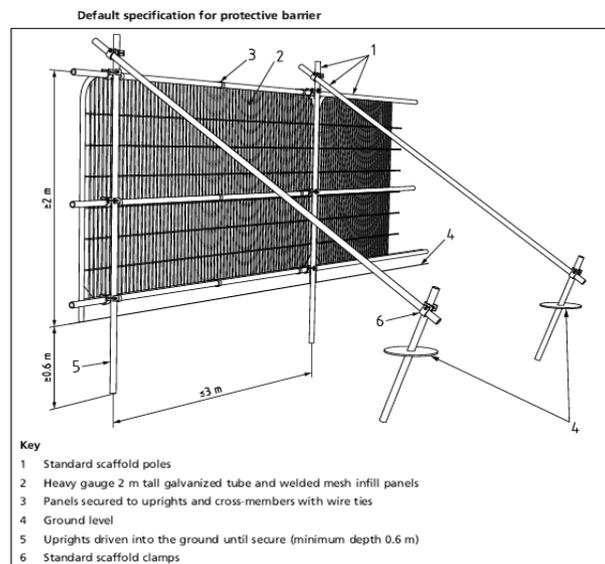
Tree Parts site signage and Figure 1: BS 5837: 2012 Standard Detail for tree protection measures

All specified fencing will remain in place until completion of all construction and only removed with the consent of the Local Planning Authority to permit the completion of the scheme.

All tree protection measures must be regularly checked and maintained to ensure they are in the same alignment and condition they were installed in and still provide the same level of protection.
