Stable Cottage, Ampney Park

Bat Survey

August 2021

Client: Simon Murray-Jones
Architects Ltd
Report Ref: SEB2429_01a
Author: Kate Hayward
MCIEEM
www.seasonsecology.co.uk

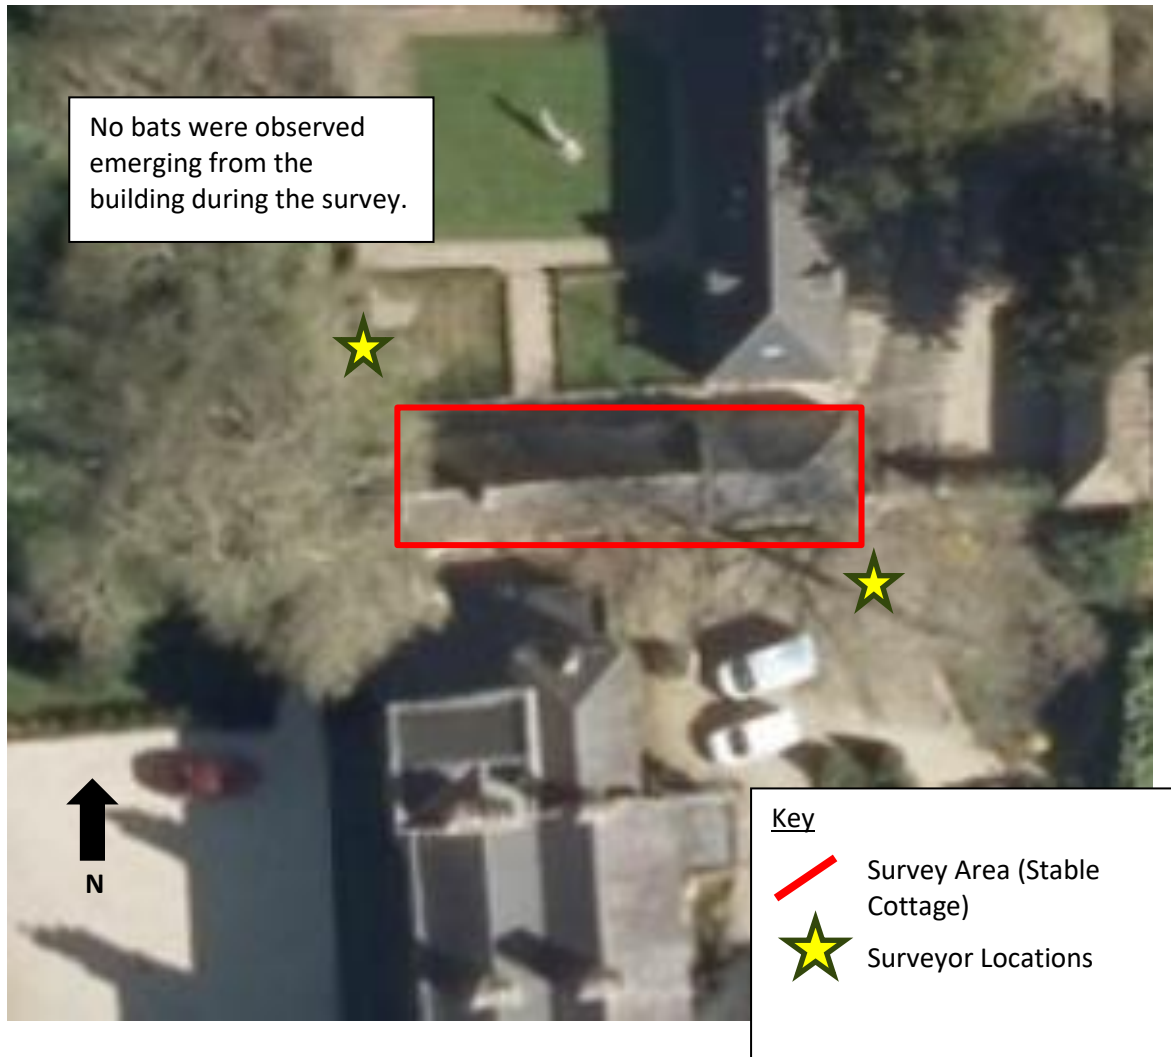
Annex 1: Surveyor Locations and Survey Results (August 2021)

3.1.1 The results of the bat survey are provided below. The locations of the surveyors and the key results are shown at Annex 1.

3.2.2 No bats were observed emerging from the Stable Cottage during the survey.

3.2.4 Common pipistrelle was the most frequently recorded species with 26 passes recorded/observed. Common pipistrelle bats were mostly seen commuting over the building from the west and foraging around nearby trees. The first pass was at 20:29 and the last pass was at 21:47 (2 minutes and 80 minutes after sunset).

3.2.8 Brown long-eared passes were recorded six times during the survey. One individual was seen commuting from the south of the building towards the nearby tree canopy at 21:02 (35 minutes after sunset). The other five passes were unseen recordings, between 21:04 and 21:42 (37 minutes and 75 minutes after sunset).

3.2.9 Seven *Myotis* passes were recorded during the survey. Two individuals were seen commuting/socialising over the building and towards the tree canopy nearby. The other five recordings were unseen passes. Activity was recorded between 20:51 and 21:48 (24 minutes and 81 minutes after sunset).
