Stables and Grooms Flat, Ampney Park

Bat Survey

August 2021

Client: Simon Murray-Jones
Architects Ltd
Report Ref: SEB2429_01b
Author: Kate Hayward
MCIEEM
www.seasonsecology.co.uk

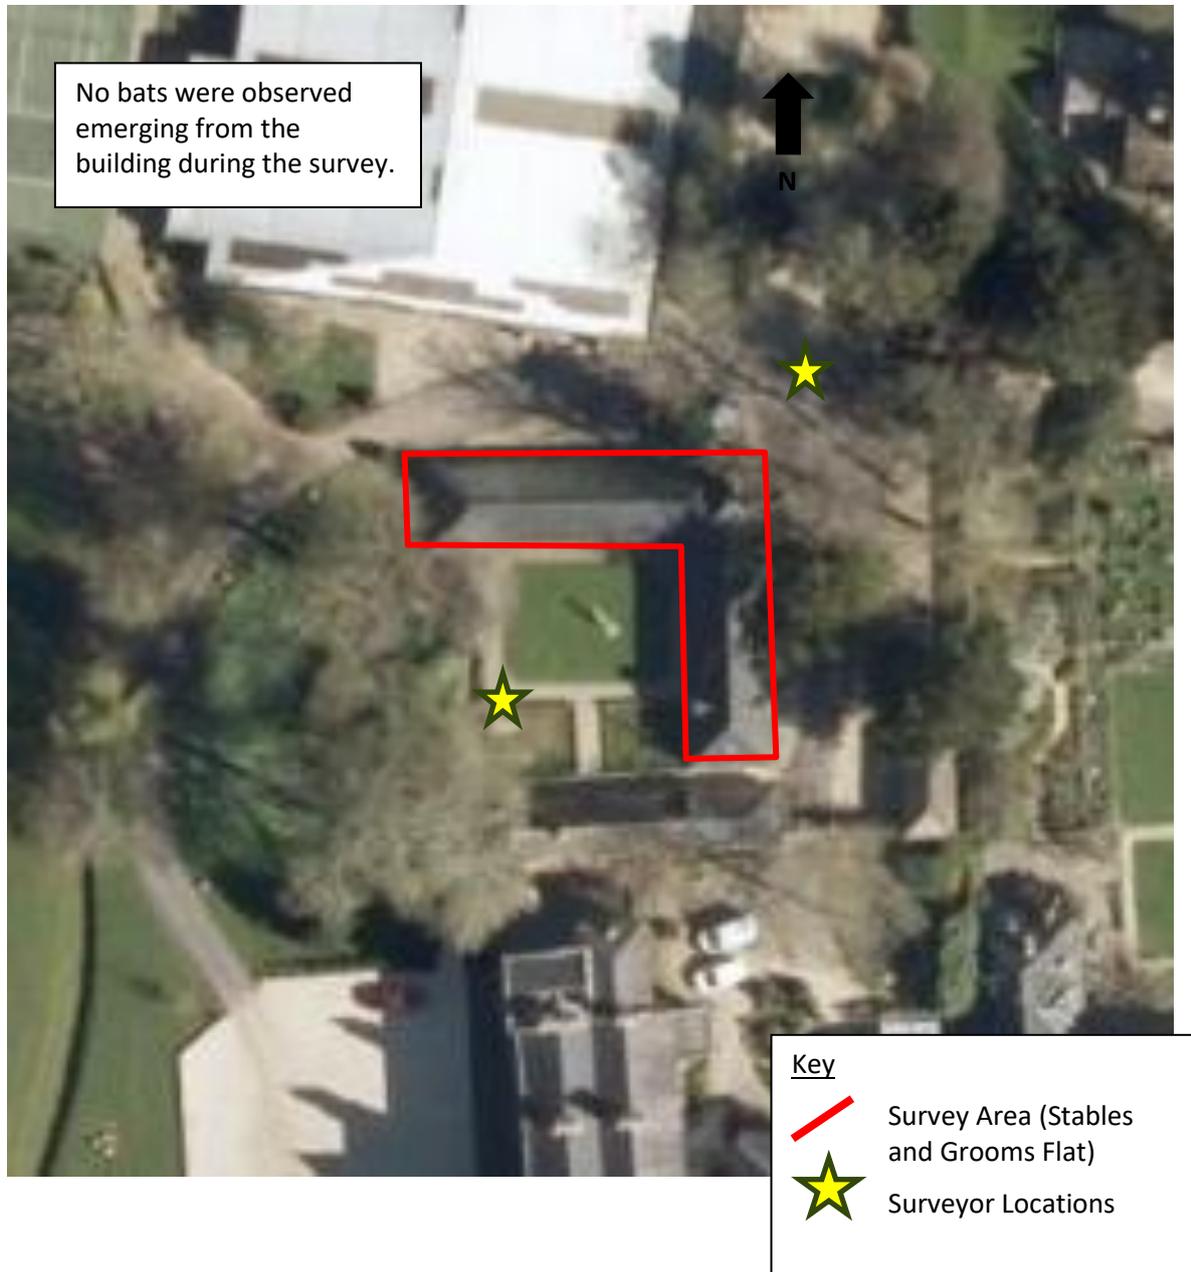
Annex 1: Surveyor Locations and Survey Results (August 2021)

3.1.1 The results of the bat survey are provided below. The locations of the surveyors and the key results are shown at Annex 1.

3.2.2 No bats were observed emerging from the Stables and Grooms Flat during the survey.

3.2.4 Common pipistrelle was the most frequently recorded species with 17 passes recorded/observed. Common pipistrelle bats were mostly seen commuting over the building from the courtyard and foraging around nearby trees. The first pass was at 21:06 and the last pass was at 22:08 (12 minutes and 74 minutes after sunset).

3.2.5 Three soprano pipistrelle passes were recorded, two were seen at 21:01 and 21:16 both commuting over the building from south-west to north-east (7 minutes and 20 minutes after sunset). The other individual was heard but not seen at 21:16.

3.2.8 Brown long-eared bat was recorded six times during the survey. The first individual was recorded at 21:37 (43 minutes after sunset) and the last individual was recorded at 22:00 (66 minutes after sunset). Only two individuals were seen, one foraging around the nearby trees and the other commuting over the building.

3.2.9 Nine *Myotis* passes were recorded during the survey. Bats were mostly seen commuting over the building, two of these individuals were observed socialising. The *Myotis* passes were recorded between 21:21 and 21:58 (27 minutes and 54 minutes after sunset).

6.3.1 To offer roosting opportunities for bats, which is currently limited on the building, it is recommended that two bat boxes (Vivara Pro Woodstone bat boxes, or similar) are installed on the west facing external wall of the converted building, which is adjacent to nearby trees and the least disturbed elevation of the building. The bat boxes should be positioned between 3m and 5m off the ground.
