STONE BARN, DOVECOTE RISE, SOUTH RAUCEBY

STATEMENT OF HERITAGE SIGNIFICANCE®

By
Elizabeth Mayle BA(Hons) MA IHBC
March & October 2023

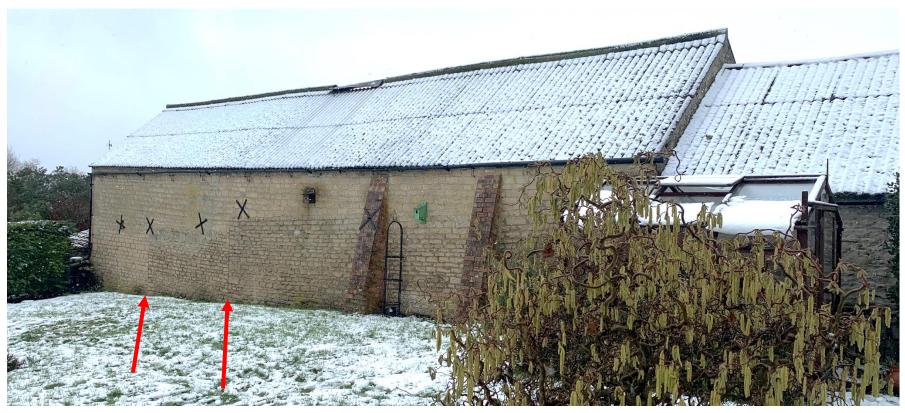
Fig 3, note the east elevation which shows part of an earlier building has been incorporated into the Stone Barn. The red arrows indicate clear joints in the building showing separate but conjoined structures. The earlier stonework is not laid level but runs at an angle following a rise in the land. Later coursing has 'levelled' the coursing.

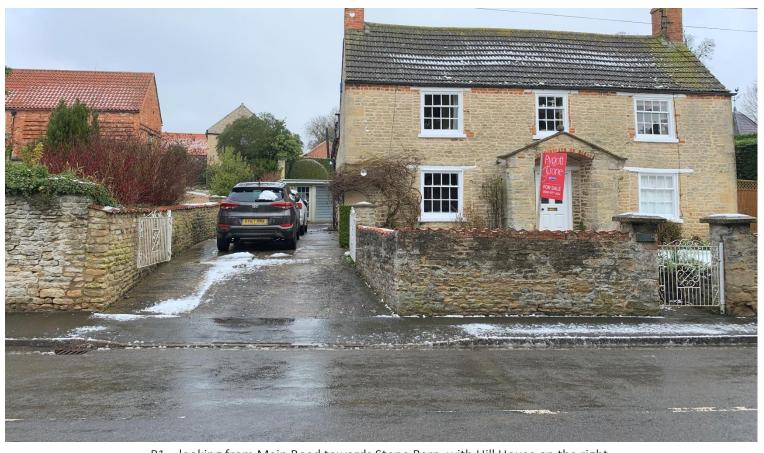
P1 – looking from Main Road towards Stone Barn, with Hill House on the right. Part of the south elevation of Stone Barn is seen with Hill House from the road.

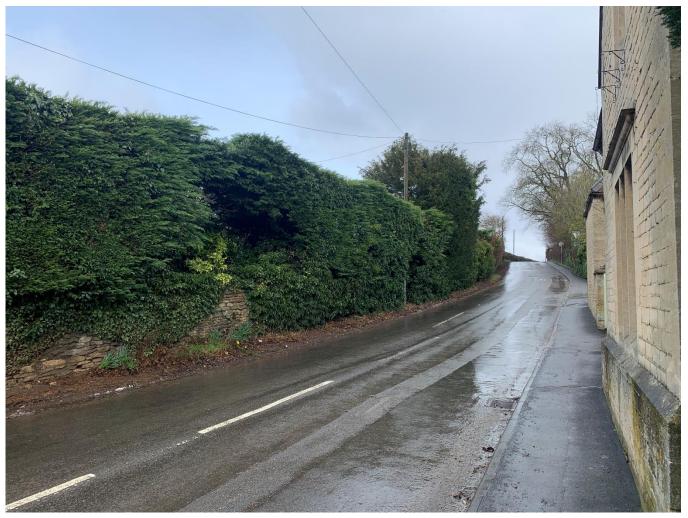
P2 – from the corner of Main Street along Tom Lane (adjacent to the Bustard Inn) looking towards Stone Barn, which is not visible due to boundary hedge treatments at Hill House and Stone Barn. There are no views of the site at all as a result of the tall hedge.

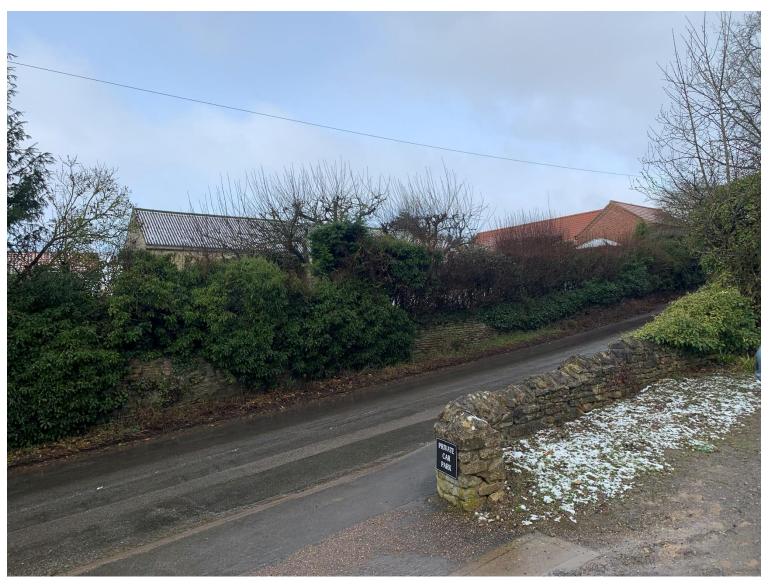
P3 – looking towards Stone Barn and modern bungalow, from the entrance of the Bustard Inn car park. The roof is seen beyond the tall hedge.

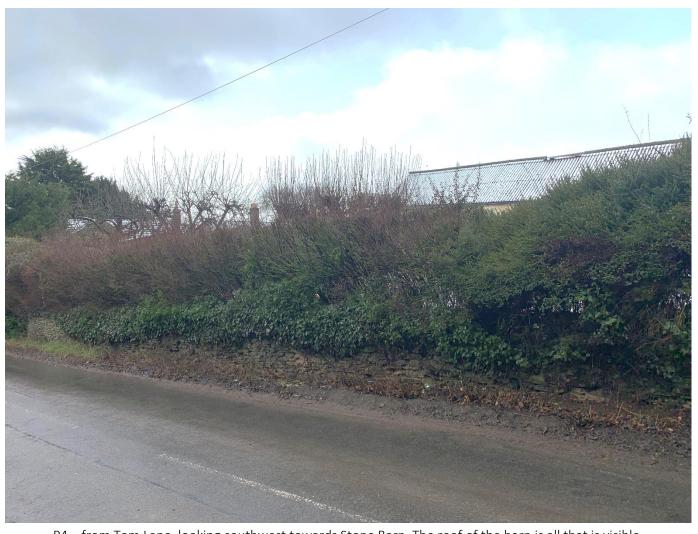
P4 – from Tom Lane, looking southwest towards Stone Barn. The roof of the barn is all that is visible.

Hill House is set further down the hill (left of photograph).

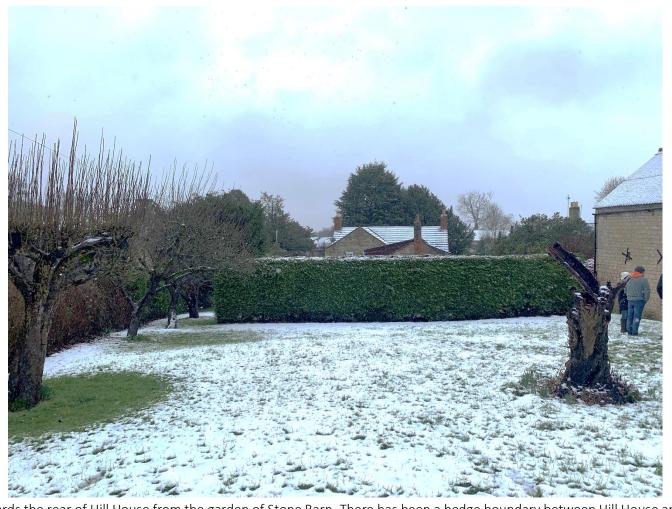
P5 – looking towards the rear of Hill House from the garden of Stone Barn. There has been a hedge boundary between Hill House and Stone Barn for many years.

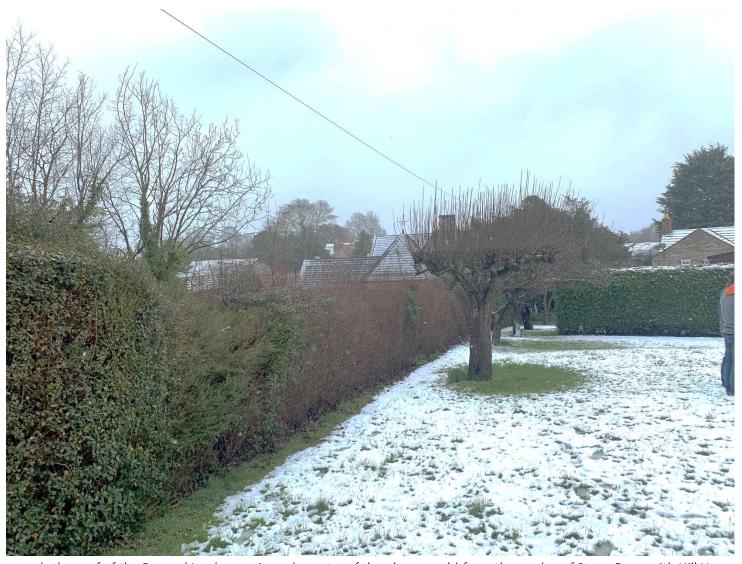
P6 – looking towards the roof of the Bustard Inn (approximately centre of the photograph) from the garden of Stone Barn, with Hill House on the right.

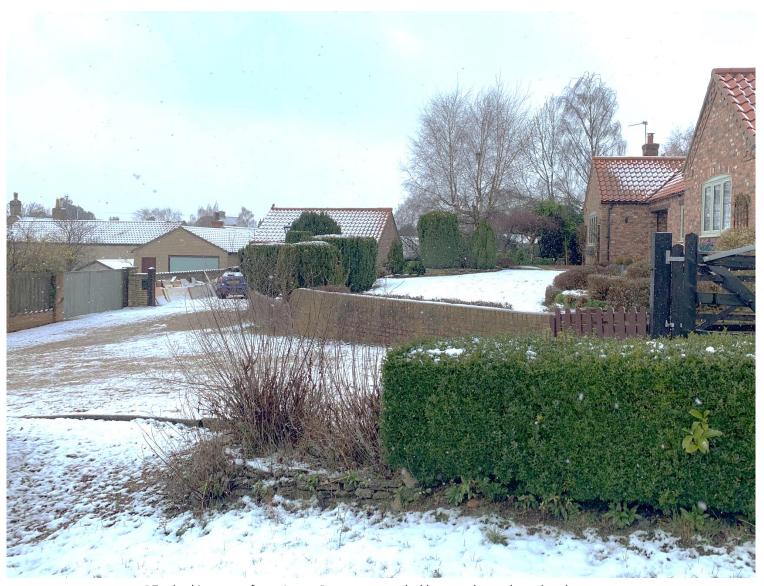
P7 – looking west from Stone Barn, surrounded by mostly modern development.

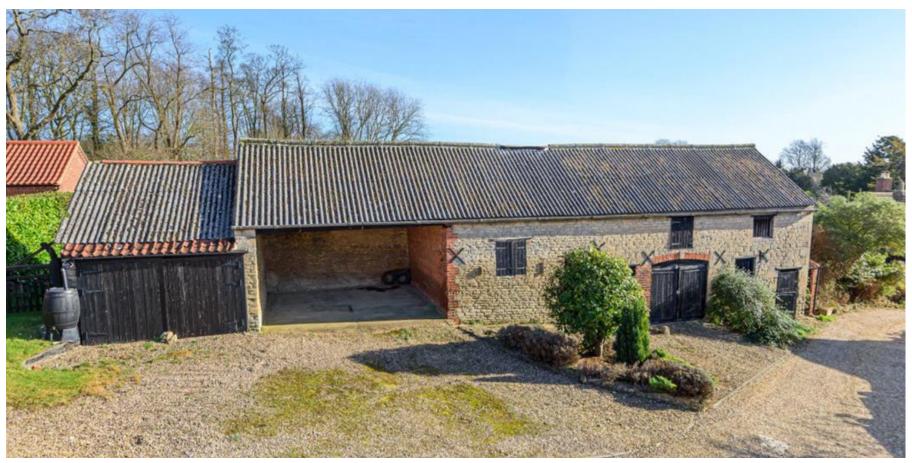
P8 – West (principal architectural) elevation (source of image: sales details 2022 – without snow and parked cars shows the full elevation of Stone Barn).

from the rear of the Bustard Inn (see views P3 and P4). Photo P8 shows the principal elevation of Stone Barn without snow on its roof, and the current roof covering is darkened with age. It is considered that the change in roof material will result from newness, and the lack of patina, but that the proposed material is appropriate to the building type, and that the change would be minimal in terms of overall appearance. The proposed new shed/store would not impact harmfully on view P1 (as already noted)

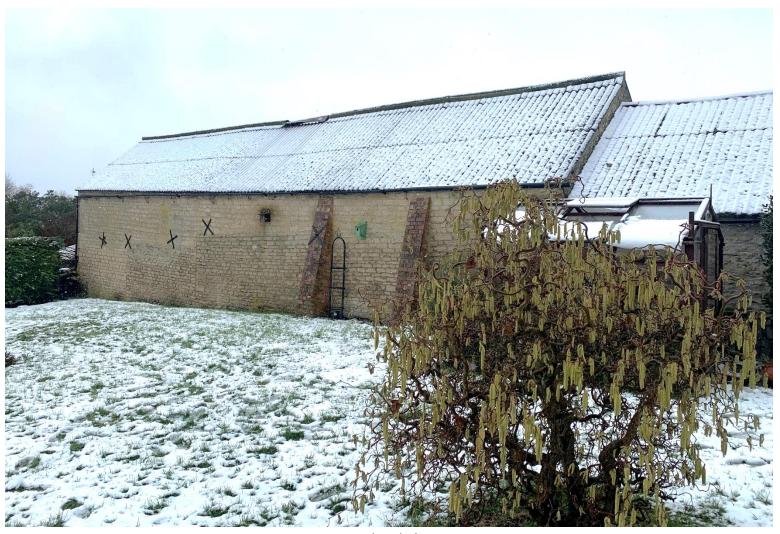
P9 – east (rear) elevation.

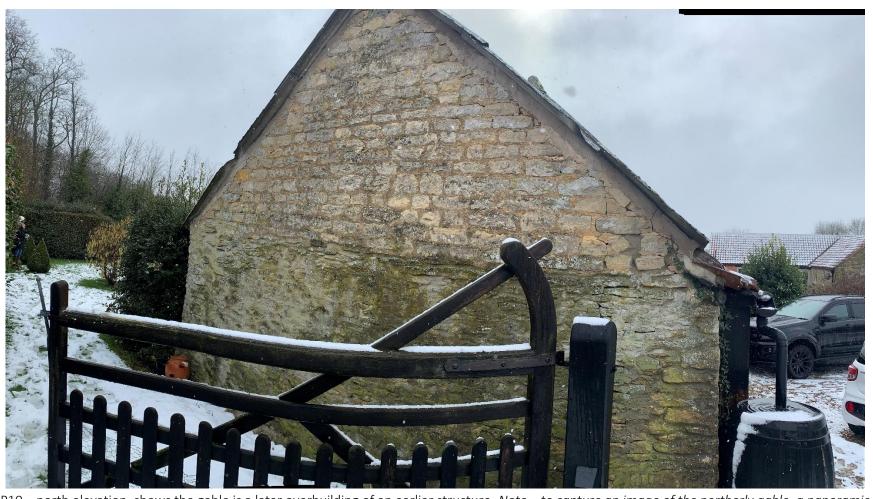
P10 – north elevation, shows the gable is a later overbuilding of an earlier structure. *Note – to capture an image of the northerly gable, a panoramic photo was taken due to limited access - hence some distortion to the image.*

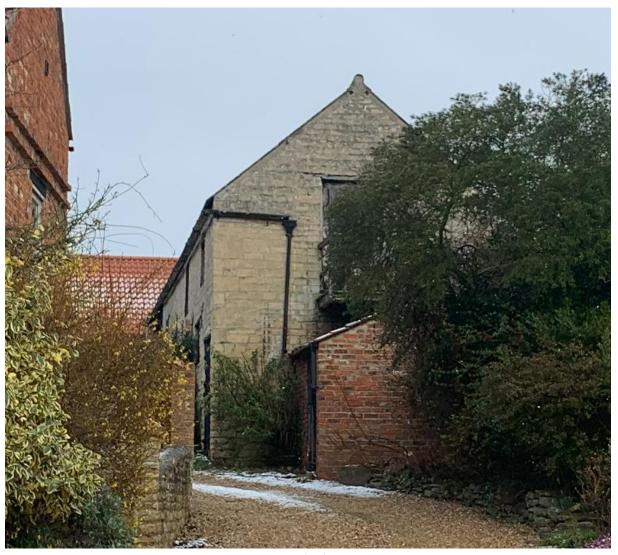
P11 – south elevation.

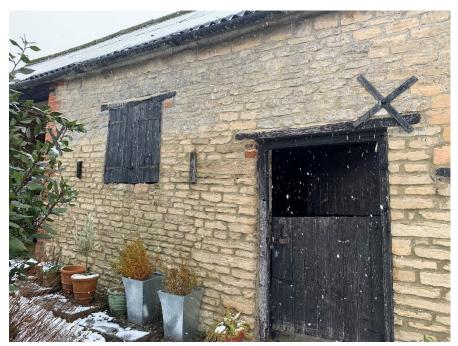
P12 left – historic shutters on cast-iron hinges and a dowel framed bead moulded plank stable door.

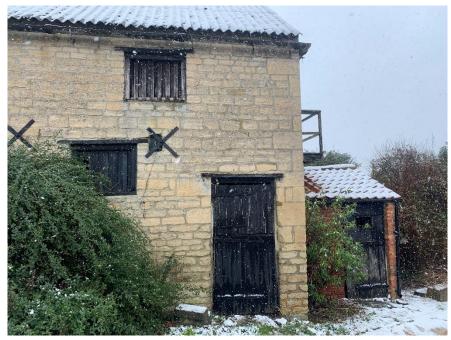
P13, right – original slatted breather vents (slide from side to side to control the flow of air). To the right, on the south elevation, a modern balcony floats above the brick outbuilding.

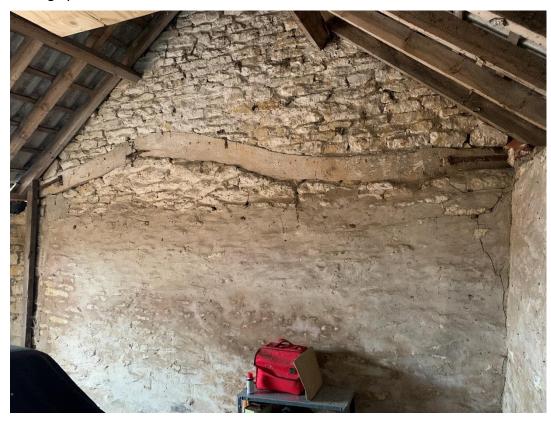
P15, right - a later but historic tie beam to the south wall of the garage. The roof structure is modern.

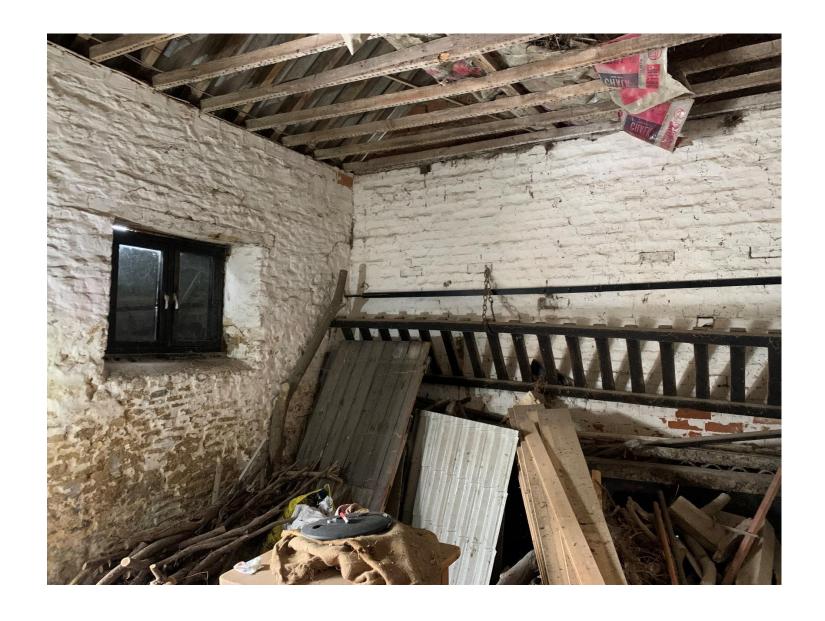
P16 – Barn 1 with feeding trough and hay rack on the north wall. Modern casement window behind historic external shutters.

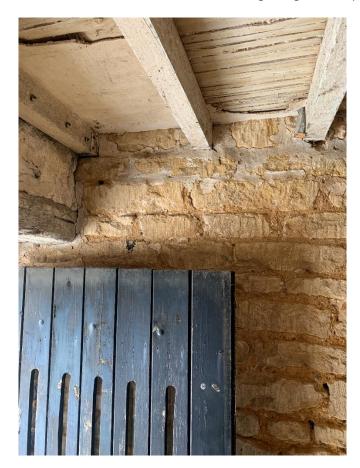
P17, left – lath and plaster between joists – lath above the joists form the base for a lime ash floor in Store 2 at first floor level.

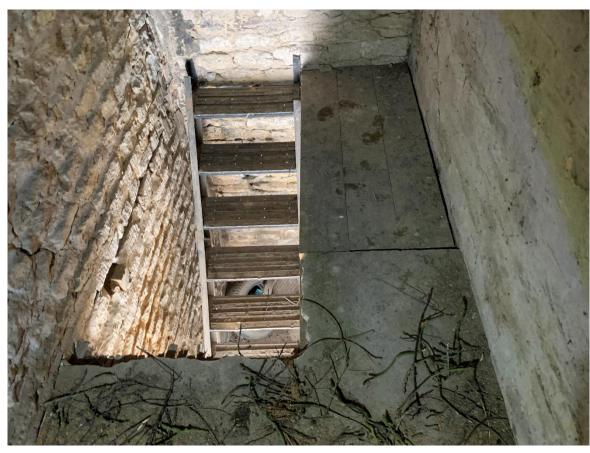
P18, right – a modern step stair to the first floor.

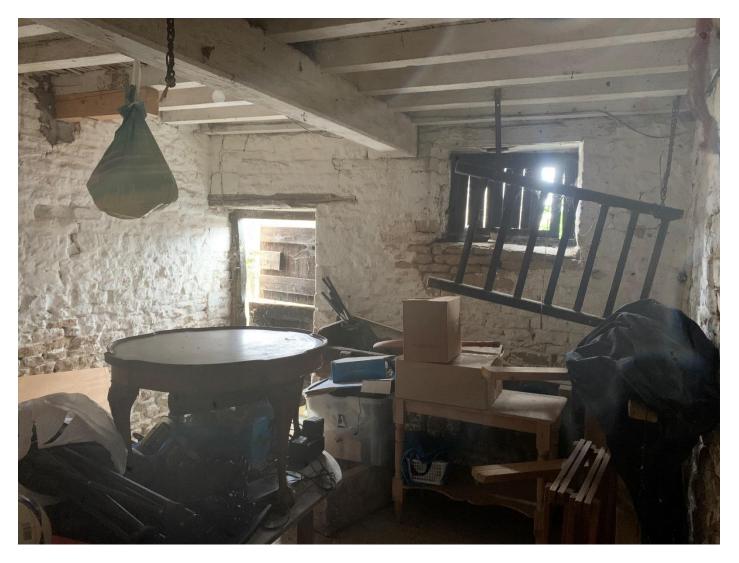
P19 – Barn 3, with beam and rafter ceiling, slatted breather vent to opening, timber lintels above the door and window opening.

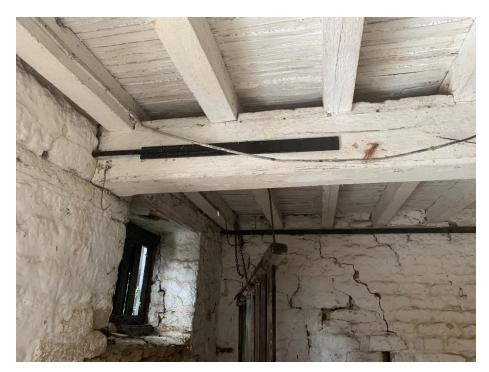
P20, left – Barn 3, detail of modern iron strap to beam. Laths laid over rafters are the base of the lime ash floor.

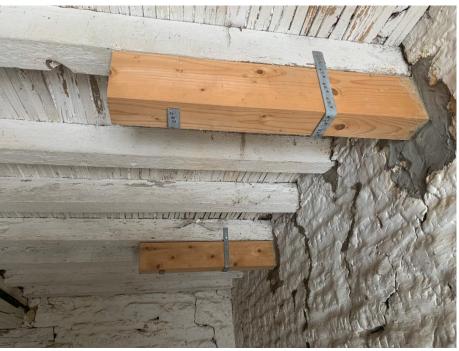
P21, right – modern structural intervention in Barn 3, these are supports for the modern balcony seen on the south elevation on first floor. A truly insensitive addition.

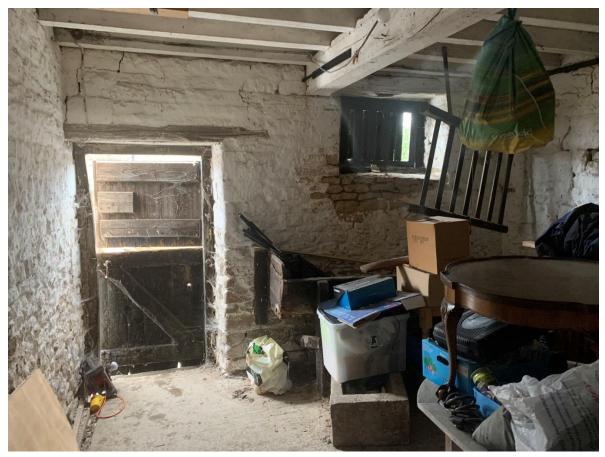
P22, left – stable door to Barn 3 with timber lintel above, feeding trough (below slatted breather vent).

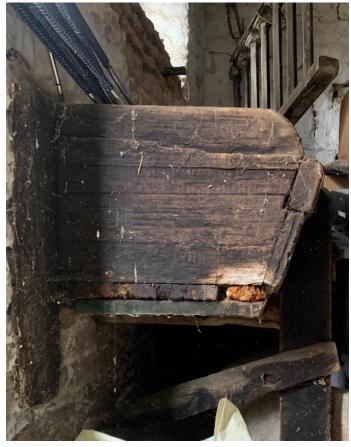
P23, right - detail of timber feeding trough in Barn 3

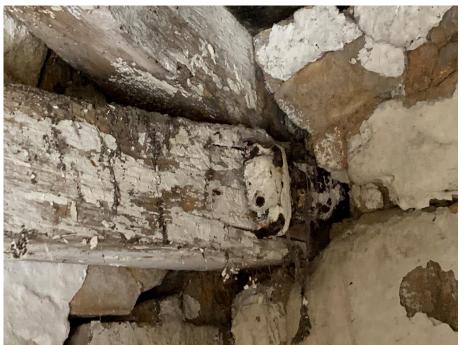
P25, right – Store 1, detail of old cast-iron tie.

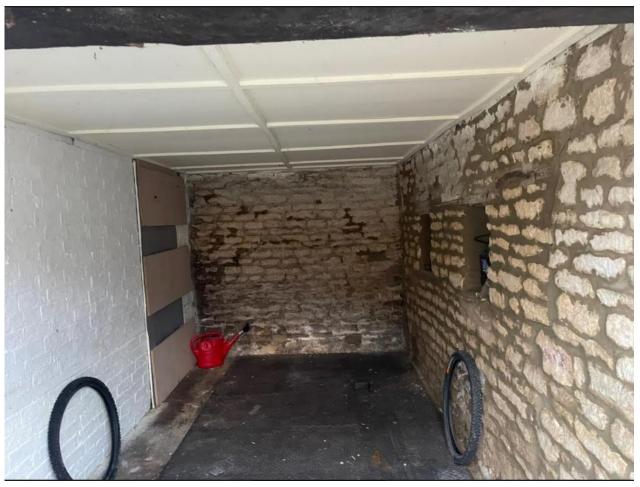
P26, Barn 2 (photo kindly supplied by the owner of the stone barn after removal of stored goods). Modern cement pointing to the walls, concrete floor, modern boarding to the ceiling and a blocked opening.

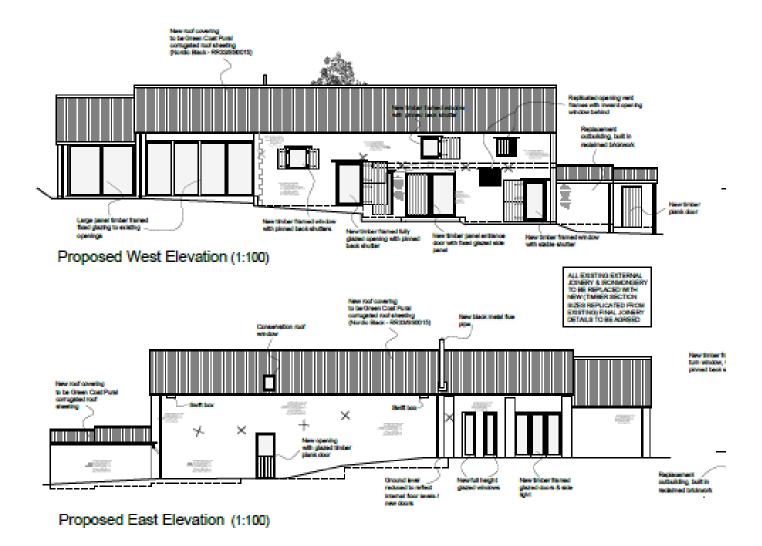
Extract of Drawing reference no. 329/SRA/0702A 02 Rev H – proposed general arrangements – shows proposed elevations of Stone Barn.
