20th September 2023

Ref: RLHP-2309-BS

Bat Survey

Riverside Lodge, Huntly Place, Aboyne

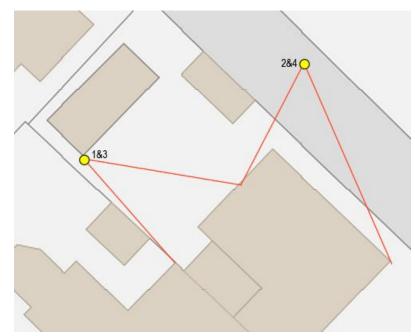
Observer Positions

Observer positions for the dusk surveys on the 1st (1&2) and 23rd of August (3&4) 2023.

IRC = Infrared Camera and NW = Nightfox Whisker. Both are infrared recording devices.

Position 1 (NW1)	There were very low levels of activity. Only four calls were recorded and no bats were seen during the survey. No bats exited the building.		
Position 2	There were low levels of activity. The only bats seen were a soprano pipistrelle foraging along the trees to the southeast at 22:30 and a common pipistrelle foraging around the same trees at 22:44.		
(OT+IRC03)	No bats exited the building.

Position 3 (IRCo3)	There were very low levels of activity with only nine calls recorded and no bats were seen. No bats exited the building.			
Position 4	The first bat was seen at 21:05 where a soprano pipistrelle foraged over the building from the south and then goes south again. After that, a couple of pipistrelles commuted from north to south.			
(JB+IRCo1)	No bats exited the building.
