**RE: Outbuilding and Land at Carpenters, Yarcombe**

Thank you for appointing Devon Ecology to undertake an ecological assessment of your property.

**Appendix 1: Photographs (red arrows indicate potential roosting feature).**

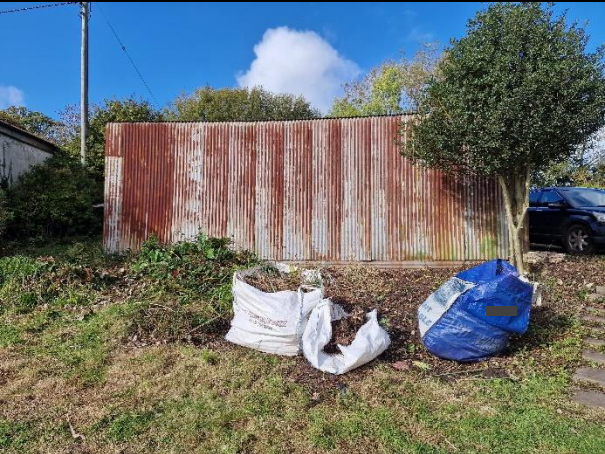
| <b>Notes</b> | <b>Photograph</b> |
|---|--|
| Outbuilding southeast elevation. | |

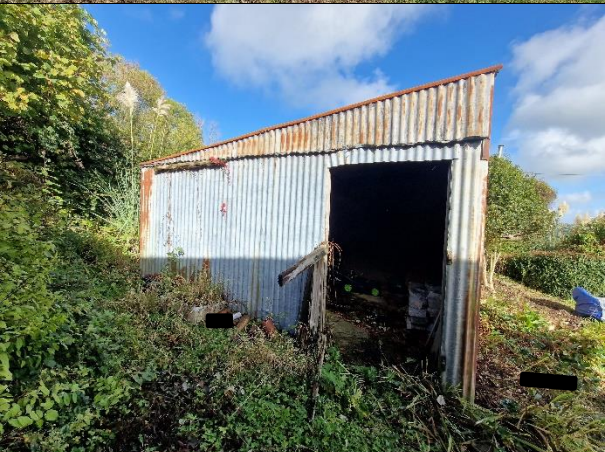
| <b>Notes</b> | <b>Photograph</b> |
|---|--|
| Outbuilding southwest elevation. | |

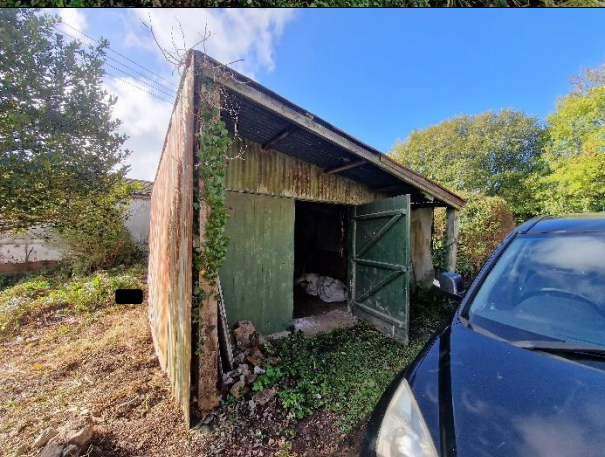
The outbuilding is a corrugated metal shed with a shallow sloping roof. It has double timber doors and a timber-framed window on the northeast elevation and an open door on the southwest elevation. The rear northwest elevation is adjacent to a box *Buxus sp.* hedge and has a small timber fascia in one place and corrugated sheet missing revealing a timber and asbestos sheet lining.

| <b>Notes</b> | <b>Photograph</b> |
|---|--|
| Outbuilding northeast elevation. | |

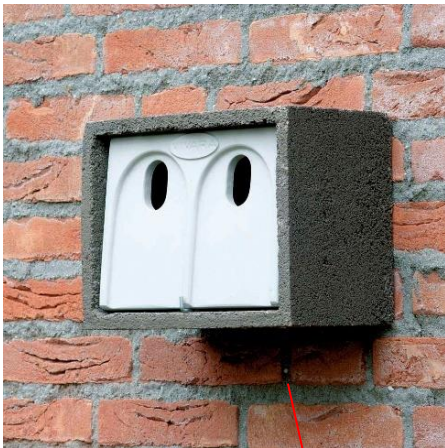
Vivaro Woodstone sparrow nest box. Available from Wildcare [Woodstone Sparrow Nest Box \(wildcare.co.uk\)](https://www.wildcare.co.uk), NHBS or other suppliers.

A bat box can be mounted on the southeast elevation and two house sparrow terraces on the northeast elevation (**Appendix 3**).
