Geo-Environmental Site Investigation Report

114-130 Lower Hythe Street
Dartford
DA1 1BN

Ref: 5477 23 09 01 Rpt 01 Rev B AK KM

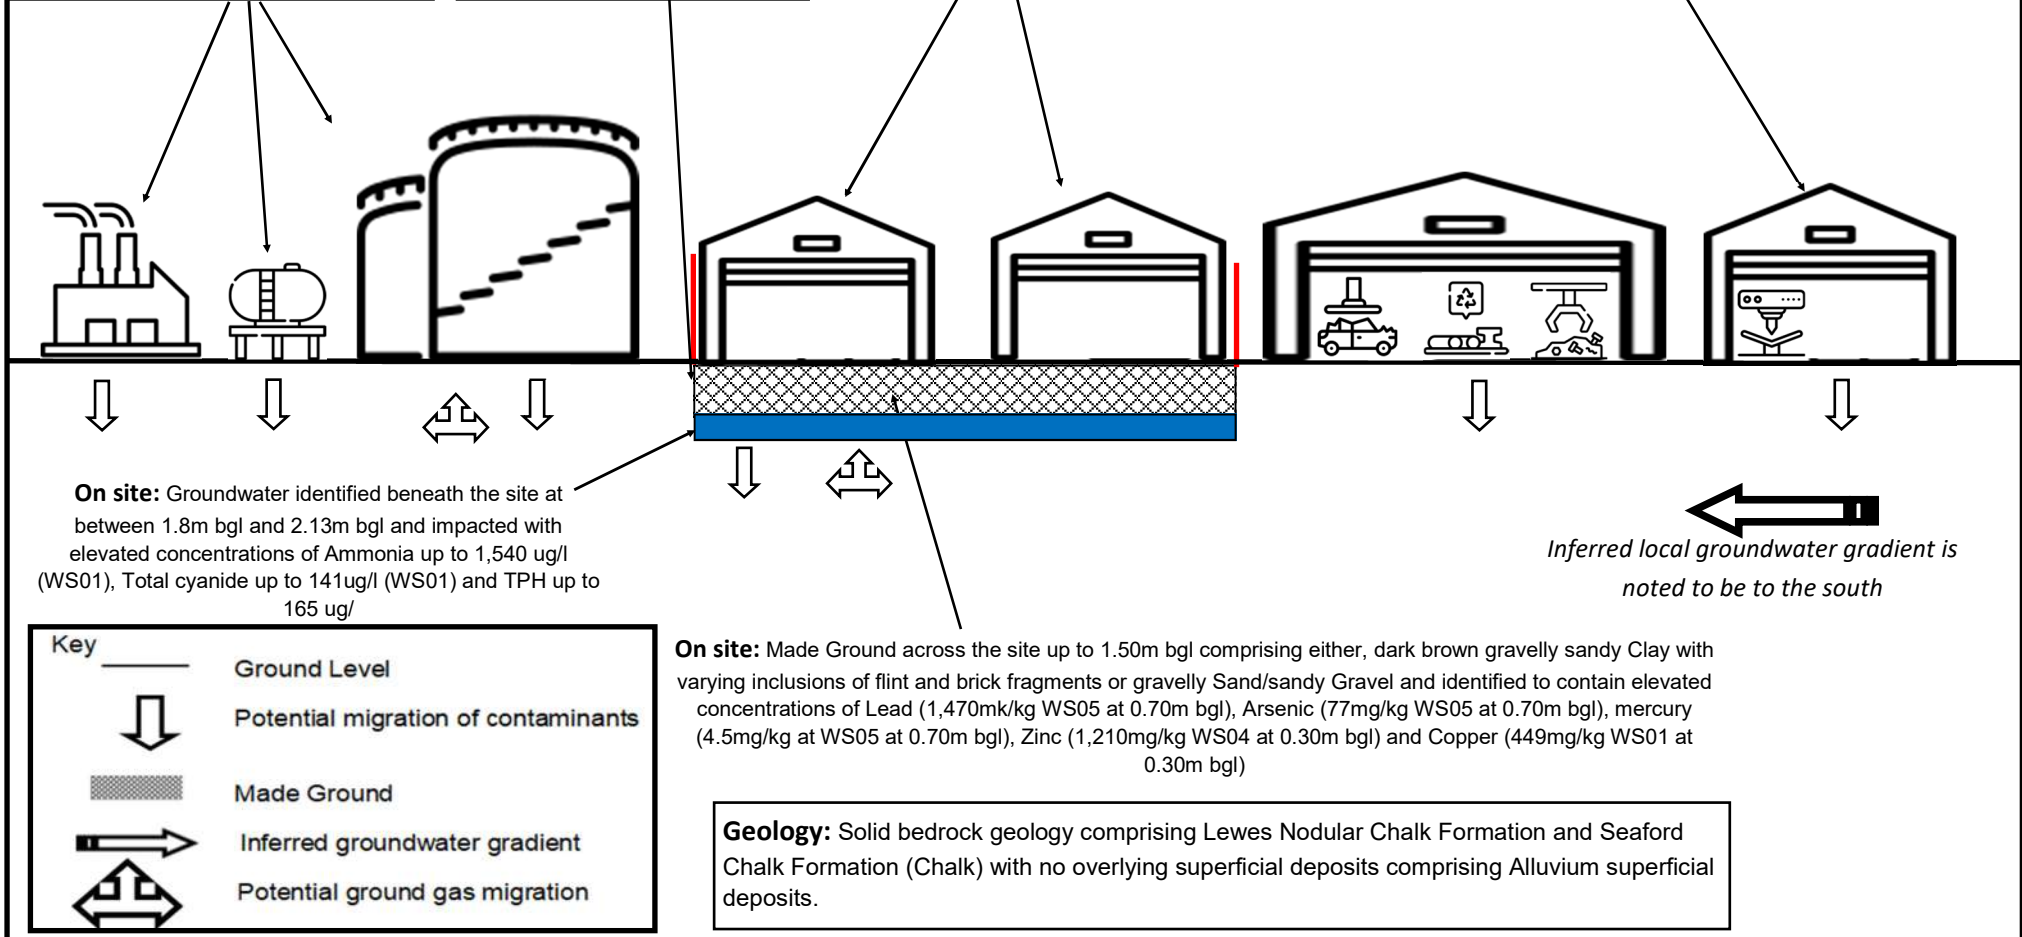
On site: Groundwater identified beneath the site at between 1.8m bgl and 2.13m bgl and impacted with elevated concentrations of Ammonia up to 1,540 ug/l (WS01), Total cyanide up to 141ug/l (WS01) and TPH up to 165 ug/l

Inferred local groundwater gradient is noted to be to the south

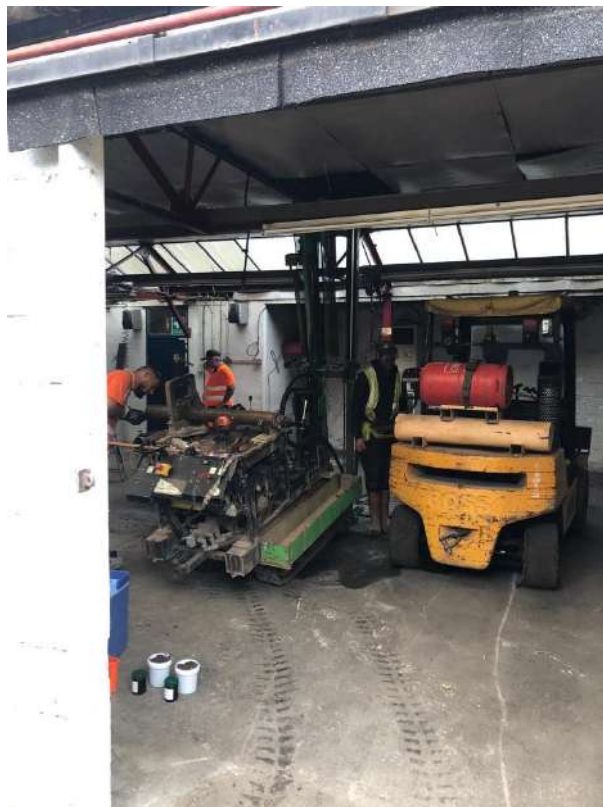
Photo 6 – Showing the rig set up at WS01

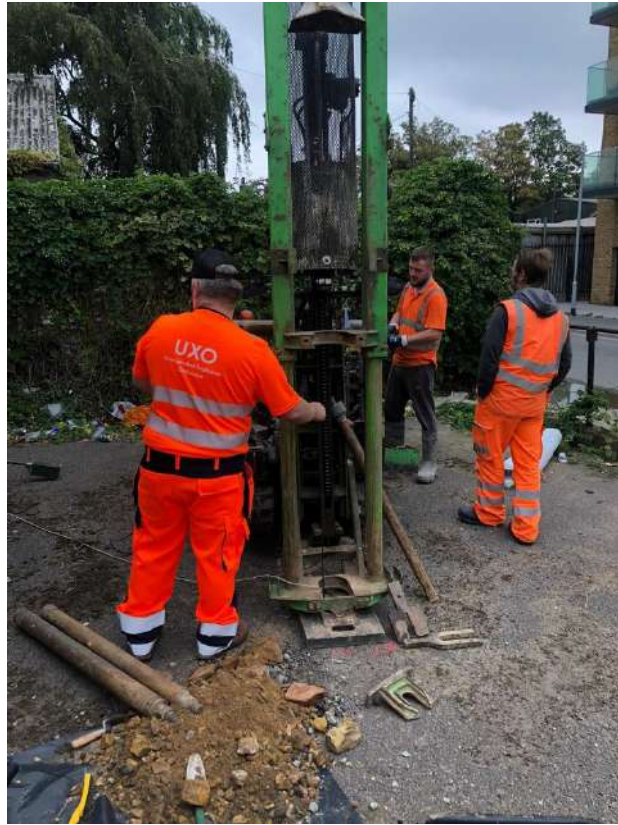
Photo 7 – Showing the UXO Detection Engineer clearing the borehole

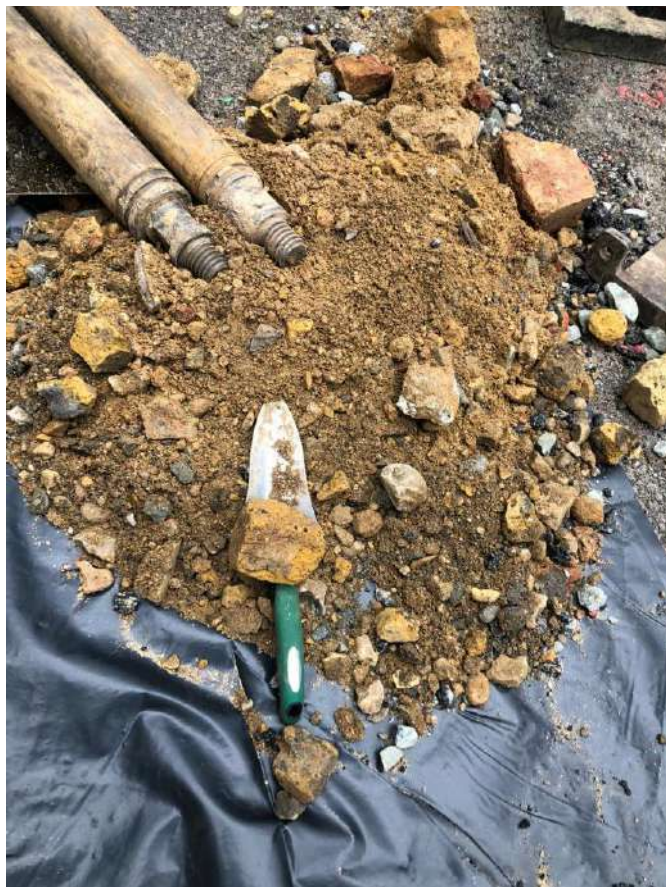
Photos 8 – Showing the soil arisings from the hand dug safety starter pit

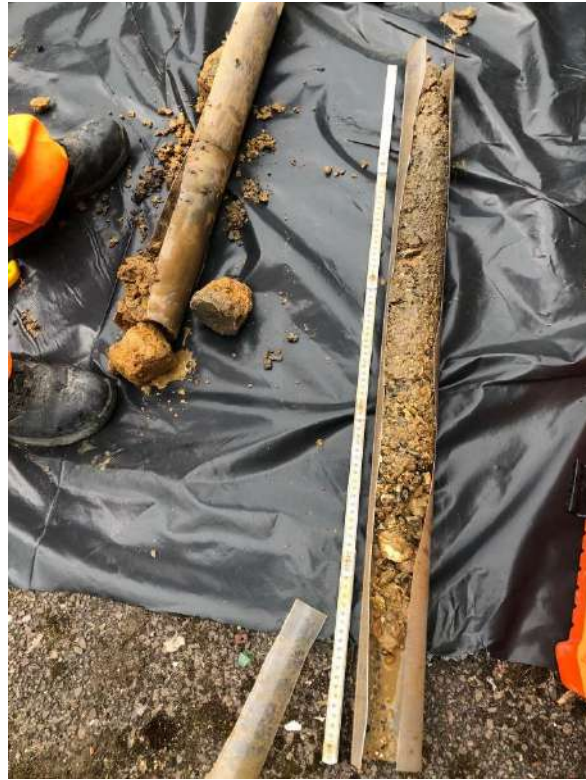
Photo 9 – Showing core samples taken from 1-3m bgl

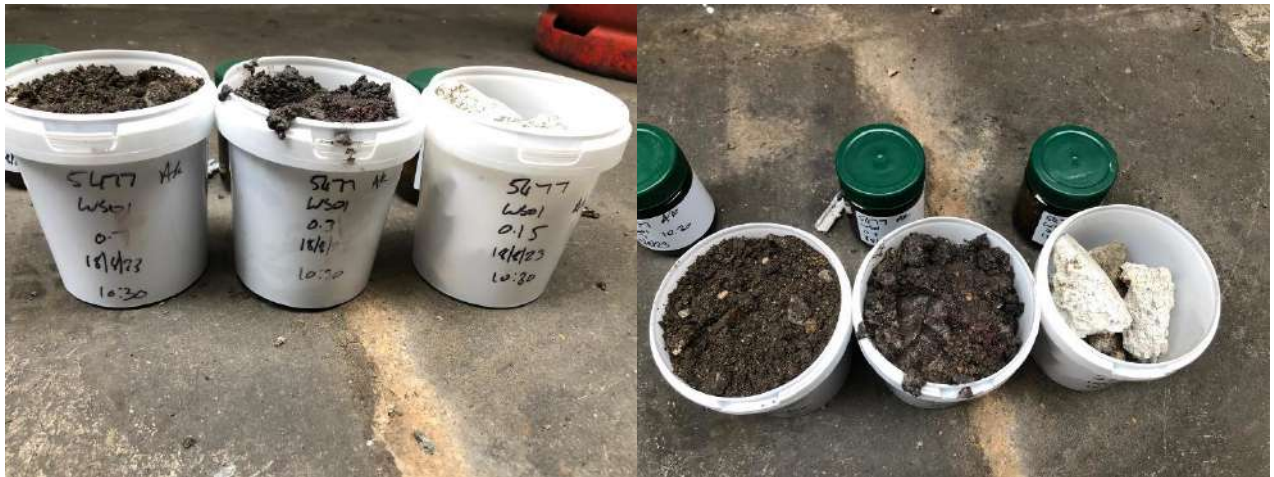
Photos 10 – Showing soil samples taken from WS01

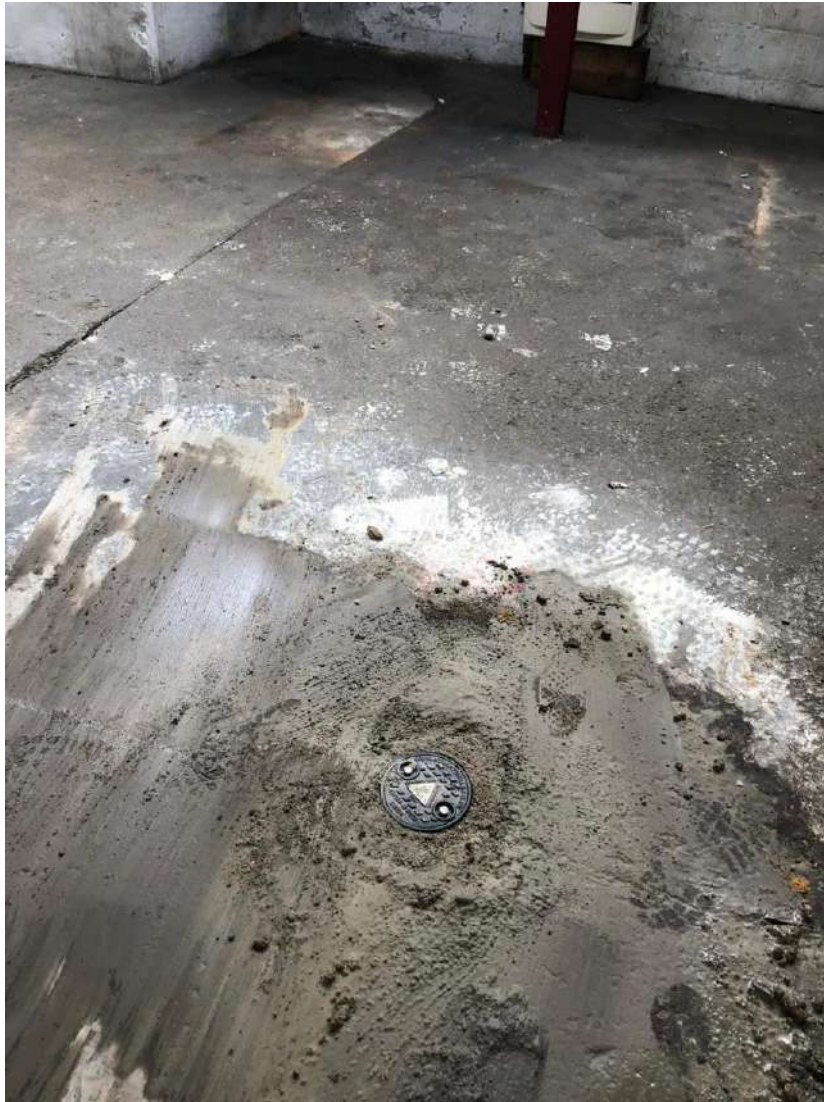
Photo 11 – Showing the borehole installed with monitoring wells and borehole cover
