**Ref: 3771/20**

**PROPOSED REDEVELOPMENT AT  
114-128 HYTHE STREET, DARTFORD,  
KENT DA1 1BN.**

**PHASE I GEO ENVIRONMENTAL DESK STUDY  
AND PRELIMINARY RISK ASSESSMENT**

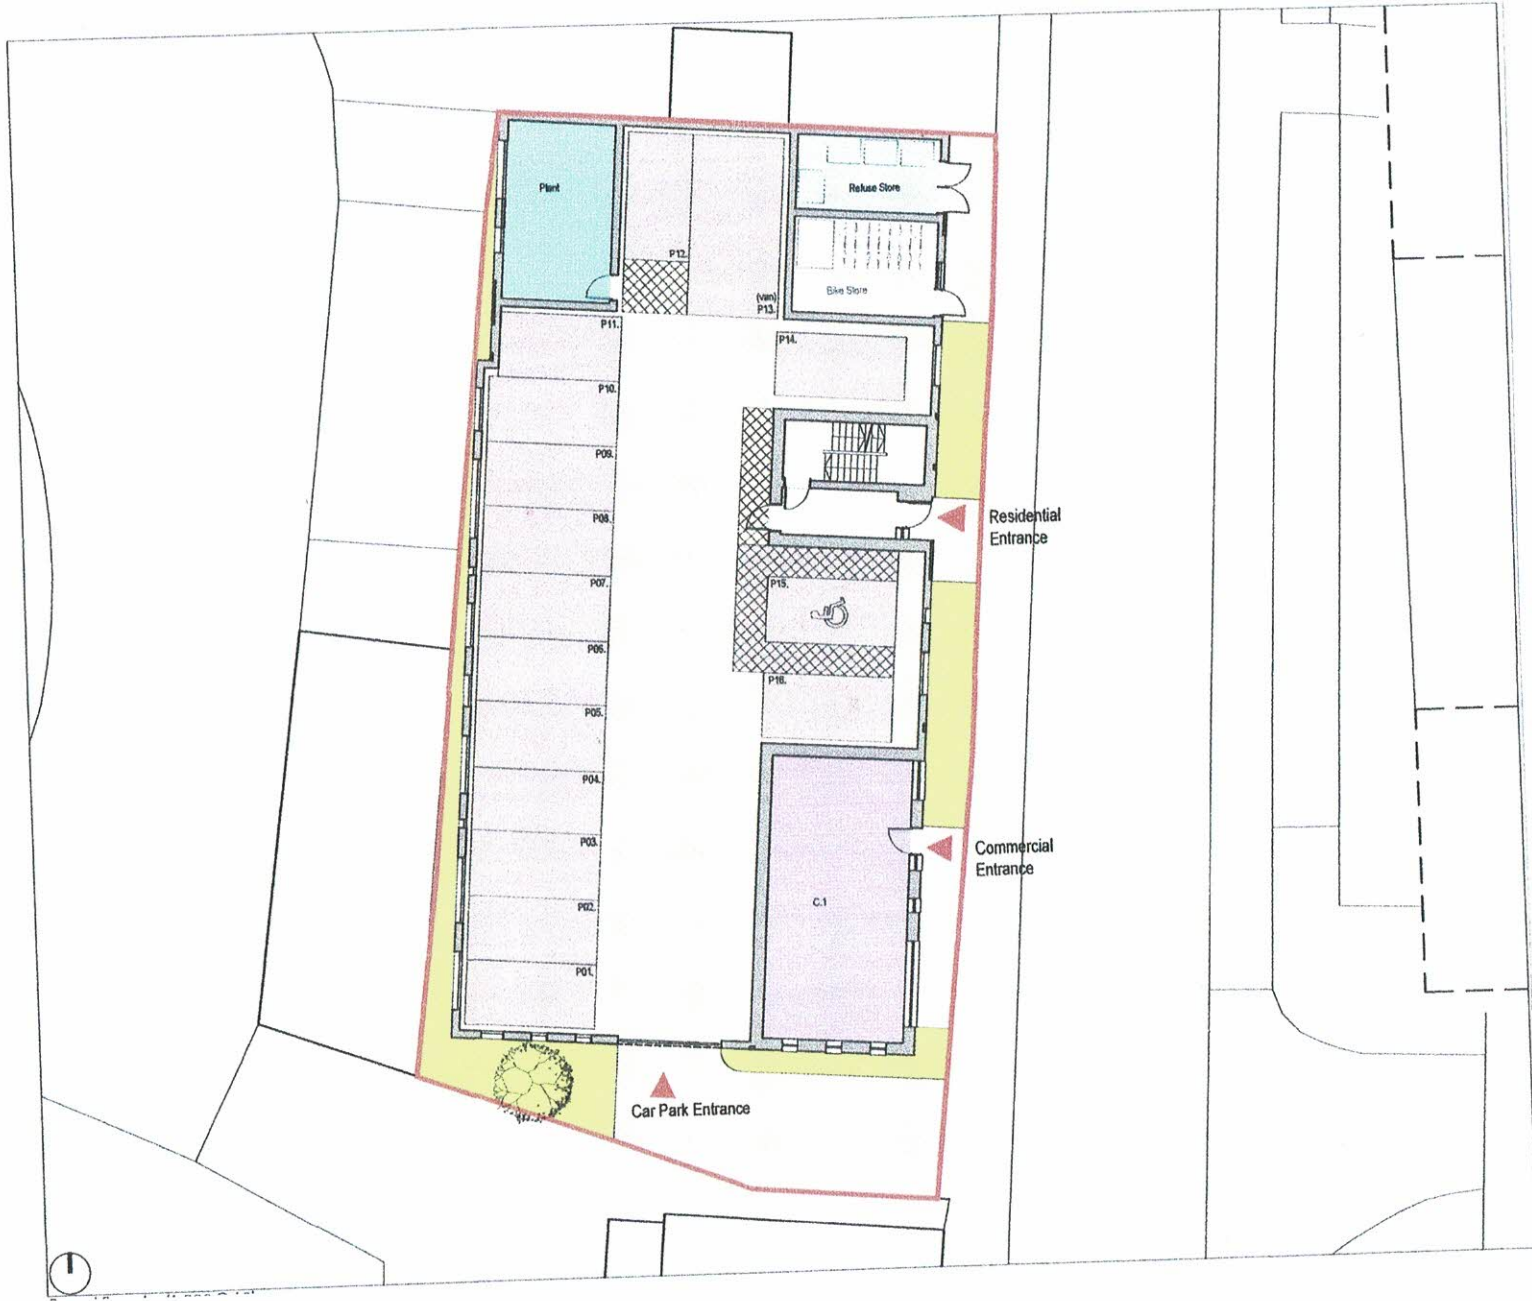
Fig 1. Plan of Proposed Development.

- 1.1 This report has been prepared on behalf of Skillcrown Homes Ltd, prospective developers of the site located at 114-128 Hythe Street, Dartford.
- 1.2 The proposed development comprises the demolition of existing buildings and the construction of one and two-bedroomed apartments with associated areas of vehicular parking. Marginal landscaping is scheduled along the south, east and west boundaries of the site and undercroft parking is proposed at ground floor level. A plan of the proposed development is shown in Fig 1.

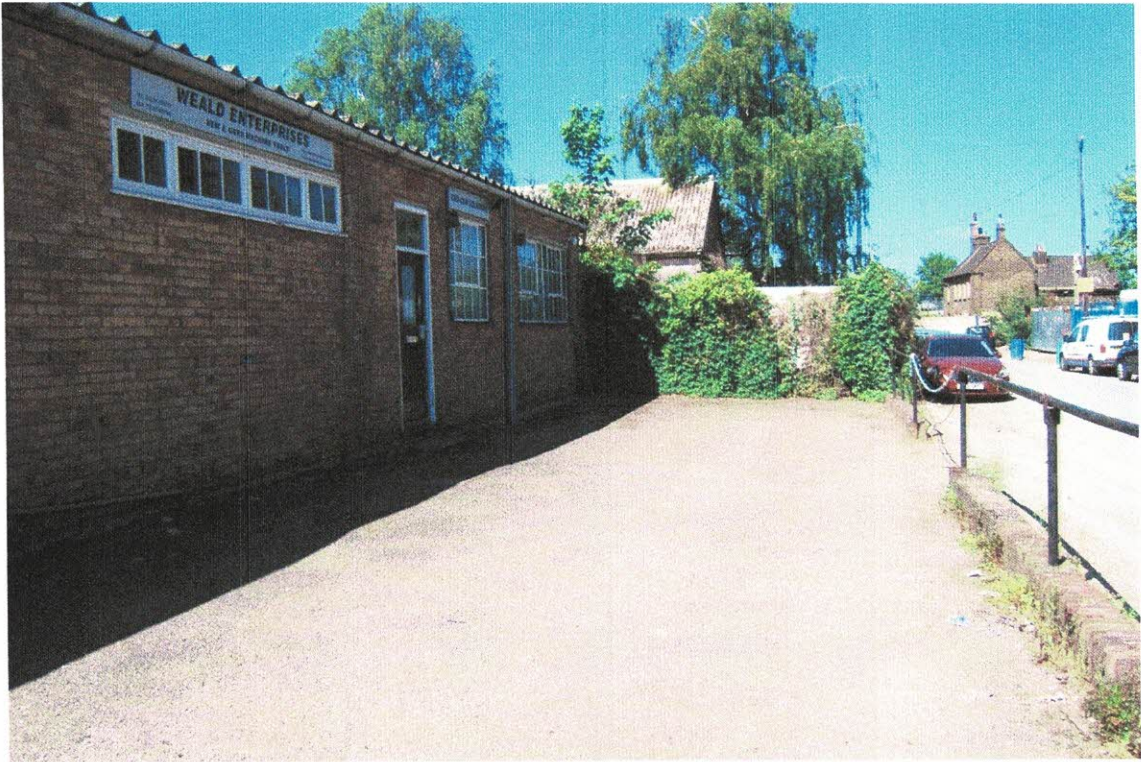
Plate 1

- 7.3 The site was roughly rectangular in shape, steel railings set in a dwarf brick wall forming its front boundary alongside Hythe Street (Plate 1). The west side of the site was occupied by a single storey brick building under a corrugated asbestos-cement roof. Ground surface along the front of the building comprised a 4m wide strip of tarmac coated concrete which provided limited parking, vehicular access into the site being gained via a padlocked chain in between the steel railings.

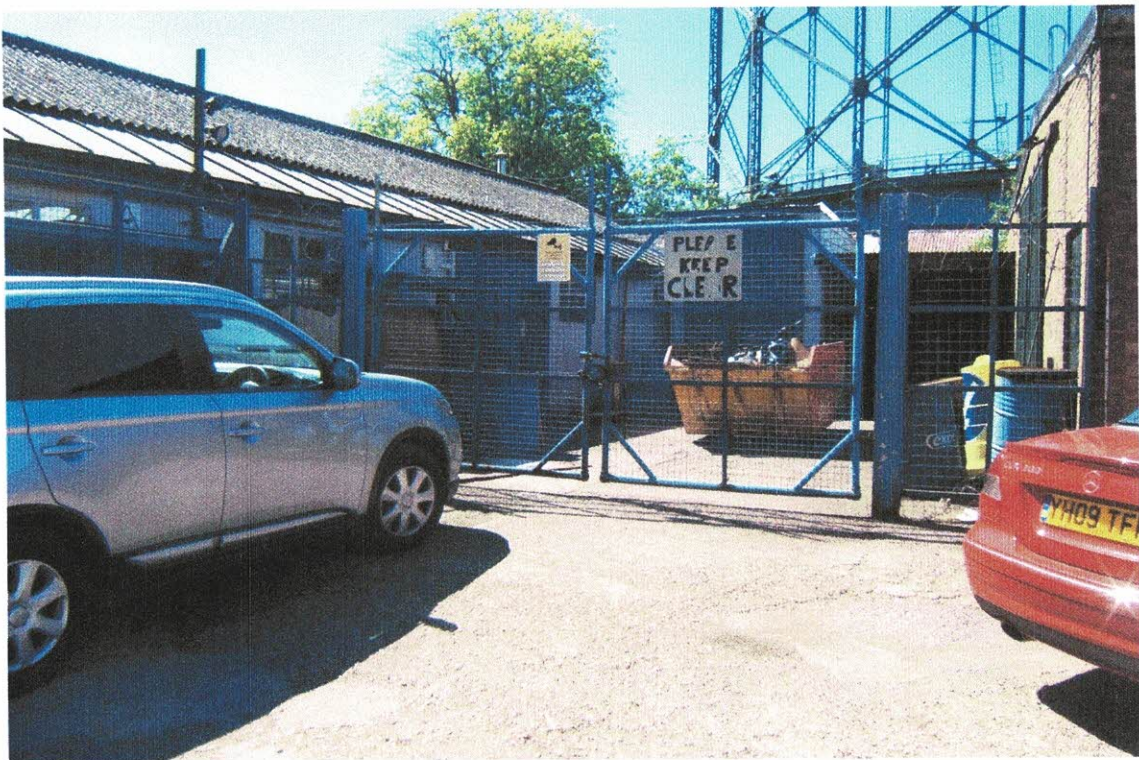
Plate 2

- 7.4 A pair of padlocked steel gates located in the southwest corner of the site secured the entrance of a small concrete-surfaced yard at the south end of the building (Plate 2).

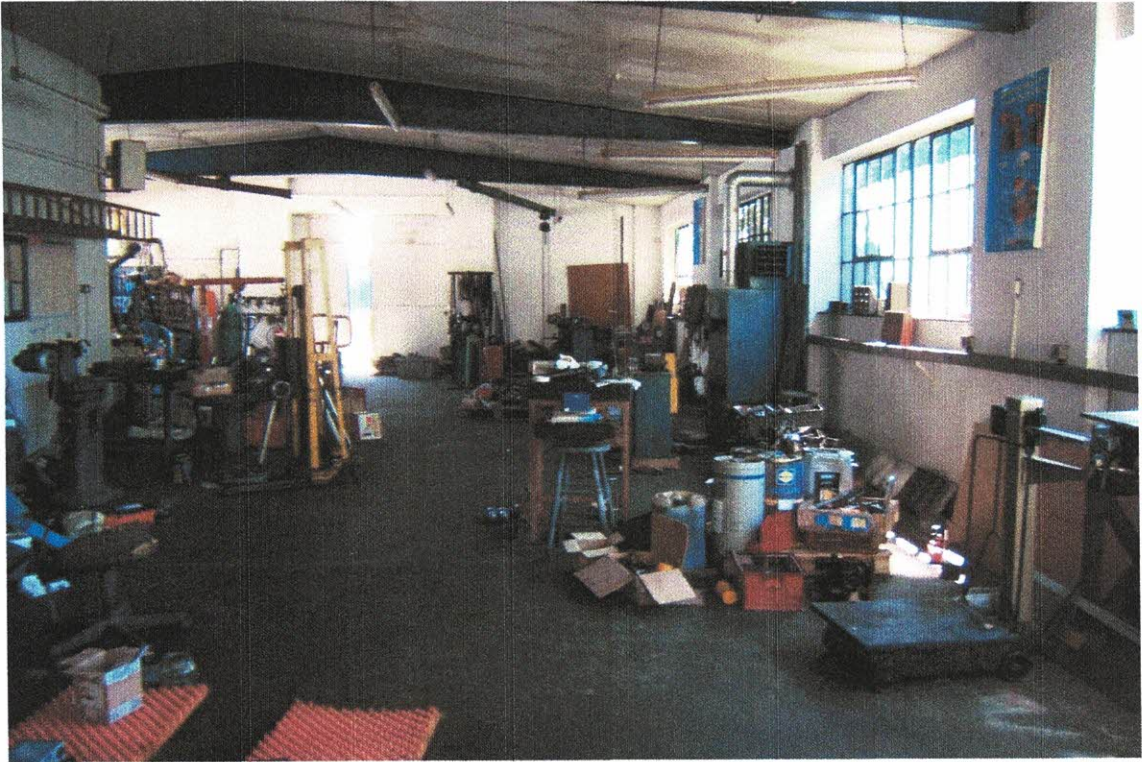
**Plate 3**

- 7.6 The building comprised a former precision-engineering workshop which was in the process of being cleared out. A small store was located in its northeast corner, staff toilets being situated centrally on its east side. Timber work benches and shelves were positioned alongside the east elevation at the south end of the building. The building was underlain by a concrete floor of a rather greasy appearance but with no

observed evidence of significant staining in its exposed areas. Numerous boxes of machine parts, hand tools, disconnected electrical machinery and trolley jacks were present on the floor of the building and on the work benches (Plate 3 and Plate 4).

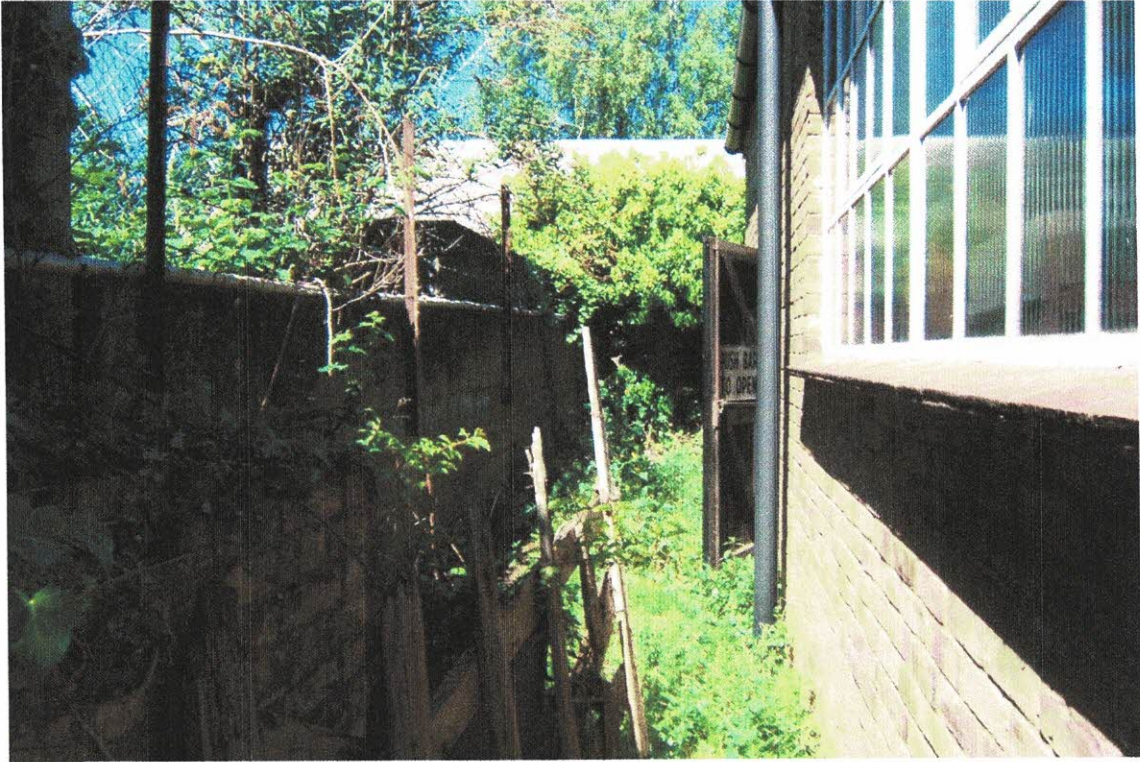
**Plate 5**

- 7.7 A strip of overgrown land approximately 1m in width was present along the west elevation of the building a brick wall approximately 1.5m in height forming the site's west boundary (Plate 5). A discarded timber pallet was leaning against the wall.

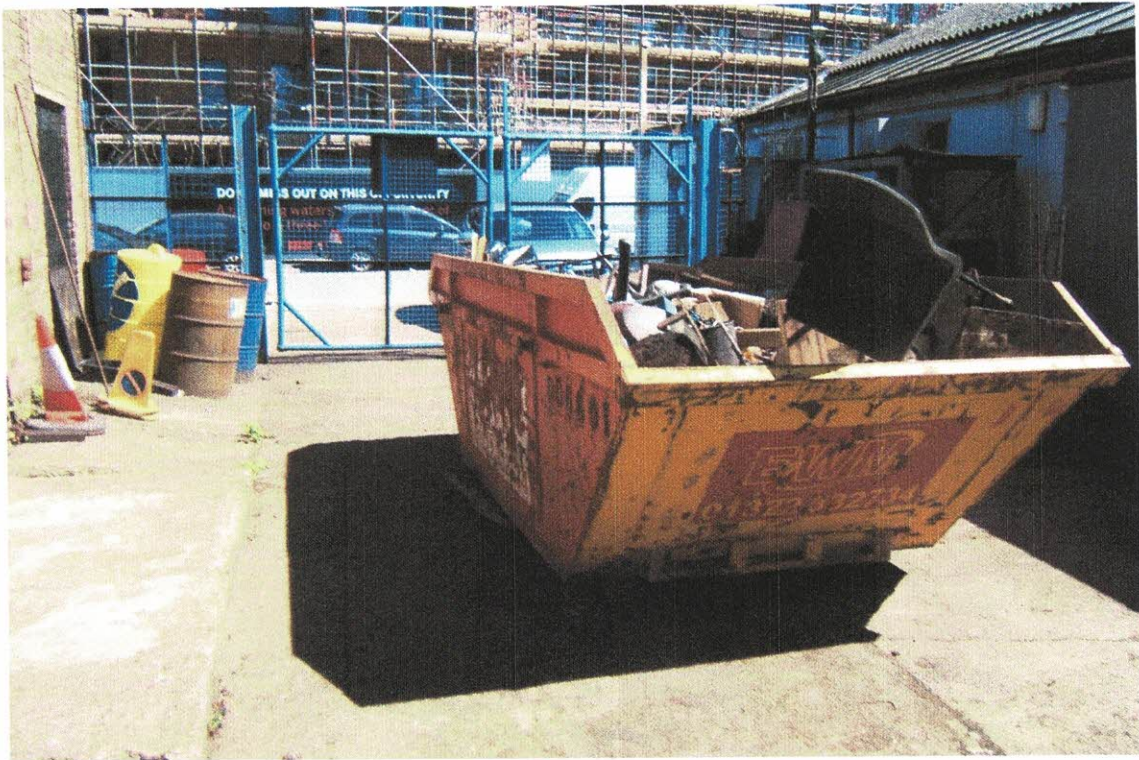
**Plate 6**

- 7.9 The small yard was accessed via a pair of timber doors located at the south end of the building, a partially filled skip being present in its central area and three empty oil drums being present near the steel gates (Plate 6). A small timber lean-to under a corrugated steel roof was located at the west end of the yard, discarded pieces of timber and steel trestles being stored within the structure.

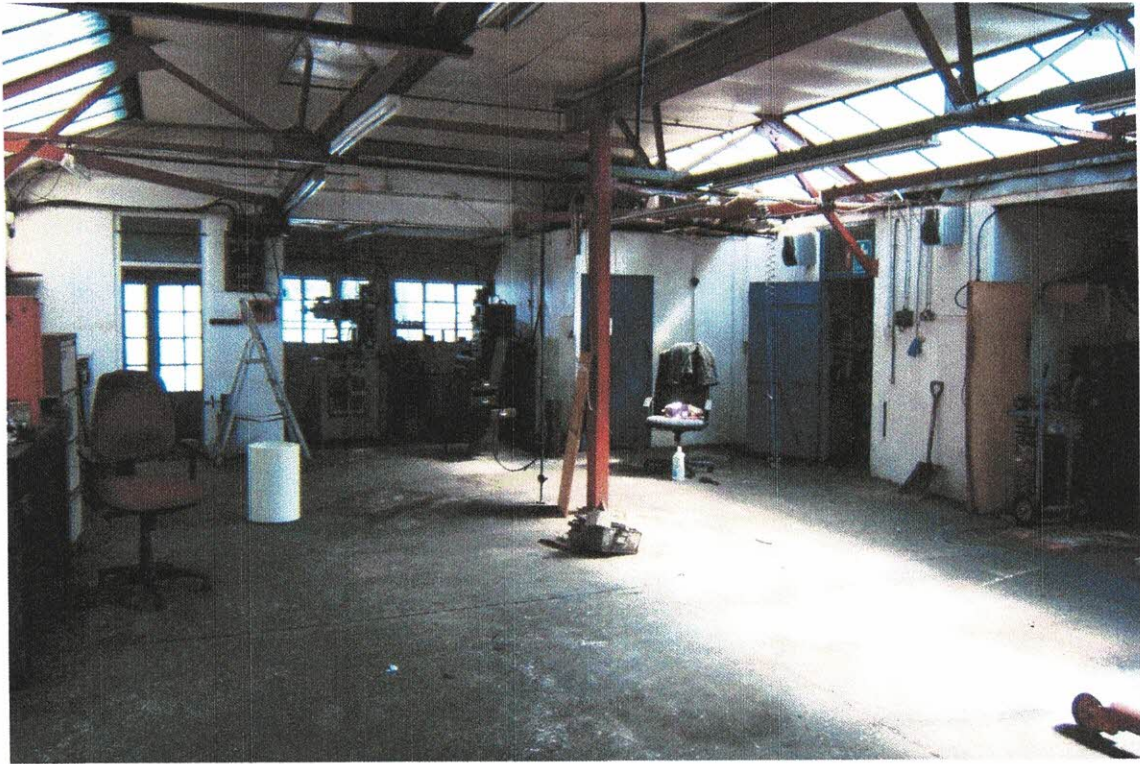
**Plate 7**

- 7.10 The south section of the site supported a smaller, single-storey rectangular building of brick, block and steel frame construction under a corrugated steel roof. Access into the building was gained from its north elevation via the yard. The building similarly comprised a former tool-making workshop which was also in the process of being cleared out. A small toilet facility was located within the southwest corner of the building and timber workbenches and shelves were positioned along its north elevation. Office chairs, hand tools and disconnected electrical machinery remained within the building, together with a fork-lift vehicle (Plate 7 and Plate 8). The concrete floor of the building also displayed a slightly greasy appearance with no evidence of significant spillages.
