# The Hemmel

Wolsingham  
DL13 3HG

## Bat Survey

Report reference: HemmelWolsingham\_Bat\_v2.0

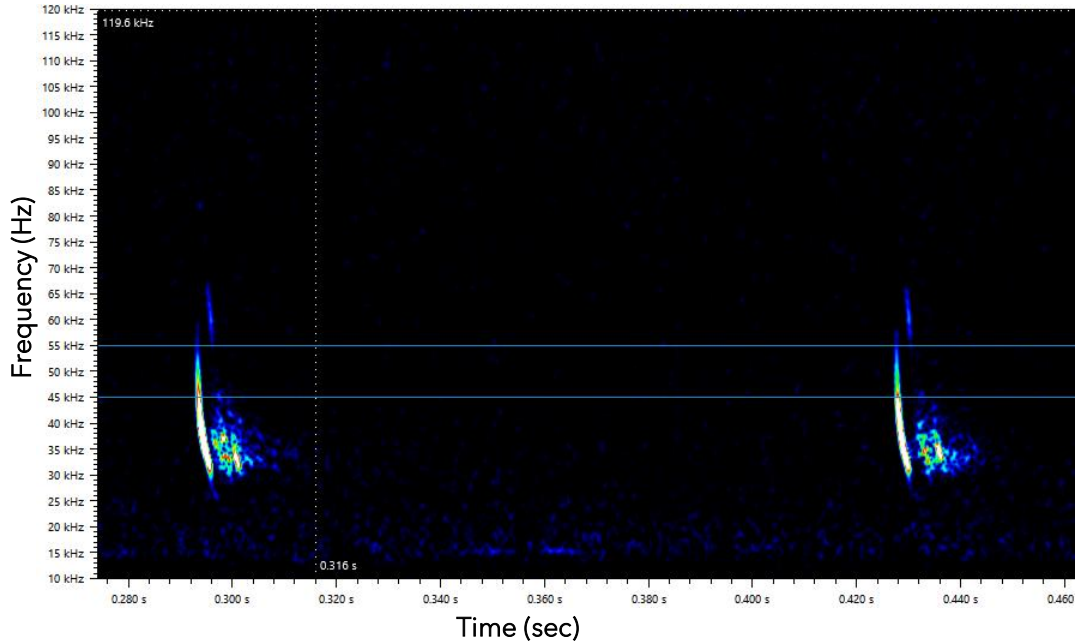
Figure 4: Sonogram of echolocating bat emerging from barn window, with call parameters and peak frequency (36.6 kHz) indicating brown long-eared.

- 4.3.1 Towards the beginning of the dusk survey, a single brown long-eared bat (Figure 4) was seen to emerge from a window opening in the northwest gable of the barn. Individual and pairs of common pipistrelles were noted commuting across the site from the north, pausing above the barn to forage amongst the tree canopy, before continuing south. Individual common pipistrelles were also noted foraging intermittently up and down the sheltered, tree-lined lane to the southeast of the barn. No further roosts were noted. Similar patterns of behaviour were recorded during the dawn survey. Individual brown long-eared bats were noted on two occasions during this survey, however no bats were seen to enter the building. Infra-red footage from within the barn during the dawn survey revealed no bat activity inside

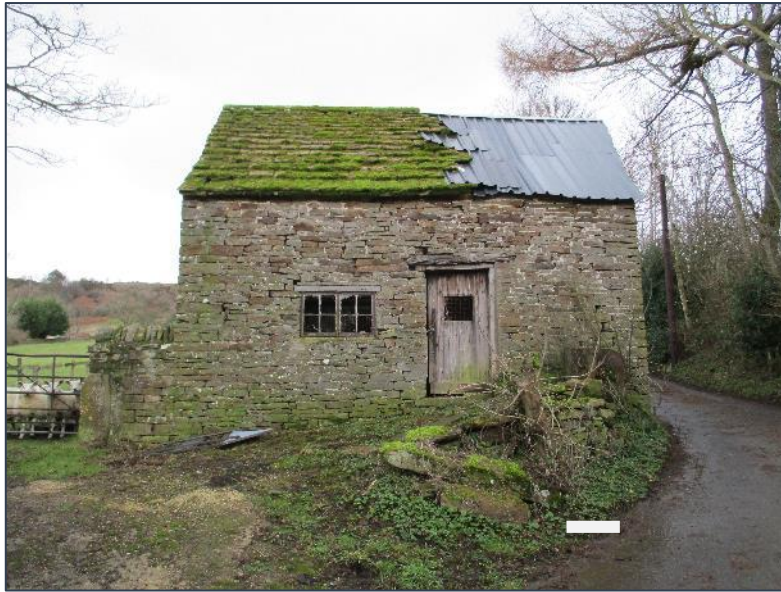
**Photograph 1**

Front (southwest) elevation of barn.

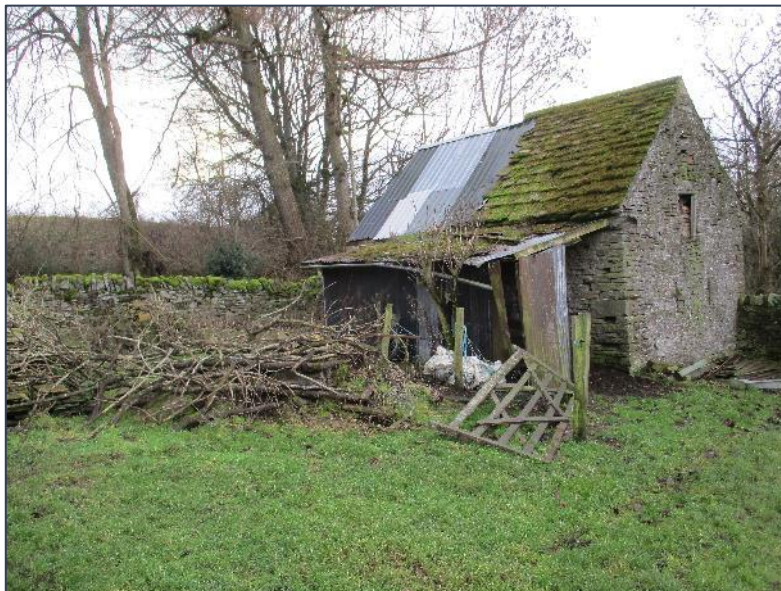
**Photograph 2**

Rear (northeast) elevation of barn and north-western gable.

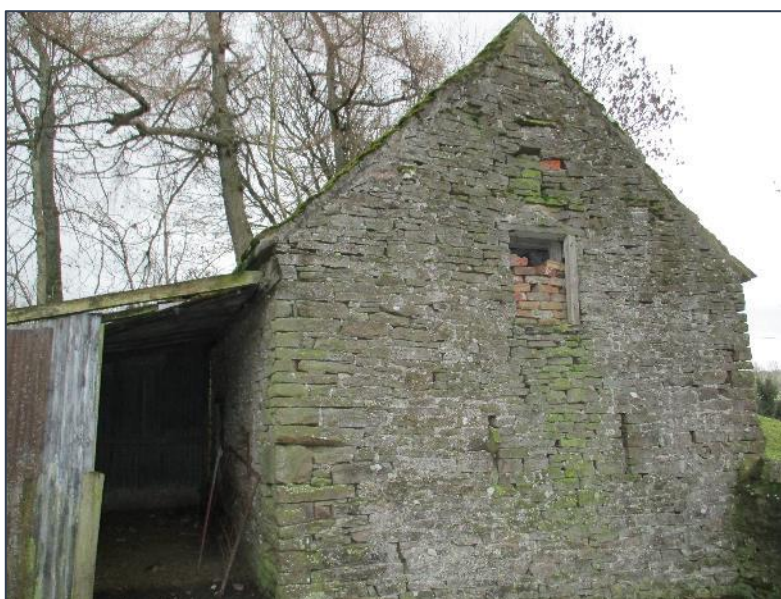
**Photograph 3**

Side (northwest) elevation of property, with window opening.

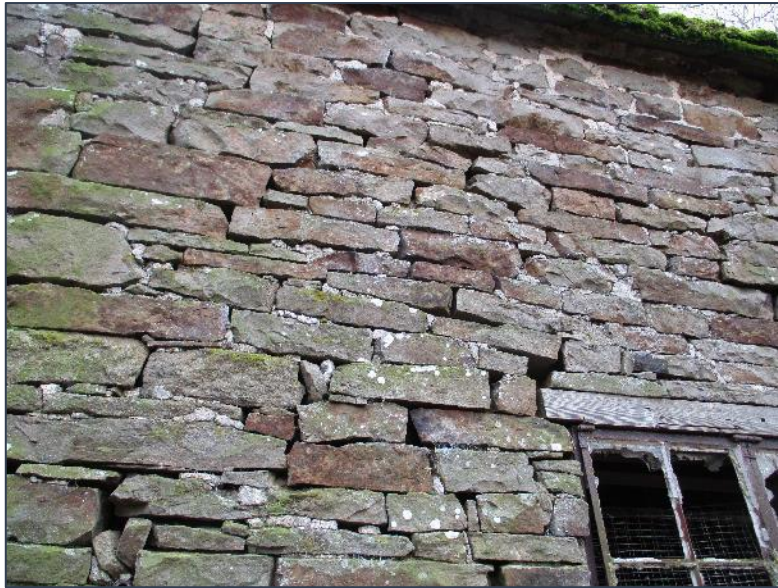
**Photograph 4**

is no rubble fill to the south-eastern gable wall and this has been replaced by a cavity. With the exception of the newly rebuilt gable, numerous potential bat access gaps were noted within the external joints of the stone walls and beneath the stone flags of the roof. Internally, stonework is generally well-pointed and stone flags sit directly onto roofing timbers, with no underfelt. No evidence of use of the barn by roosting bats was noted during the internal or external inspection (see also 3.5), however a window opening within the north-western gable would provide ample opportunity for bats to access the inside of the undisturbed building.

Typical mortar gaps in stonework.

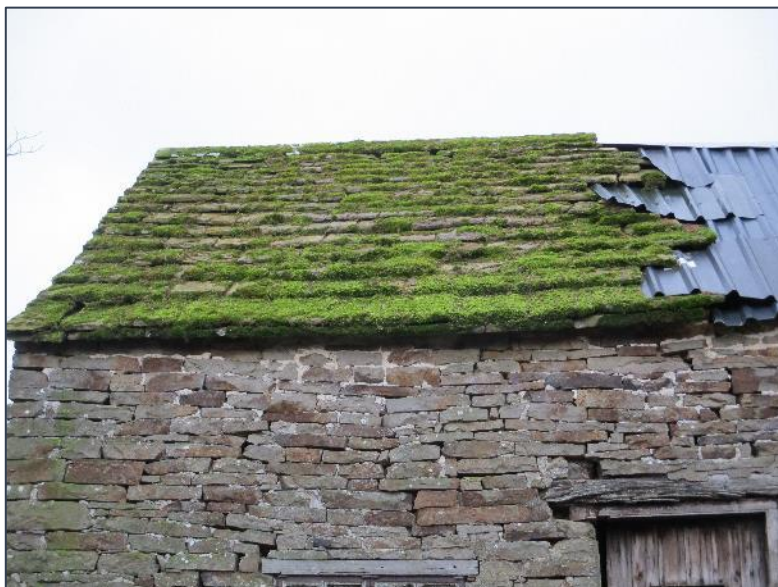
**Photograph 5**

South-western roof pitch, showing gaps beneath ridge and stone flags.

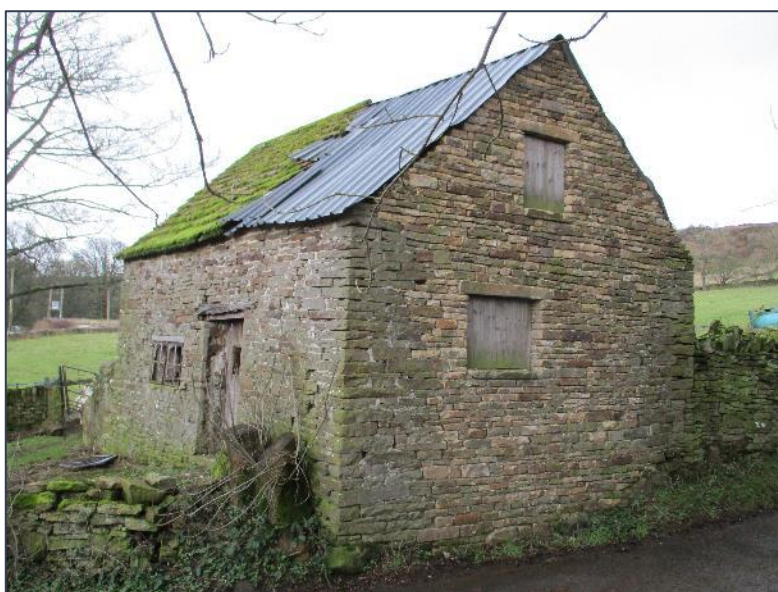
**Photograph 6**

Recently rebuilt (2022) south-eastern gable wall. This area contains fewer potential bat access gaps, however gaps remain over the wall top and potentially into the cavity.

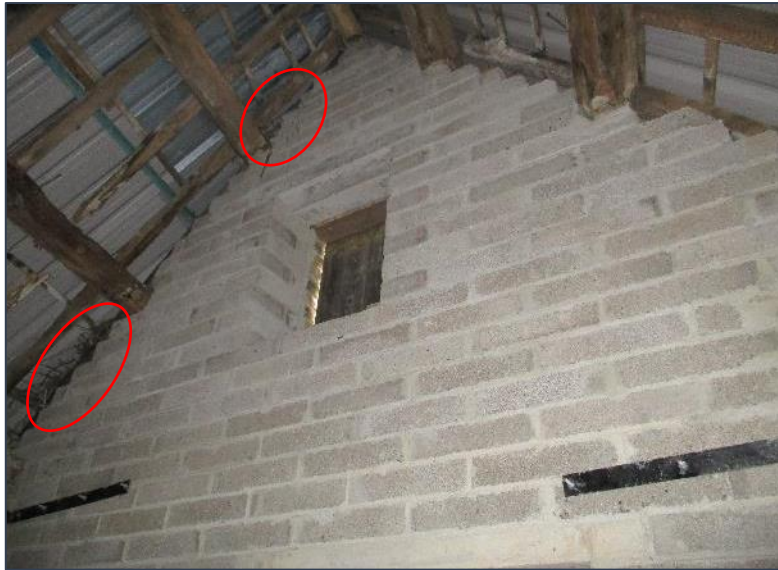
**Photograph 7**

- 4.2.2 No evidence of use of the structure by barn owl (*Tyto alba*) was noted during the building inspection (see also 3.5), although the building holds good suitability for this species. Previously used jackdaw (*Corvus monedula*) (or similar) nesting material was noted along the wall tops of the south-eastern gable, which could only have been created after the rebuilding of the wall in 2022. Bird nesting material (blue tit (*Cyanistes caeruleus*), wren (*Troglodytes troglodytes*), or similar) was noted within a gap in the stonework of the north-western gable wall and a single swallow (*Hirundo rustica*) nest was noted internally.

Interior leaf of rebuilt south-eastern gable, showing bird nesting material on wall top.

7.11.4 Redundant swallow nests and previous use of the wall tops inside the barn by jackdaw (or similar) was noted. External stonework gaps also appear to be used by wren, blue tit or similar. Works should be careful to avoid impacts to active nests, which may involve the timing of works to fall outside of the bird nesting season. If in doubt as to whether birds are actively nesting, a check should be undertaken by a suitably qualified ecologist immediately prior to the commencement of any works. Where nesting birds are found, works will not proceed in this area until chicks have vacated the nest or the nest is otherwise no longer active. To compensate for the loss of nesting opportunities, particularly for swallows, it is proposed to position at least two artificial swallow nest cups within a building 140m to the north. Nest boxes for blue tit and wren will also be provided to the exterior of this building, as shown in Appendix 2.

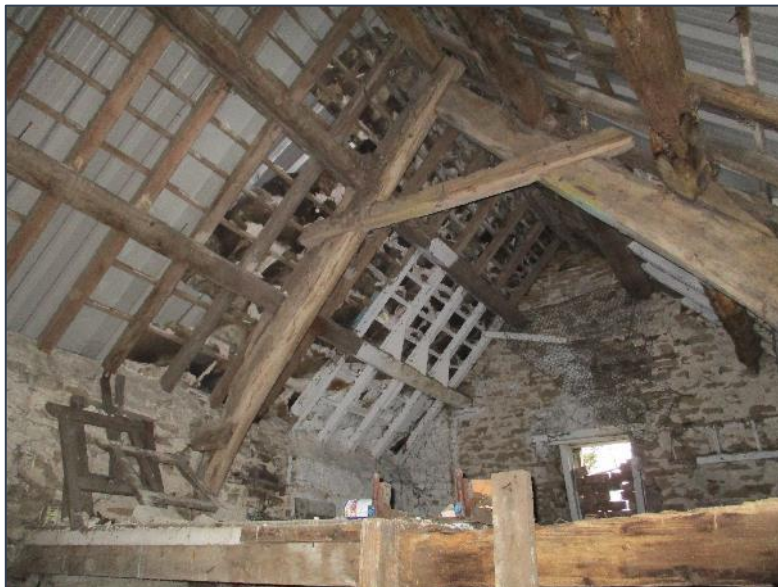
**Photograph 8**

Interior of barn, showing roof construction and interior walls.

7.7.1 In order for the small barn to function as a residential dwelling, it will be necessary to incorporate an upper storey, and therefore a roof void cannot be retained. It is proposed to provide permanent replacement roosting provision within an alternative building, located 140m to the north of the barn at NZ 08082 38374. A derelict outbuilding within the same landholding will be modified to encourage use by brown long-eared bats. Details of how this will be achieved are provided in Appendix 2.

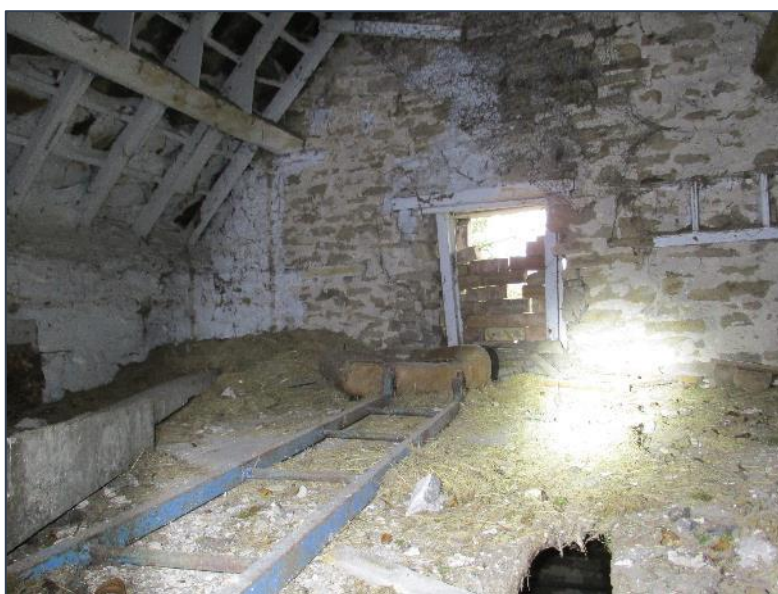
**Photograph 9**

3.5.2 Due to the deteriorating condition of the timber beams and floorboards, the mezzanine level of the barn was not walked across. Inspection of this area was undertaken by torchlight from the floor edge. It is possible evidence of bat or barn owl use exists in this area, which was not recorded during the risk assessment survey. This constraint was taken into account when attributing a risk level to the building, and recommendations for nocturnal activity surveys revised accordingly. Precautionary methods (pre works checking survey) have been recommended for barn owls.

View of mezzanine floor, from vantage point.

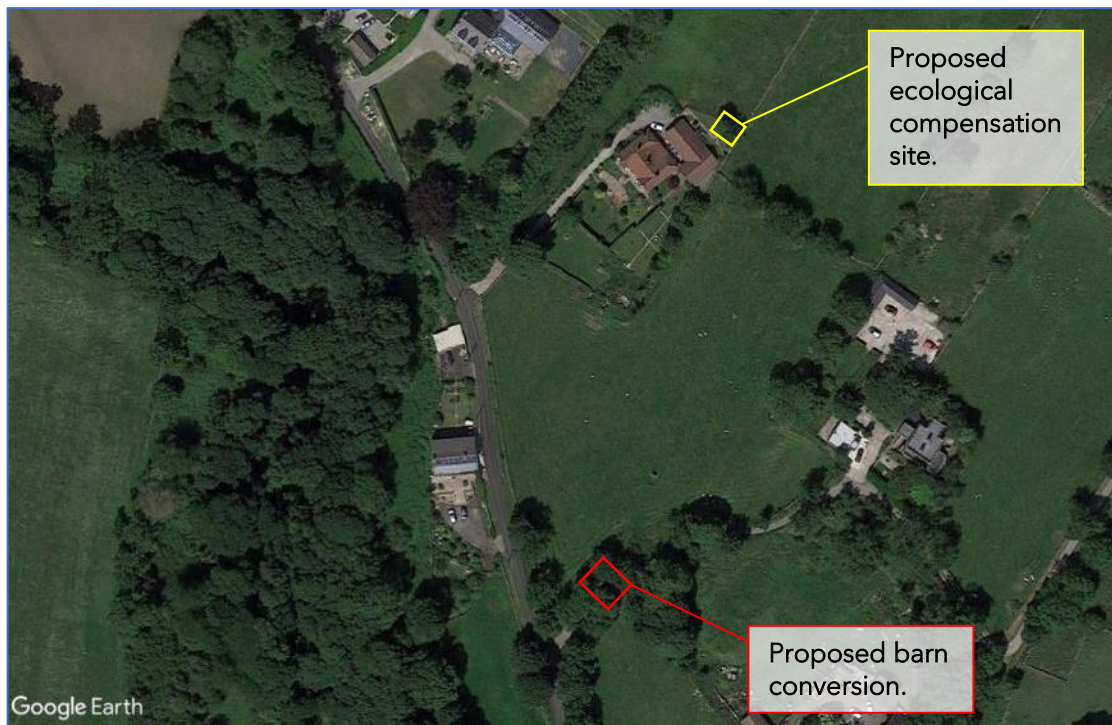
Figure A: Location of compensatory bat roosting and bird nesting provision in relation to site.

- A.1 Ecological compensation is to be delivered off-site, but within the same landholding, 140m to the north of the barn conversion at NZ 08082 38374 (Figure A).

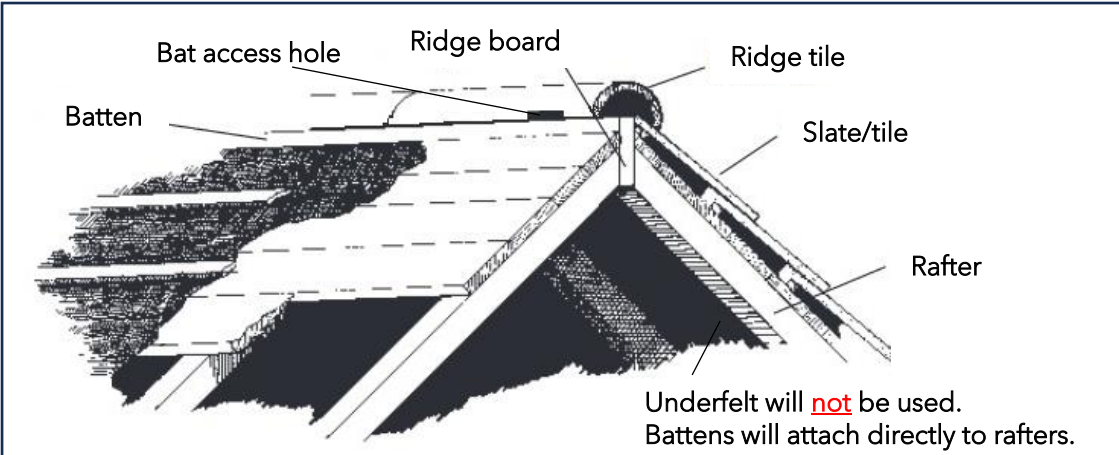
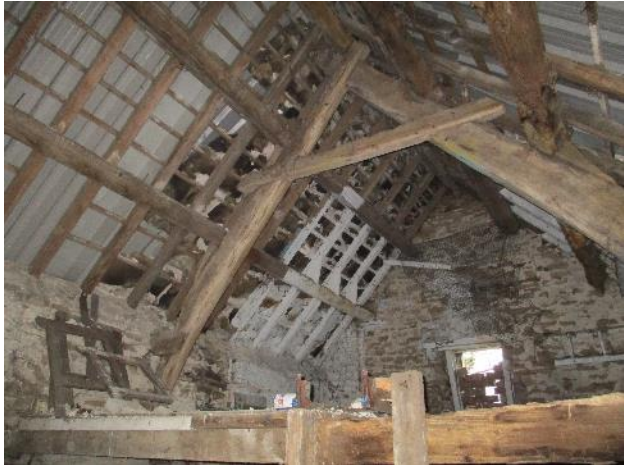
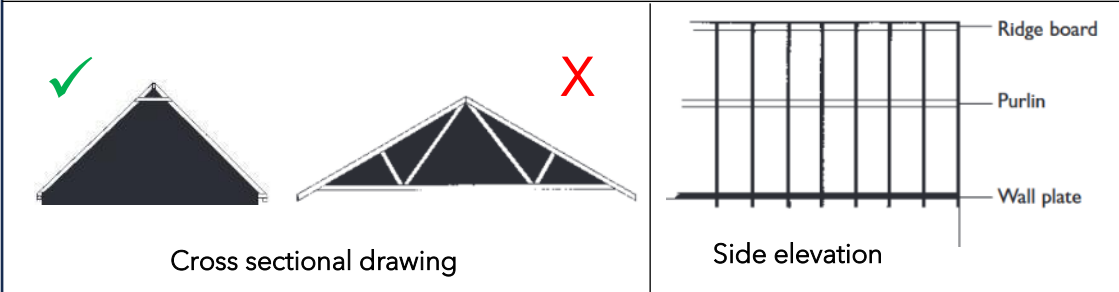
Figure B: Proposed roof construction (adapted from Mitchell-Jones & McLeish (eds). 2004).

C.1.1 The building will require a pitched roof. The existing corrugated metal roof should be removed and replaced with a slate or tiled roof of purlin and rafter construction (Figure B). It is important that the internal roof space does not contain roof trusses, so as to allow an uncluttered internal flight space for bats. Cross beams should also be avoided for this reason. The roof pitch must be at least 2000 mm in height from ground level, but preferably higher.

Underfelt will **not** be used.  
Battens will attach directly to rafters.

The proposed roof structure is designed to replicate the existing barn.

C.1.3 Access for bats will be provided via gaps along the trailing edge of a ridge tile located at either end of the roof (2 no. in total) (Figure B). To achieve this, a small notch 100 mm wide x 20 mm high will be cut from the base of the ridge tile, as per Figure C. The notch should not exceed these dimensions, so as to discourage use of the ridge gap by birds. It is important to also provide a narrow (15-20 mm) gap alongside the ridge board (as per Figure D) to allow bat access into the building itself.

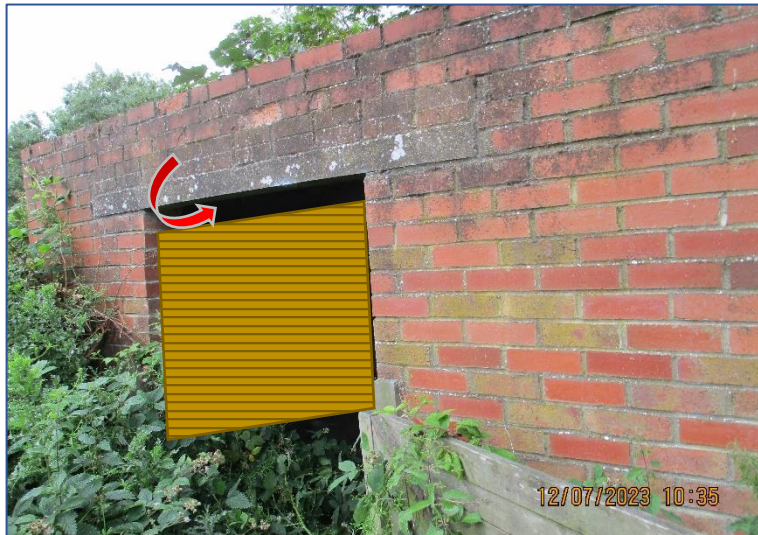
Figure E: Proposed door-top gap on north elevation.

C.2.2 A replacement upper stable door will be installed at the entrance way to the north of the building, and both the upper and lower stable doors will be kept closed at all times. The upper stable door will be constructed so as to allow a narrow gap along the door top (Figure E), equal in height to one brick (100 mm approx.).

- D.1 At least two artificial swallow nest cups will be installed **inside** the building, positioned towards the wall tops, but leaving at least 100 mm clear above the top of the nest to enable access by birds. Nests should be spaced at least 1 m apart. The stable door to the north elevation should be kept closed, and swallows will gain access through the 100 mm door-top gap shown in Figure E.

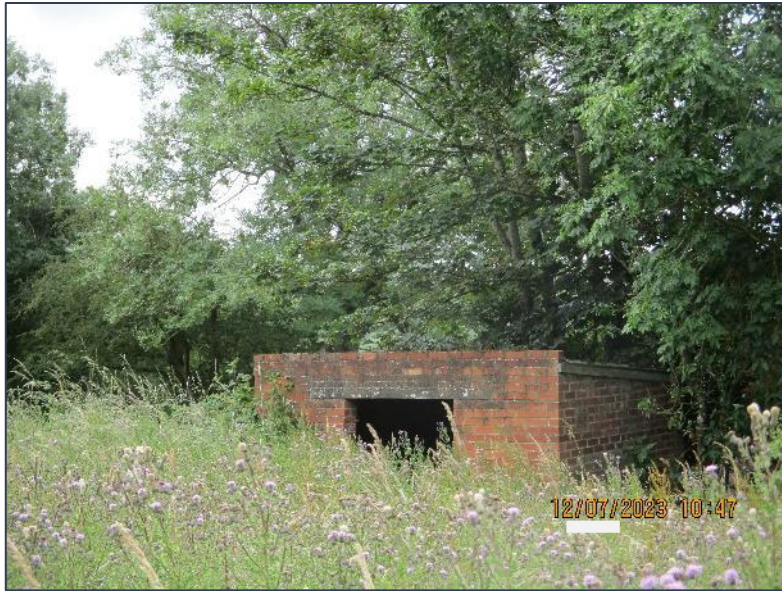
**Photograph A**  
Northern elevation of building.

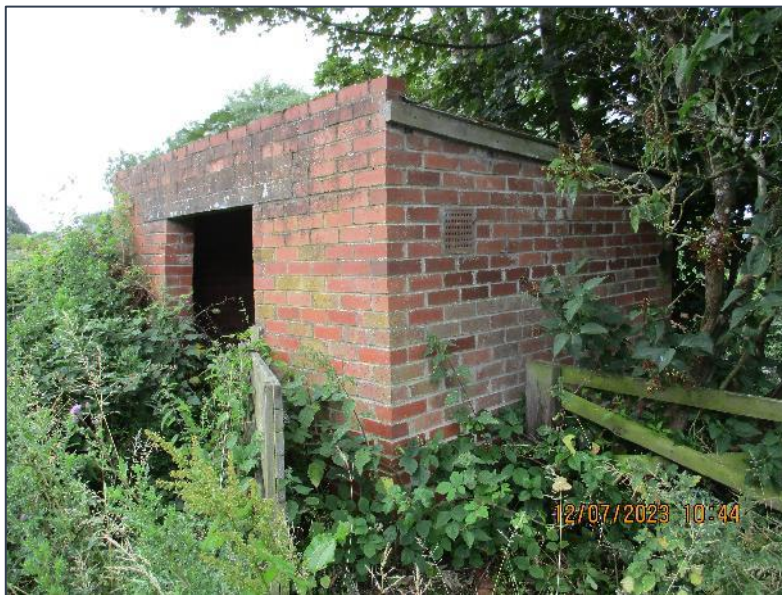
**Photograph B**  
North and west elevations of building.

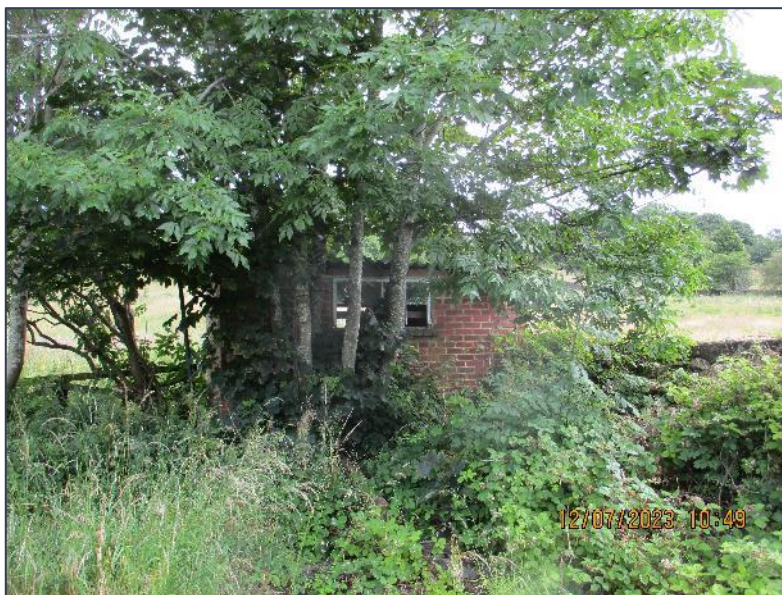
**Photograph C**  
South elevation of building.

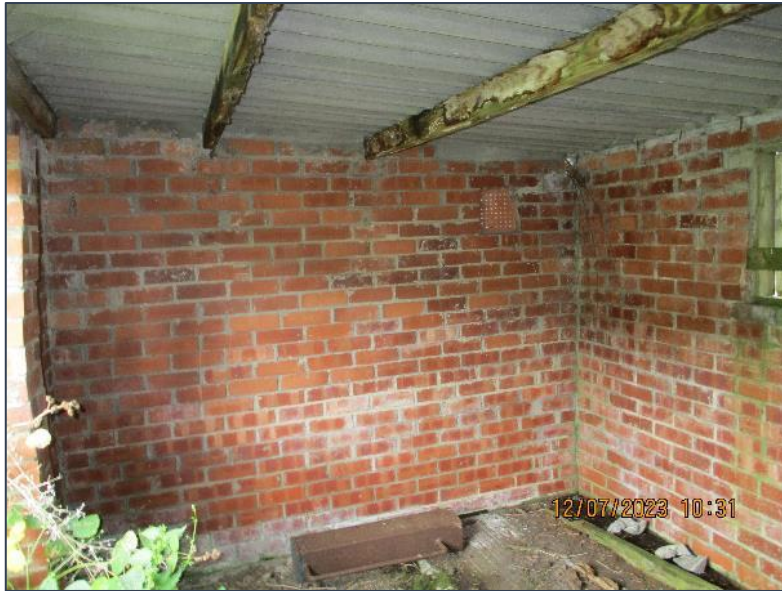
Photograph D  
Interior of building.

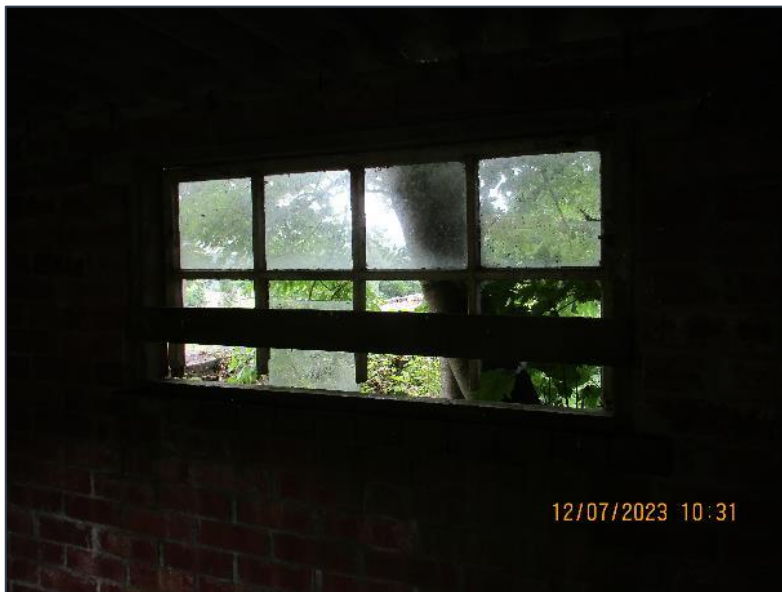
Photograph E  
Window to south elevation.

C.2.1 The broken window to the south elevation will be retained as existing. Future maintenance works should aim to retain the same ratio of broken and intact panes (Photograph E).

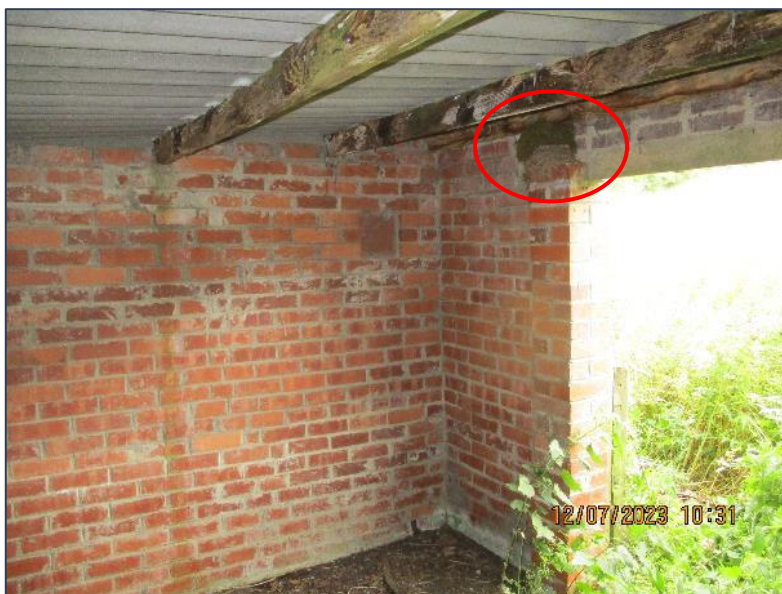
Photograph F  
Swallow nest, with wren nest built on top.

- D.3 Old swallow and wren nests were noted inside the small brick building to be renovated, on the only ledge currently available. Works should be careful to avoid impacts to birds already using the building, particularly active nests. This may involve the timing of works to fall outside of the bird nesting season. If in doubt as to whether birds are actively nesting, a check should be undertaken by a suitably qualified ecologist immediately prior to the commencement of any works. Where nesting birds are found, works will not proceed in this area until chicks have vacated the nest or the nest is otherwise no longer active.
