# Ebley House

Stroud, GL5 4SX

Design and Access Heritage Statement

# Establishing the future use of the Conservatory at Ebley House

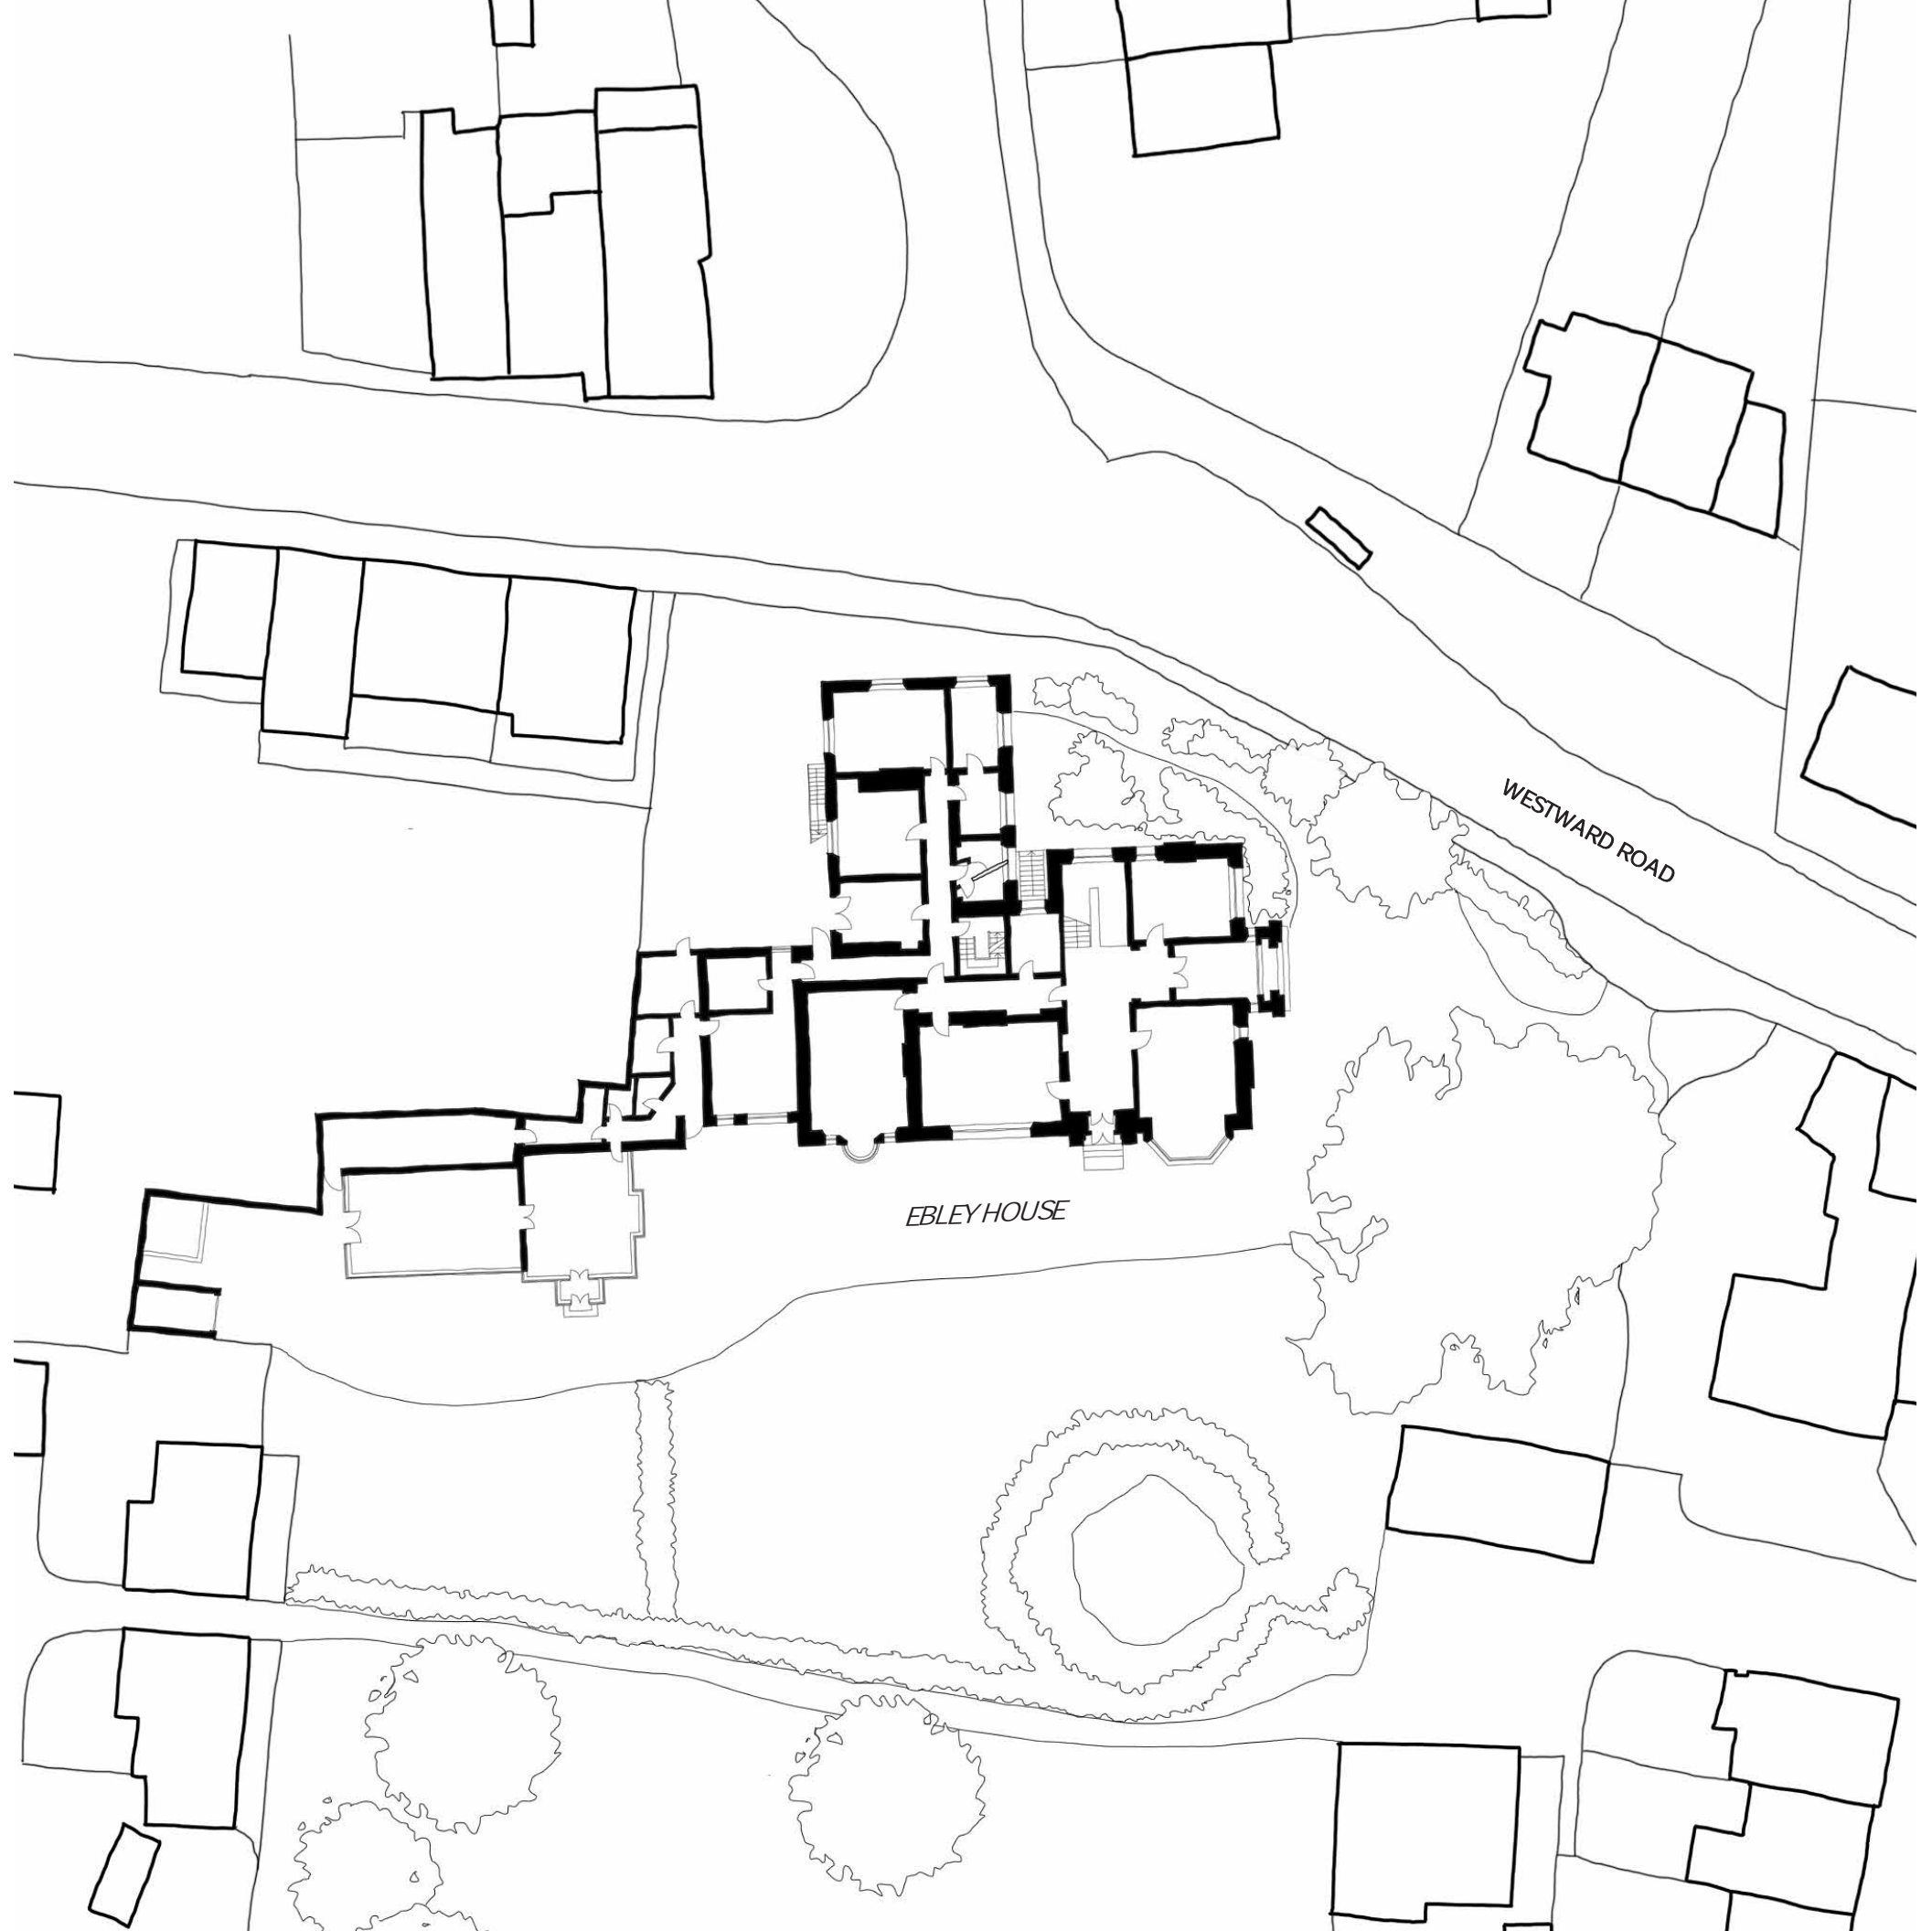
Fig 6. Ebley House Site Plan

#### 1 Ebley House

Grade II Listed large Cotswold Stone property. Described in sales particulars of 1894 as a 'modern Elizabethan Mansion of stone and high ornamental character'. No work is proposed to Ebley House.

#### 2 Conservatory

Adjoining Ebley House to the south west of the property lies the Conservatory. The Conservatory sits in a poor state of repair, requiring works to ensure its future use. The Conservatory comprises of two adjoining rooms, one featuring a porch entrance from the driveway. To the rear of the Conservatory there is a room backing onto the adjacent car park which has a half height retaining wall. This space is currently mouldy and in need of remedial work and tanking to make it a habitable and usable space.

#### 3 Garage

South west of the property lies a detached garage. No works are proposed to the garage.

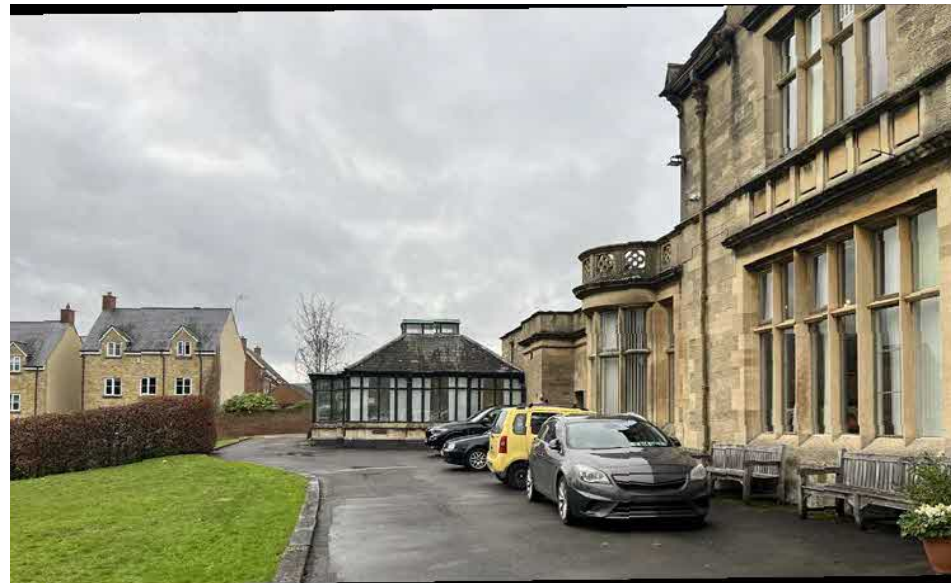
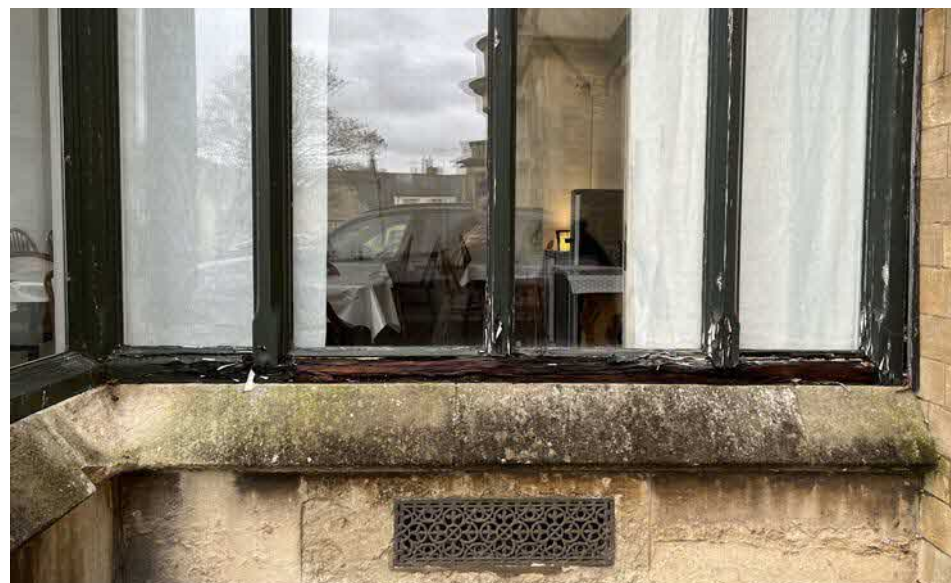
Fig 10. Existing conservatory

Fig 11. Existing conservatory

The existing Conservatory is in a beautiful setting adjacent to the Grade II listed house, however in a poor state of repair:

- Deteriorating and rotting structural timber. Structure is now currently supported with acrow props.
- Large amount of single glazing and no insulation. The space requires heating to retain at a comfortable temperature for use, which is currently a significant cost to the charity. In the summer months the spaces have issues with overheating.
- Pitted and deteriorating stone work to plinth of the conservatory.
- Excessive damp and mould growth to the rear where building meets neighbouring garage.
- Additional steelwork to support the roof. Glazing removed from the roof and replaced with heavier tiles which have compromised the structure.
- Concrete screed and laminate flooring covering.

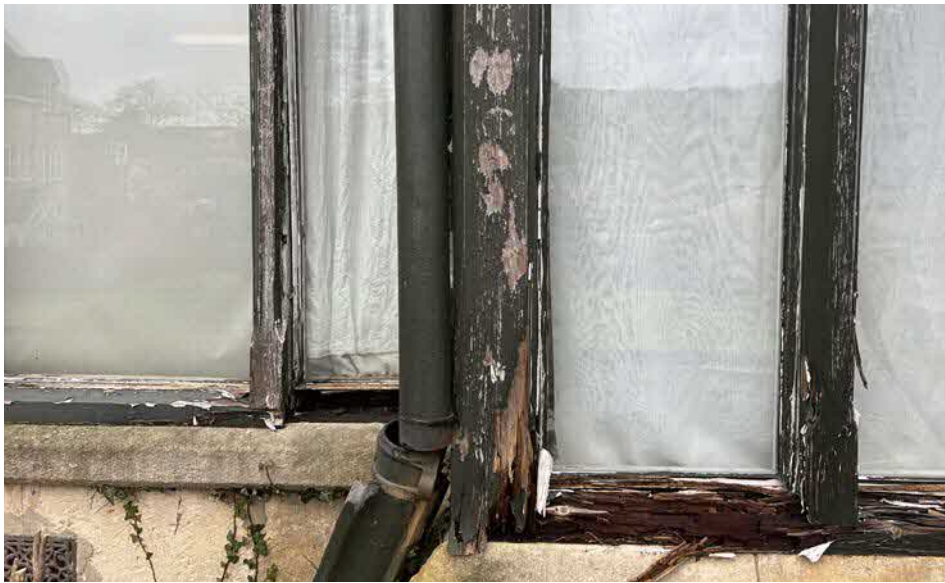
Fig 15. Deteriorating timber structure

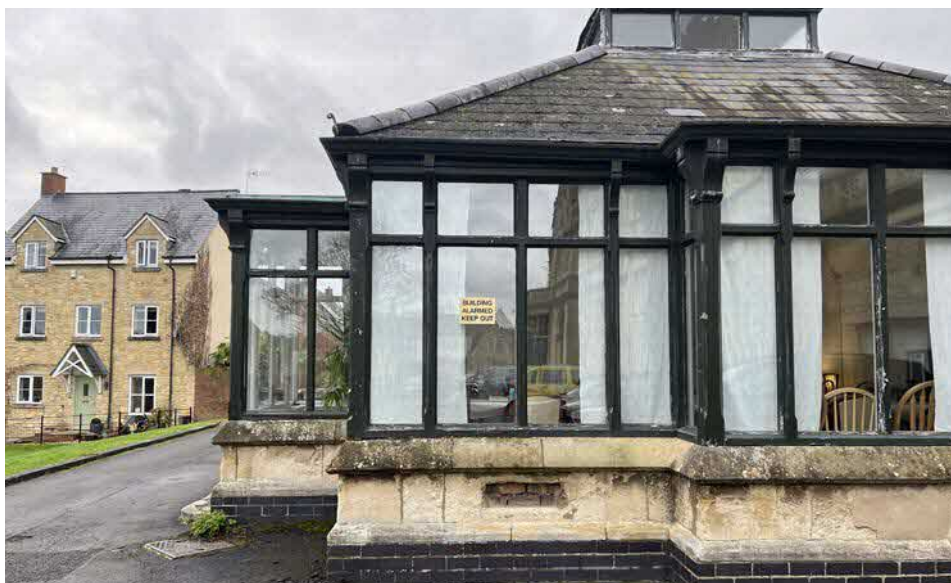
Fig 17. Original roof form replaced with a flat roof over porch

Images from the sales particulars for Ebley House from 1894 show the eastern wing of the Conservatory with curved roof forms. The original glazed roof across both sections of the east wing of the house have been removed and replaced with a flat roof covering. It is proposed that the original roof forms are reinstated.

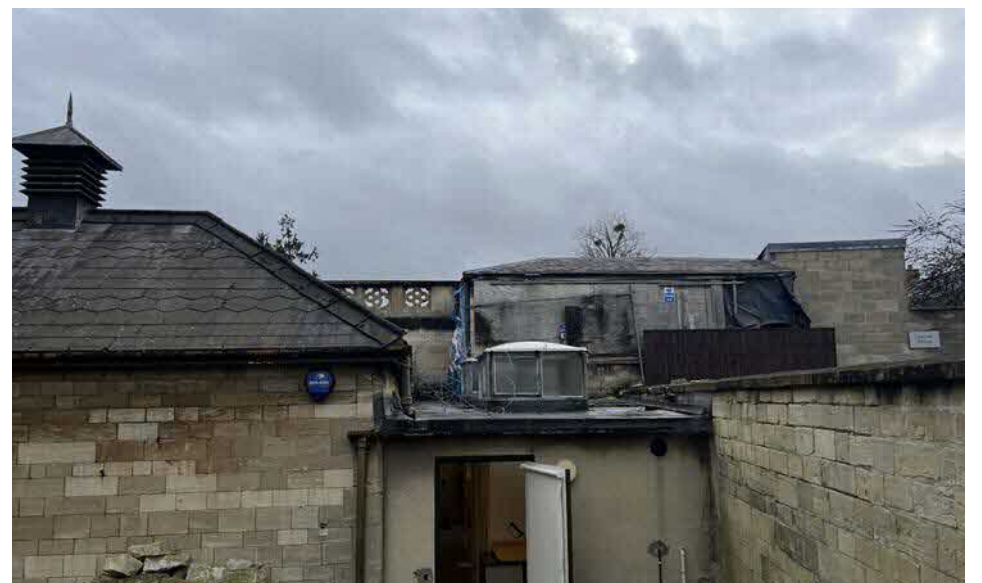
Fig 16. Existing conservatory south elevation with broken glazing

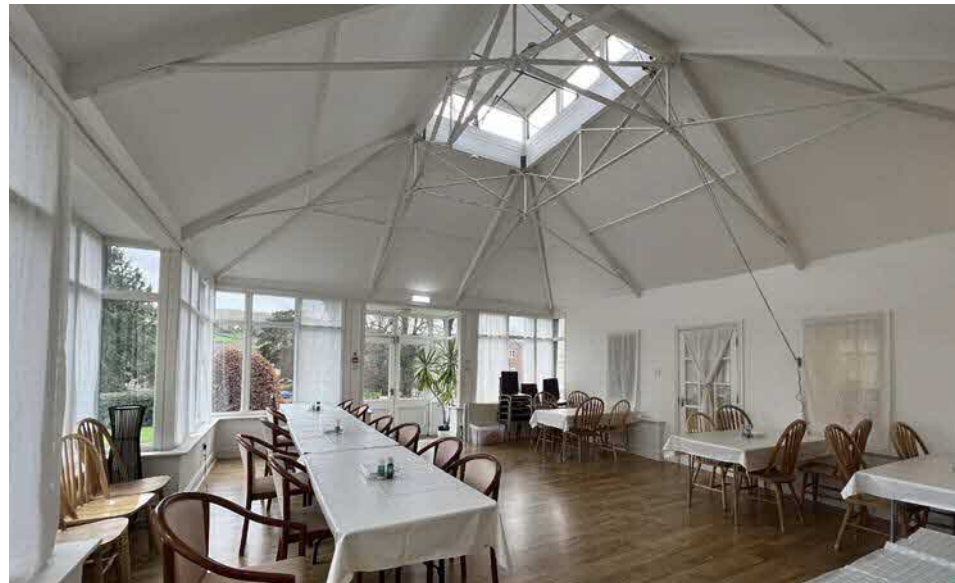
Fig 19. Existing conservatory currently used as for staff dining

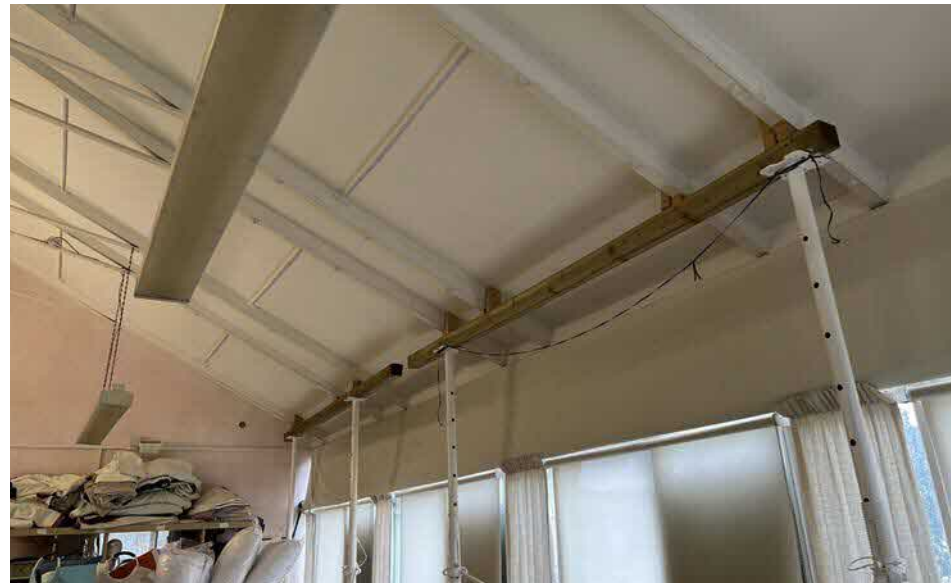
Fig 21. Acrow props supporting the existing structure

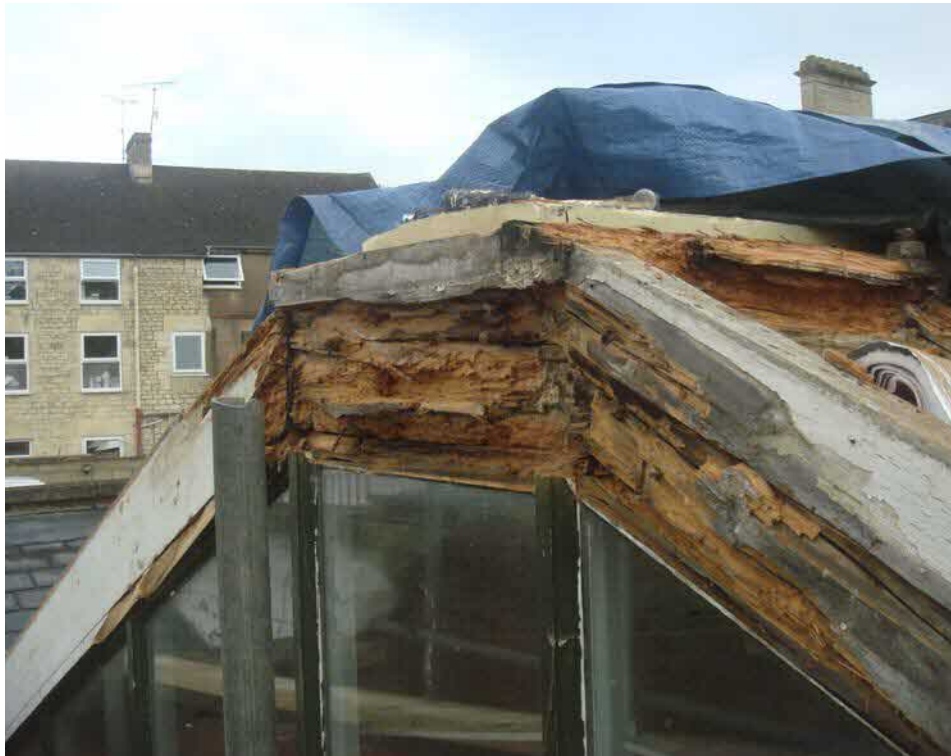
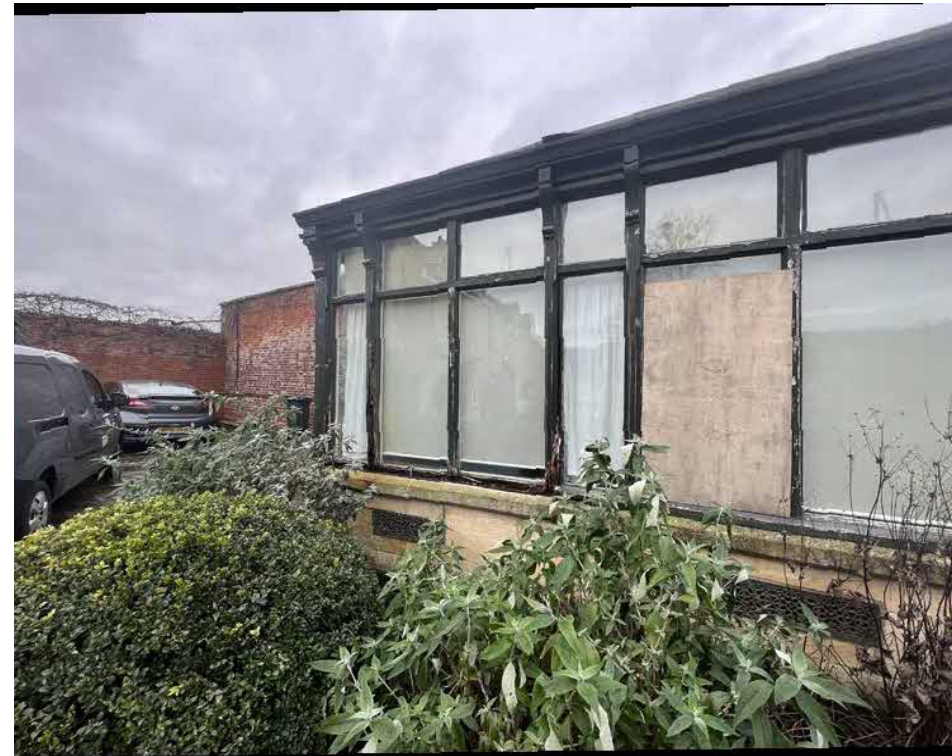
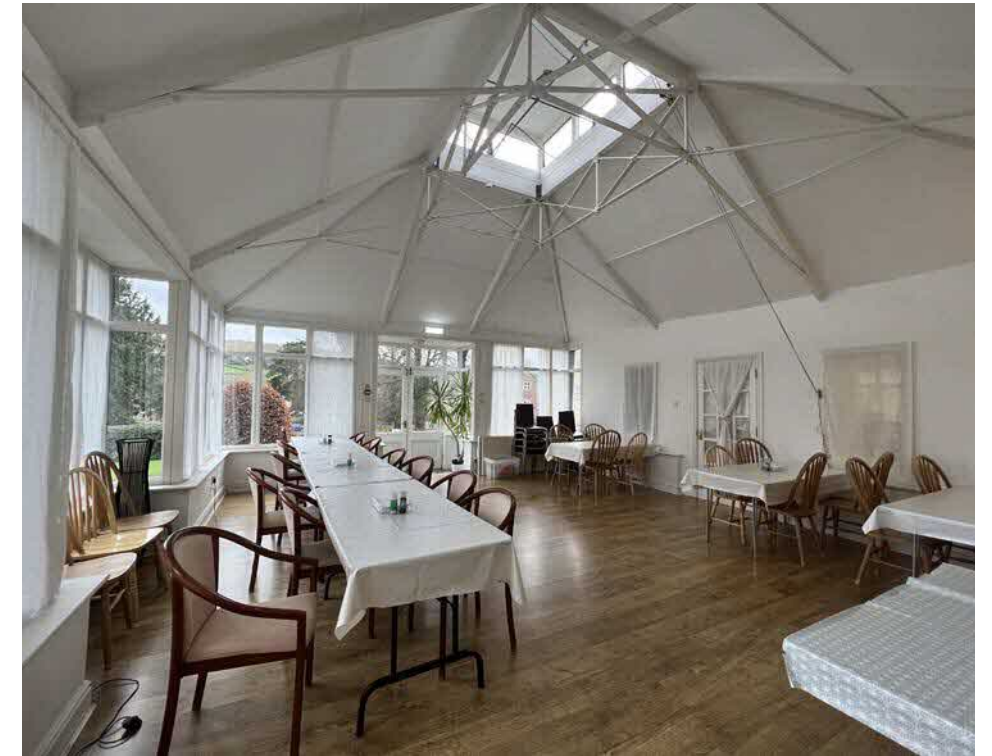
#### 1 Structural Condition

The Conservatory is in a poor state of repair with extensive damage and rot to the timber frame. Previous work undertaken to support the roof included the introduction of additional steel work within the Conservatory. Additional support to the roof is currently provided by Acrow props due to the failing timber structure and increase in weight to the roof with a tile covering. The structure is in need of urgent work/ replacement if this heritage asset is to be preserved.

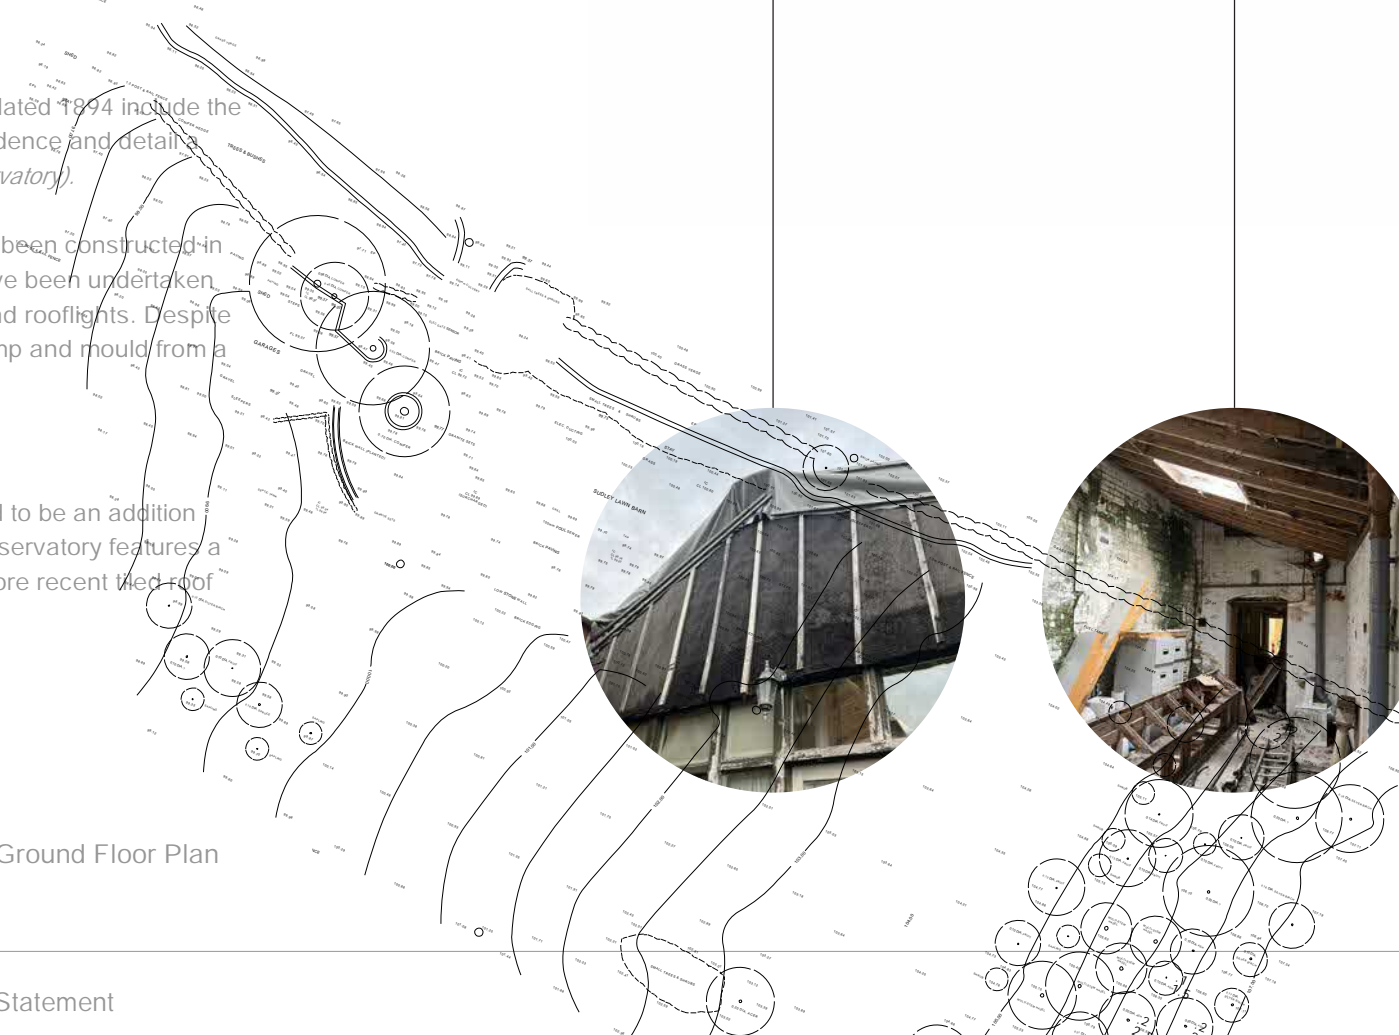
Fig 28. Ebley House Conservatory Ground Floor Plan

Adjoining Ebley House to the south west of the property lies the Conservatory. This half of the Conservatory is believed to be the original Conservatory which stood in the in the late 19th century.

Unfortunately, due to extensive repair work required, the original lantern for this half of the building has been removed. Additional steelwork has been introduced too to support the addition of a solid slated roof. Despite various works, this half of the Conservatory is in a relatively poor state of repair, with failing timber structure, propped with Acrow props. The floor appears to be concrete screed with a laminate covering.

This addition to the building appears to have been constructed in c.1910, although various works appear to have been undertaken with relatively recent timber roof structure and rooflights. Despite this, the area is uninhabitable with sever damp and mould from a poorly constructed retaining wall.

The east wing of the Conservatory is believed to be an addition in the early 20th century. This half of the Conservatory features a porch and similarly to the western wing, a more recent tiled roof covering.

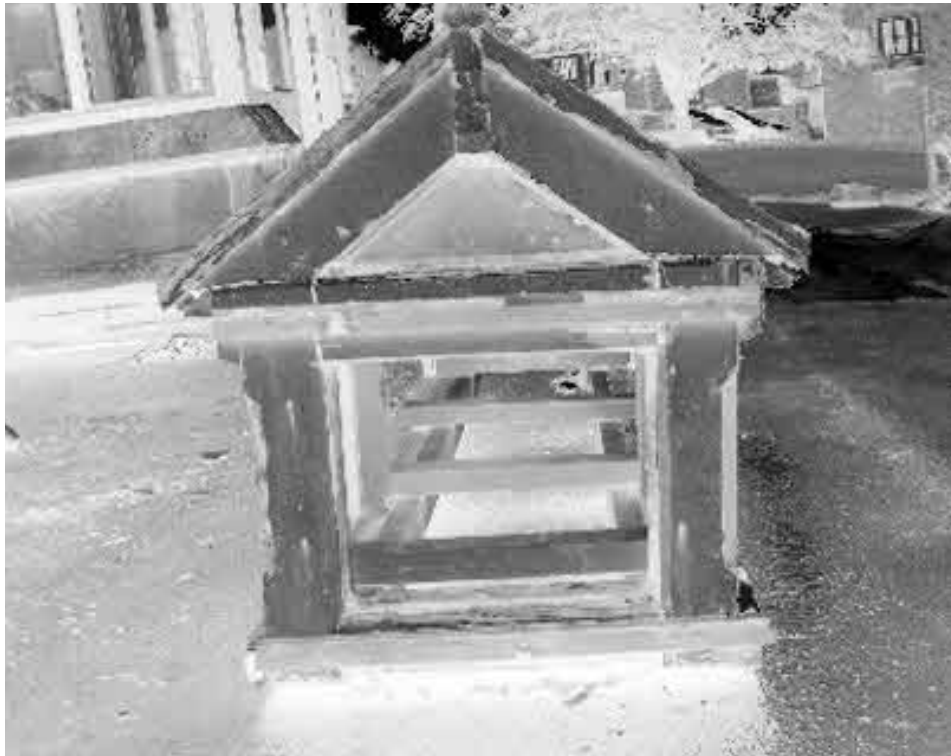
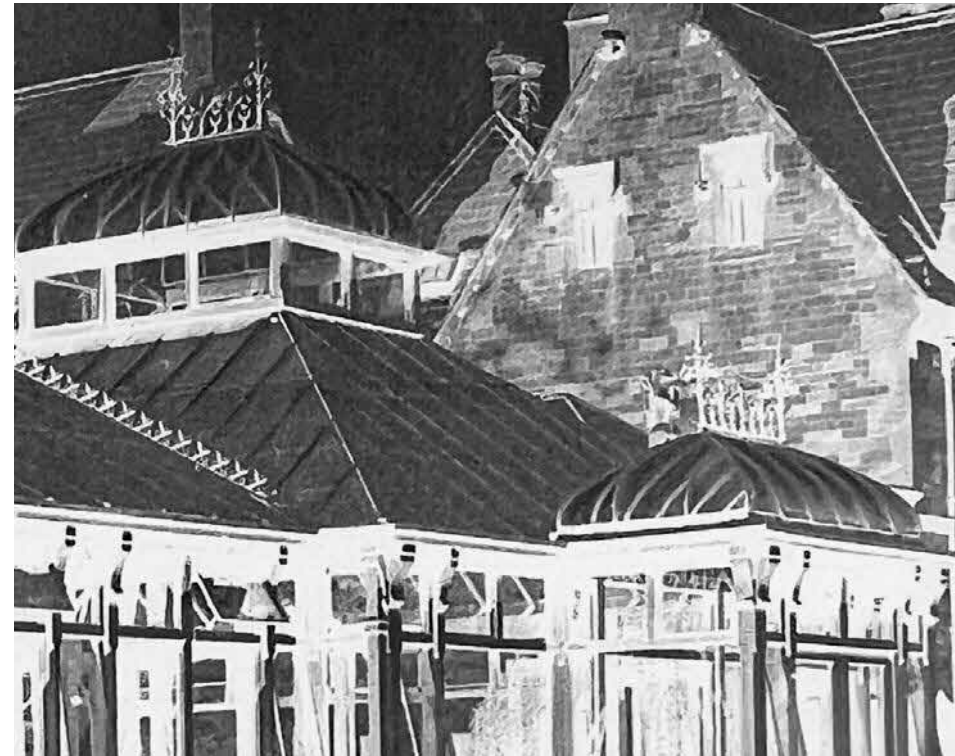
#### 1 Reinstating the Original Lanterns

The original Conservatory lantern on the west wing was removed in the early 2000s following prolonged deterioration. The lantern was carefully removed in sections and documented with the extent of works required. A number of structural timber members are beyond repair with extensive rot, and will need replacement. It is proposed that the lanterns are reinstated in their original forms.

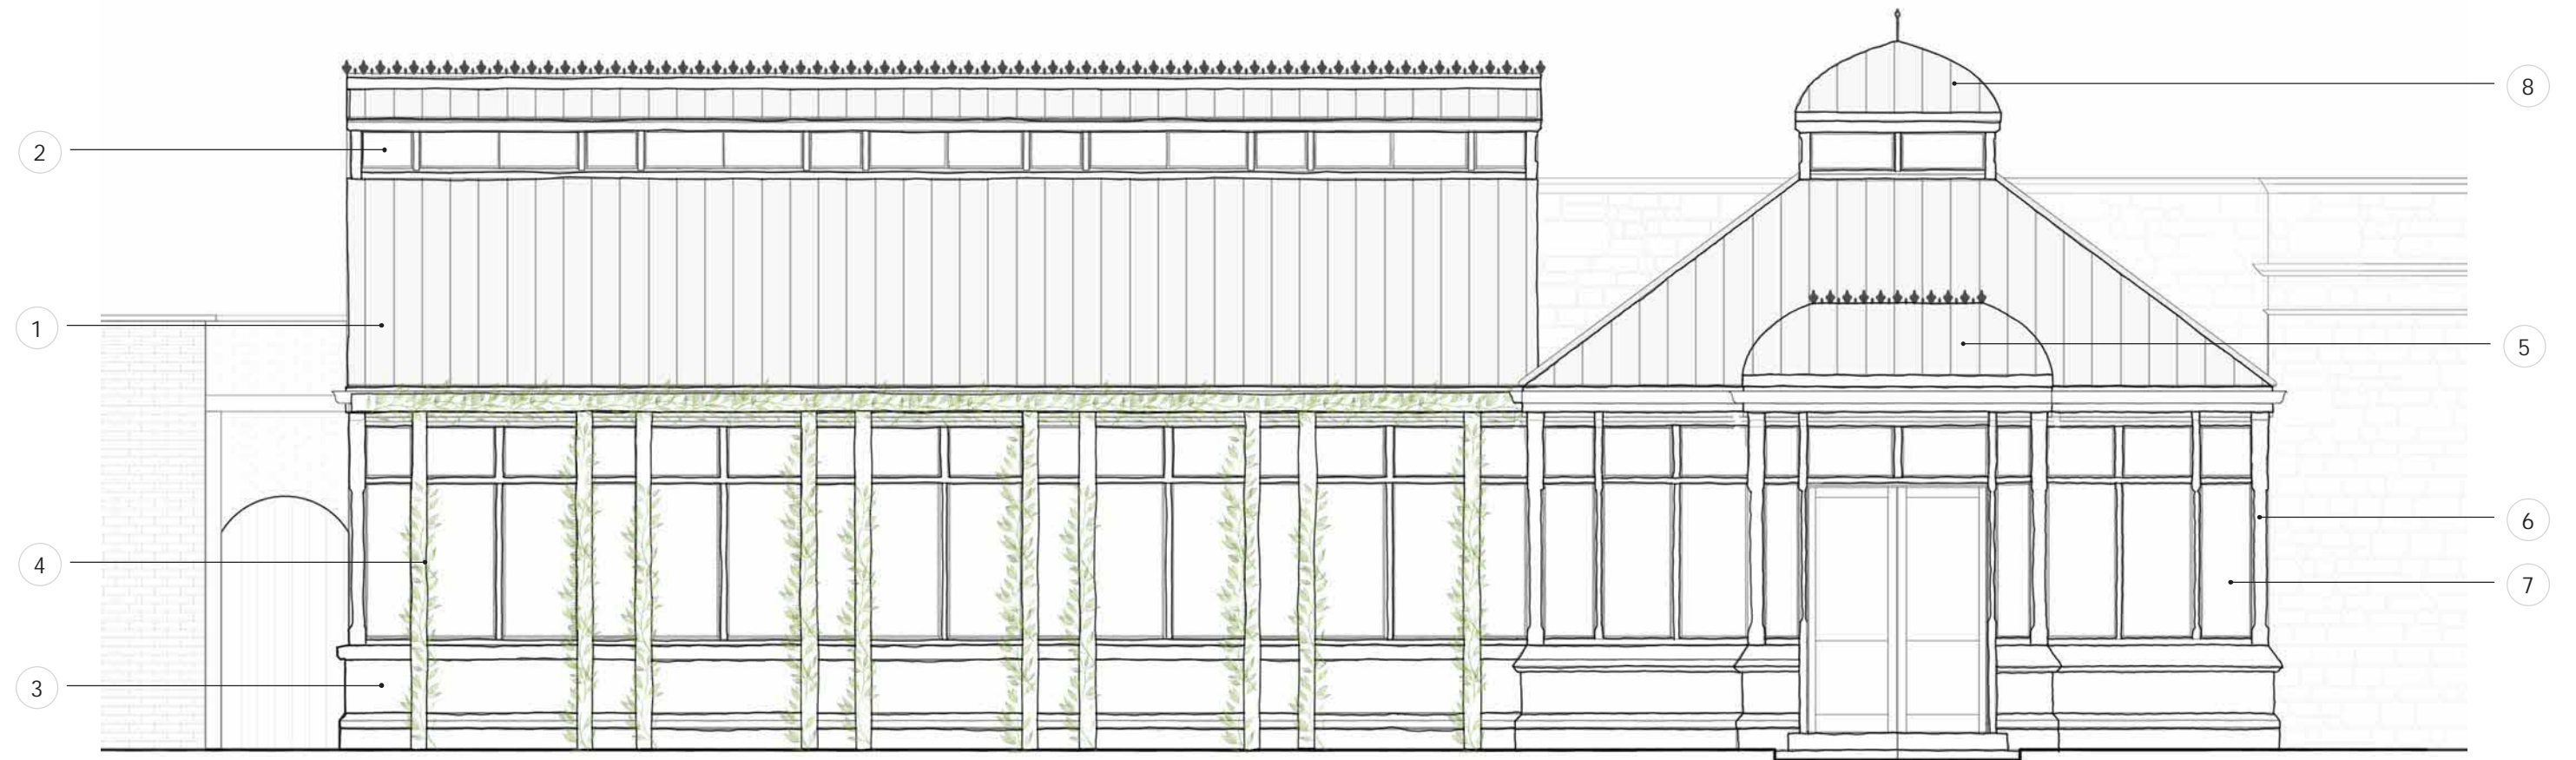
## Proposed South Elevation

- 1 Metal Standing Seam Roof  
Metal standing seam roof to follow setting out of the original glazing.
- 2 Refurbished Lantern
- 3 Stone Plinth (Refurbished/Rebuilt)
- 4 Pergola

- 5 Porch Roof Reinstated  
Metal standing seam roof to follow form and setting out of original glazed roof.
- 6 Metal Structure
- 7 Double Glazed Windows
- 8 Refurbished Lantern Roof

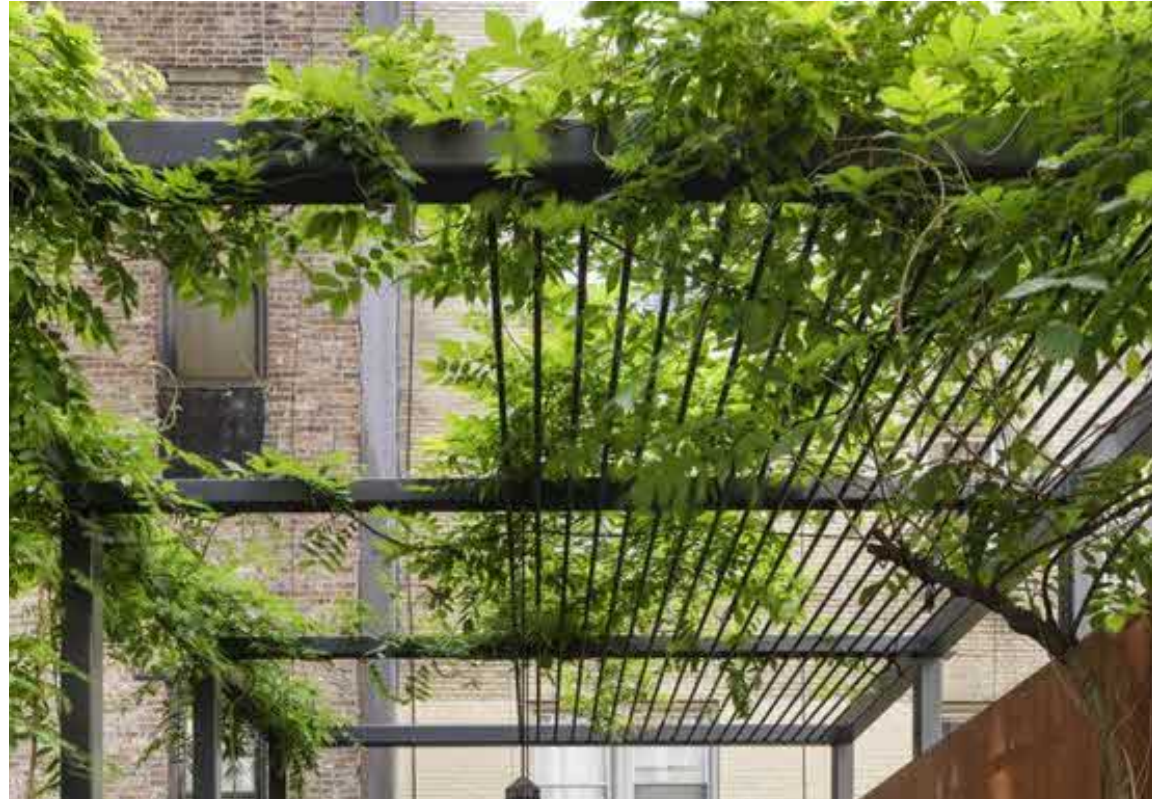
*Metal Structure and Pergola*

It is proposed that the existing timber structure is rebuilt as a metal facade. It is anticipated that if the facade was retained in timber, the size of timber members would need to be increased to accommodate the additional roof build up. A metal facade would allow structural members to remain slim and help retain the buildings elegance.

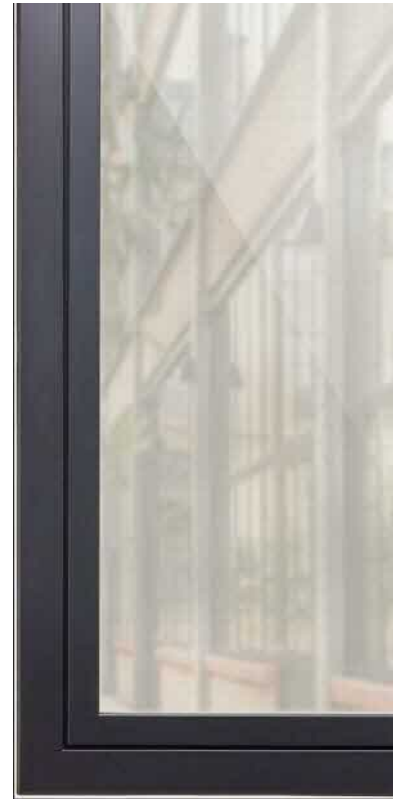
*Steel Windows*

A slimline thermally broken window profile is proposed for the glazing across the proposed conservatory. Thermally broken steel window profiles allow for wide openings with slender sightlines which reflect a contemporary look whilst retaining industrial elegance. After more than 100 years, this timeless window profile is still chosen for a great number of projects in historic settings worldwide.

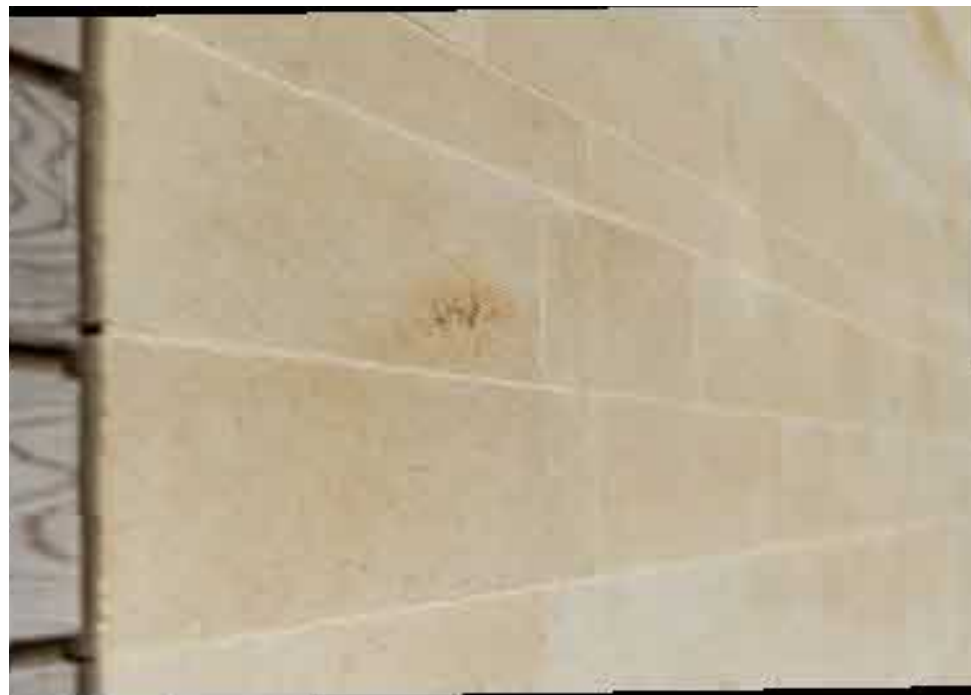
*Cotswold Stone Plinth*

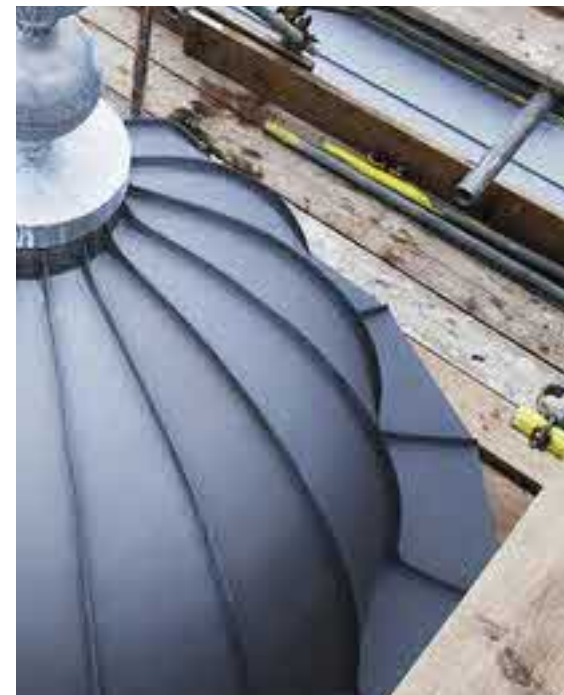
*Metal Standing Seam Roof*

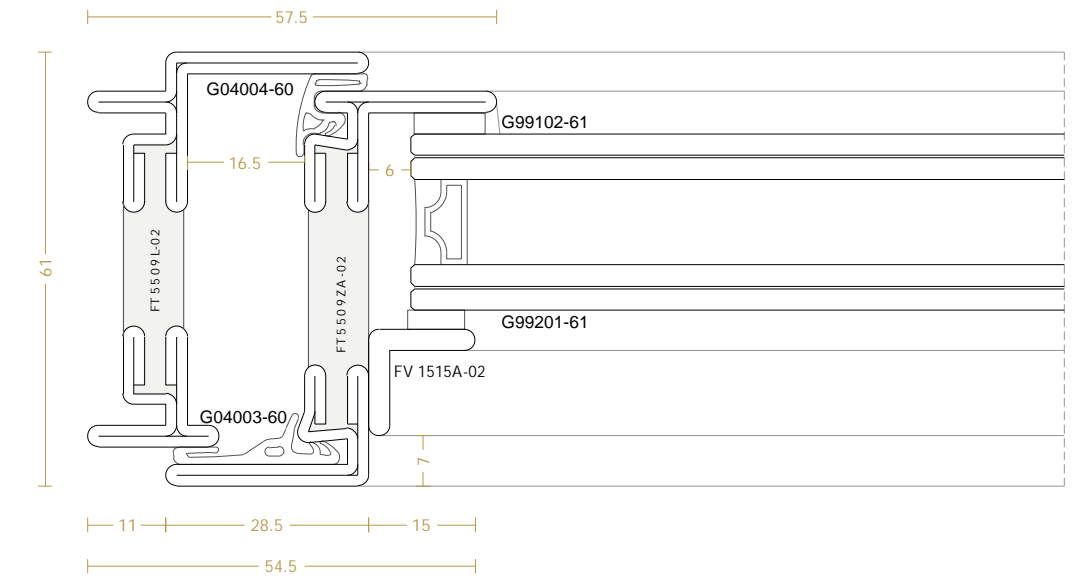
SECTION 1 EXTERNAL

**Steel Windows - Typical Detail**
