Ebley House Conservatory, Stroud

Bat Preliminary Roost Assessment Report

On behalf of The Novalis Trust

Project Code: JM2023019Av1

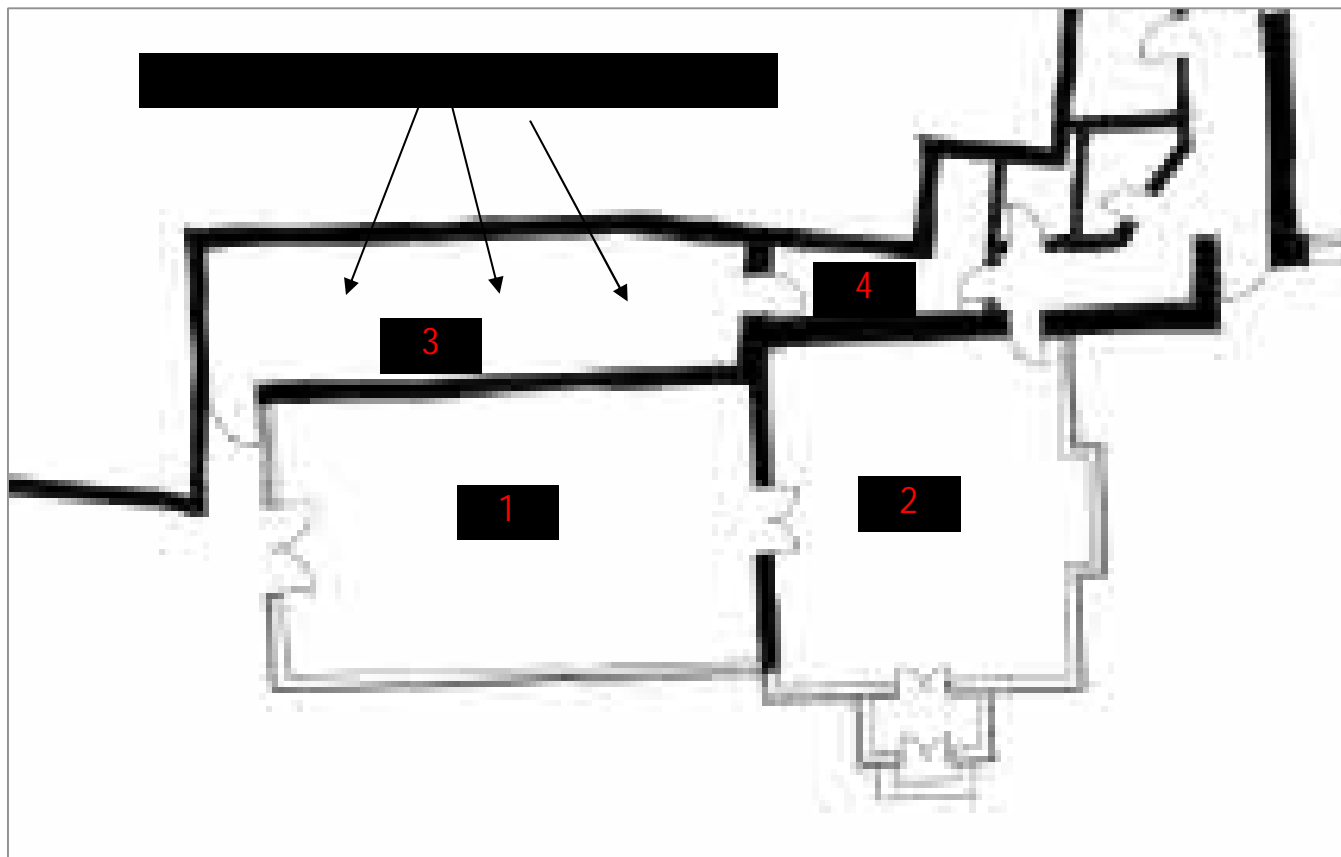
Figure 2: Plan of the conservatory at Ebley House and survey results.
NB: 1-4 indicates internal room numbers.
Plan provided by the client, annotated by Wild Service

2.1.1 The results of the Preliminary Roost Assessment are outlined in Table 2. The internal rooms of the building have been labelled Room 1-4 and these references are used throughout this report (Figure 2). Reference should be made to Figure 2 and photographs in Appendix 2.

| Internal/ External | Description |
|---|---|
| External | <p>There were large glass windows along the south, west and east elevations, which allowed ample natural light into the building. The lower half of the external walls on these elevations were of stone construction, and the stone walls appeared to be in good condition. There was evidence of rotten wood around some of the window frames on the south, west and east elevations but there were no potential gaps around the window frames to allow access to the interior for bats.</p> <p>The roof above Room 2 had stone tiles which appeared to be in good condition, with no obvious cracks/crevices which could be used by crevice-dwelling species of bats. The roof above Room 1 was covered by a temporary plastic sheet/tarpaulin and therefore the roof beneath this area was not visible. Should there be any suitable roost features on the conservatory roof above Room 1 (e.g. gaps under roof tiles), roosting bats may be able to access any such features via gaps between the plastic sheet and the conservatory roof which were visible from ground level.</p> <p>A retaining wall directly bordered the north elevation of the conservatory. The roof of the building was viewed over the top of the retaining wall and the stone roof tiles above Room 3 appeared to be in good condition. There were no obvious potential roost features on this part of the roof, however the results of the internal building inspection (see below) confirmed the presence of a large hole in the south-east corner of Room 3 which would allow access for bats to the interior of Room 3.</p> |
| Internal | <p>Rooms 1 and 2 comprise the main conservatory building, and these rooms were very well lit due to large windows on the south, east and west elevations. There was no loft/roof void in these rooms, and no obvious place for roosting bats to enter these rooms and/or roost internally, nor any suitable roost features within the rooms. Room 1 was propped with Alcrow props toward the west elevation and there were obvious signs of disrepair.</p> <p>To the rear of the main conservatory rooms was a small corridor (Room 4) which connected the conservatory to the main house and a rear room (Room 3). The rear room (3) had mould on the walls and was generally damp. There were two levels to Room 3 – the ground floor, and a small basement. The basement was accessed via a small staircase in the centre of the room. The basement was very damp, with water on the ground which was a few centimetres deep. The visible basement walls appeared to have no obvious cracks/crevices for roosting bats to use, but parts of the wall could not be surveyed. Above the ground floor room were roof lights which allowed ample natural light into Room 3. A large hole in the south-east corner roof of Room 3 could allow potential access for roosting bats, and gaps around an external door on the south elevation also provided a potential access point. On the ground floor of Room 3 there were several butterfly wings which may indicate feeding remains of bats, and these were located along the centre of the floor space. No other direct signs of roosting bats were recorded internally e.g. bat droppings, urine stains, live bats.</p> |

Room 4 had two levels – a ground floor corridor connecting the main house to the conservatory rooms (1-3) and a first-floor level above. The first-floor level was in a state of disrepair and was not fully accessible. Gaps around the wall on the north elevation of the first floor allowed potential access points for bats, and there was a roof void above the first floor which was inaccessible, but which could offer potential roosting habitat for bats.

Due to possible feeding remains in Room 3 and the features present in the building, the building was assessed as having moderate potential to support roosting bats.

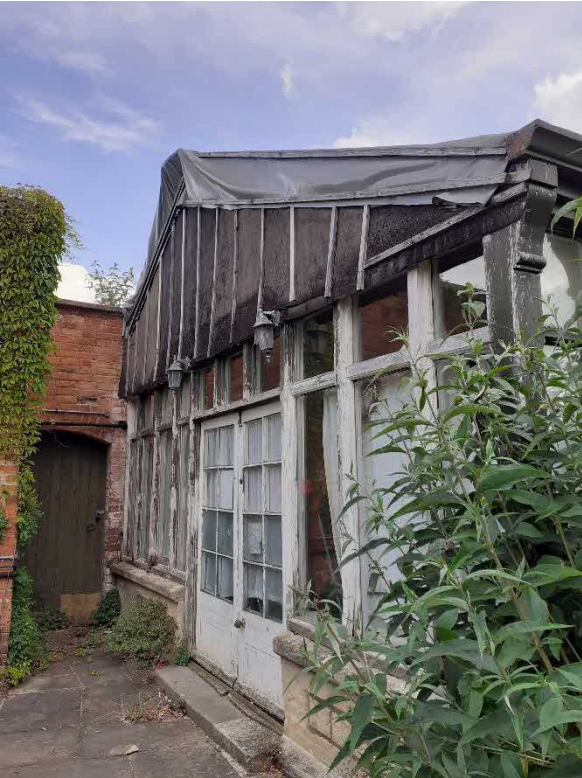
| No | Photo | Description |
|---|---|--|
| 2 | | <p>East elevation of the conservatory with rotten wooden timber around the window frames and tarpaulin/plastic sheet above roof.</p> |

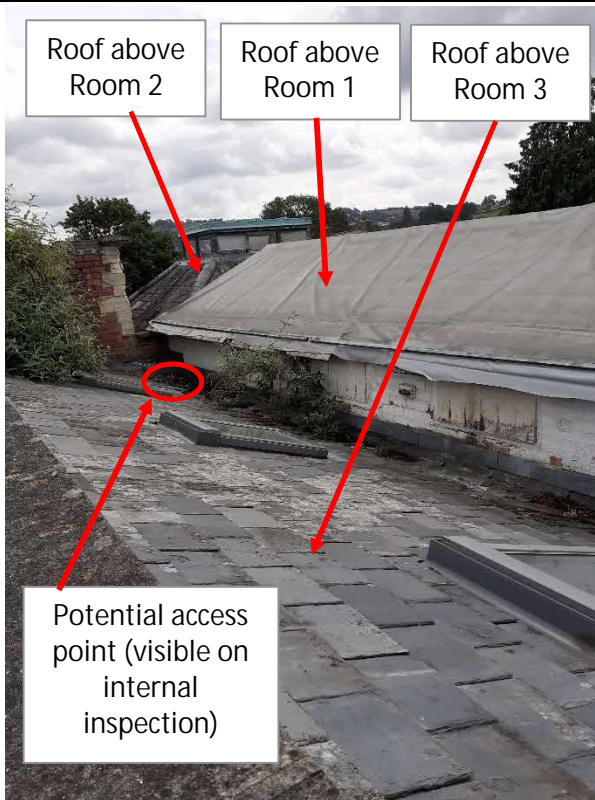
View of conservatory roof, as seen from over the top of the retaining brick wall. A potential access point to Room 3 was visible on internal inspection (see photograph 10) and the approximate location is circled opposite in red.

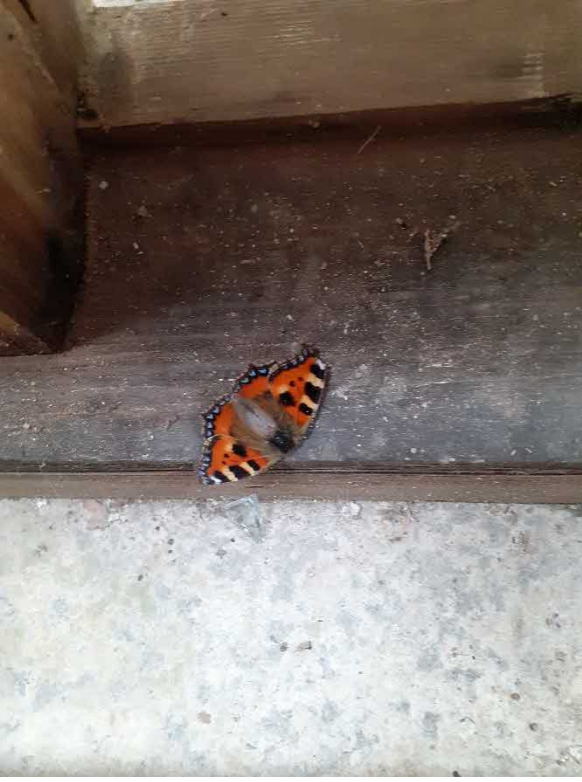
| No | Photo | Description |
|---|--|--|
| 9 | A photograph showing a butterfly with orange and black wings resting on a wooden surface. The butterfly is positioned in the center of the frame, with its wings spread. The background is a dark, textured surface, possibly a wall or ceiling. | <p>One of several butterfly wings found on ground floor of Room 3.</p> |

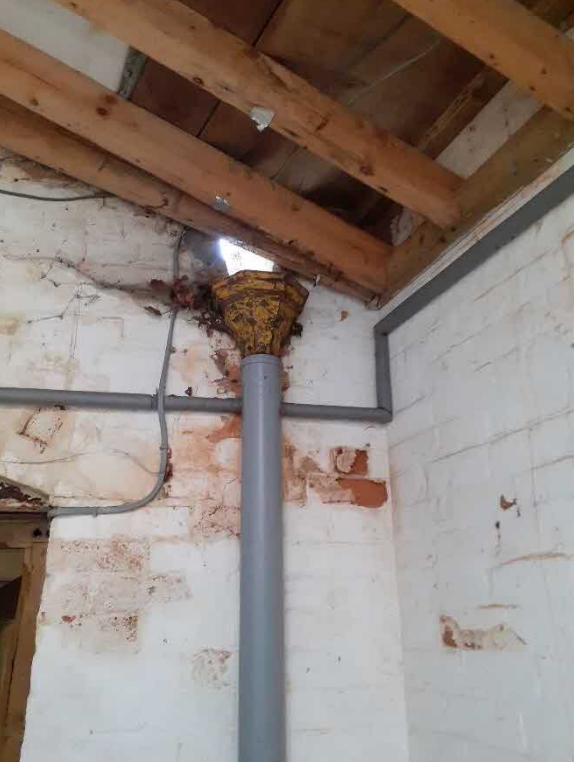
| No | Photo | Description |
|---|--|--|
| 10 | A photograph showing a large hole in the ceiling of Room 3. The hole is located at the south-east corner of the room. The ceiling is made of wooden beams, and a large pipe is visible running across the wall. The wall is white and shows signs of damage and peeling paint. | <p>Large hole at south-east corner of Room 3 provided potential access for bats (see also photograph 3).</p> |

3.1.4 Bats and their resting places are protected under the Wildlife and Countryside Act 1981 (as amended) and the Conservation of Habitats and Species Regulations 2017. The results of the PRA confirm the need for further bat surveys, and in accordance with best practice guidelines, two dusk emergence/dawn re-entry surveys are required for the conservatory building to establish presence/absence of roosting bats. If a bat roost is confirmed on these surveys, a third survey will be needed to characterise the roost. It should be noted that no works which could obstruct access to the potential roosting sites and/or damage/destroy these potential roosting sites should be undertaken prior to the bat surveys being carried out.

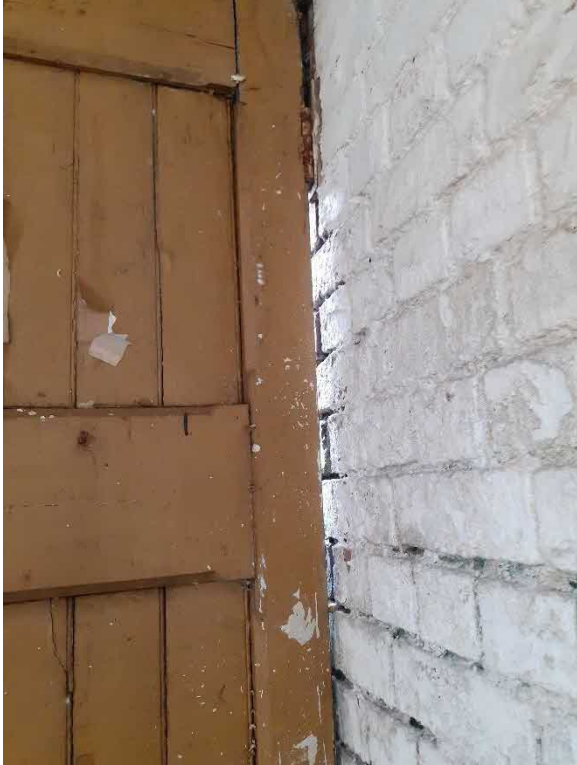
| No | Photo | Description |
|---|---|---|
| 11 | | Gaps between door and west elevation wall of Room 3. |

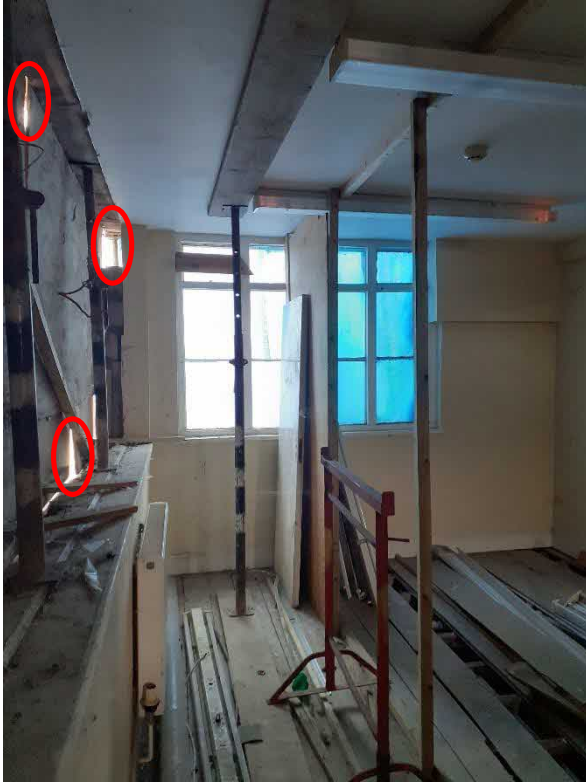
13

First floor level above the corridor (Room 4), with gaps between timber window boards (circled in red) which provided potential access to the loft above this room.

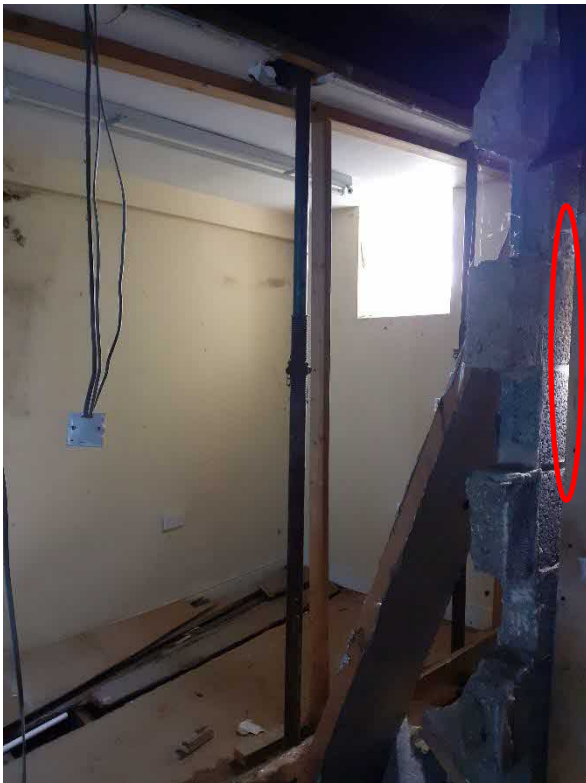
14

First floor level above the corridor (Room 4), with gaps between outer wall and temporary cover (circled in red).

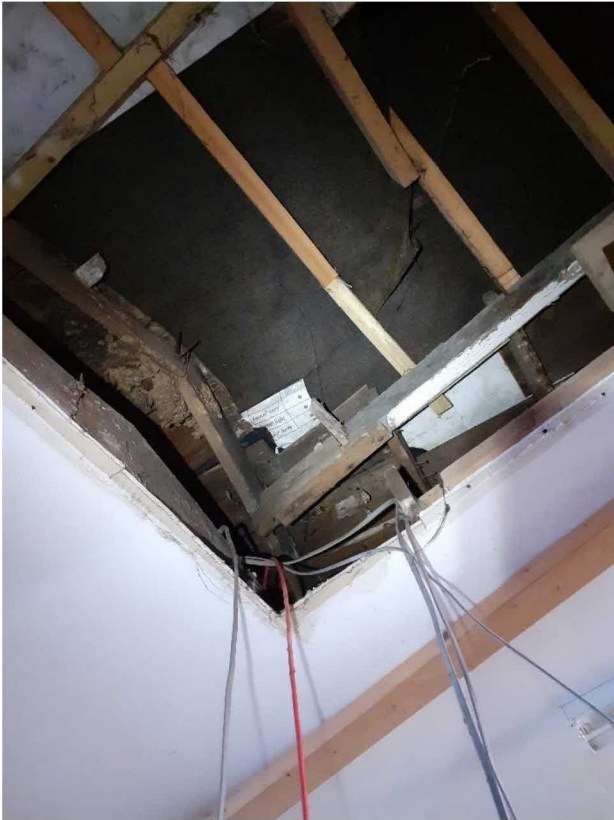
| No | Photo | Description |
|---|---|--|
| 15 | | Small open roof void above first floor level of Room 4 which was inaccessible. |

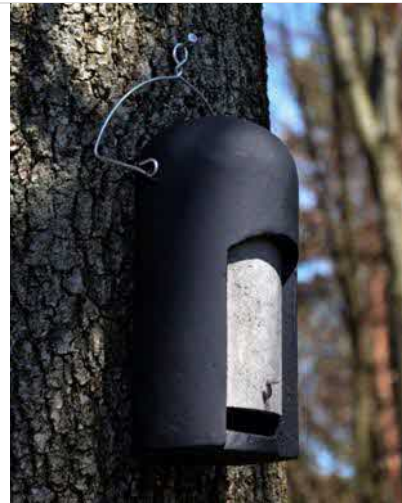
Diagrammatic view of ridge tile and cross section through ridge tile showing access point (taken from Scottish Natural Heritage 1996). Bitumastic lining must be used near/on the ridge beam to ensure bats can only have contact with this type of membrane to avoid any possible entanglement with a breathable membrane.

3.1.4 Roosting opportunities for local bats can be incorporated into renovated buildings through the installation of bat boxes under the eaves either on the exterior walls (e.g. Schwegler 1WQ/1FF bat box) or fitted into the walls (e.g. Habibat 001 bat box) and the creation of raised ridge tiles. Bat boxes (e.g. Schwegler 2FN) can also be installed on medium - large trees. Bat boxes should be installed at minimum heights of 3.5m, facing away from external illumination and should ideally face in a south-east or south-west orientation. Examples are provided in the Ecological Enhancements Appendix below.
