Report	Preliminary Ecological Appraisal
Site Name	76 Portsmouth Road, Southampton
Author(s)	Lewis Lakudzala BSc (Hons), MRes
Checked by	Adam Jessop MSc ACIEEM
Client	Mr David Ember
Date of Issue	23 th May 2022
Status	<i>Draft not for submission</i>

Executive Summary

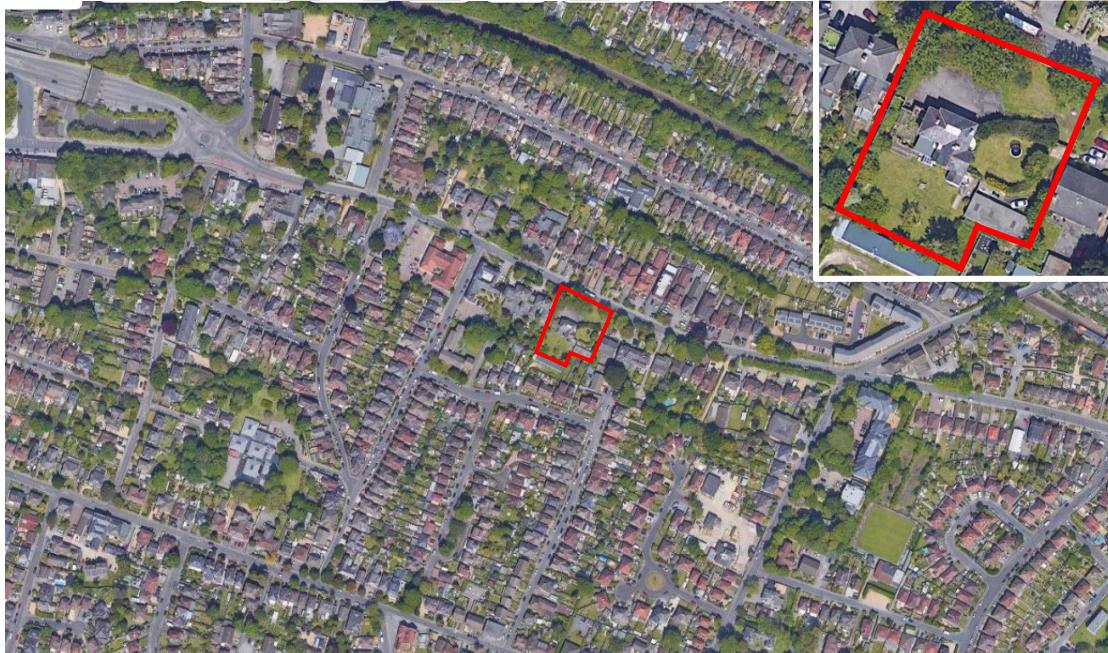
Figure 1. Aerial image of the site with approximate redline boundary given.

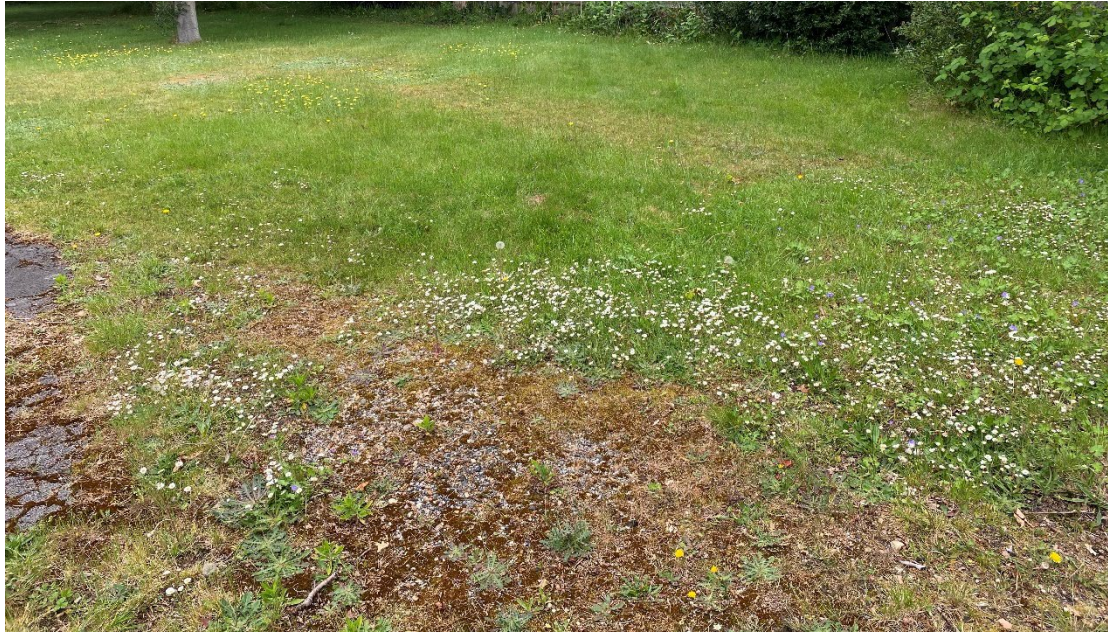
This type of grassland was the dominant habitat on type and covered the majority of the site to the north, east and south of the main dwelling (**Figs 2 & 3**). Although the species diversity remained similar across each area, sward height was higher in the areas to the east and south of the dwelling (**Fig 3**) as these had been left unmanaged for some time. As such, the species diversity was poor and dominated by grasses. Species noted across the site included Cocksfoot Grass (*Dactylis glomerata*), Cats ear (*Hypochaeris radicata*), Yarrow (*Achillea millefolium*), White Clover (*Trifolium repens*), Crane's-bill (*Geranium dissectum*), Bluebell (*Hyacinthoides non-scripta*), Daffodil (*Narcissus sp.*), Common Daisy (*Bellis perennis*), Dandelion (*Taraxacum agg.*),

Figure 2. Poor semi-improved grassland located north of the main dwelling on site (taken May 2022).

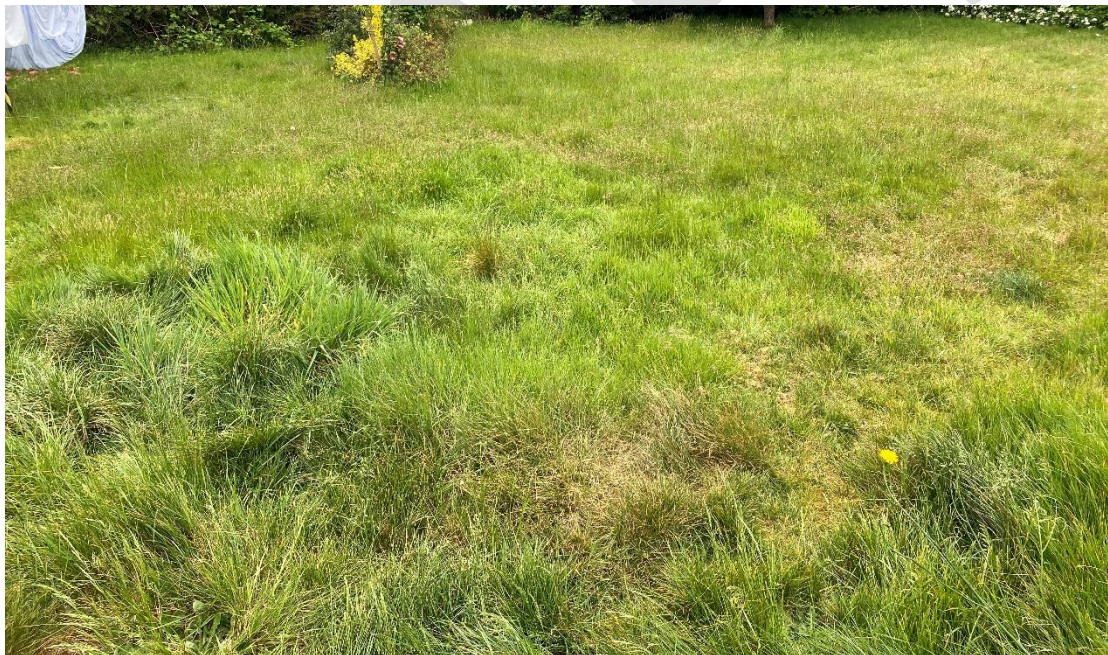
Figure 3. Unmanaged poor semi-improved grassland located south of the main dwelling on site (taken May 2022).

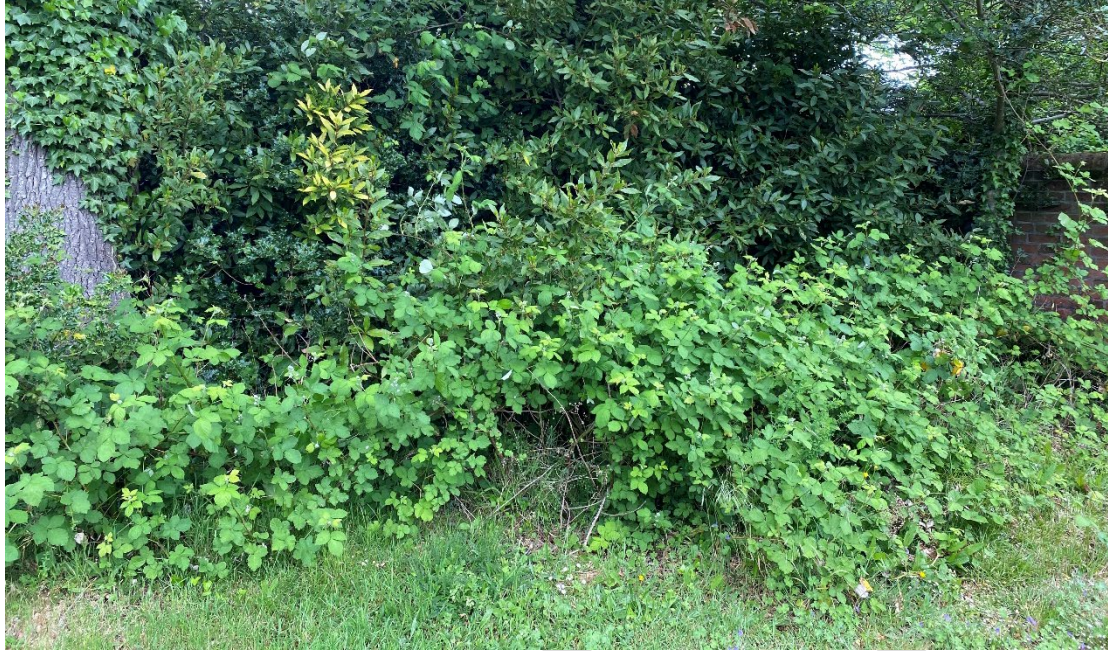
Areas of scrub were located along the northern and southern boundary of site (**Fig 4**). These were dominated by Bramble (*Rubus fruticosus*) and supported a similar species composition across both areas. Species recorded included: Nettle (*Urtica dioica*), Curled Dock (*Rumex crispus*) and Broad-leaved Dock (*Rumex obtusifolius*), Creeping Buttercup (*Ranunculus repens*), Ivy (*Hedera helix*) and Ragwort (*Senecio jacobaea*).

Figure 4. Scrub located along the north on site (taken May 2022).

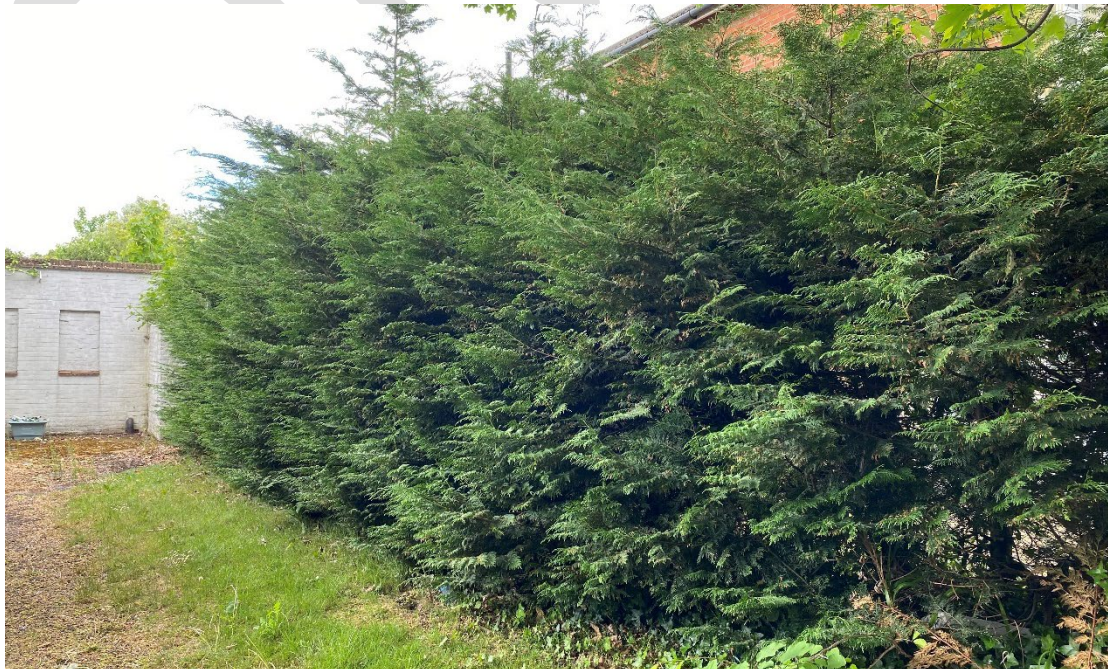
Several hedgerows were recorded on site. A *Leylandii* hedge was situated along the western boundary of the site (Fig 5). Native species hedgerows were recorded along the north, south and parts of the east boundaries, as well as two isolated hedgerows east of the main dwelling (Fig 6). Hedgerows on site supported similar species compositions which included: Laurel (*Prunus* sp.), Holly (*Ilex aquifolium*), Privet (*Ligustrum Ovalifolium*), Purging Buckthorn (*Rhamnus cathartica*) and Ivy.

Figure 5. *Leylandii* hedgerow located along the western boundary of the site (taken May 2022).

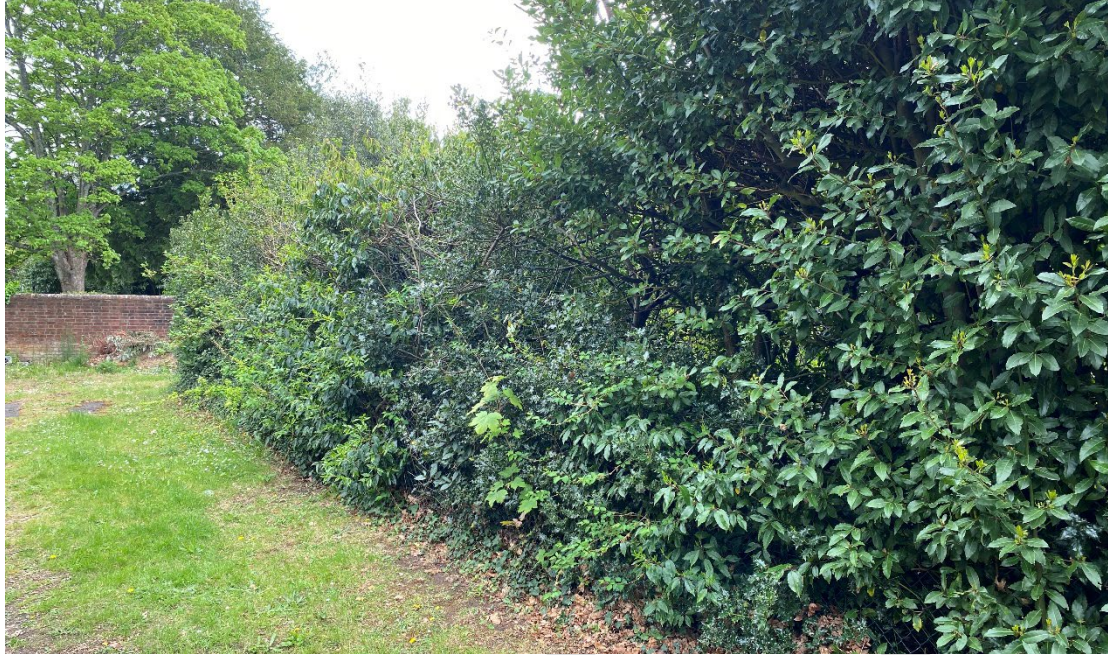
Figure 6. A native hedgerow located to the east of the main dwelling (taken May 2022).

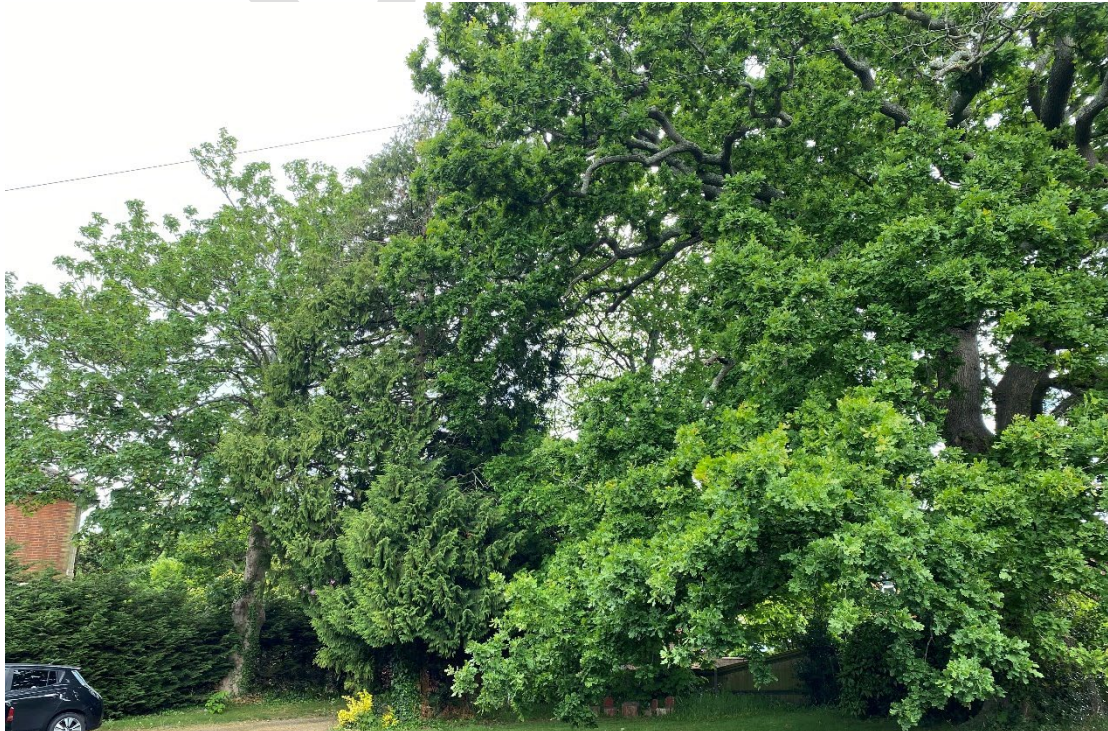
Several mature trees were recorded on site at the front and rear of the main dwelling (**Fig 7**). 7 trees were recorded in total and species recorded consisted of: Oak (*Quercus robur*), Sycamore (*Acer pseudoplatanus*), Horsechestnut (*Aesculus hippocastanum*), Cypress (*Cupressus x leylandii*), Yew (*Taxus baccata*), Lime (*Tilia x europaea*) and Apple (*Malus* sp.).

Figure 7. Mature Sycamore, Cypress and Oak located along the northern boundary of the site (taken May 2022).

During the preliminary roost assessment (PRA) of the trees on site, 3 Potential Roosting Features (PRFs) were identified on the mature Oak located on the north of the site (pictured in **Fig 7**). A large woodpecker hole (approx. 6-7cm in diameter) was visible on a limb on the southeastern face of the tree (**Fig 11**). A smaller woodpecker hole was recorded on the western facing side of the oak (**Fig 12**), in addition to a small opening on the main trunk of the tree (**Fig 13**). It was not determined whether this hole supported a large enough cavity for roosting bats.

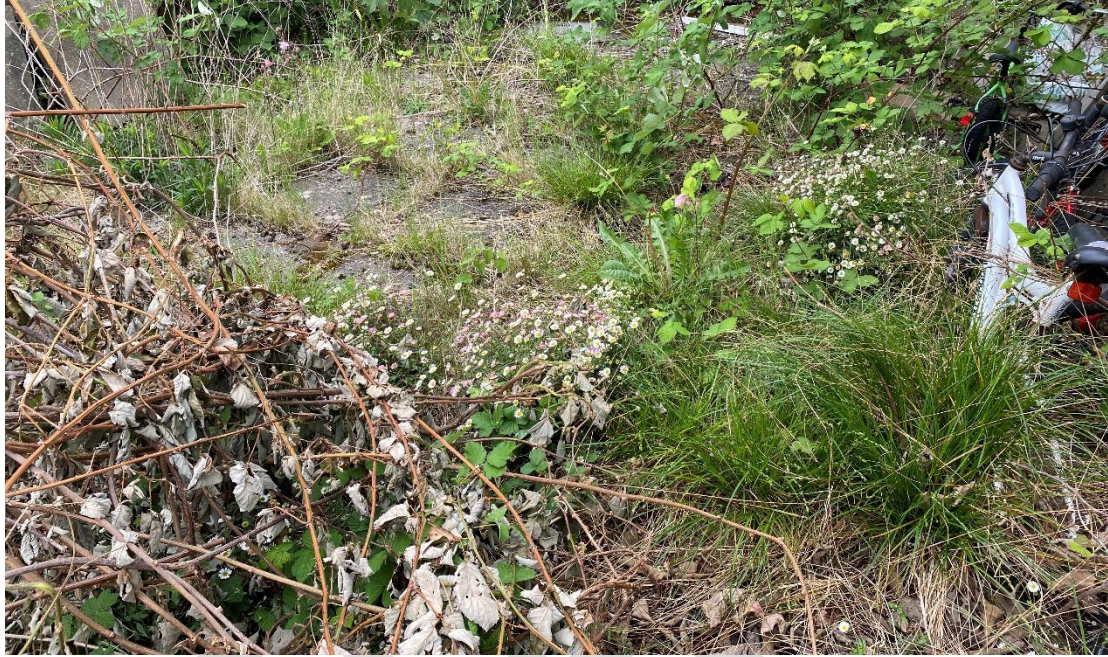
Where areas of the site have been left unmanaged for some time patches of ruderal vegetation had established, particularly by the garages and greenhouse at the rear of the dwelling (**Fig 8**). A small patch of ruderal vegetation was also recorded along the eastern boundary of the site. Species recorded include Bramble, Thistle (*Cirsium* sp.), Dandelion and Ragwort.

Figure 8. The ruderal vegetation by the greenhouse on the west of site (taken May 2022).

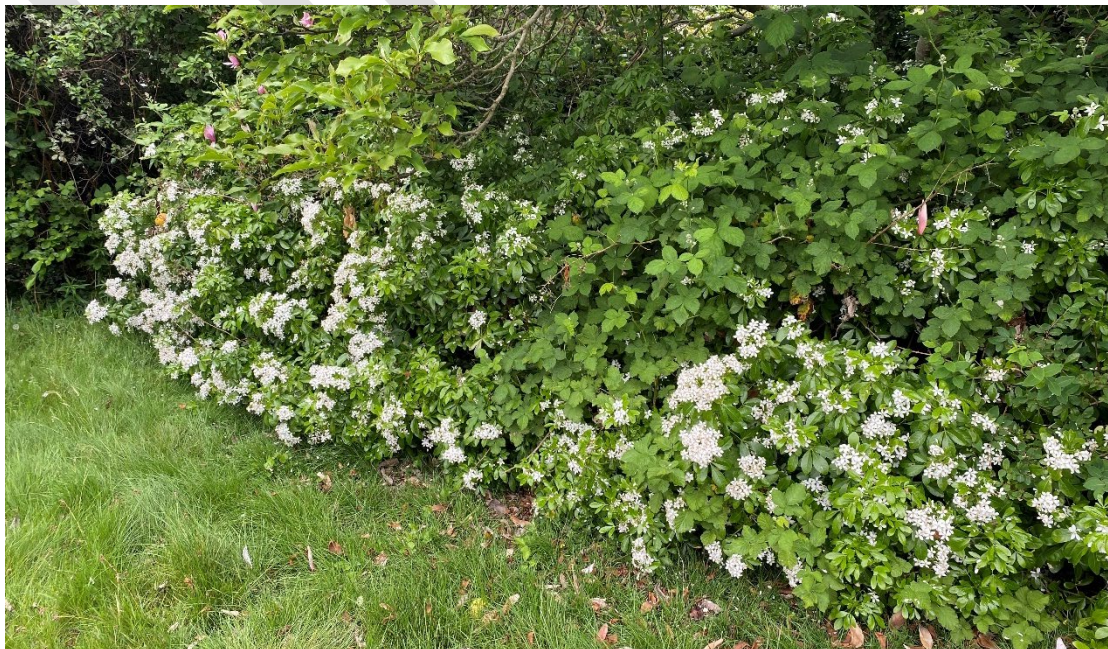
The boundaries of the rear garden were formed by areas of ornamental planting (**Fig 9**). The species in this area were non-native ornamentals.

Figure 9. Ornamental planting located along the southern boundary of the site (taken May 2022).

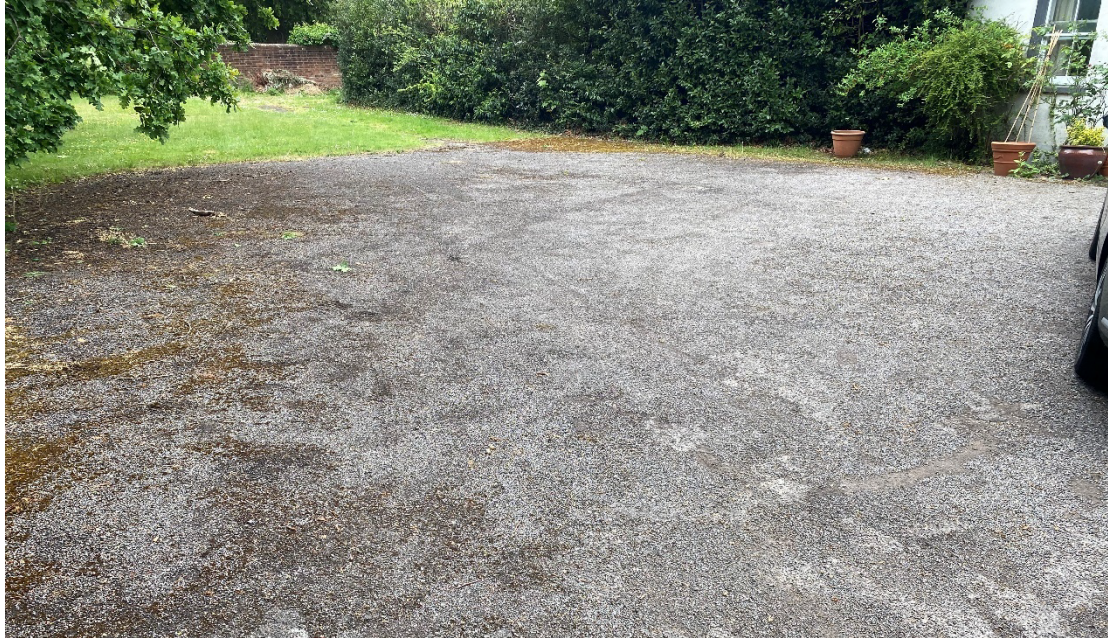
Areas of hard standing were present to the front and rear of the main dwelling formed of concrete (**Fig 10**).

Figure 10. Hard standing driveway located to the front of the main dwelling (taken May 2022).

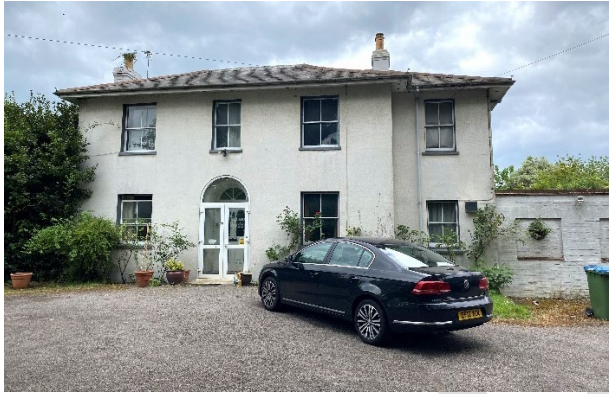
Building	Fig	Description of Construction	PRFs / Evidence of Occupation	Assessed Roost Potential
Main dwelling	<p data-bbox="387 435 1028 496">Figure 14. External view of the northern (front) elevation of the main dwelling.</p>

<p data-bbox="1050 435 1464 579">Detached, two-storey property constructed from a mixture of brick, rendered wall and hanging slate tiles on the rear (Fig 14).</p> <p data-bbox="1050 616 1464 791">The roof is constructed of mostly slate tiles with a small area of bitumen roofing material located on the southwestern corner of the building. The ridge tiles are constructed of clay.</p> <p data-bbox="1050 828 1464 932">It also supports a conservatory and small single-storey extension at the rear of the property.</p>	<p data-bbox="1485 435 1821 611">Due to the nature of the hanging slate tiles, several gaps were present on the walls at the rear of the property (Fig 15).</p> <p data-bbox="1485 647 1821 823">A central ridge tile (visible from the eastern elevation) had lifted, and gaps had formed from raised lead flashing.</p>	<i>Moderate potential</i>

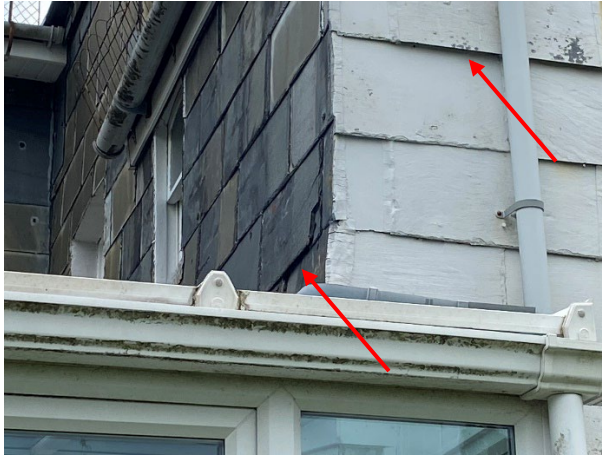
Figure 15. Gaps between slate tiles on the southern elevation of the dwelling.

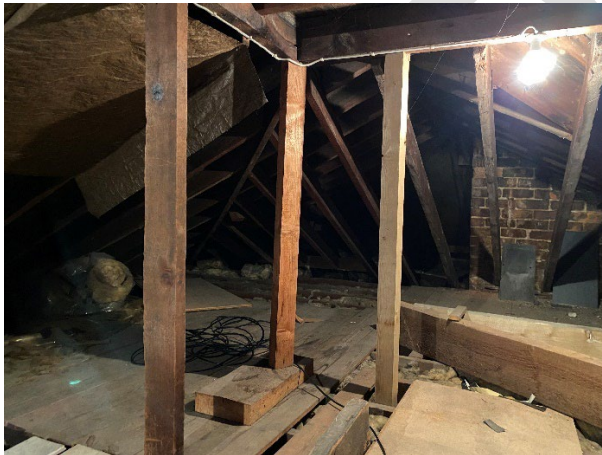
Figure 16. Internal view of the within the main dwelling.

The internal wooden frame is of a typical truss design and bitumen felt lined the loft space throughout (**Fig 16**).

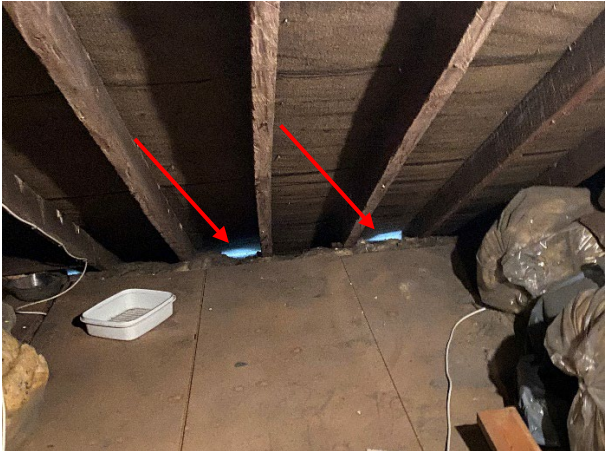
Two gaps were visible within the internals of the building where tiles had lifted (**Fig 17**). No other PRFs or evidence of bats was identified during the internal inspection.

<p>Figure 17. Gaps within the loft space that provide access into the internals of the dwelling.</p>

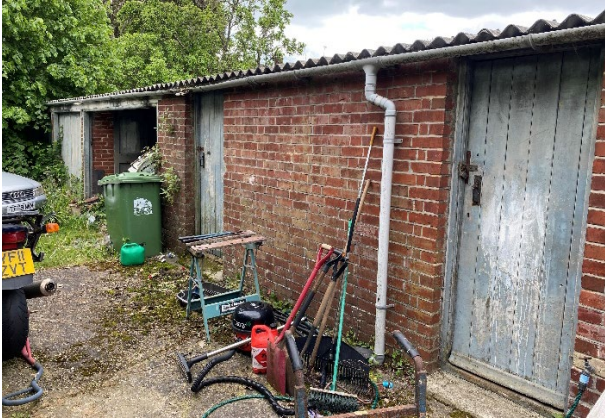
<p>Garages</p>	<p>Figure 18. External view of the northern (front) elevation of the garages.</p>

<p>Garage of brick construction with a corrugated metal roof (Fig 18). The garage supported multiple sections separated by brick walls, each with a separate entrance door and window (Fig 19).</p>	<p>A large crack had formed along the side of the building where a section of wood had broken off (Fig 20).</p> <p>A gap was identified above one of the doors that provided access to the internals of the building (Fig 21).</p> <p>Due to the windows, each section supported large amounts of light (Fig 19).</p>	<p>Low</p>

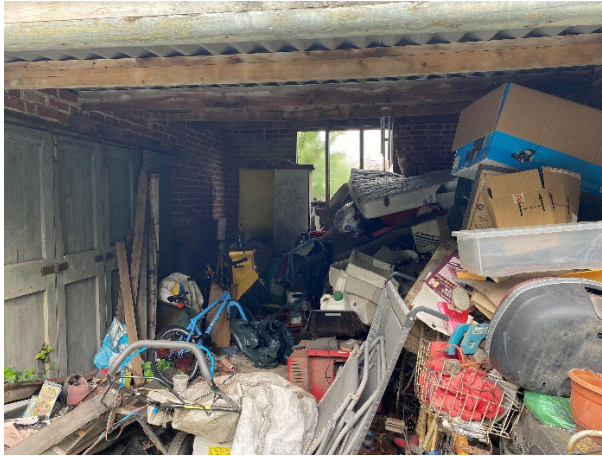
Figure 19. Internal view of the garages.

The internals were constructed with wooden supports that backed directly onto the corrugated metal and brick (Fig 19). The internals of the garage are currently used for storage.

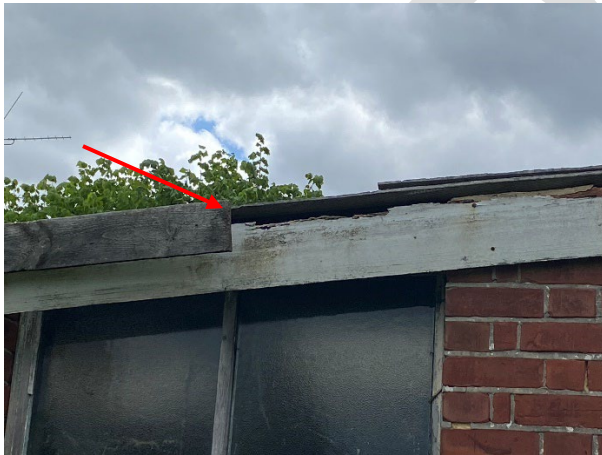
Figure 20. External view of the western (side) elevation of the garages.

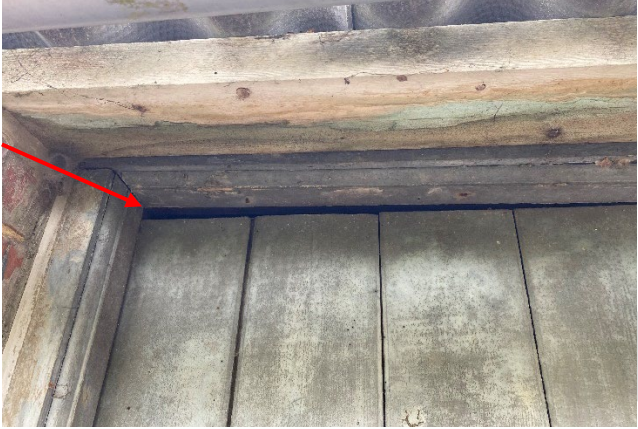
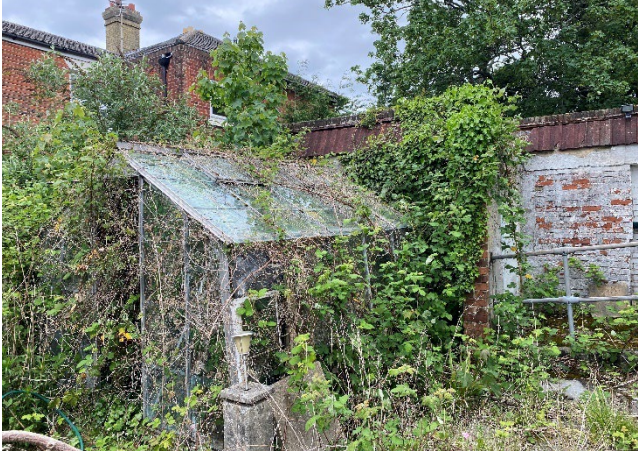
<p>Figure 21. The greenhouse located to the west of the main dwelling.</p>

<p>Greenhouse</p>	<p>Figure 22. The greenhouse located to the west of the main dwelling.</p>

<p>Disused greenhouse located to the west of the main dwelling (Fig 21). The internal space had become completely overrun from vegetation.</p>	<p>No PRFs or signs of use (droppings, insect remains etc) were noted during the assessment.</p>	<p>Negligible</p>
