Cookham Dene, Chislehurst, Kent

Bat Survey and Mitigation Strategy

7th August 2023/ Ref No 2022/11/22

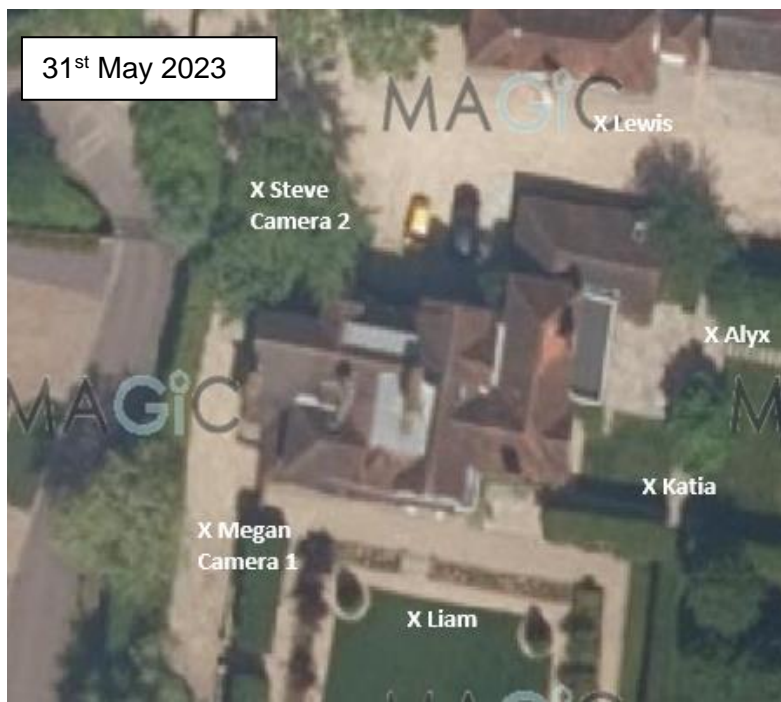
Dwelling:

Site Name and Building Number	Cookham Dene, Chislehurst	Surveyor Name / Equipment	Steve Stanley / Batlogger M2
Weather Conditions	100% Cloud, Wind 3, Rain 0	Date	31st May 2023
Start Time	20:50	Finish Time	22:35
Air Temperature (°C) at Start of Survey	13	Air Temperature (°C) at End of Survey	12
Sunset	21:05	Sunrise

Position: NW corner

Time	Species	Activity*	Comments
21:34	Pip 55	C	Brief and distant pass, not seen.

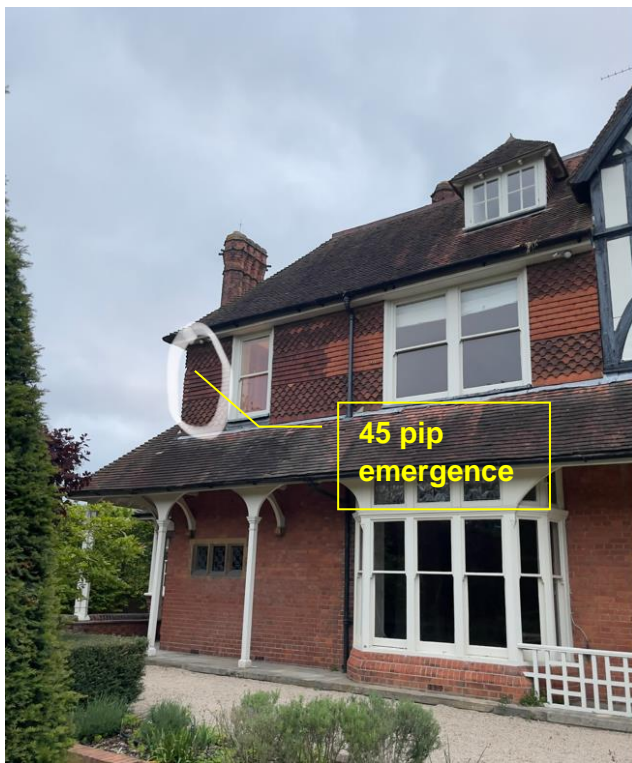
Site Name and Building Number	House at Cookham Dene, Chislehurst, BR7	Surveyor Name / Equipment	Liam Hoadley/Echo Meter Touch 2 Pro
Weather Conditions	cloud - 100% wind - 2 slight wind rain - 0	Date	31/05/2023
Start Time	20:50	Finish Time	22:35
Air Temperature (°C) at Start of Survey	13	Air Temperature (°C) at End of Survey	12
Sunset	21:05	Sunrise	N/A

position around building: S side

Time	Species*	Activity**	Comments
21.31	45 pip	C	S, flew SE to NW past SW corner, 1 bat, 1 pass, flew back 1 min later
21.34	45 pip	C	S, flew SE to NW past SW corner, 1 bat, 1 pass, flew back 1 min later
21.38	45 pip	C	S, flew E to W along guttering, 1 bat, 1 pass
21.40	45 pip	E	S, from SW corner

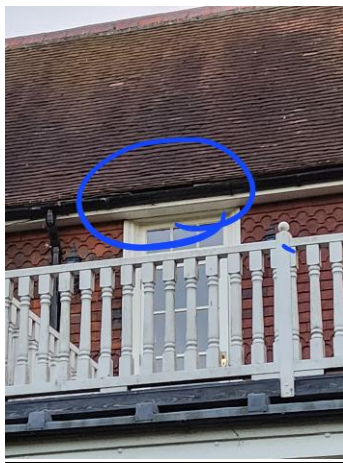
Site Name and Building Number	House at Cookham Dene, Chislehurst, BR7		Surveyor Name / Equipment	K Bresso / Batlogger M
Weather Conditions	cloud - 100% wind - 2 slight wind rain - 0		Date	31/05/2023
Start Time	20:50		Finish Time	22:35
Air Temperature (°C) at Start of Survey	13		Air Temperature (°C) at End of Survey	12
Sunset	21:05		Sunrise	N/A
position around building: East side				
Time	Species*	Activity**	Comments	
21:33	45 pip	E	above middle first floor window	
21:38	45 pip	C	commuting from back garden towards Liam	
21:41	45 pip	C	commuting from back garden towards Liam	
22:10	Noc	CNS

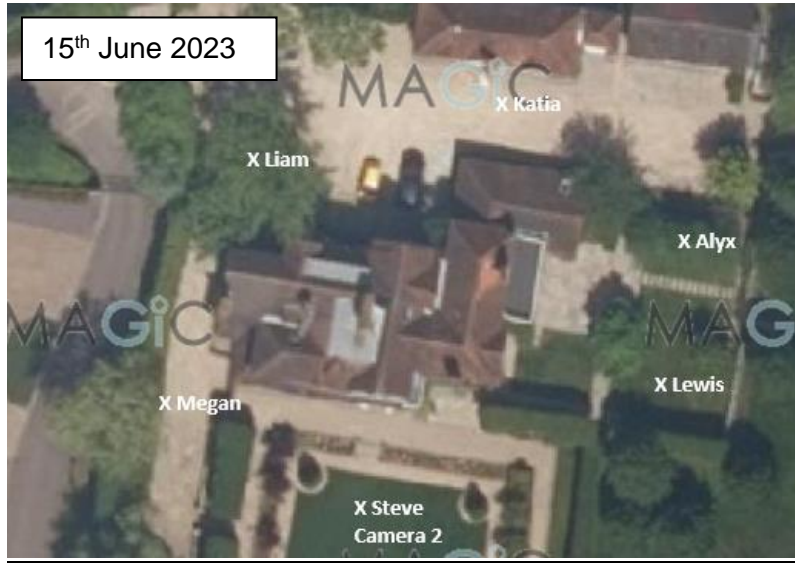
Site Name and Building Number	Cookham Dene, Chislehurst		Surveyor Name / Equipment	L Carterlilley / Echo Meter Touch 2 Pro
Weather Conditions	100% Cloud, Wind 3, Rain 0		Date	31.5.23
Start Time	20:50		Finish Time	22:35
Air Temperature (°C) at Start of Survey	13		Air Temperature (°C) at End of Survey	12
Sunset	21:05		Sunrise	
Position: north elevation				
Time	Species	Activity*	Comments	
21:34	55Pip	CNS		
21:38	45pip	CNS		
22:09	NOC	CNS

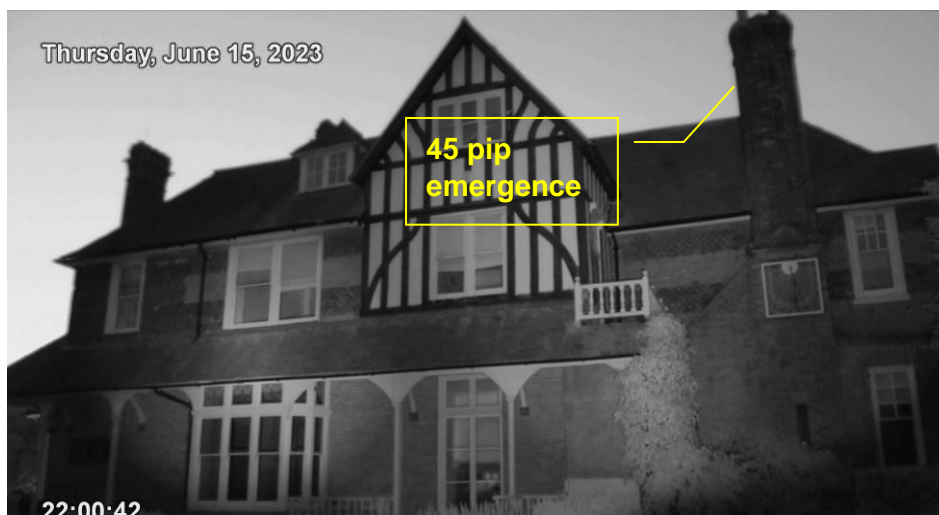
21:57	Pip 45	F	Brief F in garden.	
22:00	Tawny Owl	C	Tawny owl C along south elevation of building, from east to west.	
22:03	Pip 45	F	Brief F in garden.

22:10	Pip 45	F	Brief F nearby, not seen.	
22:15	Pip 45	F	Brief F in garden.	
22:28	Pip 45	C	Brief pass, not seen.	
22:37	Pip 45	F	F in garden south of building for 2 mins.

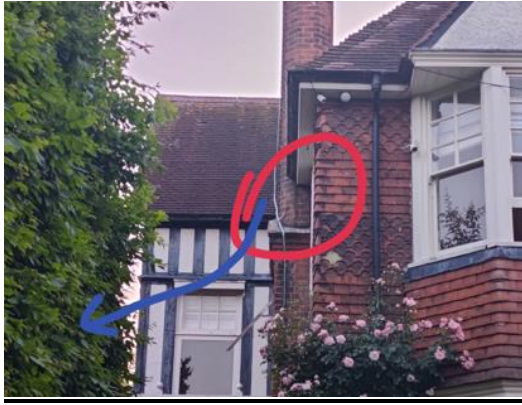
Site Name and Building Number	Cookham Dene, Chislehurst		Surveyor Name / Equipment	Lewis Carter-Lilley / Elekon BatScanner
Weather Conditions	0% Cloud, Wind 1, Rain 0		Date	15/6/23
Start Time	21:02	Finish Time	22:47	
Air Temperature (°C) at Start of Survey	20	Air Temperature (°C) at End of Survey	17	
Sunset	21:17	Sunrise		
Position:	East side (garden)			
Time	Species	Activity*	Comments	
21:35	Pip 45	E	from around chimney stack (see photo)	
21:44	Pip 45	E	above window over balcony (same as Alyx)	
21:46-22:18	Pip 45	F	Flying between hedgerows (south east corner of house)	
22:39	Pip 45	F	Flying between hedgerows (south east corner of house)

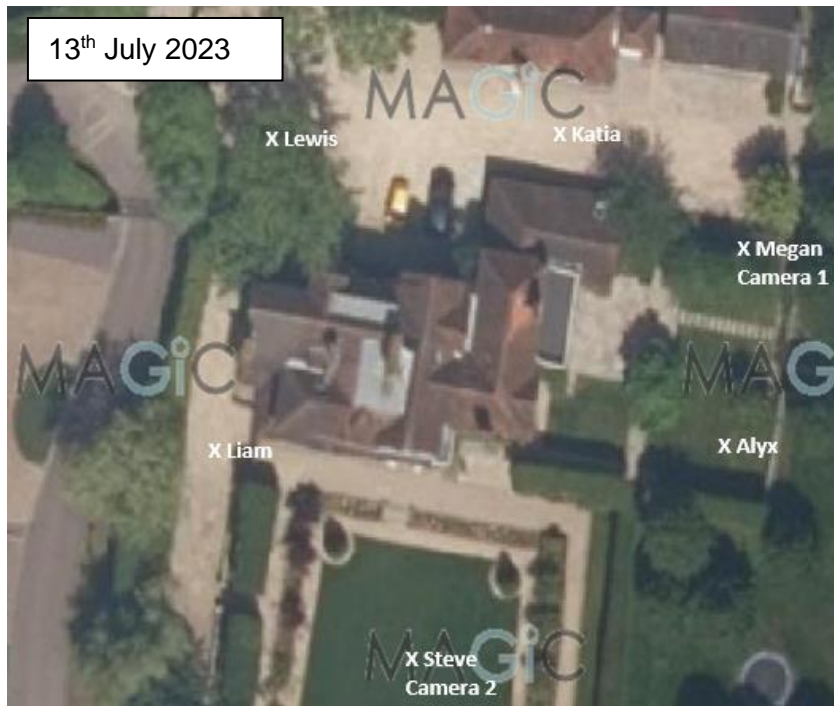
Site Name and Building Number	Cookham Dene, Chislehurst	Surveyor Name / Equipment	Alyx Penny / Echo Meter Touch 2 Pro
Weather Conditions	0% Cloud, Wind 1, Rain 0	Date	15/6/23
Start Time	21:02	Finish Time	22:47
Air Temperature (°C) at Start of Survey	20	Air Temperature (°C) at End of Survey	17
Sunset	21:17	Sunrise	
Position:	East side (garden)		
Time	Species	Activity*	Comments
21:35	c.pip	NS	possibly emerging on the south side near the chimney
21:44	c.pip	E	above window in the middle of E side, above gutter.
21:47	c.pip	NS	to SE, obscured by tree
21:53	c.pip	F	to SE, obscured by tree
21:58	c.pip	NS	to SE, obscured by tree
22:01	c.pip	F	around garden, off to field E

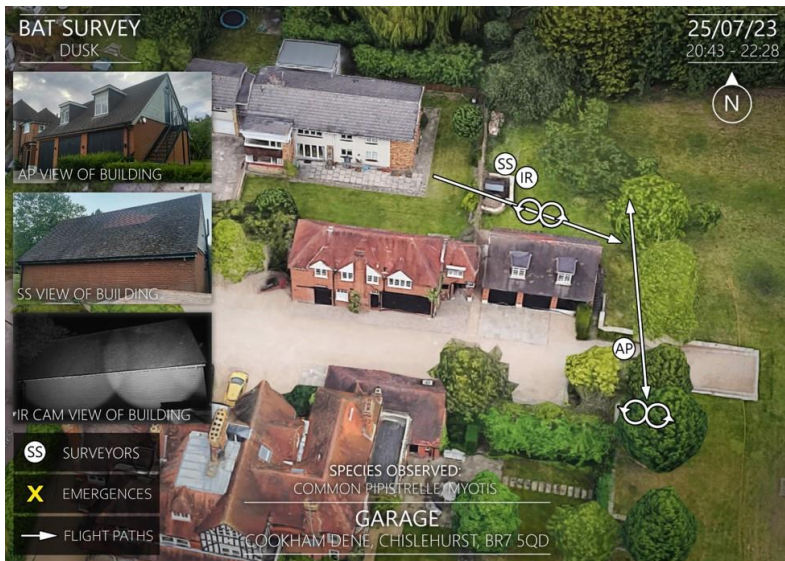
Garage:

Site Name and Building Number	Garage, Cookham Dene, Chislehurst	Surveyor Name / Equipment	Alyx Penny / Echo Meter Touch 2 Pro
Weather Conditions	70% Cloud, Wind 2, Rain 0	Date	25/7/23
Start Time	20:43	Finish Time	22:28
Air Temperature (°C) at Start of Survey	19	Air Temperature (°C) at End of Survey	17
Sunset	20:58	Sunrise	
Position:	SE corner		
Time	Species	Activity*	Comments
21:12	45 pip	C	from W to E via N of building, just above roofline, then off to S
21:15	45 pip	F	from S to N below roofline via E of building
21:23	45 pip	NS	foraging nearby
21:36	45 pip	NS	
21:38	45 pip	NS	
21:50	45 pip	NS	
21:52	45 pip	NS	
21:54	45 pip	F	from S of building to W over roofline, then foraging to SE until 21:55
22:14	45 pip	NS

Site Name and Building Number	Garage, Cookham Dene, Chislehurst		Surveyor Name / Equipment	Steve Stanley / Batlogger M2 and Canon XA
Weather Conditions	70% Cloud, Wind 2, Rain 0		Date	25th July 2023
Start Time	20:43		Finish Time	22:28
Air Temperature (°C) at Start of Survey	19		Air Temperature (°C) at End of Survey	17
Sunset	20:58		Sunrise	
Position:	North West corner			
Time	Species	Activity*	Comments	
21:13	Pip 45	C	From NW to E past north side of building.	
21:15	Pip 45	C	From NW to E past north side of building.	
21:31	Pip 45	C	Distant pass, not seen.	
21:36	Pip 45	F	Brief F north of garage, then CNE.	
21:53	Myotis	F	Brief F nearby, not seen.	
22:14	Pip 45	F	Brief F nearby, not seen.

The Coach house and garage buildings are not considered as being used as a bat roost and no mitigation or licence is expected to be needed prior to their demolition/ conversion¹².
