## **SALAMANDER STREET, EDINBURGH**

### **STAGE 1 GEOENVIRONMENTAL INVESTIGATION REPORT INCORPORATING COAL MINING RISK ASSESSMENT (CMRA)**

<b>STATUS</b>	<b>REV 0 ISSUE</b>
<b>DATE OF ISSUE</b>	<b>OCTOBER 2023</b>

**STAGE 1 GEOENVIRONMENTAL INVESTIGATION REPORT**

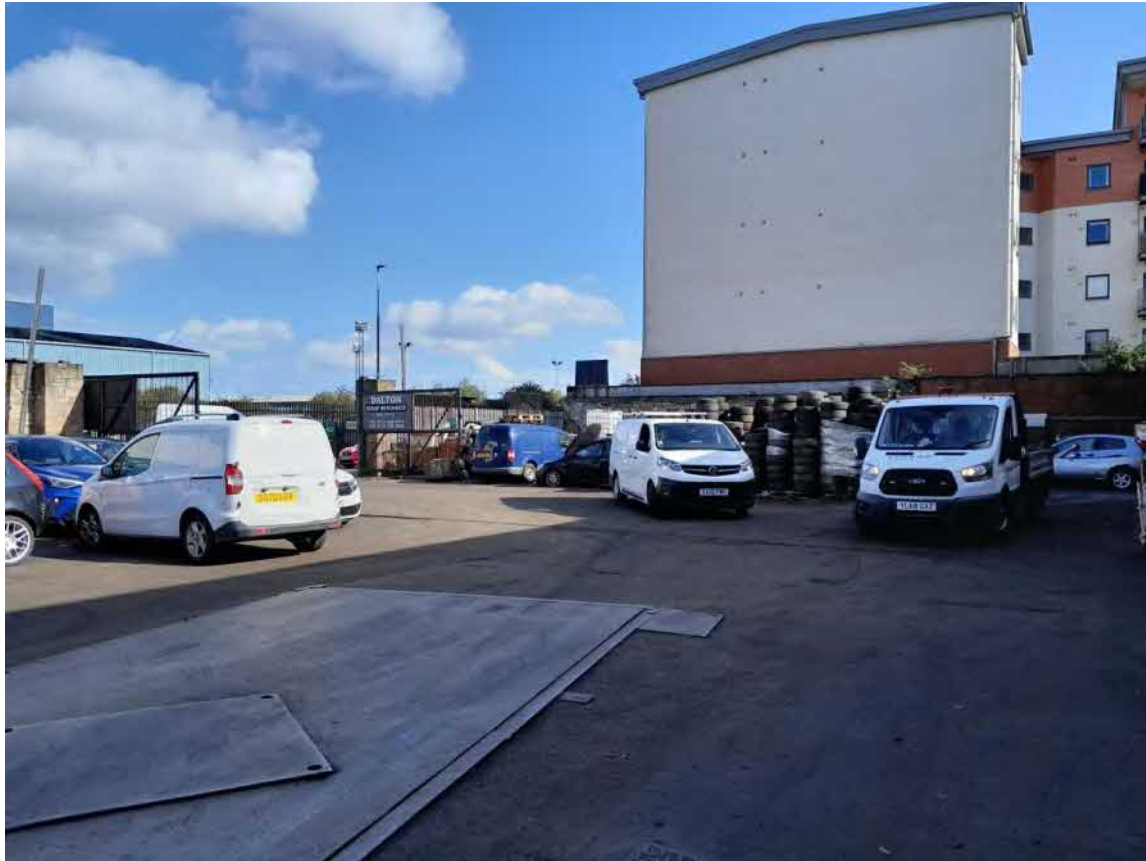
**Plate 1:** Photo taken facing East, showing the entrance to site.

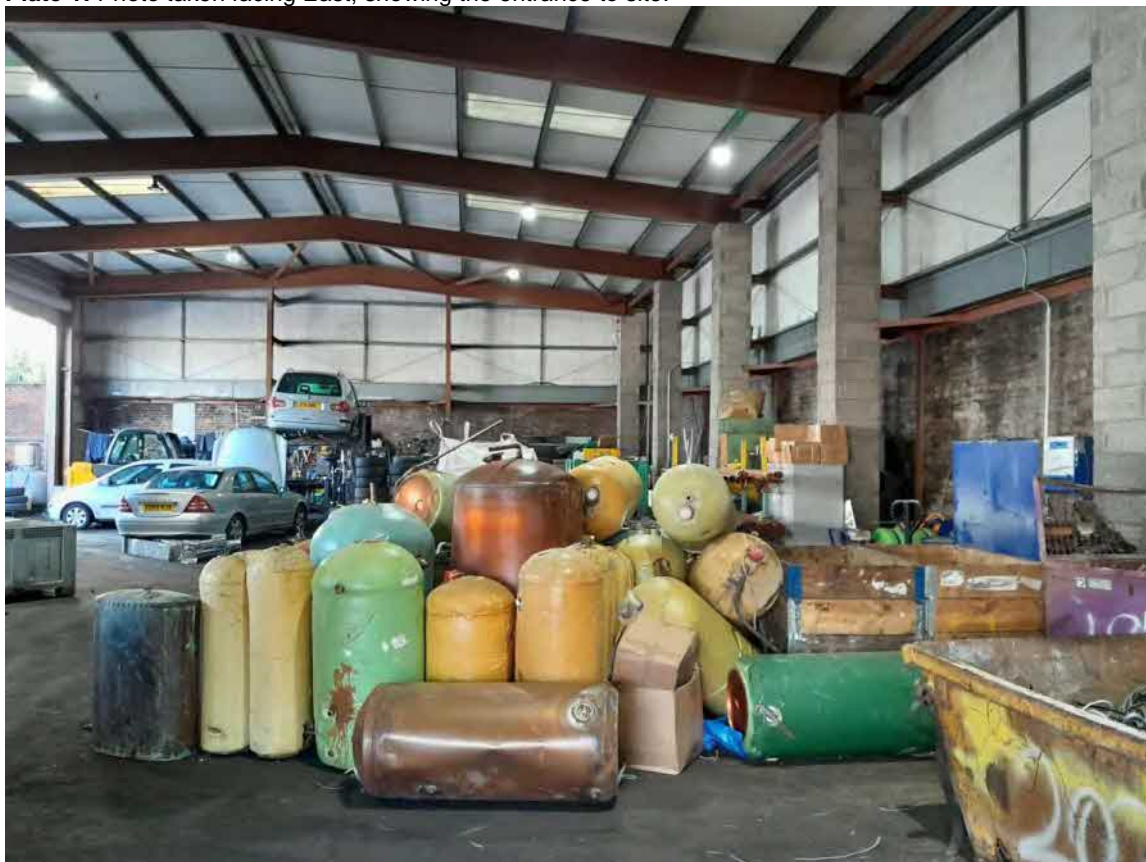
**Plate 2** Photo taken facing south-east inside the building which occupies the south-western corner of site, showing multiple empty tanks and associated scrap.

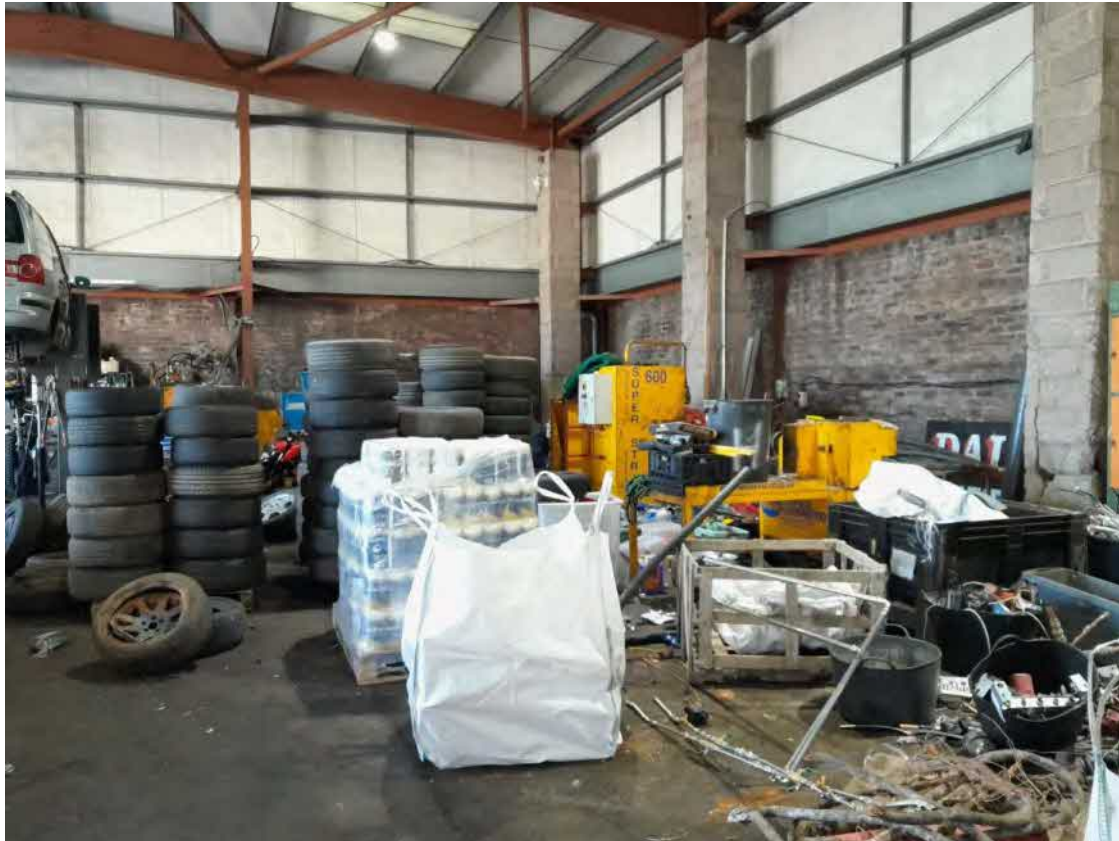
**Plate 3:** Photo facing the south-east corner of the building, containing stacks of tires and various car equipment/parts.

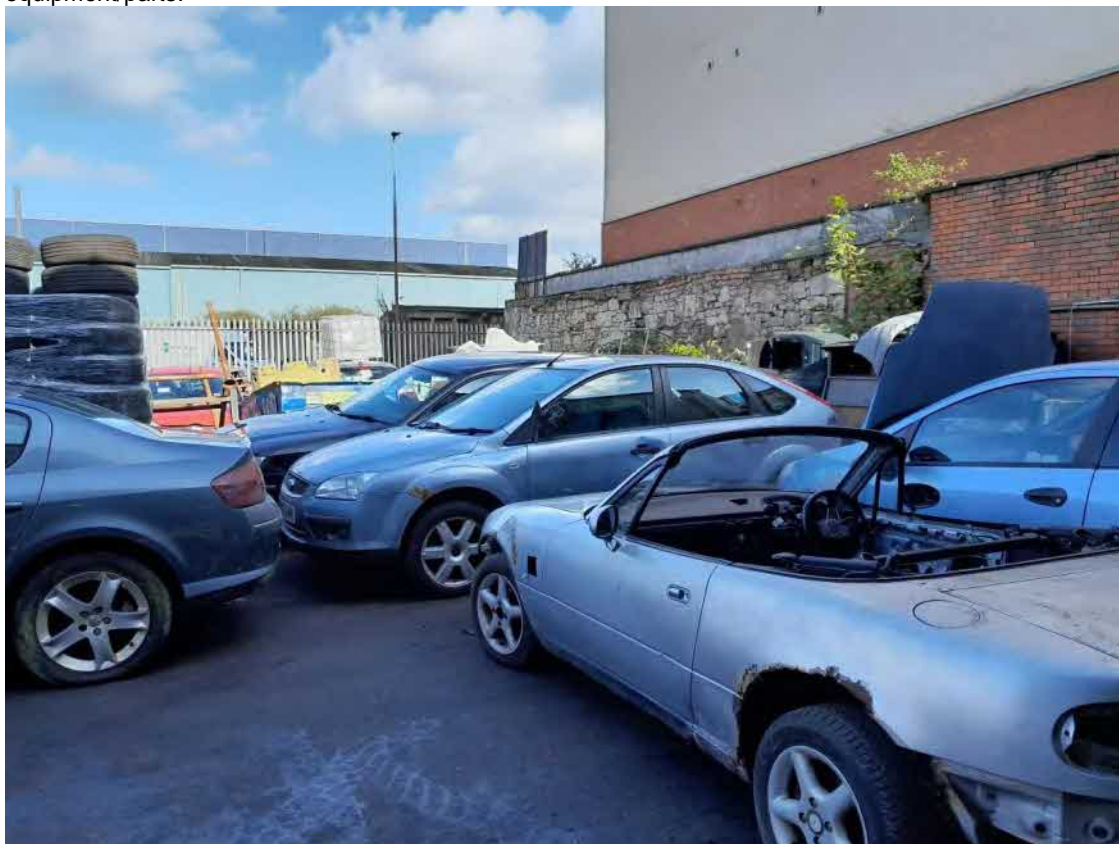
**Plate 4:** Photo facing north-east showing multiple cars.

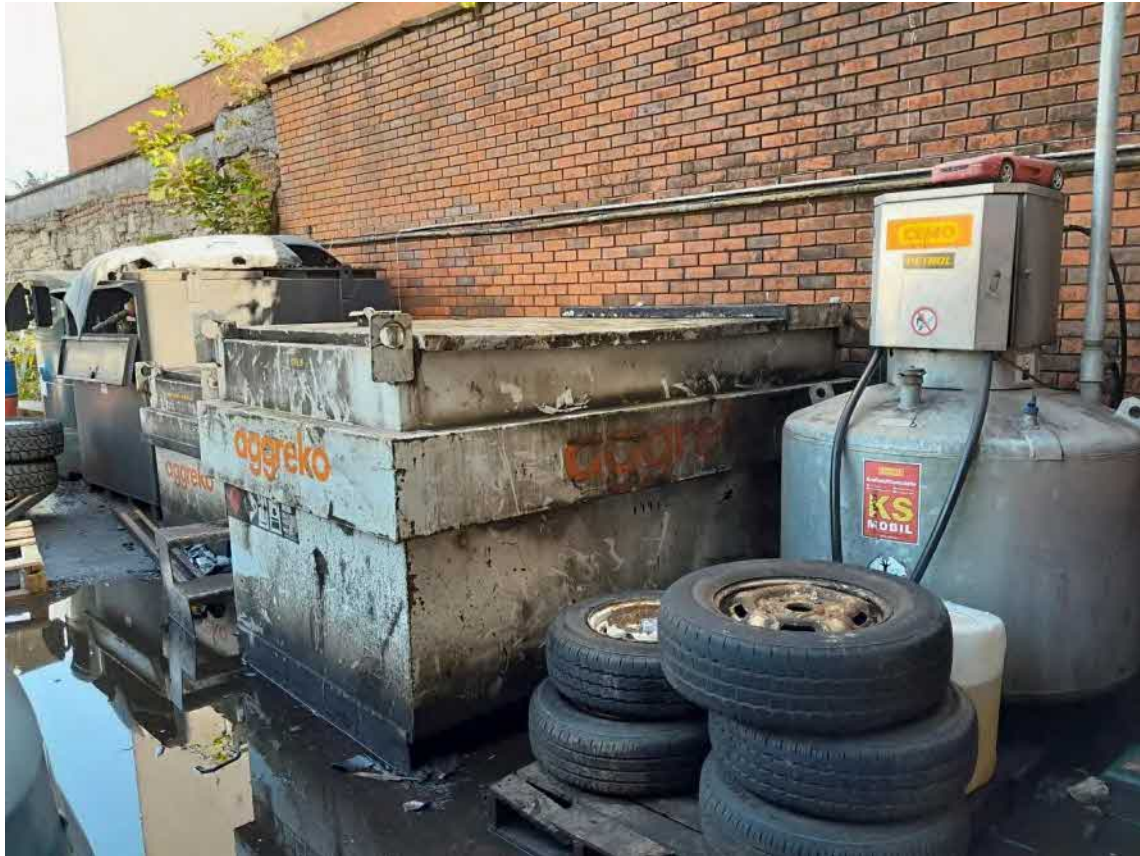
**Plate 5:** Photo facing north-east, showing a petrol tank and multiple other storage container against the eastern boundary of site.

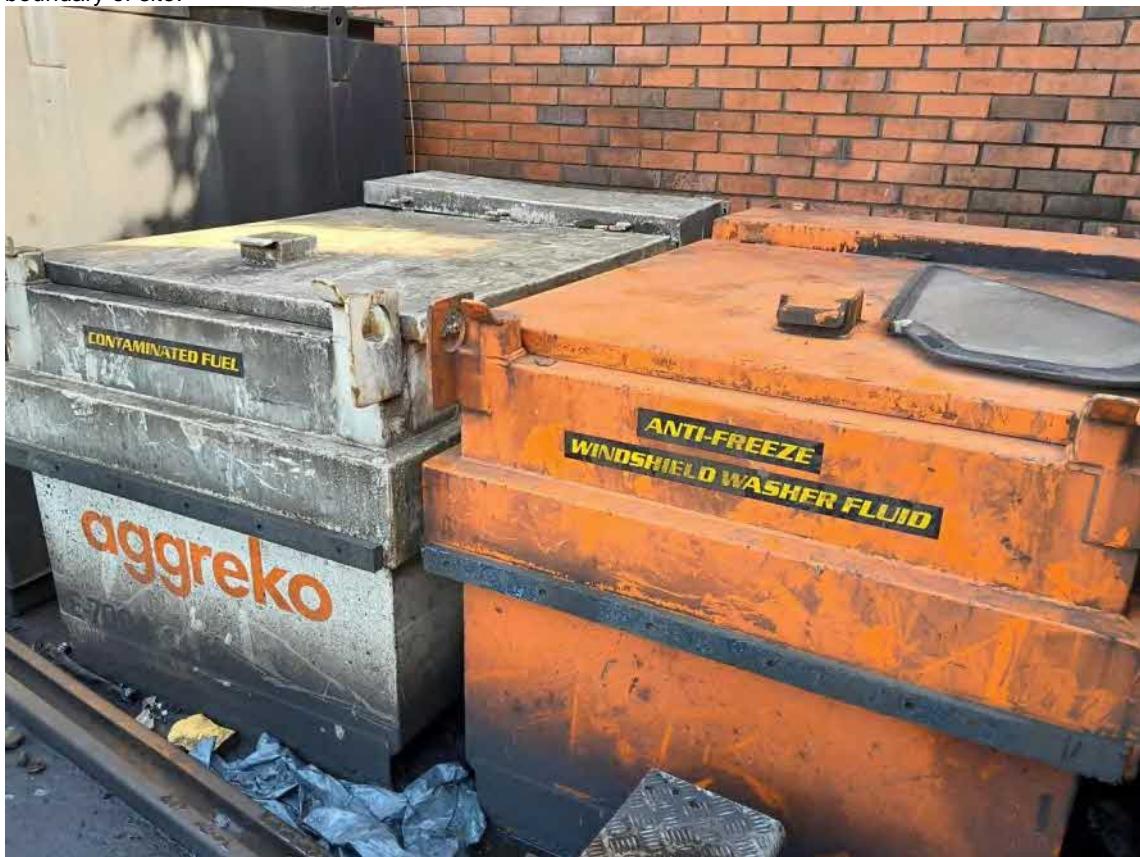
**Plate 6:** Close up photo of two of the containers against the southern boundary.

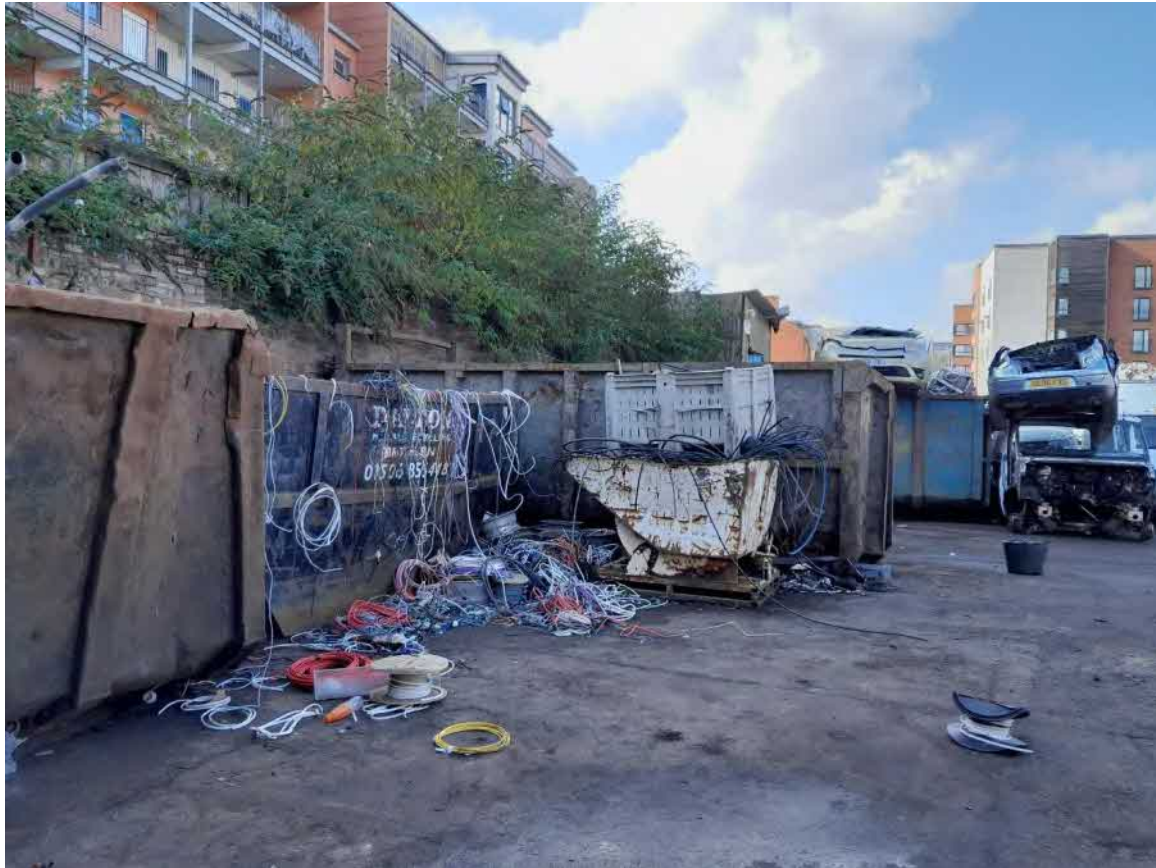
**Plate 7:** Photo facing north-west, showing multiple containers resting against the southern boundary.

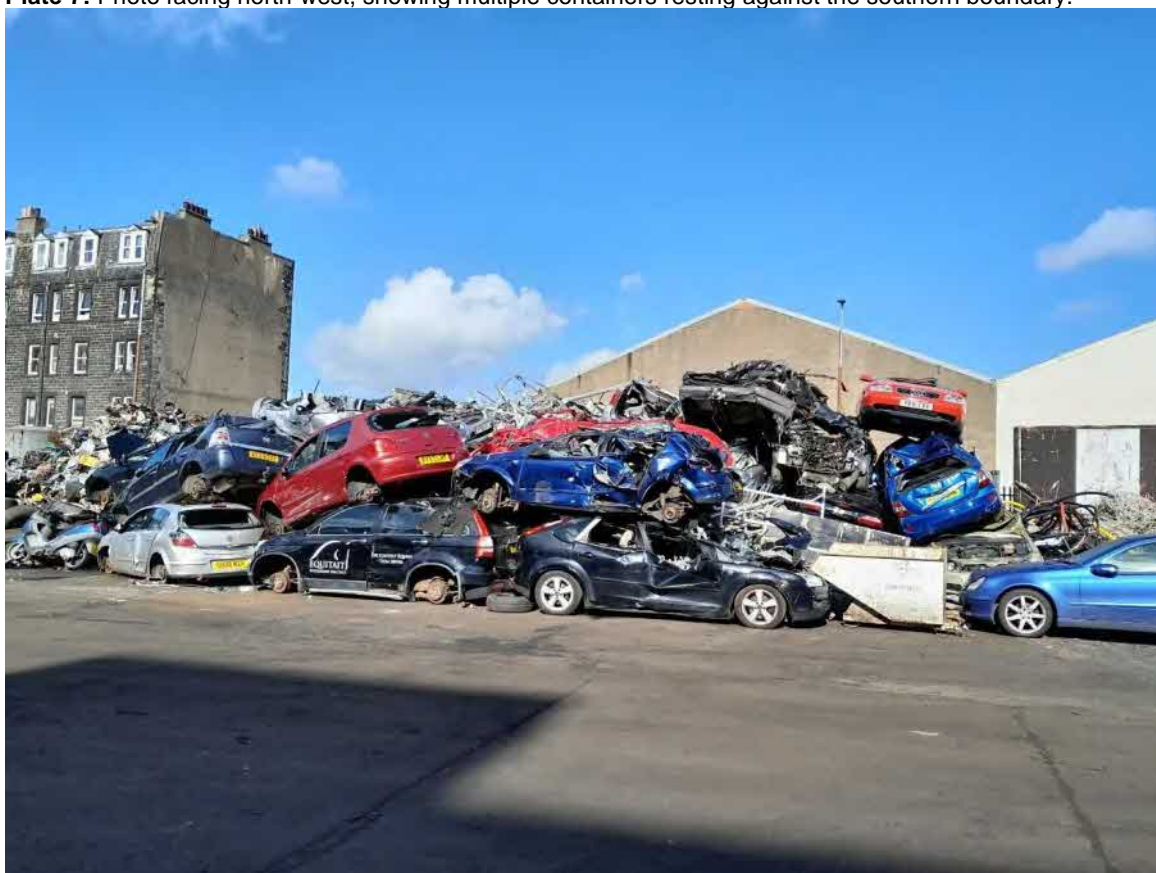
**Plate 8:** View facing north-east, showing the pile of cars and various scrap metal piled along the northern boundary.

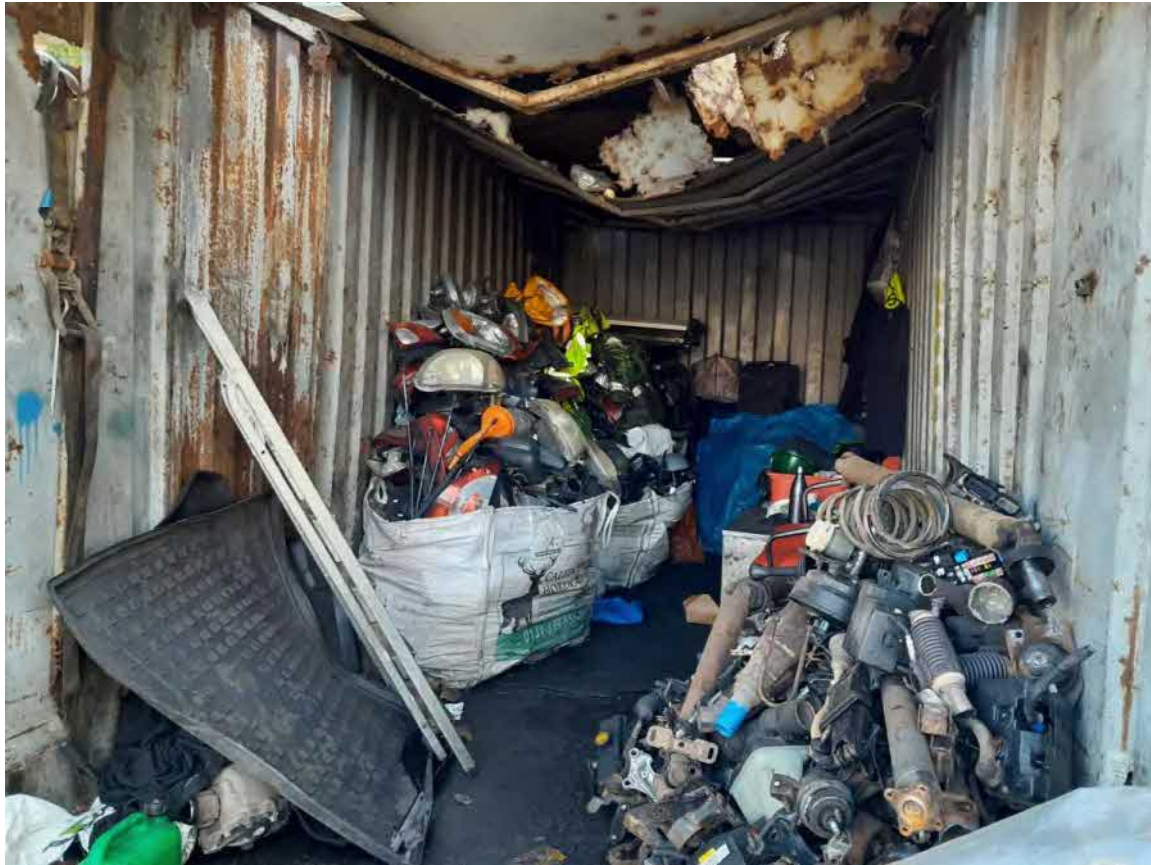
**Plate 9:** Photo showing the inside of one of the containers along the southern boundary, showing various car parts.

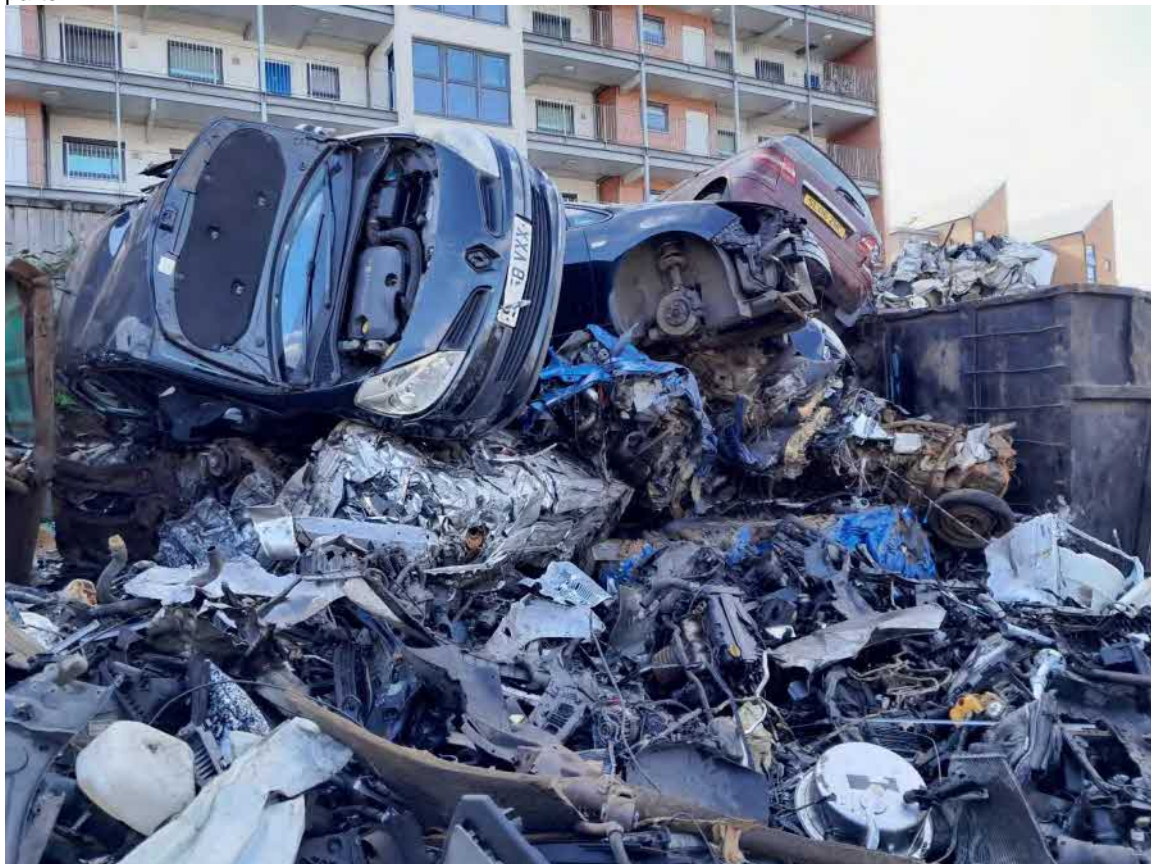
**Plate 10:** Photo showing multiple scrapped cars and their parts, against the southern boundary.

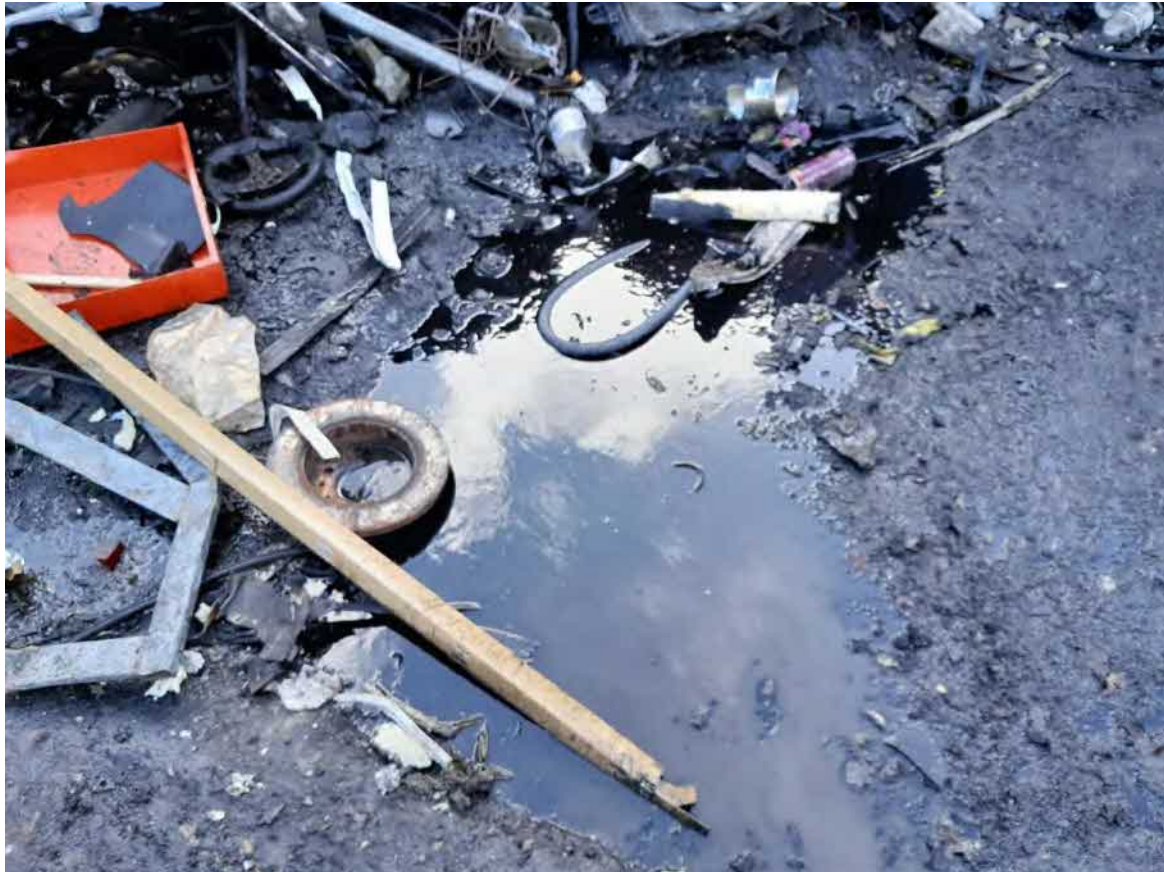
**Plate 11:** Photo showing possible contaminated water.

Previous site uses and the site visit indicate the potential for made ground beneath parts of the site, which could contain biodegradable material and could degrade to produce elevated levels of gas including methane, carbon dioxide, hydrogen sulphide and carbon monoxide. In addition the site is potentially underlain by peat/organic silts which could provide a source of ground gas emissions. This may cause a constraint to any future developments and further intrusive investigations are required to confirm ground gas conditions.

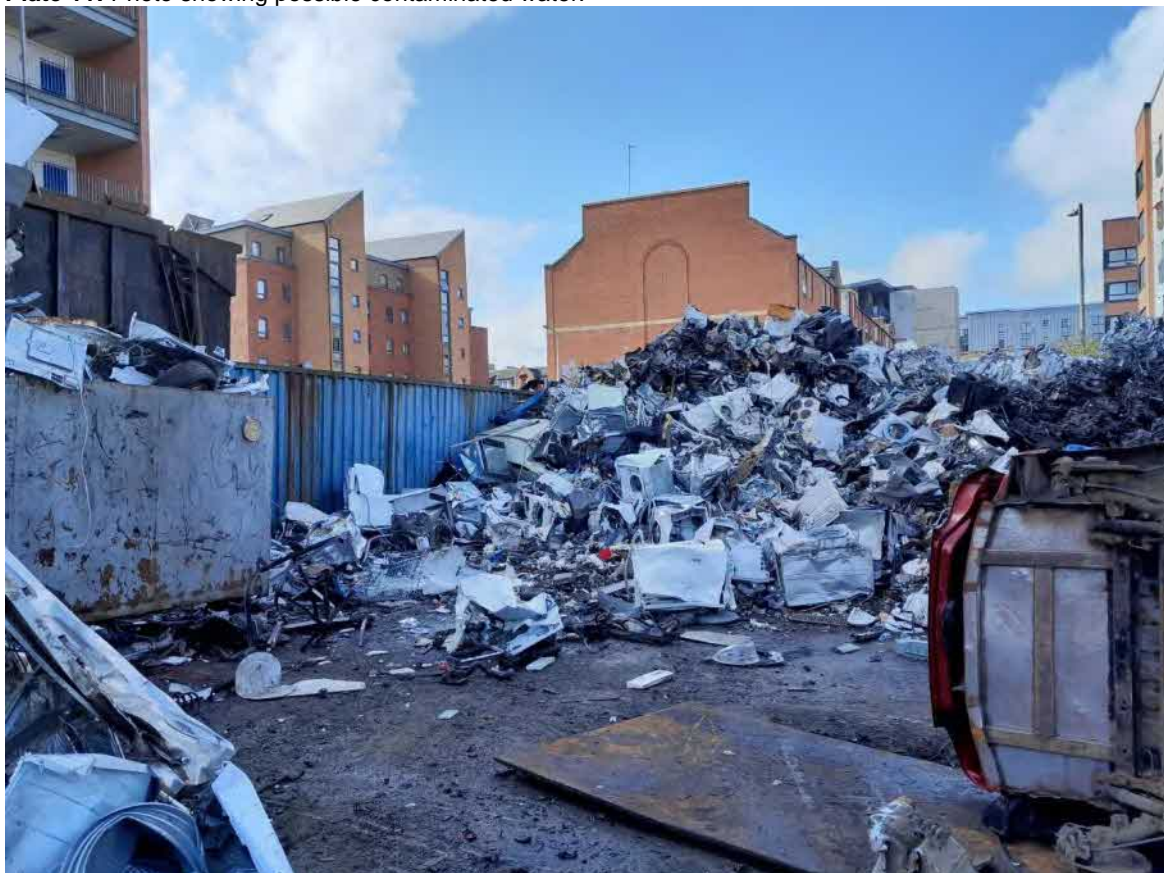
**Plate 12:** View facing into the western corner of site, showing a pile of scrapped washing machines and other kitchen appliances.

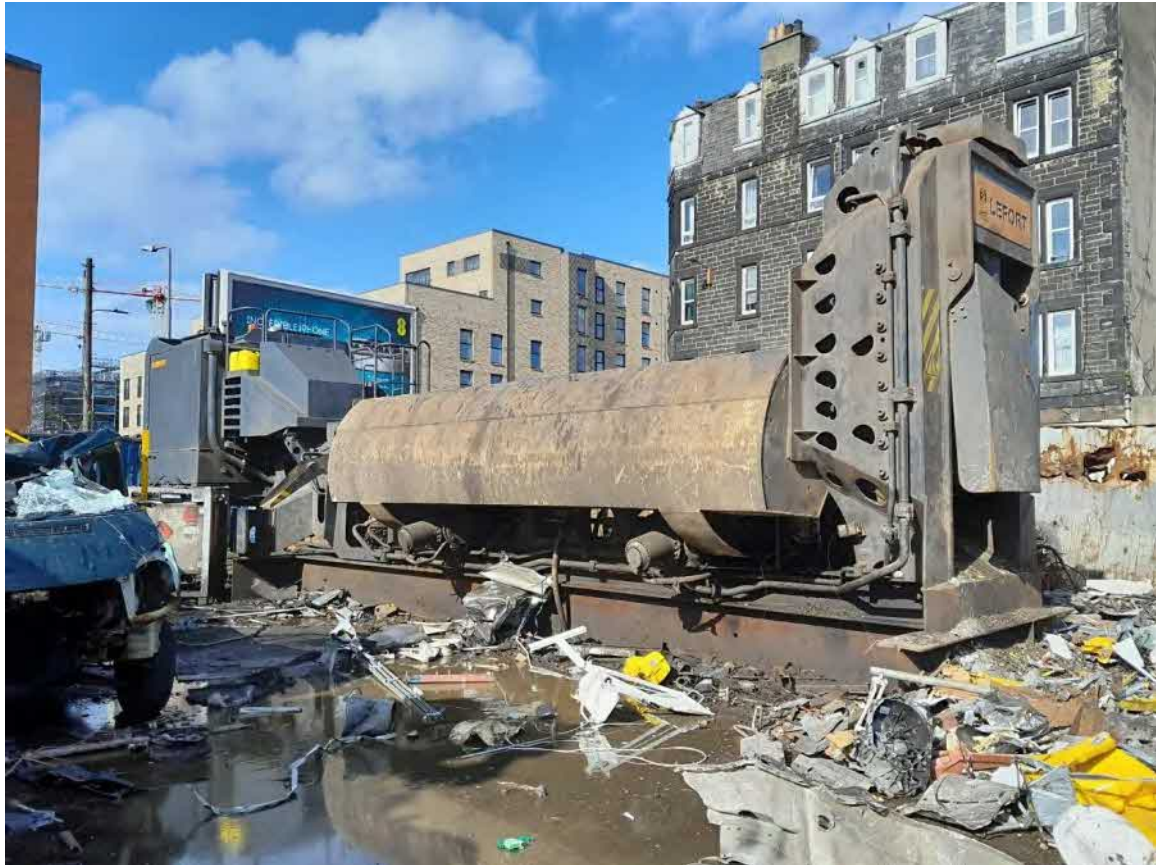
Plate 13: Photo in the north-west corner, showing a baler.

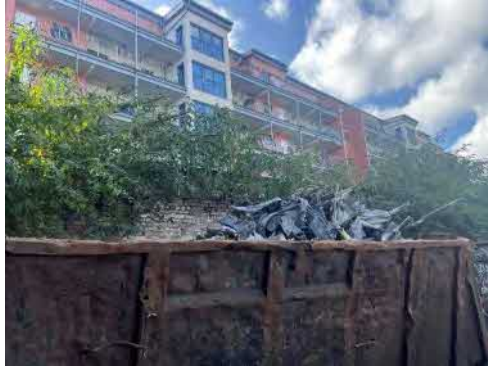
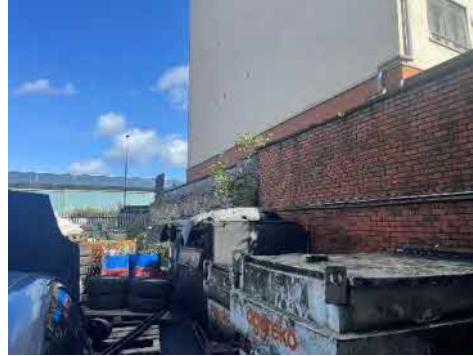
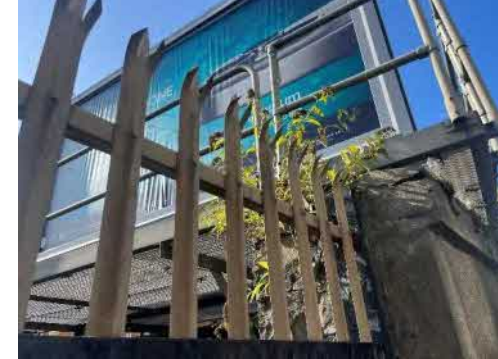
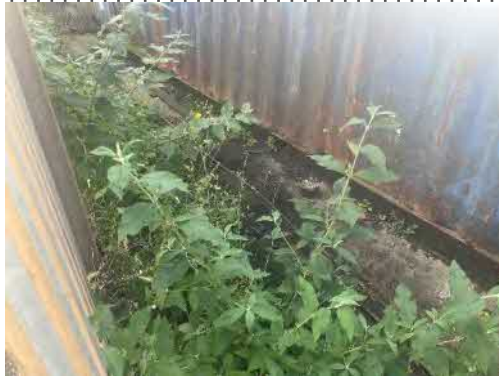
BD1 Buddleia

The ecologist noted the presence of some invasive or non-native species during the visit that may be of concern, including buddleia. The report notes that the vegetation clearance should be undertaken in a controlled manner which ensures that no further spread of these invasive weeds results.

However, the ecologist noted the presence of some invasive or non-native species that may be of concern, including Buddleia during the visit. The report notes that the vegetation clearance should be undertaken in a controlled manner which ensures that no further spread of these invasive weeds results.
