Report prepared for: Tony Blair

For the Site of: 25 Church Street, Stanwick, NN9 6PS

# Emergence and Activity Bat Survey (EBS)

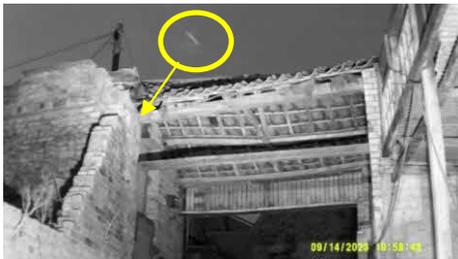
Surveyor	Building, Tree or Structure	Dates, Times and Survey Type	Bat Activity Observed
ZH	B1	14/09/2023 19:08 to 21:15 Dusk	<p>A Brown long-eared bat (BLEB) was observed emerging at 19:58 from the apex of B1b and foraging under the roof across B1a and B1b.</p>

<p>Figure 2- BLEB emergence from apex of B1b.</p> <p>Bats including Common Pipistrelle <i>Pipistrellus pipistrellus</i> (Cpip), Soprano Pipistrelle <i>Pipistrellus pygmaeus</i> (SPip) and</p>

The surveys have shown Brown long-eared bats to be present within the interior of B1a and B1b. A Brown long-eared bat was observed emerging from the eastern apex of B1b on 14.09.2023. A single BLEB was observed flying within the first storey of B1a on 14.09.2023.

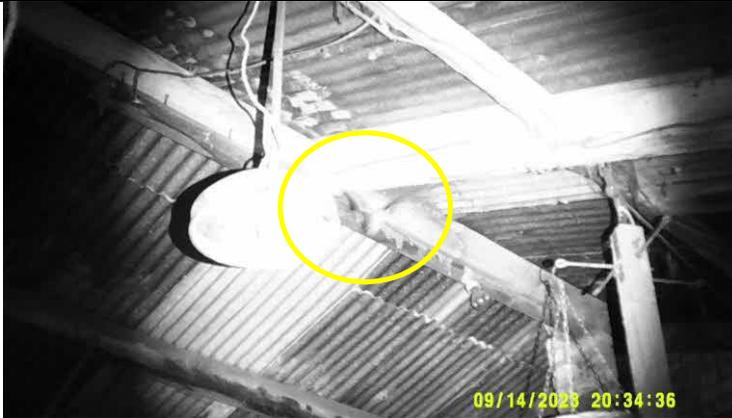
Figure 3- Single BLEB flying inside interior of B1a on 14.09.2023.

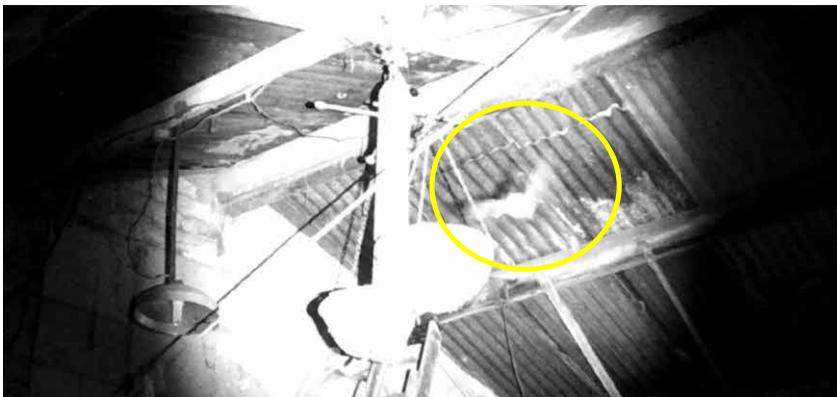
28/09/2023 - A pair of BLEBs were recorded flying within the interior of the first storey of B1a. A single BLEB was observed flying within the interior of B1b at 20:22.

Figure 4- BLEB observed flying within the interior of B1a on 28.09.2023.

No emergences were identified during 28.09.2023. However, a pair of BLEBs were recorded flying within the interior of B1a and a single BLEB was observed flying within the interior of B1b on 28.09.2023.

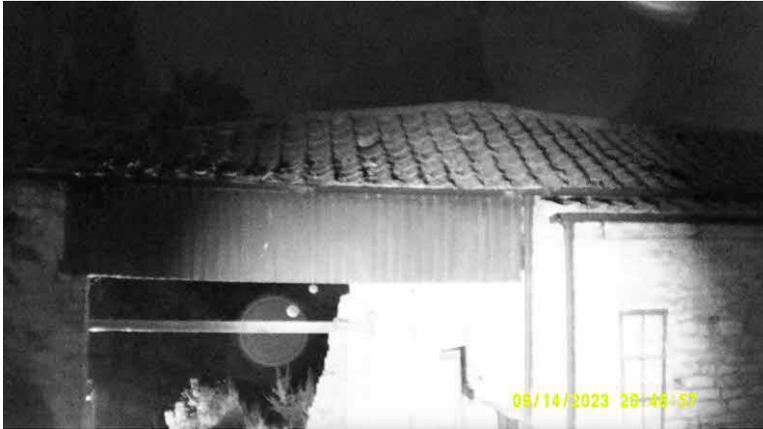
Figure 6: IR image of B1b on 14.09.2023.

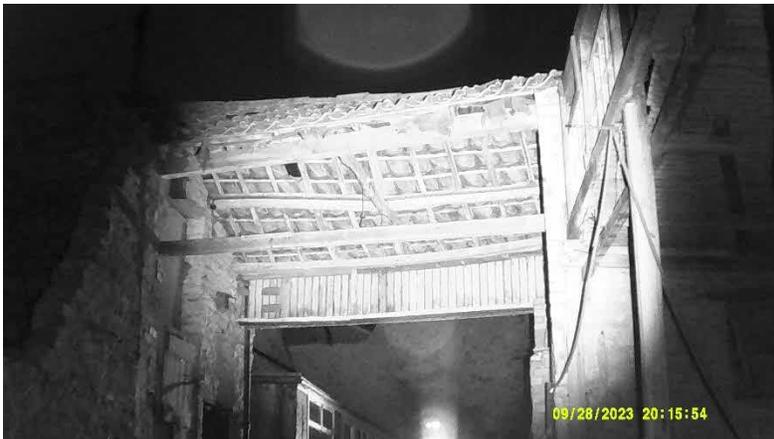
Figure 7: IR image of B1b from 28.09.23.

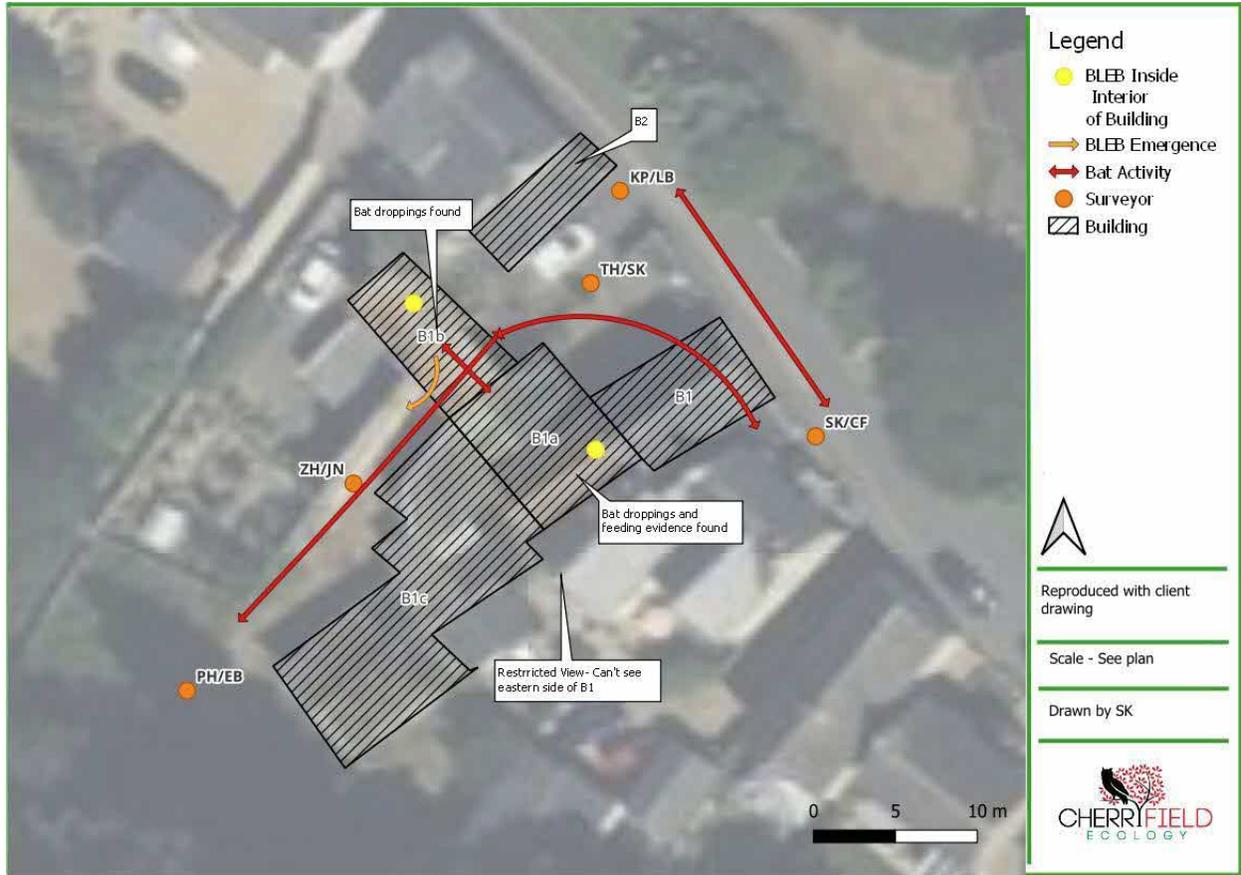
Figure 8: Site Plan

The following section details the structure(s) reference, bats located, evidence located and observed emergence (see Figure 8 for Site Plan). Five surveyors were positioned around the building and IR cameras placed within the interior of B1a and B1b.

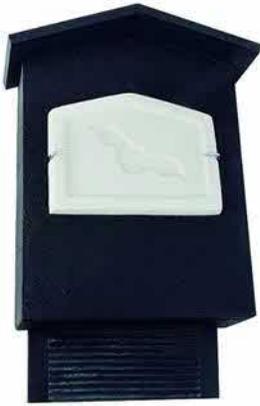
</div> <p>Figure 9: Chillon Woodstone Bat Box (British-made)</p> <p>Commuting bats maybe using the grounds and surrounds; therefore, any tree, hedges or linear feature should be retained were possible.</p>
<p>Lighting</p>	<p>Any lighting near or shining onto any trees/buildings, especially those with bat boxes in or commuting routes shown to be present at further survey stage, will be designed to minimise the impact it has on potential bat roosting and commuting.</p> <p>Lighting will be in line with the BCT lighting guidelines (Bats and Lighting in the UK (Bat Conservation Trust, 2023) <a href="https://www.theilp.org.uk/documents/guidance-note-8-bats-and-artificial-lighting/">https://www.theilp.org.uk/documents/guidance-note-8-bats-and-artificial-lighting/</a>)</p> <p>This lighting where possible will be of low level, be on downward deflectors and be on PIR sensors. Using LED directional lighting can also be a way of minimizing the light spill affecting the habitat. No up-lighting should be used. Light spill must be minimized to 0.5lux.</p> <p>This will ensure that the roosting and commuting resources that the bats are likely to be using is maintained.</p>

<p>Licence application</p>	<p>will be checked for bats i.e. endoscope (were possible). If bats are found, these will be removed by hand and placed in bat boxes that will be in place before works commence.</p> <p>One bat box will be installed on trees or buildings; it is currently understood that there are trees to the rear of the dwelling bordering the garden that could be used for this purpose.</p> <div data-bbox="787 520 1047 926" data-label="Image">

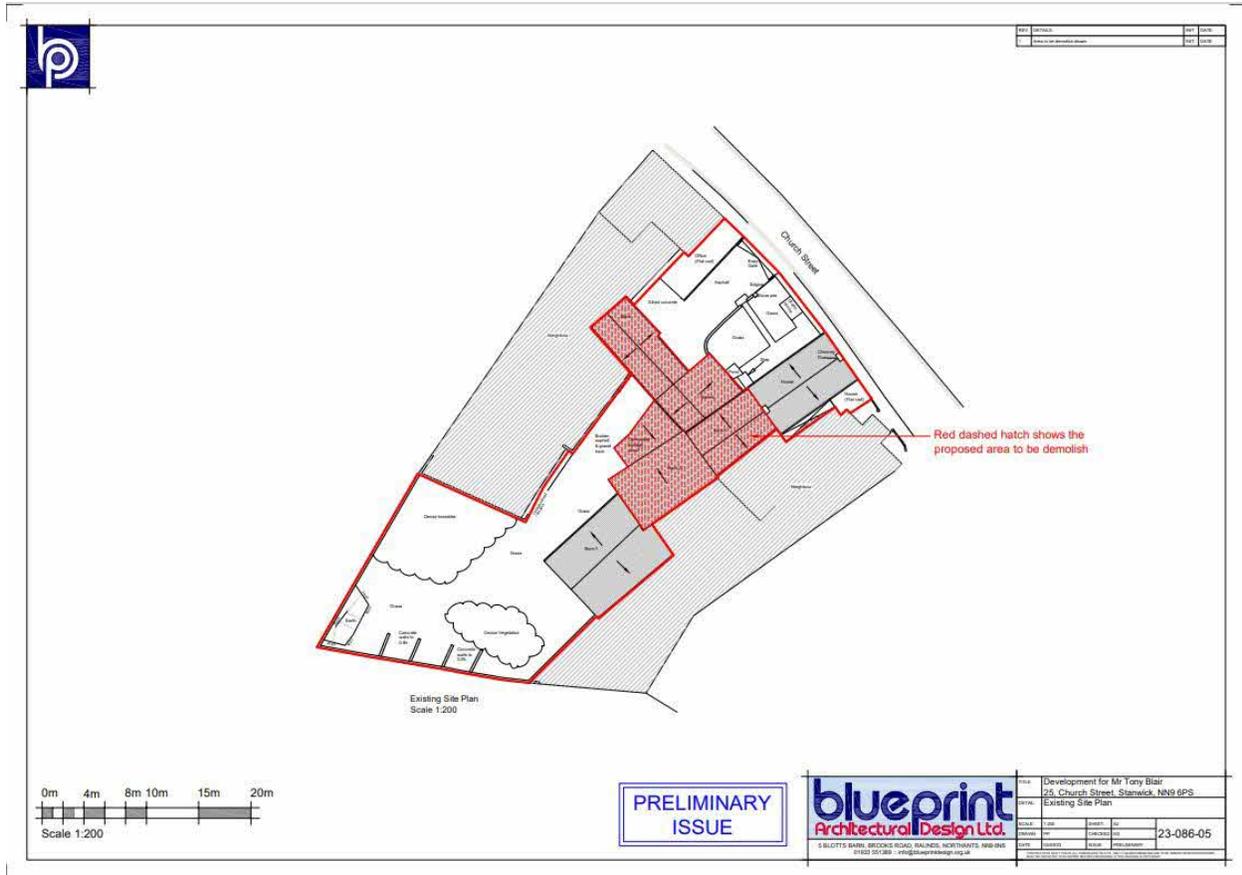
Proposed Site Plan (Blueprint Architectural Design Ltd, 2023)

The proposals include for the demolition of sections of B1 including B1a and B1b (see Appendix I).
