FORMER METHODIST CHURCH,  
LIVERPOOL ROAD, MAGHULL

Bat Report & Preliminary Ecological  
Appraisal (PEA)

| Report Title | Bat Report and Preliminary Ecological Appraisal |

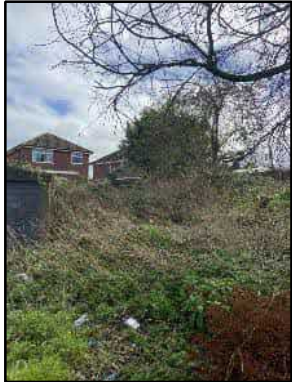
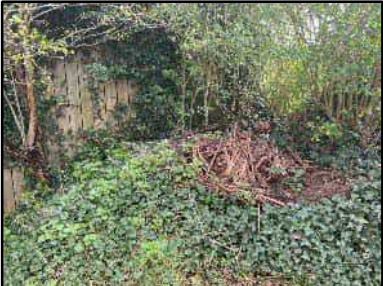
| Habitat | Description | Area (m <sup>2</sup> ) | Proportion of site (%) | Ecological Importance & Outcome of Proposal | Photograph |
|---|---|---|---|--|---|
| A2.1<br>Scrub<br>Dense/ continuous | <p>Dense scrub was located along the eastern portion of Site. This was dominated by bramble (<i>Rubus fruticosus</i>) with frequent common nettle (<i>Urtica dioica</i>), green alkanet (<i>Pentaglottis sempervirens</i>), ivy (<i>Hedera helix</i>) and cleavers (<i>Galium aparine</i>). Dock (<i>Rumex obtusifolius</i>) and daffodil (<i>Narcissus</i>) were seen occasionally, and elder (<i>Sambucus nigra</i>) and cherry laurel (<i>Prunus laurocerasus</i>) were seen on Site but classed as rare.</p> <p>A small section of dense scrub was located within the southern portion of Site. This was dominated by ivy with frequent hawthorn (<i>Crataegus monogyna</i>) and privet (<i>Ligustrum ovalifolium</i>), common nettle, periwinkle (<i>Vinca</i>) and green alkanet seen rarely.</p> | n/ a | n/ a | Low ecological value. To be lost within current proposals. | <br> |

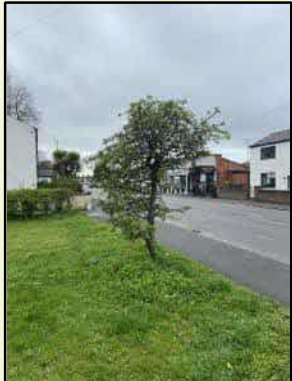
| Habitat | Description | Area (m <sup>2</sup> ) | Proportion of site (%) | Ecological Importance & Outcome of Proposal | Photograph |
|---|---|---|---|--|---|
| A2.2<br>Scattered scrub | A small area of scattered scrub was located in the southwestern corner of Site consisting of hawthorn | n/a | n/a | Low ecological value. To be lost within current proposals. | |

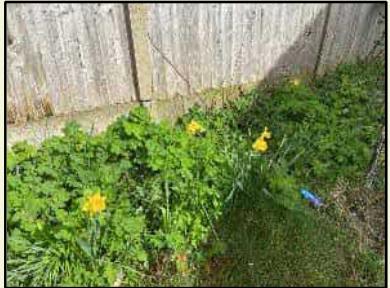
| Habitat | Description | Area (m <sup>2</sup> ) | Proportion of site (%) | Ecological Importance & Outcome of Proposal | Photograph |
|---|---|---|---|--|--|
| C3.1<br>Tall ruderal | A parcel of tall ruderal is located along the northeastern boundary of the site. This is dominated by perennial rye grass with abundant common nettle, alkanet ( <i>Pentaglottis sempervirens</i> ) and greater celandine ( <i>Chelidonium majus</i> ). Dandelion and bramble were also present but classed as rare. | n/a | n/a | Limited ecological value. To be lost within current proposals. | |

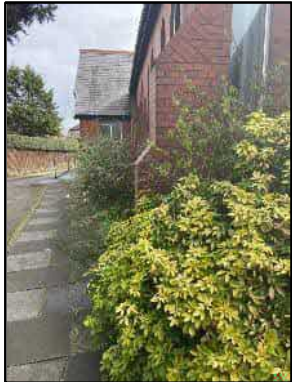
| Habitat | Description | Area (m <sup>2</sup> ) | Proportion of site (%) | Ecological Importance & Outcome of Proposal | Photograph |
|---|---|---|---|--|--|
| J1.4<br>Introduced shrub | <p>Several parcels of introduced shrub are present on Site.</p> <p>Two parcels were located in the northwest corner of Site. The first parcel consisted of frequent cotoneaster (<i>Cotoneum</i>), occasional barberry (<i>Berberis vulgaris</i>) and Japanese laurel (<i>Aucuba japonica</i>) which was seen as rare. The ground layer was dominated by common nettle and dandelion with occasional ivy. Bracken (<i>Pteridium aquilinum</i>) and harts tongue fern (<i>Asplenium scolopendrium</i>) were present but classed as rare.</p> <p>The second parcel was situated in the northwest corner and was dominated by cotoneaster with occasional cleavers and cow parsley (<i>Anthriscus sylvestris</i>). Dandelion and sedge (<i>Carex sp</i>) were present but seen as rare.</p> <p>A third parcel was located in the southwest portion of Site, adjacent to building B1b. this consisted of frequent periwinkle with occasional dandelion, lavender (<i>Lavandula angustifolia</i>), tulip (<i>Tulipa</i>), rose (<i>Rosa</i>) and barberry.</p> <p>A fourth parcel was situated in the centre of Site</p> | n/a | n/a | Limited ecological value. To be lost within current proposals. | |

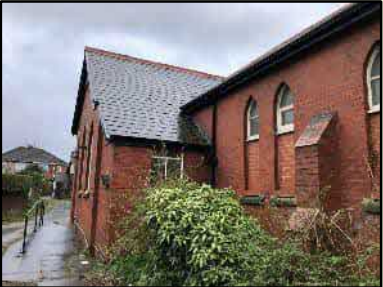
| Habitat | Description | Area (m <sup>2</sup> ) | Proportion of site (%) | Ecological Importance & Outcome of Proposal | Photograph |
|---|--|---|---|--|---|
| J.5 Buildings | Five buildings in total were located throughout the Site. See Appendix 4 for more details. | n/a | n/a | Of some ecological value. To be lost within current proposals. | <br> |

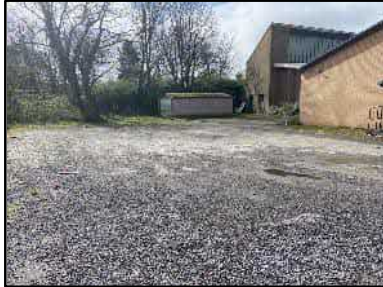
| Habitat | Description | Area (m <sup>2</sup> ) | Proportion of site (%) | Ecological Importance & Outcome of Proposal | Photograph |
|---|--|---|---|--|---|
| Hardstanding | Hardstanding is present through the majority of the Site | n/a | n/a | Negligible ecological importance. To be lost within current proposals. | |

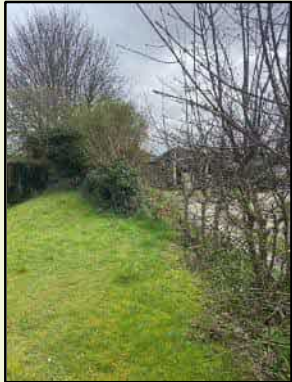
| Habitat | Description | Area (m <sup>2</sup> ) | Proportion of site (%) | Ecological Importance & Outcome of Proposal | Photograph |
|--|--|---|---|---|---|
| <p>J2.2.2<br/>Species poor defunct hedge</p> | <p>A defunct species poor hedgerow which was 3m tall and 1.5m wide was located along the southwest corner of the Site. This consisted of frequent sycamore (<i>Acer pseudoplatanus</i>), with occasional blackthorn (<i>Prunus spinosa</i>), hawthorn and oak (<i>Quercus robur</i>) rarely.</p> | <p>n/a</p> | <p>n/a</p> | <p>Limited ecological value. To be lost within current proposals.</p> | |

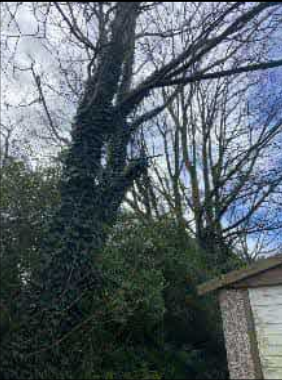
| Habitat | Description | Area (m <sup>2</sup> ) | Proportion of site (%) | Ecological Importance & Outcome of Proposal | Photograph |
|---|---|---|---|--|---|
| J2.3.2<br>Species poor hedge with trees | A species poor hedge with trees which was 2m tall and 2m wide was located along the southern border of the Site. The hedge consisted of privet ( <i>Ligustrum vulgare</i> ). Tree species were dominated by sycamore with willow ( <i>Salix alba</i> ) rarely present. The understorey was dominated by ivy with frequent common nettle and daffodil. Green alkanet and cleavers were occasionally present. Spear thistle ( <i>Cirsium vulgare</i> ) was also present but seen as rare. | n/a | n/a | Low ecological value. To be lost within current proposals. | |

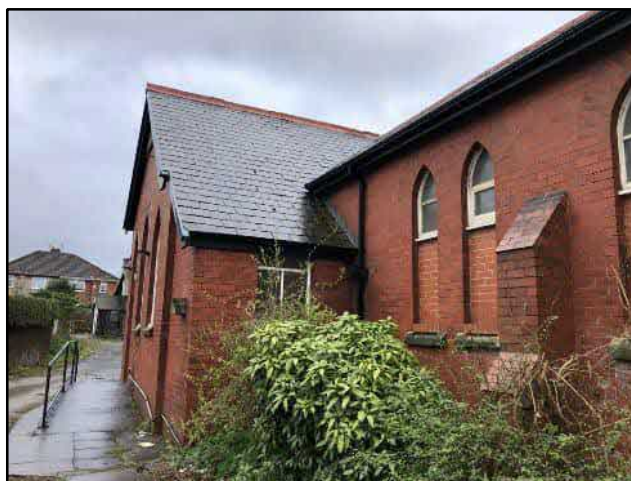
Figure 2: General View of Site

- i Building 1 was split into an older section (B1a) and a modern section (B1b) and consisted of the main former methodist church building. Buildings 2, 3, 4, 5 were a series of single storey outbuildings associated with the former Methodist Church situated to the east.
- ii A full descriptions of the buildings and their condition is given in [Table 10](#).

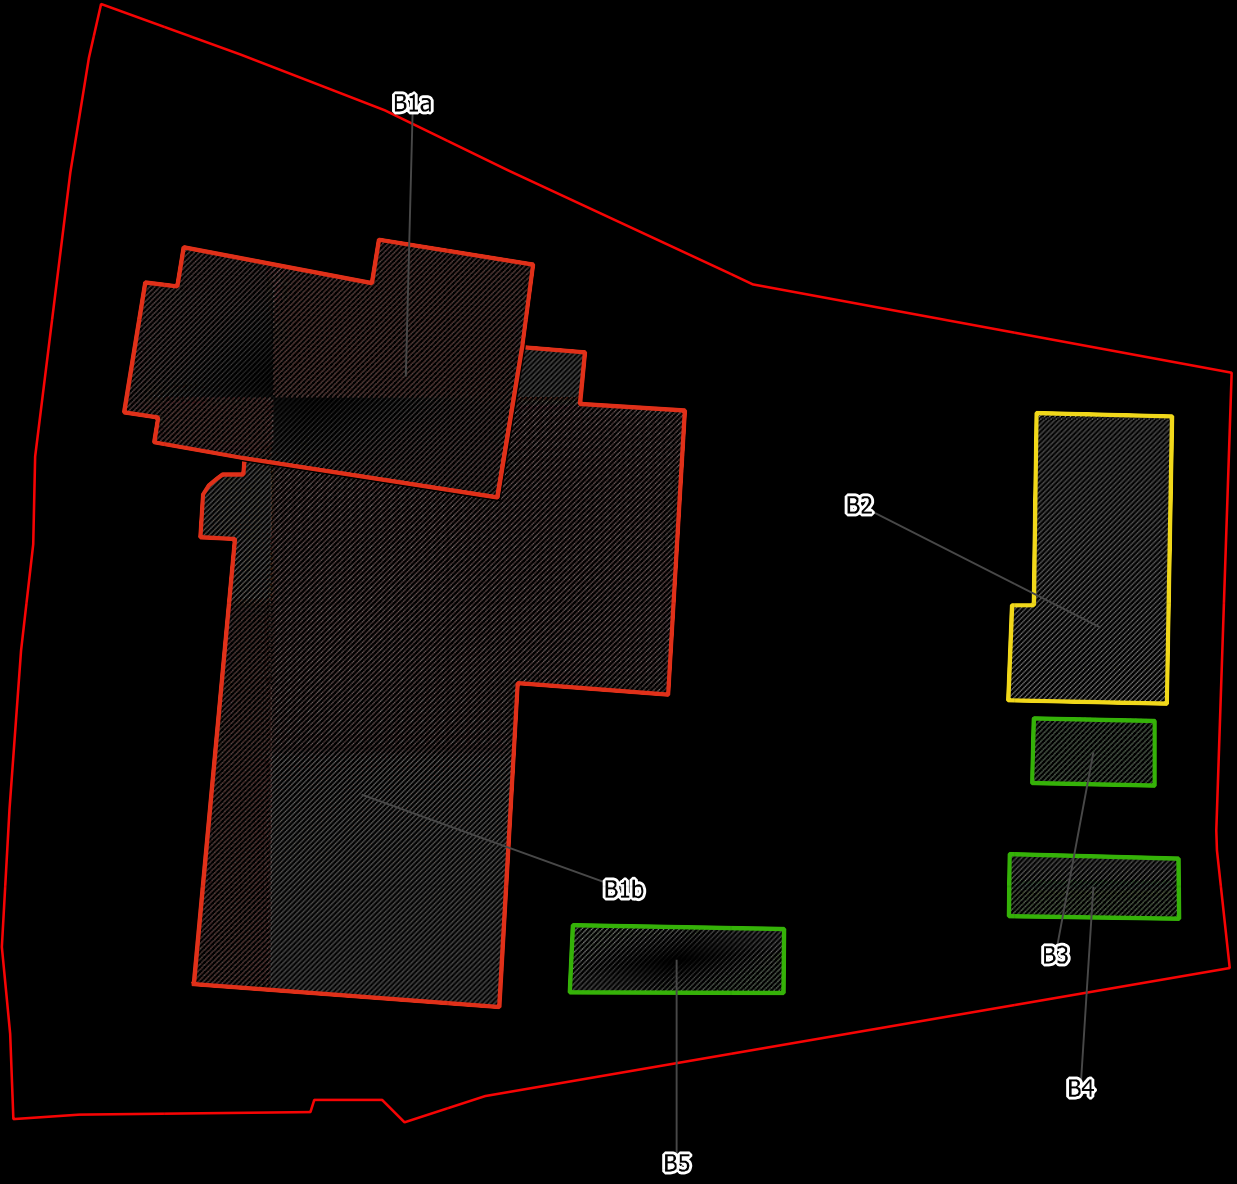
| Title: Bat Building Assessment (preliminary) | | |

- iii B1a/b was in the western section of Site. The loft area of B1a was inaccessible and thus the chance of an active roost in this section of the building could not be ruled out. Numerous potential access points were located within the interior and exterior of B1a/b and therefore the building was assessed as offering high potential to support roosting bats. B2 was located within the eastern section of Site and demonstrated a lack of suitable access points and insufficient space and shelter for large numbers of bats. As a result, B2 was assessed as offering low potential to support roosting bats. B3 and B4 located within the southeastern section of Site and B5 located within the southern portion of Site were all assessed as offering negligible potential to support roosting bats. Locations of buildings are shown in Figure 3. Full assessment results are in Appendix 4.

- ii The works should be completed following an ecologist inspection and / or dawn swarming survey (depending upon the time of year) and in the extremely unlikely event that a bat is found during redevelopment or demolition of these buildings, work should cease and a qualified ecologist should be notified immediately. No further survey work or mitigation is required for buildings 2 – 5.

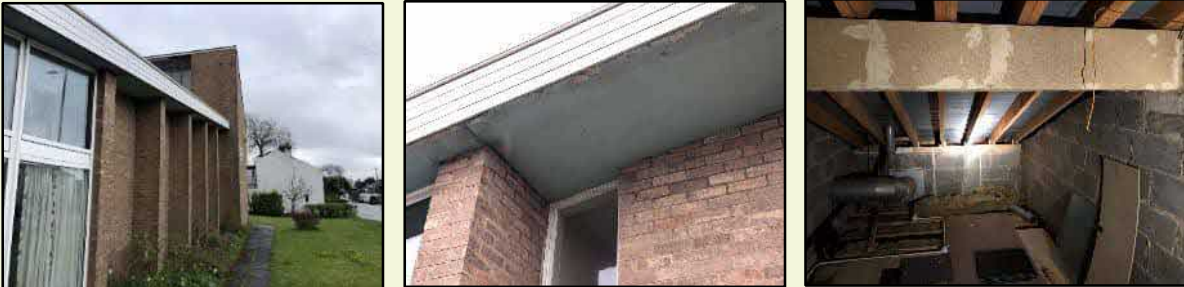
| Feature | Description | Location | Grading | Photographs |
|---|--|---|---|---|
| Building<br>B1b | <p>Single storey building, single layer bricked with pebble dash rendering and double glazed windows. Brickwork was in a good state of repair and several pvc boxes were apparent on the building starting to rot. A large hole was located on the eastern side of the building and several gaps in the mortar were present. Holes in the ceiling, a single large gap leading into the loft and gaps between timber beams were located internally.</p> | Western section of Site | High | |

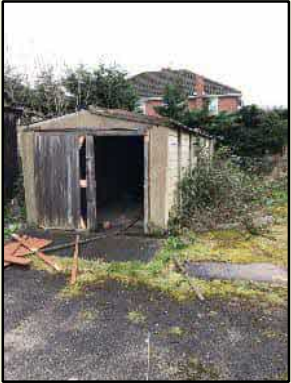
| Feature | Description | Location | Grading | Photographs |
|---|--|---|---|---|
| Building B3 | Single storey building with a corrugated roof. | Eastern section of Site, to the south of B2 | Negligible | |

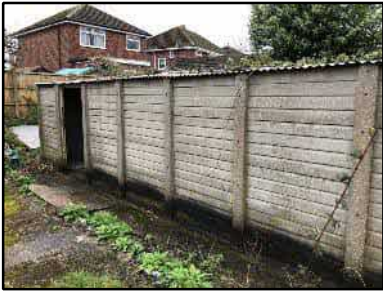
| Feature | Description | Location | Grading | Photographs |
|---|--|---|---|--|
| Building B4 | Single storey building with a corrugated roof. | Eastern section of Site, to the south of B3 | Negligible | |

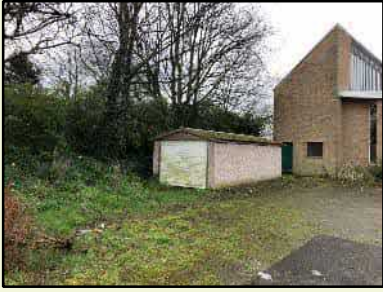
| Feature | Description | Location | Grading | Photographs |
|---|--|---|---|--|
| Building B5 | Single storey outhouse building | Southern section of Site | Negligible | |
