Maghull Methodist Church, Liverpool Phase 1 Geo-environmental Assessment

For Central England Co-operative Limited

Date: 4 July 2023 Doc. Ref: 29112-HYD-XX-XX-RP-G-1000

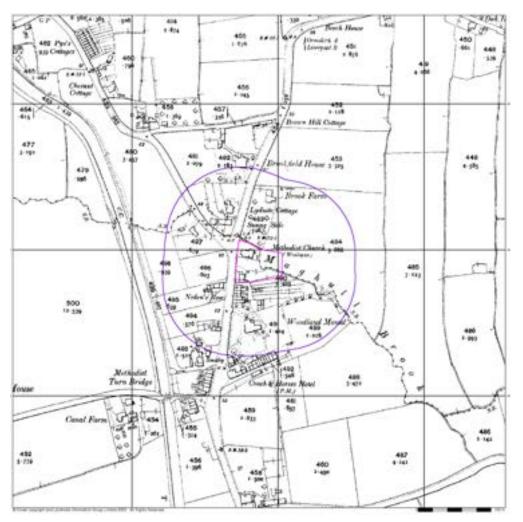
Figure 3.1: Maghull Brook (1908 1:2500 map).
