BAT, BARN OWL AND NESTING BIRD SURVEY

**1 BURLEY COURT, WELL LANE,
FALMOUTH, CORNWALL**

November 2023

Filename & issue number: BBONB_1 Burley Court, Falmouth_Final 1

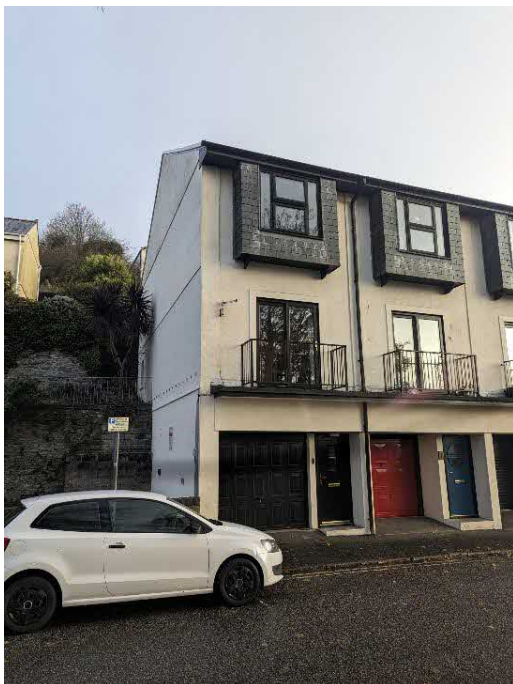
The building subject to this survey is an end of terrace, three storey high dwelling, built from rendered blockwork with a natural slate covered roof. It has a room built into the roof space and is partially built into the hillside behind. The ground floor of the building is a garage with the living space above and there is a doorway out onto the garden to the rear of the house from the 2nd floor. At 1st floor level there is a set of double doors to the front with a very small balcony and on the 2nd floor there is projection around the window clad with tight fitting hanging slates, see Photo's 1 and 2.

Photo 1. Showing the front of the house from the east

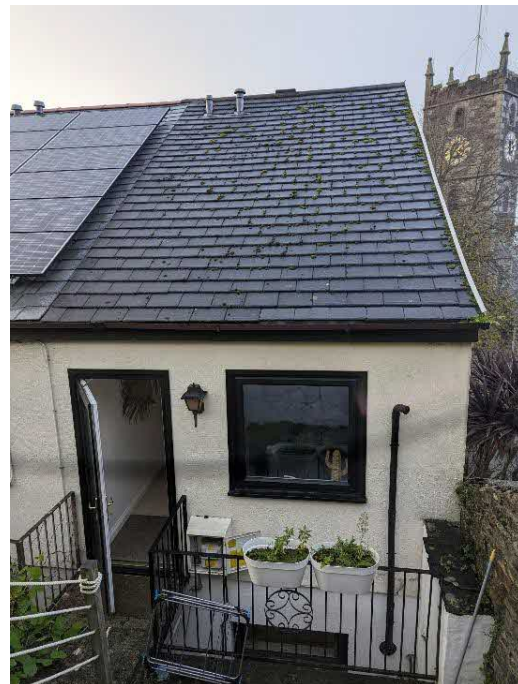
Photo 2. Showing the rear of the house from the west

Externally the building is very well sealed, the fascia boards and soffits along with the rendering on the gable end wall are tight fitting and well-sealed as is the roof covering and ridge tiles. There is a single breather vent in the roof but this has complete mesh preventing access by birds or bats.

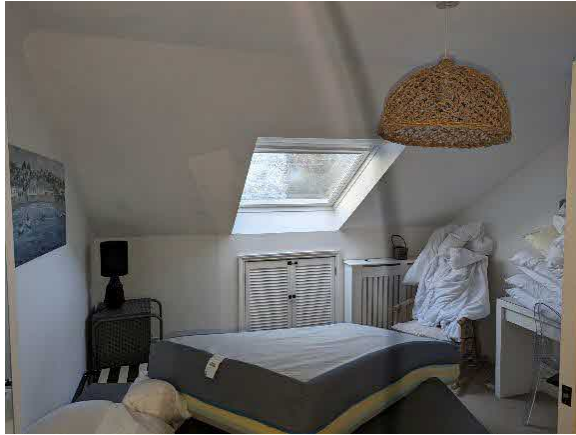
Internally there is a room built into the roof space with a small area of remaining roof void along the front edge, see Photos 3 and 4. The ceiling in this room follows the underside of the timbers supporting the roof and the remaining area of roof void is used for storage having a boarded floor and then being open to the underside of the roof which is lined with black breathable roofing membrane.

**Photo 3. Showing the room built into
the roof space**

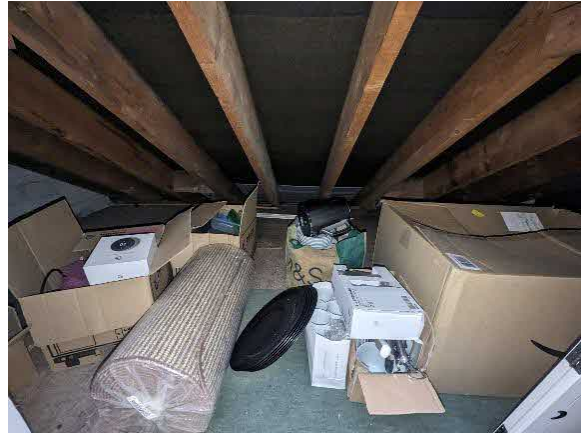
**Photo 4. Showing the remaining
area of roof void to the front**

The conversion of the roof space meant that there were areas of the roof void which were enclosed and could not be inspected but the building appeared well sealed and the exterior was fully inspected from the ground.
