Drakes House, Gatcombe, Blakeney

Design and Access Statement.

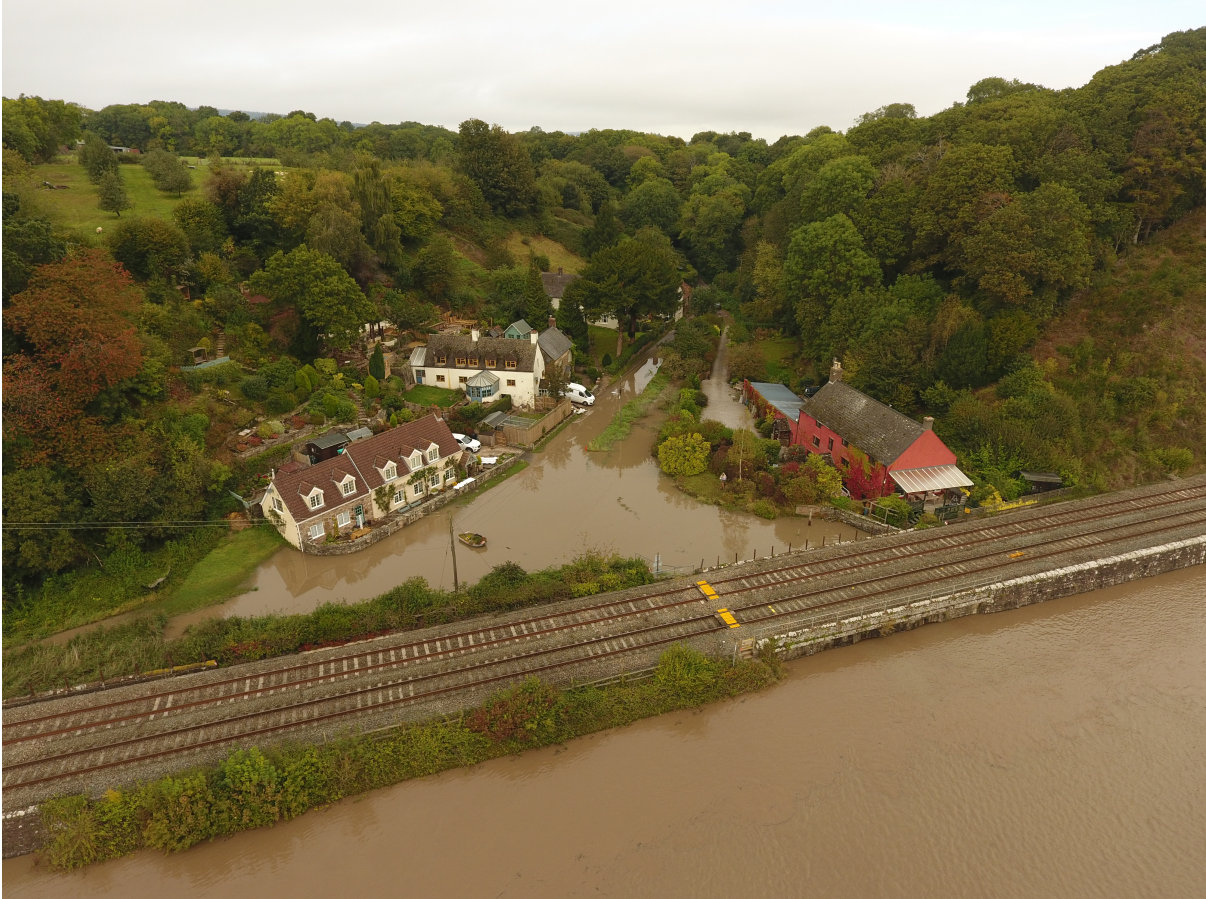
Gatcombe pill at high tide. Drakes house is the pink house on the right.

Drakes house is currently painted in a very dark pink red colour, using a ‘Santex’ paint. This is a plastic coating, which traps water. The paint was applied in the 2000’s and replaced a paler emulsion. The present colour is not historic. We will replace this with a much paler

and historically more authentic pale pink, included as a pigment in the lime render / limewash coating.

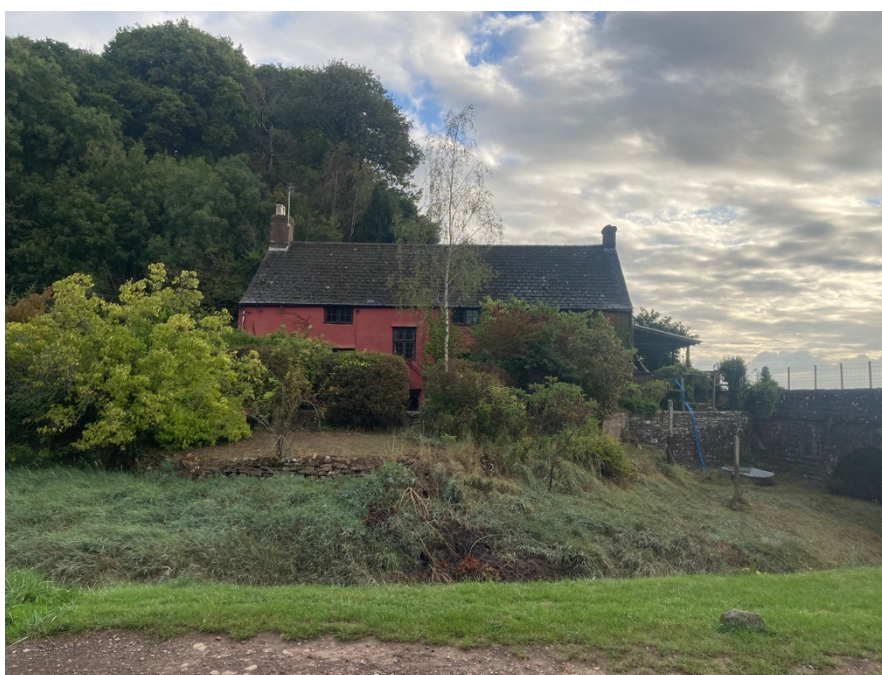
Drakes House, from the Gatcombe 'turning circle' and Severn Way. The exterior view will be unaffected, with the exception of a historically informed paint.

As part of this application we intend to enhance the heritage aspects of the property, by restoring a more authentic colour scheme for the exterior and replacing three unsightly UPVC windows on the East Wall with wooden mullions. A neutral, but minimal change, will involve the relocation of the present Aga flue to service the restored ground floor fireplace on the east wall of the house. Otherwise, the external appearance of the building will remain unchanged.
