Oriel Cottage
51 Doultong
Shepton Mallet
Somerset
BA4 4QE

Preliminary Bat Roost Assessment

October 2022

Reference: SC_002_R01_Oriel Cottage_PRA

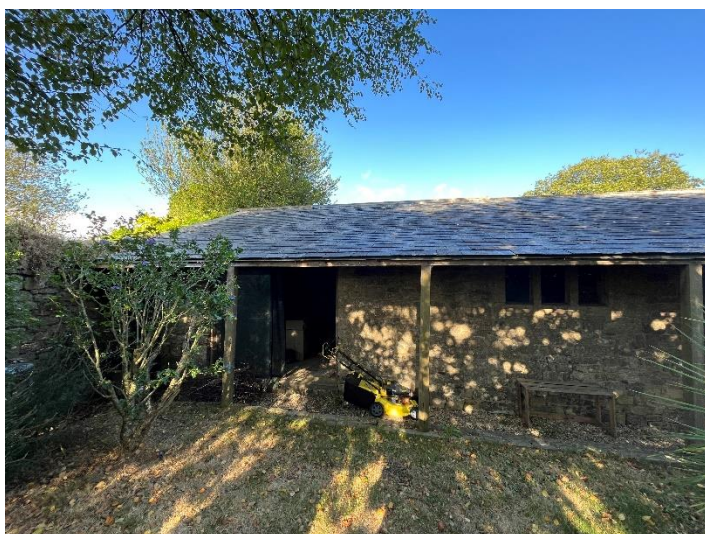
The site comprises a single storey, stone built building with a half pitched, slate tiled roof used as an outbuilding (Figure 2). Gaps are present where the roof of the building meets the stone wall along the western aspect of the building, and the roof overhangs a hardstanding path along the edge of the building. Externally, windows are located along the western aspect and access is gained via a stable door to the south and glass patio doors to the north (Figure 2). Both of these doors are open for the majority of the time providing internal access into the building. The building is connected in parts to an adjacent building to the east of the site where lead flashing is present. A number of tiles are slightly raised and a gap between the flashing and gable is present on the north western aspect (Figure 3).

Figure 2: External view of barn surrounded by residential garden with glass door

The outbuilding has a number of features which have the potential to support roosting bats, including access into the internal space. It is therefore considered to have **moderate potential** to support roosting bats.

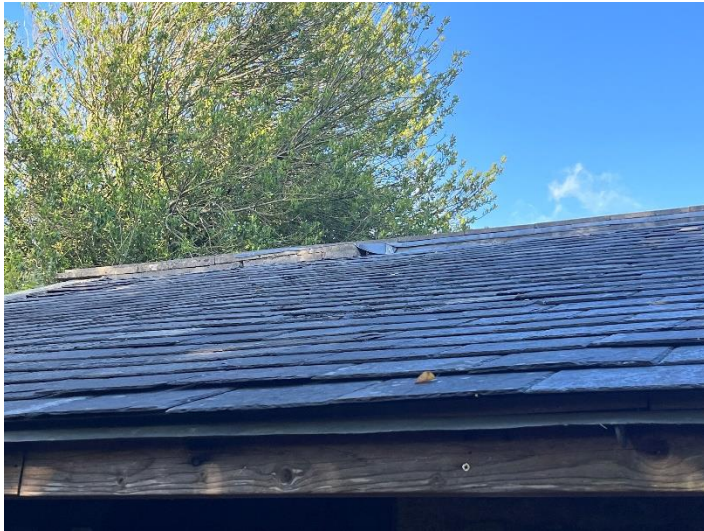
Figure 3: Raised tiles and gap beneath lead flashing at the northern end of the building

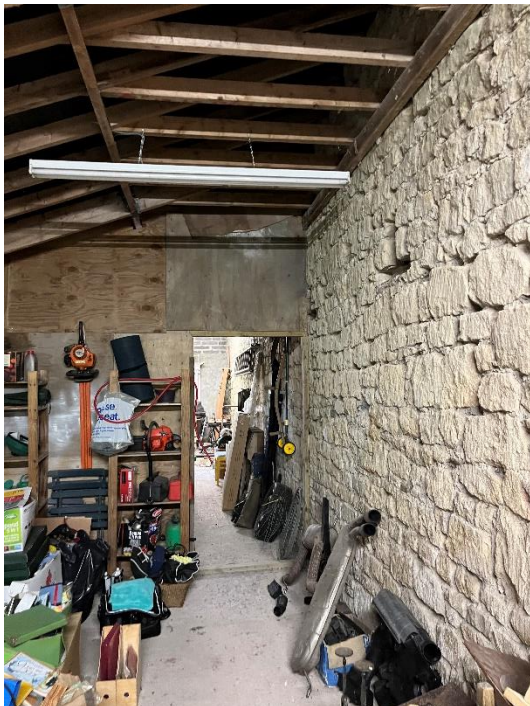
Internally, the building is open to the wooden rafters and the tiles are backed by felt. Generally, the felt is in a good state of repair and used regularly by the current tenants of the main property for storage and a workshop (Figure . Internally, light enters through the windows and doors and a draft runs through the building from the two open doors and gaps above the eastern wall. A number of shallow holes are present within the stonework along the internal eastern wall.

Figure 4: Internal view of building

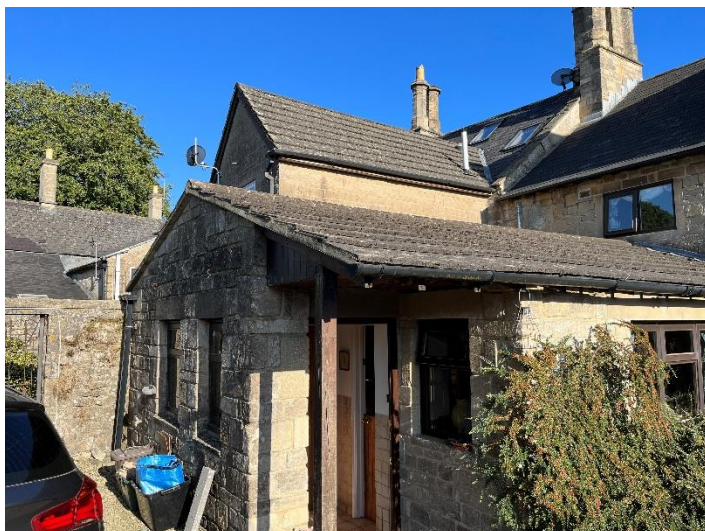
Immediately to the south of the building is an area of hardstanding used for parking, then a single storey, brick built building which forms the kitchen and utility area to the main property (Figure 5). This adjoins to the terraced houses along Church Lane. The kitchen and utility area of the main house has a pitched, tiled roof with wooden soffits and lead flashing present where the building adjoins the terraced property. The main property is in a good state of repair and was assessed as providing **negligible potential** to support roosting bats.

Figure 5: External view of kitchen and utility building of the main house

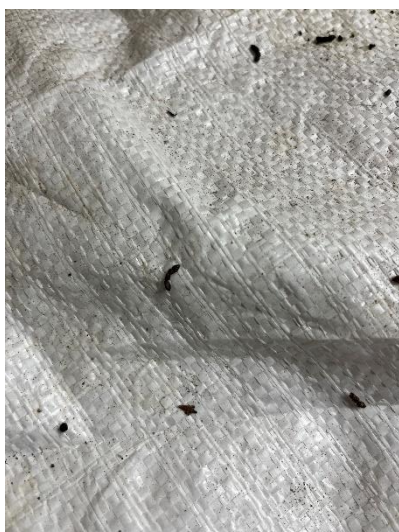
During the internal inspection on the 25th August 2022, an individual lesser horseshoe bat *R. hipposideros* was recorded hanging from a wooden beam within the outbuilding. Approximately 10 droppings which are characteristic of a lesser horseshoe were also observed beneath the lesser horseshoe bat (Figure 6). During the second emergence survey on the 20th September 2022, an individual lesser horseshoe bat was again observed within the building with a scattering of approximately 10 further droppings characteristic of the species.

Figure 6: Scattered lesser horseshoe bat droppings within the outbuilding

Due to the loss of the protection afforded to roosting bats, a Natural England development licence will need to be applied for once planning consent is granted. This licence will ensure that no bats are killed or injured during the construction phase of the development. Both roosts are considered to be of low conservation significance, therefore a Bat Mitigation Class Licence CL21 (BMCL) can be applied for.

The BMCL will be applied for prior to work commencing. The BMCL registered ecologist on the approved licence will attend the site to carry out an inspection of all roost features to check for any bats present. The methods of working will include:

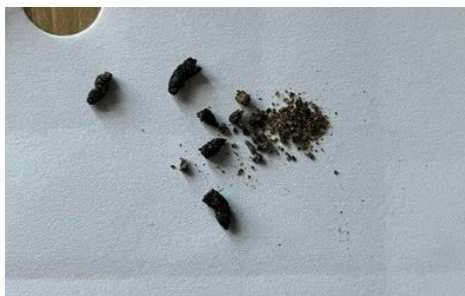
During the second survey, a further scattering of 5 droppings were also recorded within the building beneath a wooden beam within the north of the building. The droppings are black in colour, 6-7 mm in length and 2.3 mm wide, medium in size with medium particles. Overall, given the dropping shape, size, particle size, roost type and location, the droppings are characteristic of a whiskered bat *Myotis mystacinus* (Figure 7). Apart from the lesser horseshoe bat, no other bats were identified within the building.

Figure 7: Droppings characteristic of whiskered bat
