**GEO-ENVIRONMENTAL INVESTIGATION  
FACTUAL REPORT**

**Lunan Park,  
Guthrie Street  
Friockheim**

**SITE WORKS BETWEEN The 3<sup>RD</sup> October – 4<sup>TH</sup> October 2022**

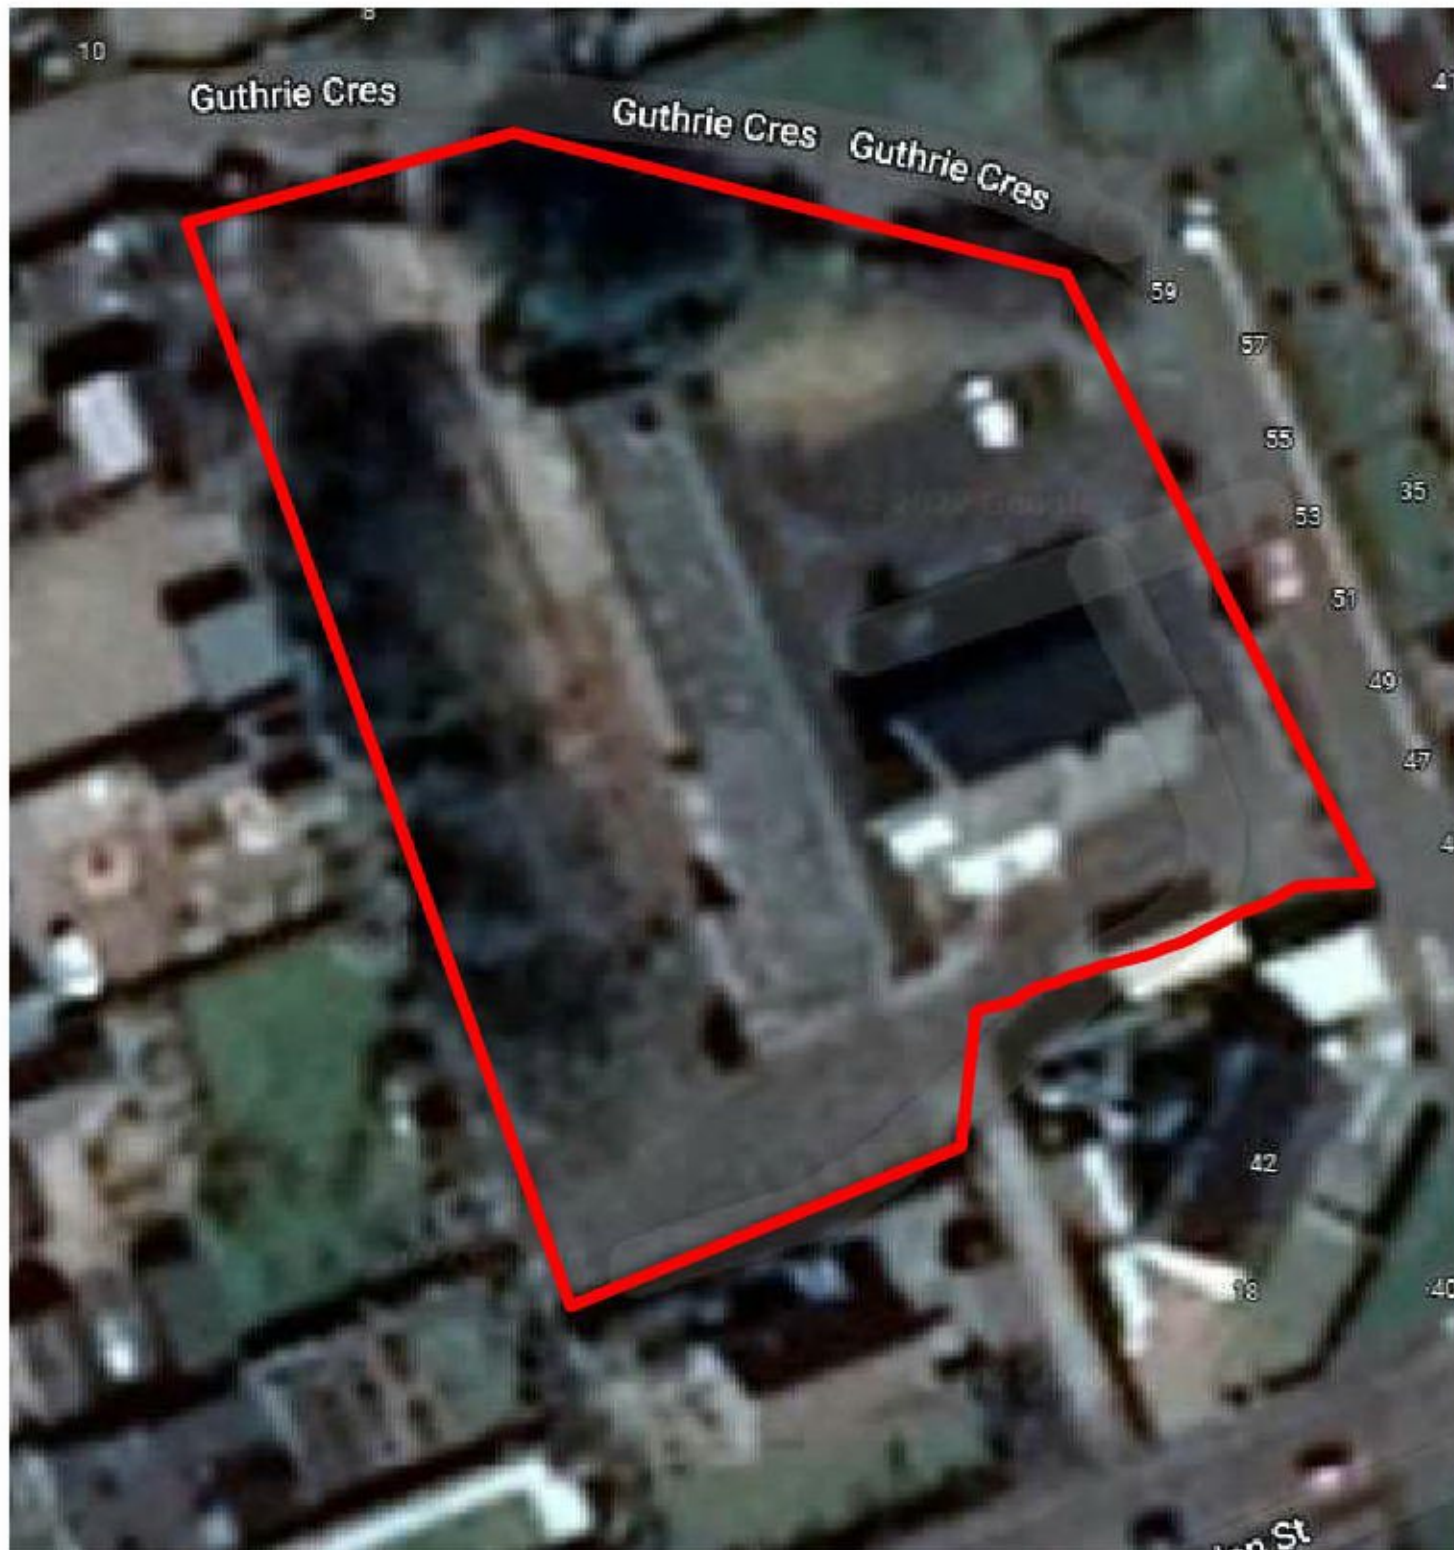
Figure 1 – Approximate site boundary is outlined in the google satellite image above in red.

Grampian Geotechnical were appointed by Fairhurst to complete a site investigation for the proposed development at Lunan Park, Guthrie Street, Friockheim (Approximately Centred at OS Grid Ref NO 59660 50042)
