Excavation Method 8 T Tracked Excavator	Dimensions 0.60m x 3.0m x Terminal Depth	Ground Level (mOD) 44.90	Client Fairhurst	Job Number 3764-22
	Location (Handheld GPS) 359643.988 E 750054.816 N	Dates 04/10/2022	Project Contractor Grampian Geotechnical	Sheet 1/1

Site : Lunan Park, Guthrie Street, Frickheim

Job Number
3764-22

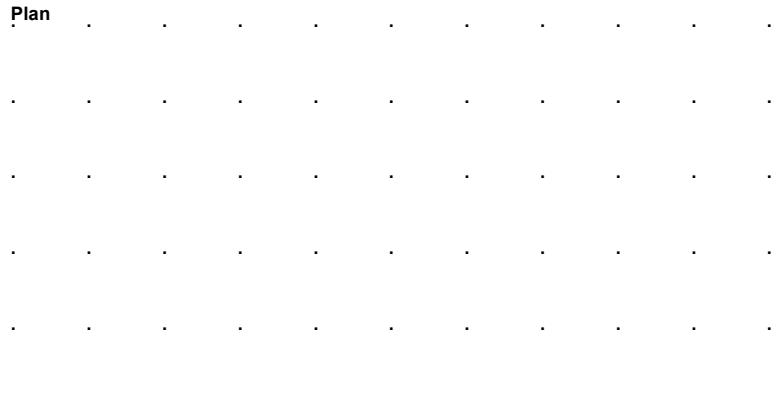
Depth (m)	Sample / Tests	Water Depth (m)	Field Records	Level (mOD)	Depth (m) (Thickness)	Description	Legend	Water
1.00-1.00	B1			44.40	(0.50)	Dark brown sandy SILT. Common rootlets, fibrous roots and roots

2.00-2.00	B2				(2.30)	Orangish light brown very sandy fine to coarse GRAVEL medium cobble fine to coarse sands

3.00-3.00	B3			42.10	(1.10)	Brown very gravelly medium to coarse SAND with medium cobble low boulder. Gravel is fine to coarse rounded to subangular, cobble and boulder are rounded to subangular.

3.90-3.90	B4			41.00	3.90	Complete at 3.90m

Remarks Location CAT scanned prior to excavation Weather: Overcast Light Rain ~14C Stable sidewalls No water ingress Sampling B = Bulk Disturbed Hole terminated at 3.80mbGL due to mechanical limitations. Pit orientation East		
	Scale (approx) 1:40	Logged By JP & JA	Figure No. TP04

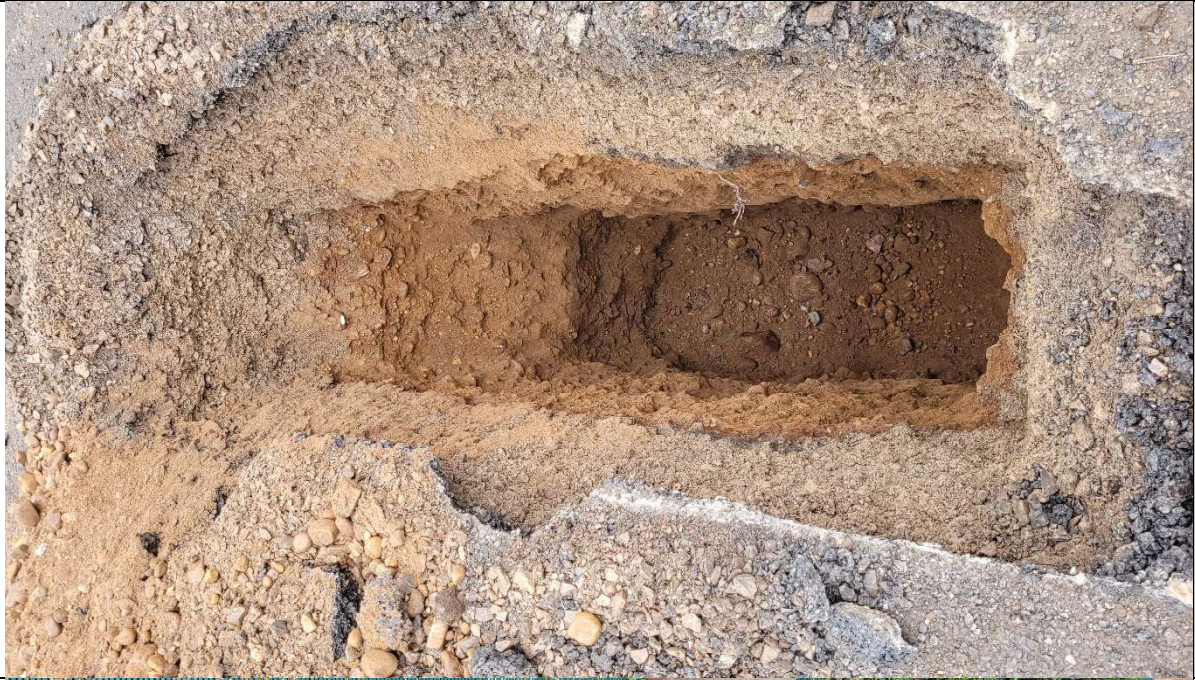
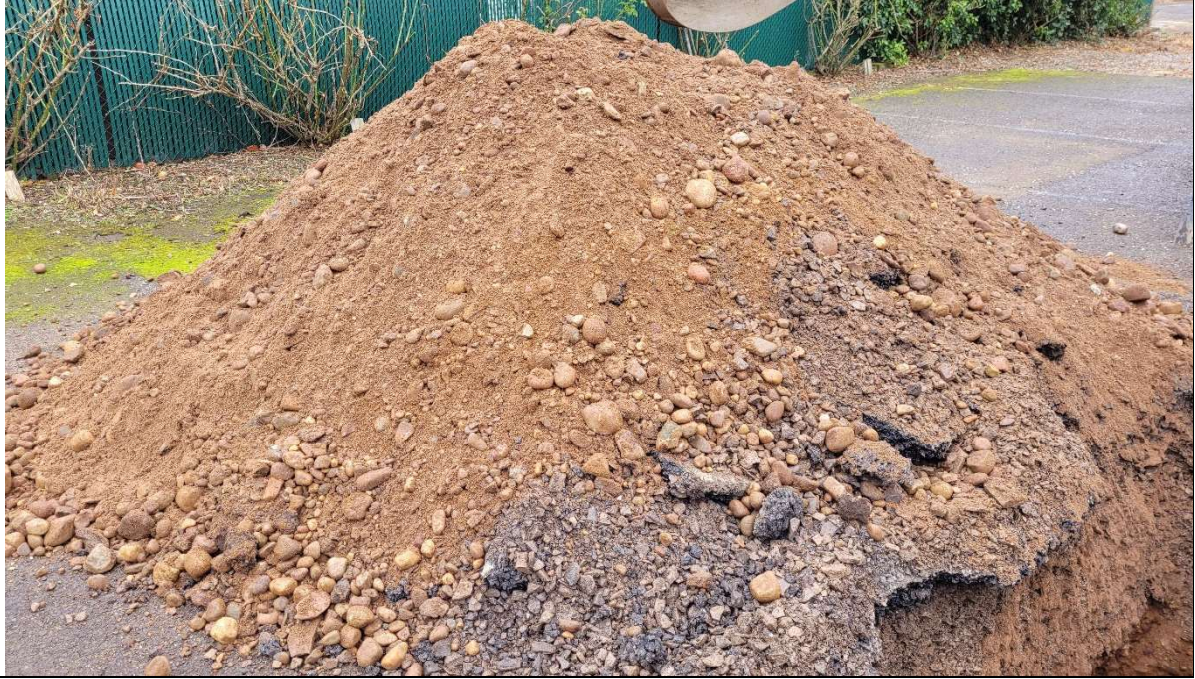
Depth (m)	Sample / Tests	Water Depth (m)	Field Records	Level (mOD)	Depth (m) (Thickness)	Description	Legend	Water
0.70-0.70	E1			44.47	0.10	FILL - Asphalt

(0.50)	FILL - Light Brown slightly silty slightly sandy GRAVEL. Sand is fine to coarse, gravel is sub angular to angular (MADE GROUND)

1.00-1.00	B1			43.97	0.60	Dark brown sandy slightly gravelly SILT. Sand is fine (possible relict topsoil)

43.77	0.80	Orangish Brown very sandy GRAVEL with medium coble. Sand is fine to coarse, gravel is fine to coarse rounded to subangular, coble is rounded to subangular.

2.00-2.00	B2				(3.00)			
3.50-3.50	B3			40.77	3.80	Complete at 3.80m

Plan .	Remarks Location CAT scanned prior to excavation Weather: Overcast ~14C Stable sidewalls No water ingress Sampling B = Bulk Disturbed Sampling E = Environmental sample disturbed Pit orientation East Terminated at 3.80 mbGL due to mechanical limitations		
		<table border="1"> <tr> <td>Scale (approx) 1:40</td> <td>Logged By JP & JA</td> <td>Figure No. TP05</td> </tr> </table>	Scale (approx) 1:40
Scale (approx) 1:40	Logged By JP & JA	Figure No. TP05

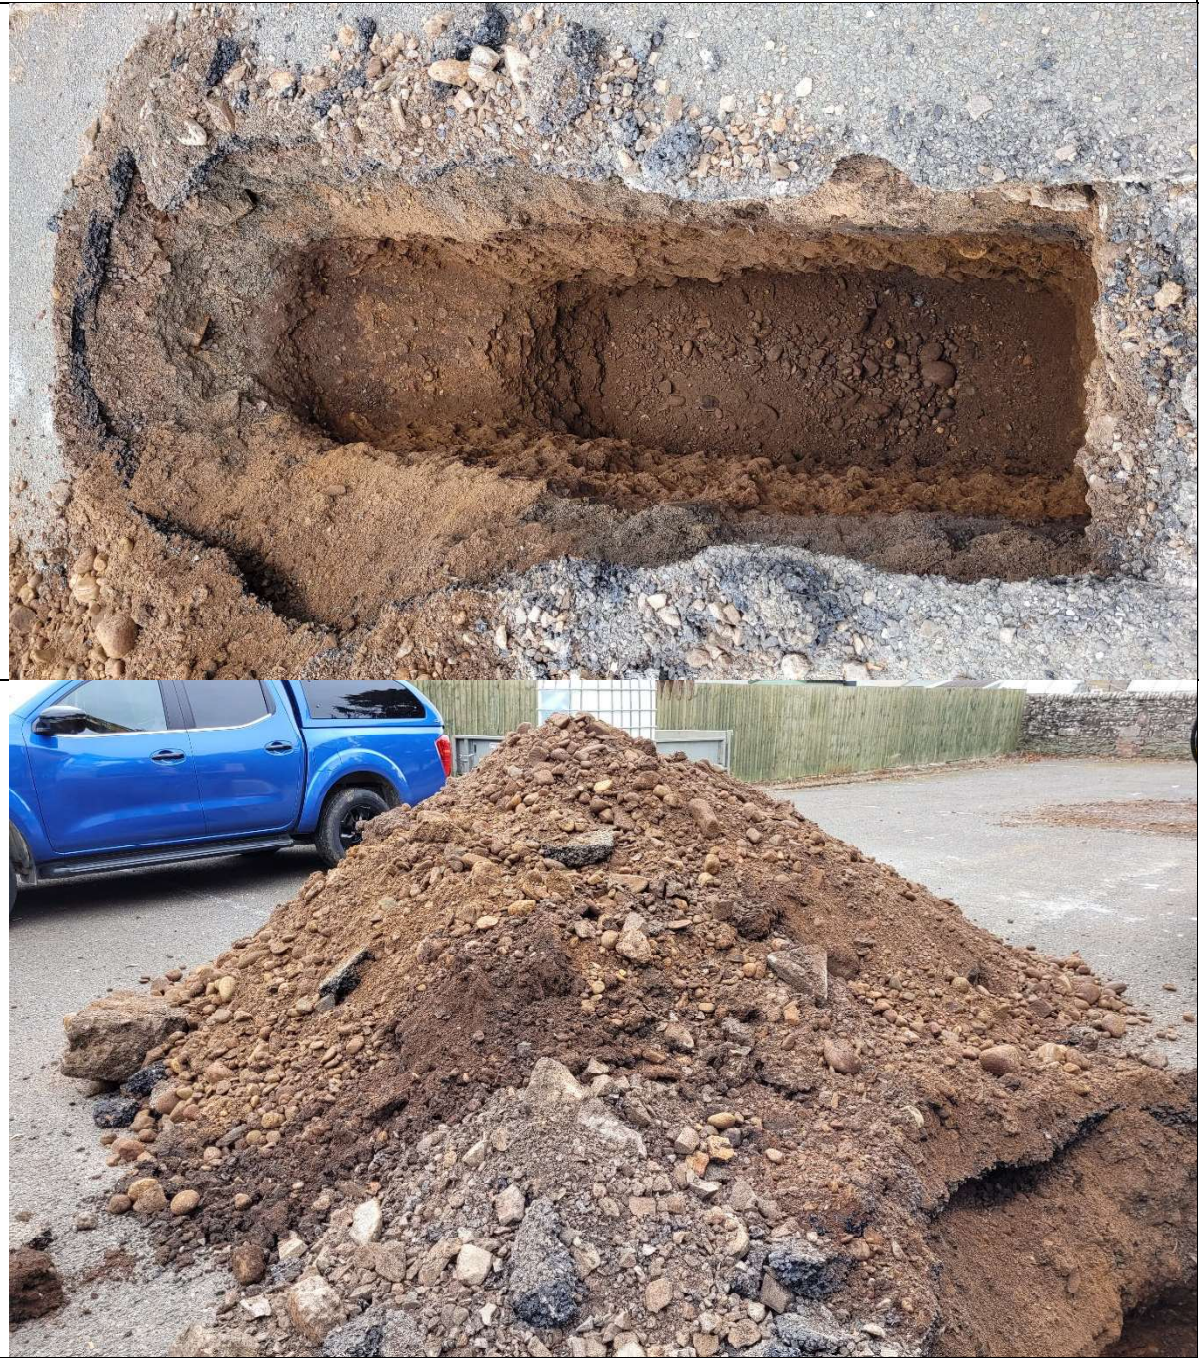
Depth (m)	Sample / Tests	Water Depth (m)	Field Records	Level (mOD)	Depth (m) (Thickness)	Description	Legend	Water
0.60-0.60	E1			44.68	0.09	FILL - Asphalt

(0.39)	FILL - Light brown slightly silty slightly sandy GRAVEL. Gravel is fine to medium sub angular to angular grains

44.29	0.48	MADE GROUND

(0.37)	Dark brown very silty fine to medium SAND (possible relict topsoil)

1.00-1.00	B1			43.92	0.85	Orangish brown very sandy GRAVEL with medium coble. Sand is fine to medium, gravel is fine to coarse rounded to subangular grains.

2.00-2.00	B2				(3.15)			
3.00-3.00	B3							
4.00-4.00	B4			40.77	4.00	Complete at 4.00m

Plan	<p>Remarks</p> <p>Location CAT scanned prior to excavation Weather: Overcast ~14C Stable sidewalls No water ingress Sampling B = Bulk Disturbed Sampling E = Environmental sample disturbed Pit orientation East</p>		
		<table border="1"> <tr> <td>Scale (approx) 1:40</td> <td>Logged By JP & JA</td> <td>Figure No. TP06</td> </tr> </table>	Scale (approx) 1:40
Scale (approx) 1:40	Logged By JP & JA	Figure No. TP06

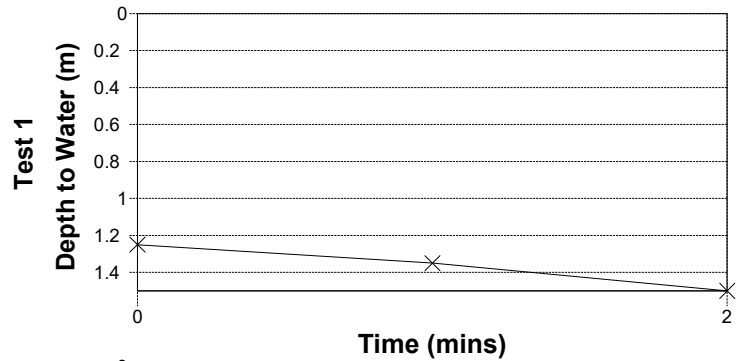
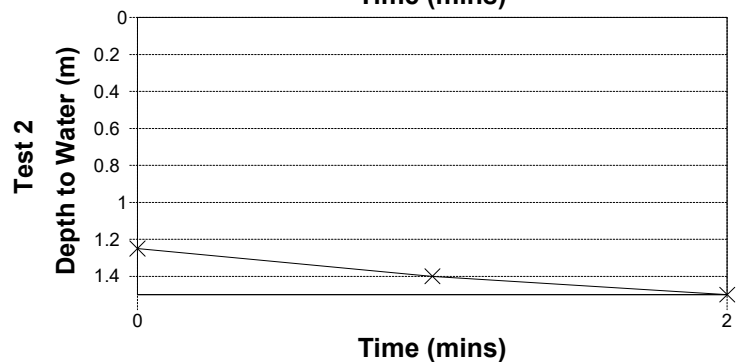
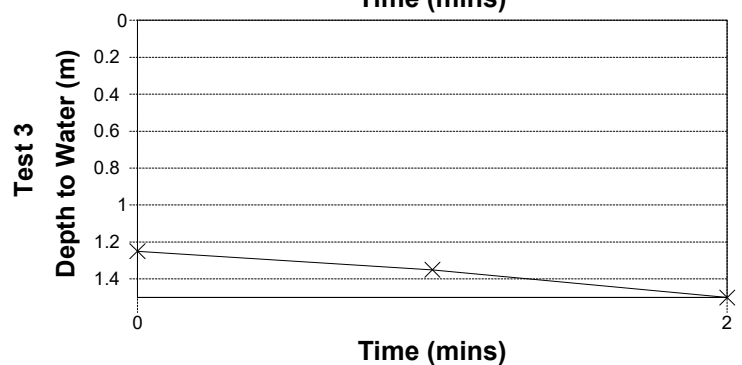
Location	Date	Level	Location
SA03	03/10/2022	44.74 mOD	E: 359657 N: 750029

Soil type at test level	very sandy GRAVEL
Groundwater	
Drain discharge depth	0.5
Sidewall stability	Stable
Stone filled or open pit	Open pit

1	2	3
Effective depth (m)	0.25	0.25	0.25
Volume outflowing between 75% & 25% (m3)	0.08	0.08	0.08
Mean surface area through which outflow occurs (m2)	1.00	1.00	1.00
Time for outflow between 75% & 25% (min)	0.95	0.96	0.95
SOIL INFILTRATION RATE (ms-1), f	1.32E-3	1.30E-3	1.32E-3

Rate of infiltration was so great that pit could not be filled to complete test.

Elapsed time (mins)	Depth to Water		
	Test 1	Test 2	Test 3
0	1.25	1.25	1.25
1	1.35	1.40	1.35
2	1.50	1.50	1.50
